**CONCRETE BARRIER DISTRESS
IN LA GRANDE, OREGON**

Final Report

PROJECT SR 500-211

Amanda Joy Bush
Oregon Department of Transportation
Research Unit
200 Hawthorne Ave. SE, Suite B-240
Salem OR 97301-5192

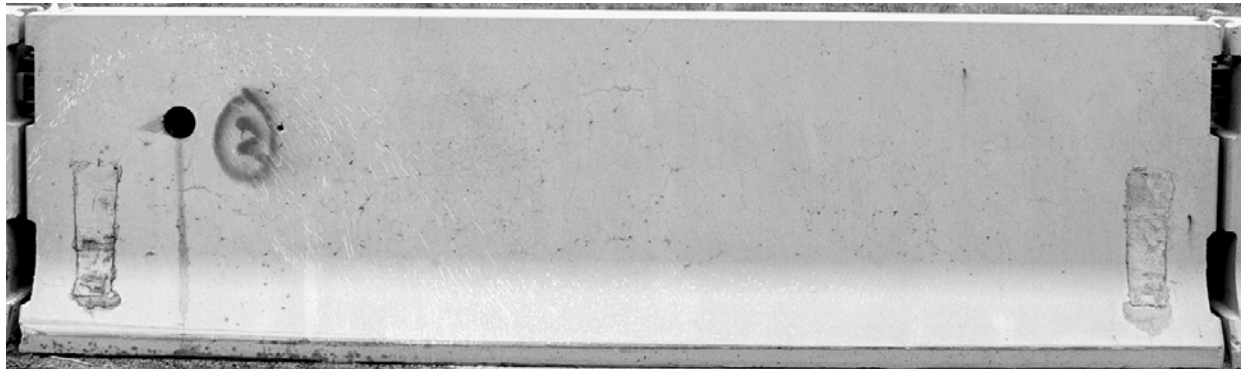
Figure 3.2: Overview photograph of barrier 002 in the Ladd Canyon project area

Core 002 was extracted from the upper, eastern portion, of barrier 002 (Figure 3.2). The core was removed intact. Minimal surface map cracking was observed over the entire surface of the barrier. Approximately 5-10 low severity horizontal and transverse cracks were observed, averaging 2-6 inches in length. At the top of the barrier, small portions of the latex paint coating had come off, apparently where it had not bonded well with the aggregate. Iron oxide was concentrated around two exposed staples.

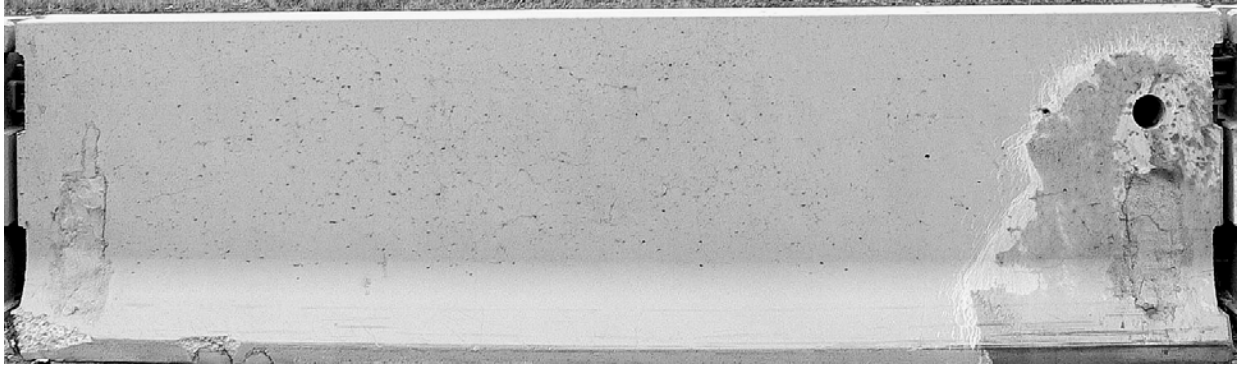
Figure 3.3: Overview photograph of barrier 003 in the Ladd Canyon project area

Core 003 was removed from the west end of barrier 003 (Figure 3.3). The core was taken intact. The surface face of the core included a staple surrounded by rust. Several reinforcing steel elements were included in the interior of the sample. Overall, this barrier had less cracking than 002, and the paint was in better condition. Aggregate was exposed in the lower, eastern, portions of the barrier. These areas were likely damaged by a snow plow.

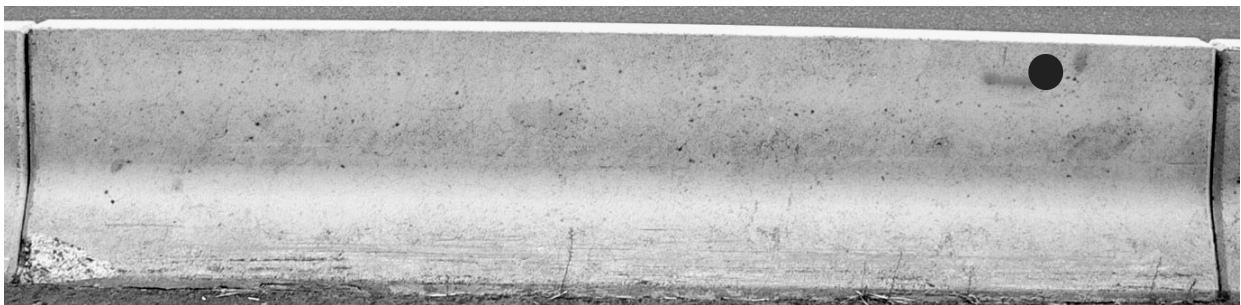
Figure 3.4: Overview photograph of barrier 005 in the Lower Meacham project area

One core sample (005) was extracted from the Lower Meacham project area. This core sample was sent to the lab for petrographic analysis and comparison. The sample was removed intact from the western portion of the barrier, at the upper section (Figure 3.4). There was no apparent transverse or horizontal cracking on the surface of the barrier, but there were a few small map cracked areas. The lower, eastern corner of the barrier was broken off, likely by a snowplow blade.

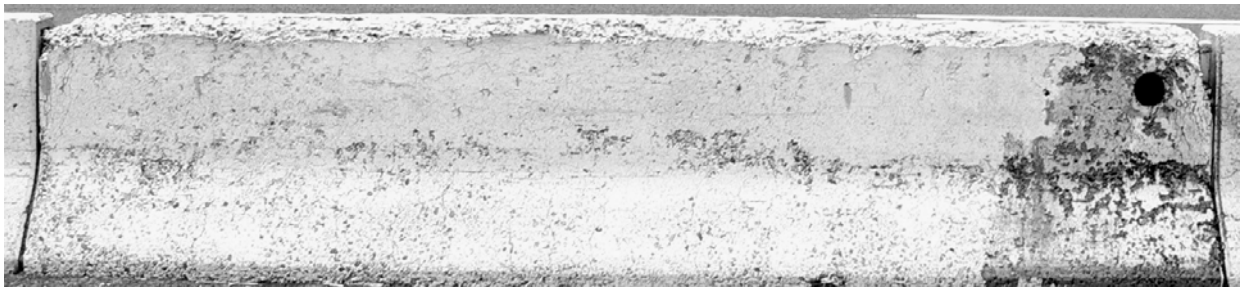
Figure 3.5: Overview photograph of barrier 007 in the Upper Meacham Project Area

The distress seen in barrier 007 was some of the most advanced noted during the field study (Figure 3.5). Several transverse cracks were observed, averaging 1 foot in length. Roughly the same number of horizontal cracks, as transverse cracks, (5-10) were also observed, but these cracks were much longer, averaging 7-10 feet. The transverse and horizontal cracks were of medium severity (width: greater than 3 mm, but less than 13 mm). Map cracking was present the entire length of the upper 6-inches of the barrier and occurred sporadically across the surface.

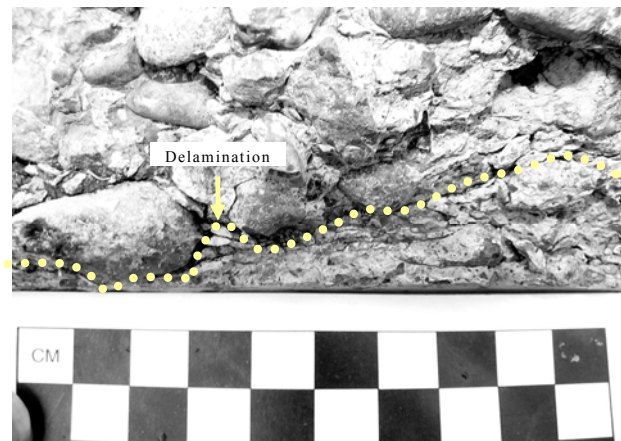
Both the east and west upper corners of barrier 007 had disintegrated and were missing. Rebar was exposed in both areas. The top surface of the barrier was scaled, and the coating had worn off. The coating in other places had delaminated from the barrier surface. This was the case across the length of the barrier in the upper 6-inches. This delaminated area is depicted in Figure 3.6. The photograph was taken looking down at the top of the barrier. The scale that is depicted is abutted against the outside surface/face of the barrier. Core sample 007 included a portion of this delaminated section.

Figure 3.6: Plan view photograph of delaminated portion of barrier 007 in Upper Meacham

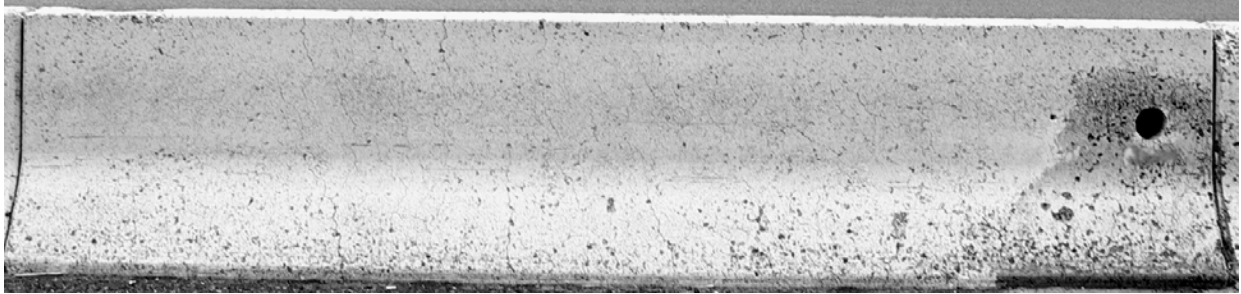
Figure 3.7: Overview photograph of barrier 008 in the Upper Meacham Project Area

In the Upper Meacham project area, Core 008 was also sent in for petrographic analysis. The core was removed intact from the mid section of the east end of barrier 008 (Figure 3.7). There was little to no disintegration of the corners of this barrier. The severity of horizontal cracking

was low, though many horizontal cracks (10-20) were present. Transverse cracking, on the other hand, was abundant (25-30), and was of medium severity. Map cracking appeared to be particularly severe in the eastern portion of the barrier, but occurred throughout the entire surface. Much of the surface coating was worn and aggregate was exposed.

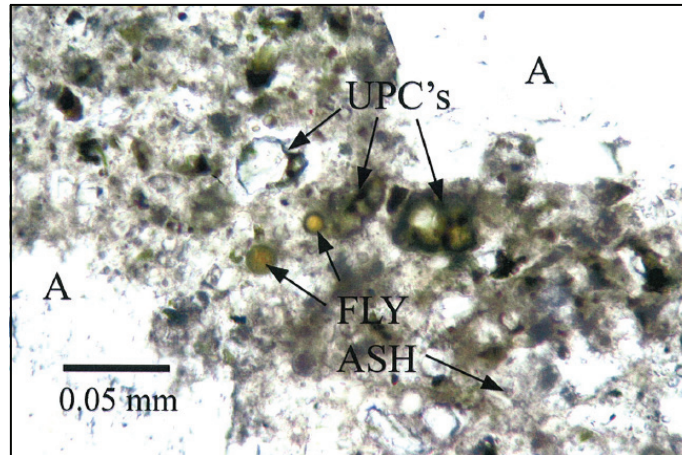
Cores 002 and 003, from Ladd Canyon, were examined. The cores exhibited overall good paste hardness. The samples were bound with Portland cement and fly ash (Figure 4.2). The presence of fly ash in these cores prompted additional testing for alkali-silica reactivity (ASR). A Gel Fluorescence Test of Core 003 yielded no ASR gel products.

Figure 4.2: Micrograph thin-section of Core 003 showing fly ash spheres, aggregate (A), and un-hydrated Portland cement particles (UPC's)

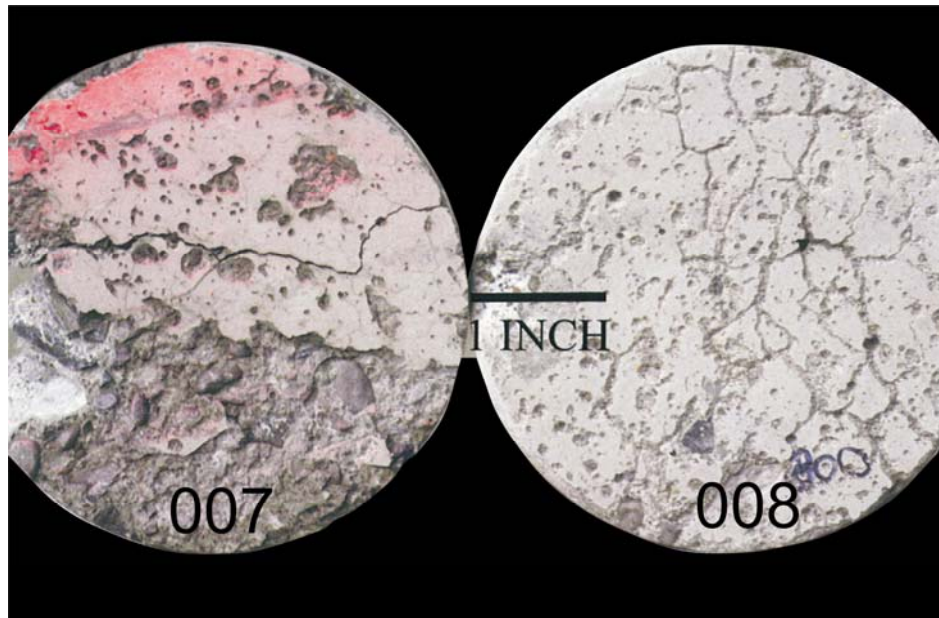
Cores 007 and 008, from Upper Meacham, were examined. While the surface face of the core samples from both Ladd Canyon and Lower Meacham was relatively smooth, visible signs of distress (cracking, delamination, popouts, and disintegration) were immediately evident on the surface faces of Cores 007 and 008 (Figure 4.3).

Figure 4.3: Exposed surface face of core samples 007 and 008

The Upper Meacham cores exhibited advanced signs of distress. Abundant cracks were observed with the unaided eye, and an abundant amount of additional fine microcracks were noted (Figure 4.4). These cracks mostly paralleled the exterior vertical surface of the cores and passed through the paste. A few cracks were noted to propagate through the aggregate as well. The widths of the cracks varied from 0.001 to 0.005 inch wide. Vertical cracks in Core 007 were up to 2 inches deep and were 1 inch deep in Core 008.

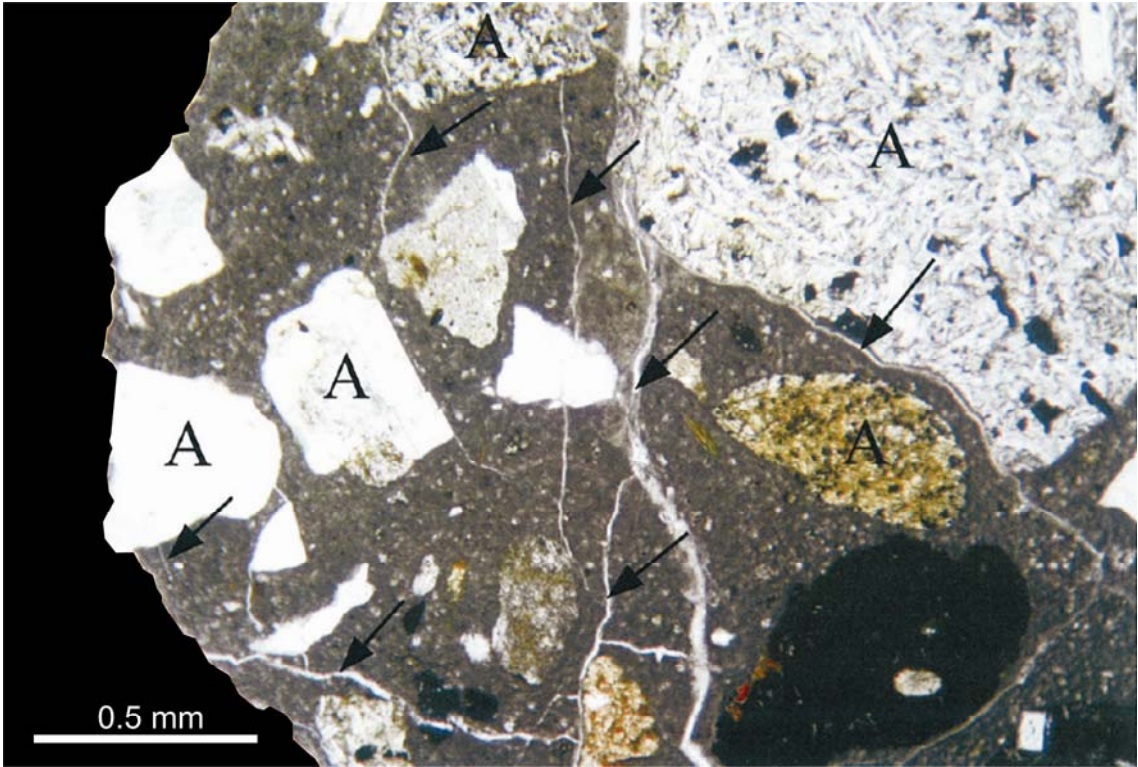
The air void system in both samples was uneven and was well below the 4-7 percent prescribed in ODOT specifications (2002) – 1-2 percent in Core 007, and 2-3 percent in Core 008. Water to cement ratios were consistent with samples from both Ladd Canyon and Lower Meacham (0.40-0.45). The deepest level of carbonation, $\frac{1}{2}$ inch, was seen in Core 007, with a pH of 4-7. The pH for Core 008 was 7-8. A Gel Fluorescence test was done on Core 008 to check for ASR gel products, and none were detected. Total chloride concentrations for Cores 007 and 008 were low, 0.003 percent and 0.008 percent respectively.

Figure 4.4: Micrograph thin-section of Core 007 showing cracks (indicated by arrows) and aggregate (A)
