FIELD EVALUATION OF FLY ASH IN  
AGGREGATE SHOULDER MATERIALS

Final Report

Research Report No. 177

Conducted by  
LOUISIANA DEPARTMENT OF TRANSPORTATION  
AND DEVELOPMENT  
Research and Development Section  
In Cooperation with  
U. S. Department of Transportation  
FEDERAL HIGHWAY ADMINISTRATION

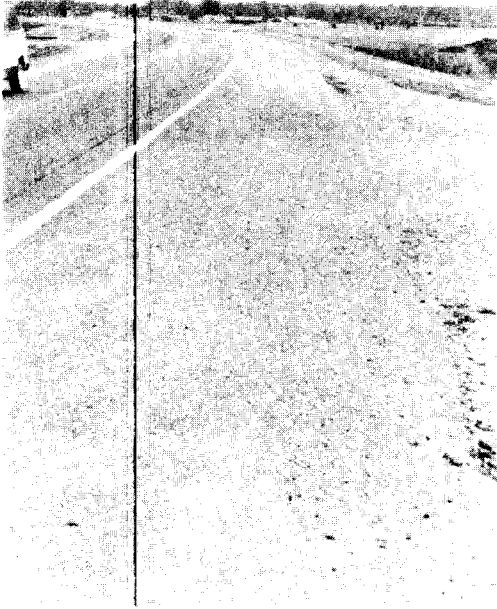
*FIGURE 4*

Sand Clay Gravel Test Sections - The physical condition of all the test sections at site 1 after more than four years of performance is very good. The typical physical condition of each test section is shown in Figures 4 through 6. The only unusual feature in any test section is one shrinkage crack, shown in Figure 6A, that appeared in the 18 percent section between one and two years after construction. There are no visual differences between any two sections, regardless of percent fly ash added.

*6% Fly Ash 1*

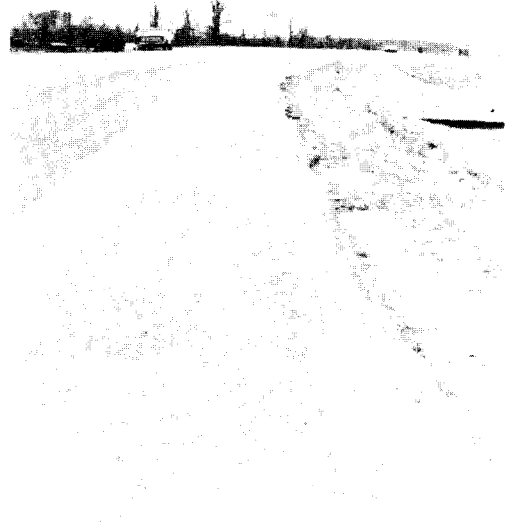
*FIGURE 5*

*12% Fly Ash 1*

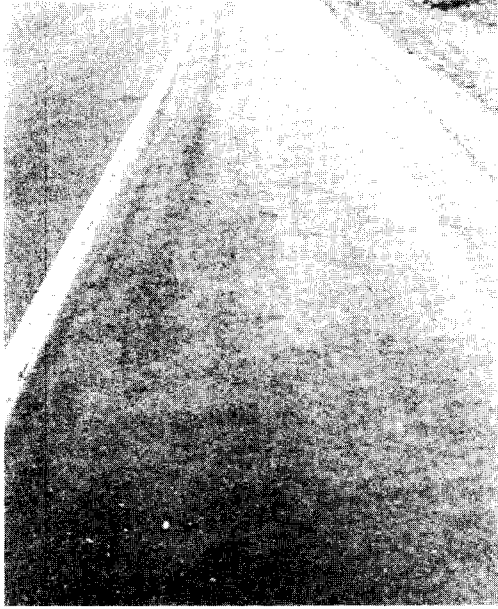
*FIGURE 7*

Figures 7 through 17 show the physical condition of test sections at site 3 after more than two years of performance. These show test sections of fly ash 2 (eastbound shoulder) and 3 (westbound shoulder) and portland cement (4 and 6 percent). Figures 7 through 9 show the typical, good condition of 6, 12 and 18 percent fly ash 2 test sections. Potholes have recently developed at the pavement-shoulder joint in one area of the 18 percent fly ash 2 test section as shown in Figure 10. As in the portland cement test sections at this site, the breaks in the shoulder appear to develop in conjunction with the joints or cracks of the concrete pavement. Overall, the physical condition of the shoulders is very good and, here as in site 1, the condition of all the test sections of fly ash 2 appears to be equally good.

*6% Fly Ash 2 - Eastbound*

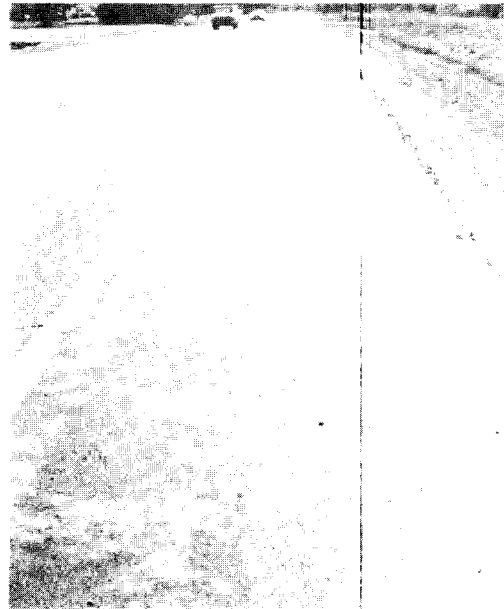
*FIGURE 8*

*12% Fly Ash 2 - Eastbound*

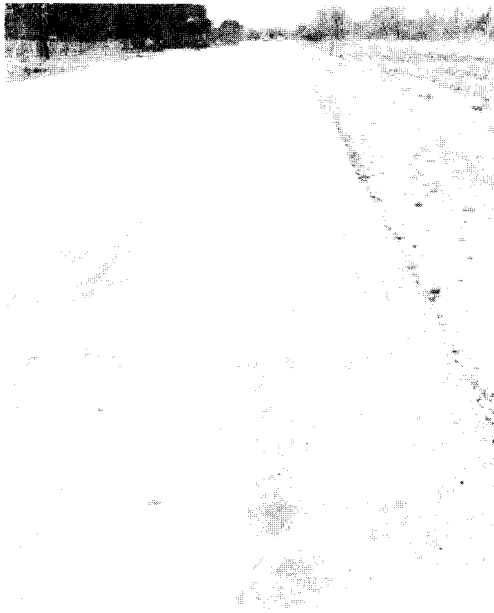
*FIGURE 9*

*18% Fly Ash 2 - Eastbound*

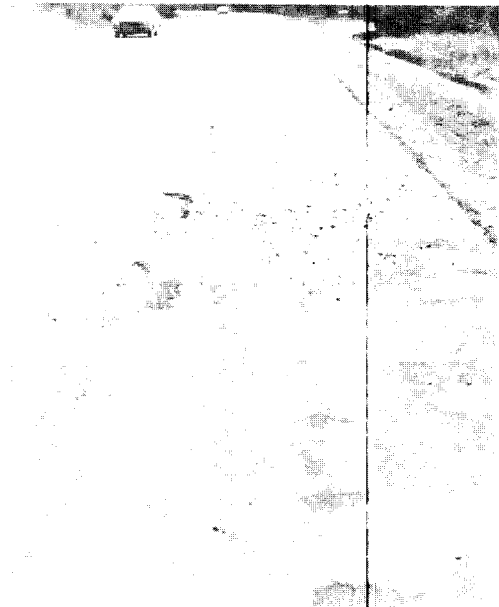
*FIGURE 10*

*18% Fly Ash 2 - Eastbound*

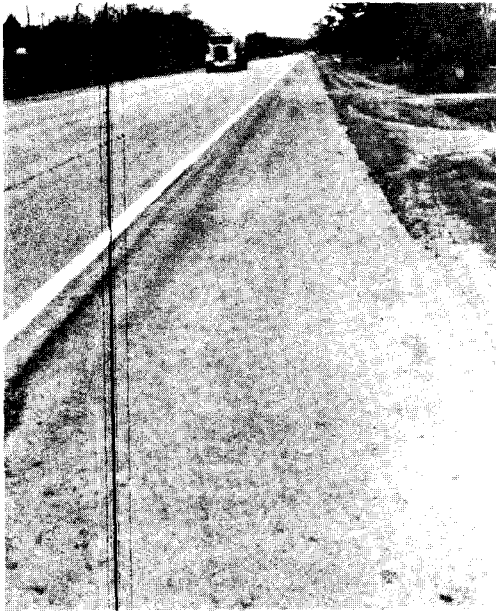
*FIGURE 11*

Figures 11 through 13 show the typical physical condition of fly ash 3 test sections on the westbound shoulders. Figure 14 shows the junction of the 6 percent portland cement and 18 percent fly ash 3 test section. There is no discernible difference in the physical condition of one over the other; the dark spots in the figure were caused by oil. Again, the overall physical condition of all fly ash 3 test sections is very good and, visually, equally good.

*6% Fly Ash 3 - Westbound*

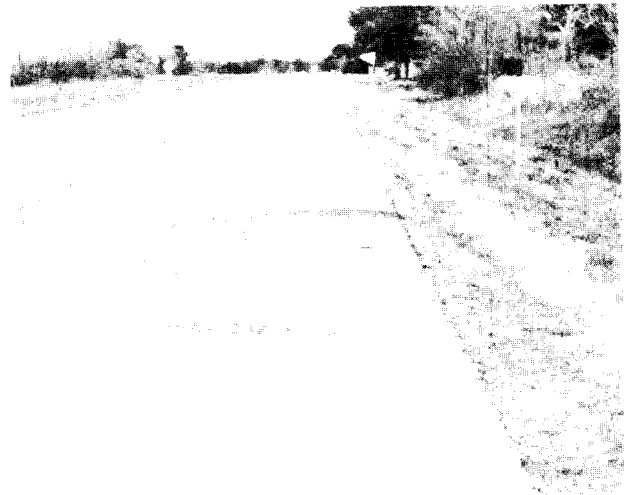
*FIGURE 14*

*18% Fly Ash 3/6% Portland Cement*

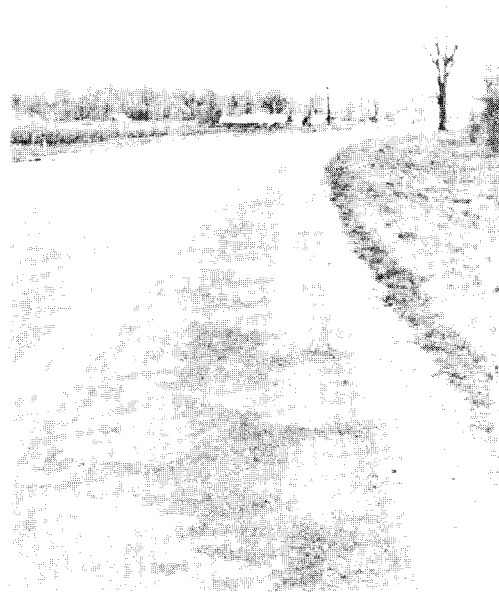
*FIGURE 15*

Figure 15 is of the 4 percent portland cement test section and shows the generally good condition of the portland cement sections. As discussed above, Figures 16 and 17 show the pothole development in the two portland cement test sections. The physical condition of either portland cement test section, visually, appears to be equal to any and all fly ash test sections at site 3.

*4% Portland Cement - Eastbound*

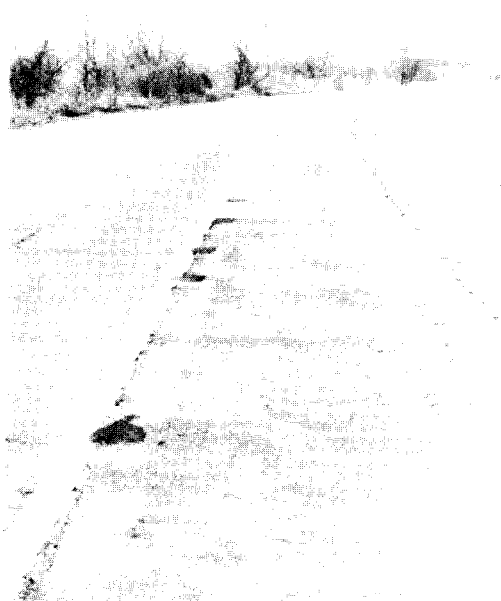
*FIGURE 16*

*6% Portland Cement - Westbound*

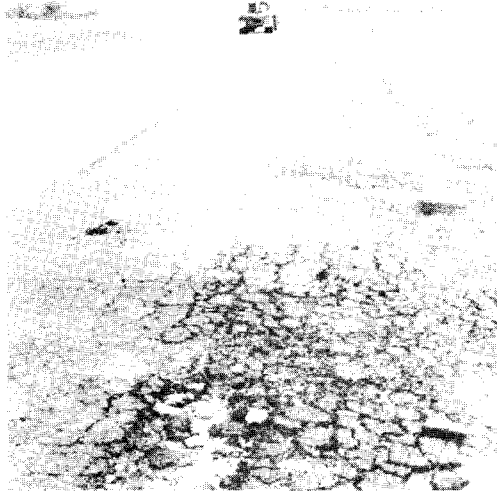
The physical condition of the test sections at site 4 is shown in Figures 26 through 42. Fly ash 2 was used in test sections on the eastbound shoulder and fly ash 4 in the test sections on the westbound shoulder. The overall physical condition of the shoulder test sections is fair. With the possible exception of the 18 percent fly ash 2 and 4 test sections, all sections show some loosening of material, pothole development and shoulder edge breakup. The pavement drop-off discussed elsewhere in this report has increased in some test sections, probably due to traffic densification, and is easily seen in many figures covering this site. Figures 26 through 29 show the physical condition of the 18 percent fly ash test sections. The 18 percent fly ash 4 test section has a truck stop located within the section limits. As a result, trucks egressing onto its parking area and back onto the roadway caused early problems. Within the first year after construction it became apparent that bituminous concrete mixture overlay was needed to prevent total deterioration of the shoulder. Since the addition of the overlay, the shoulder, as shown in Figure 29, has maintained good performance. The portion of the 4 percent portland cement test section across from the truck stop has failed; even the patches are breaking out as

shown in Figure 30. The remaining portion of the 4 percent test section is in fair shape with some shoulder edge breakup. The fair condition of the 6 percent portland cement test section is surprising. This section was expected to outperform all other test sections at sites 2 and 4; however, it contains areas of pothole development and edge breakout as shown in Figures 32 and 33. Some portions of the 6 percent test section, as shown in Figure 34, are in fairly good condition.

*4% Portland Cement - Eastbound*  
*FIGURE 30*

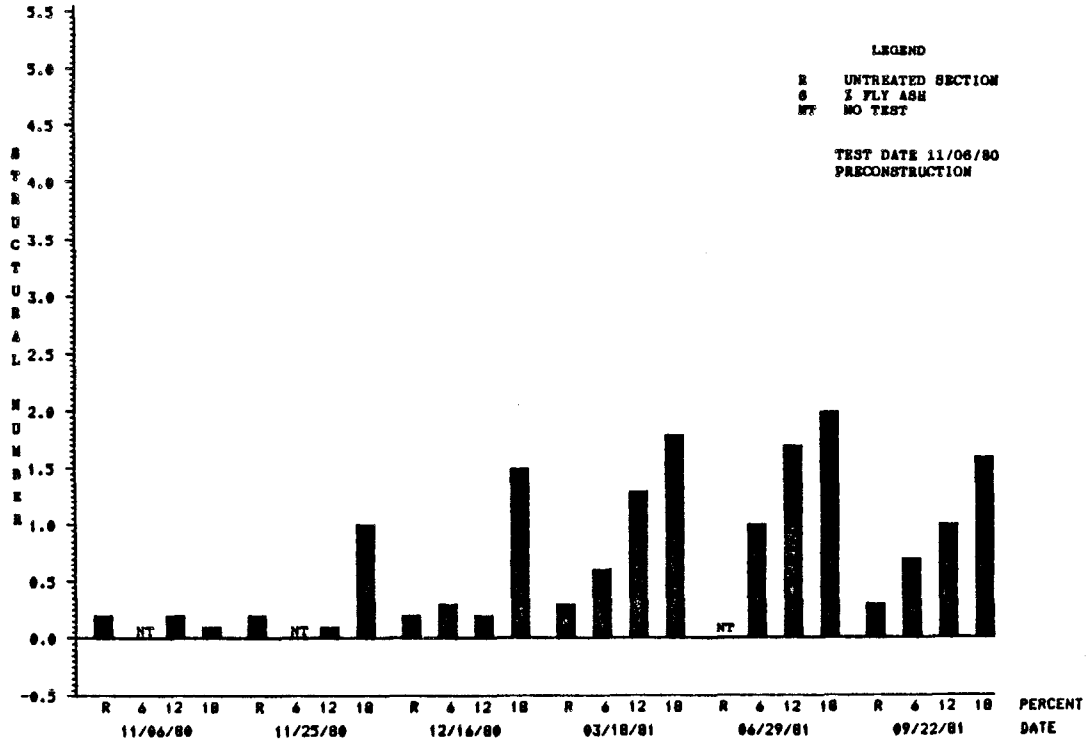
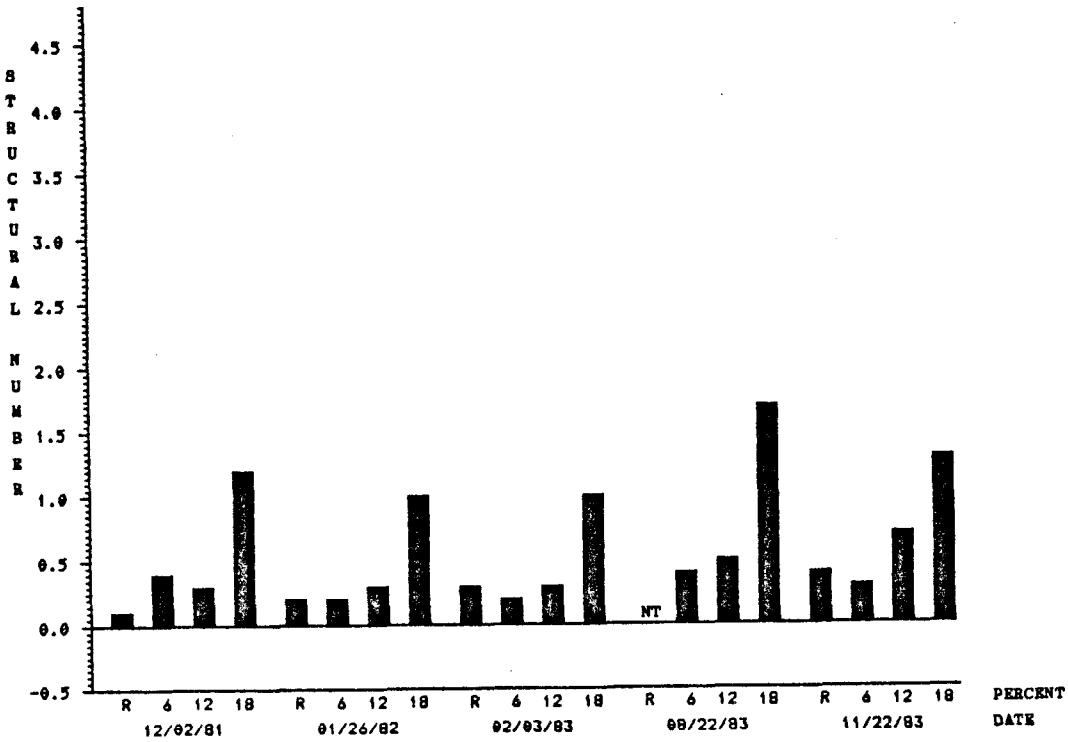
FIGURE 43

Sand Clay Gravel Test Sections - Deflection measurements were taken periodically at site 1 from November 1980 to November 1983. Mean SN values for test sections at each test date are shown in Figure 43. All measurements taken prior to December 1981 were on unsurfaced shoulders. After this date, the shoulders were covered with bituminous surface treatment as described earlier. The SN values increased during the first year after construction, reaching a high point at 7.4 months of age. The values showed a decrease, especially the 6 and 12 percent fly ash sections, between the measurements of September and December of 1981. The only visual change in the condition of the test sections between these two test periods was the addition of the surfacing.

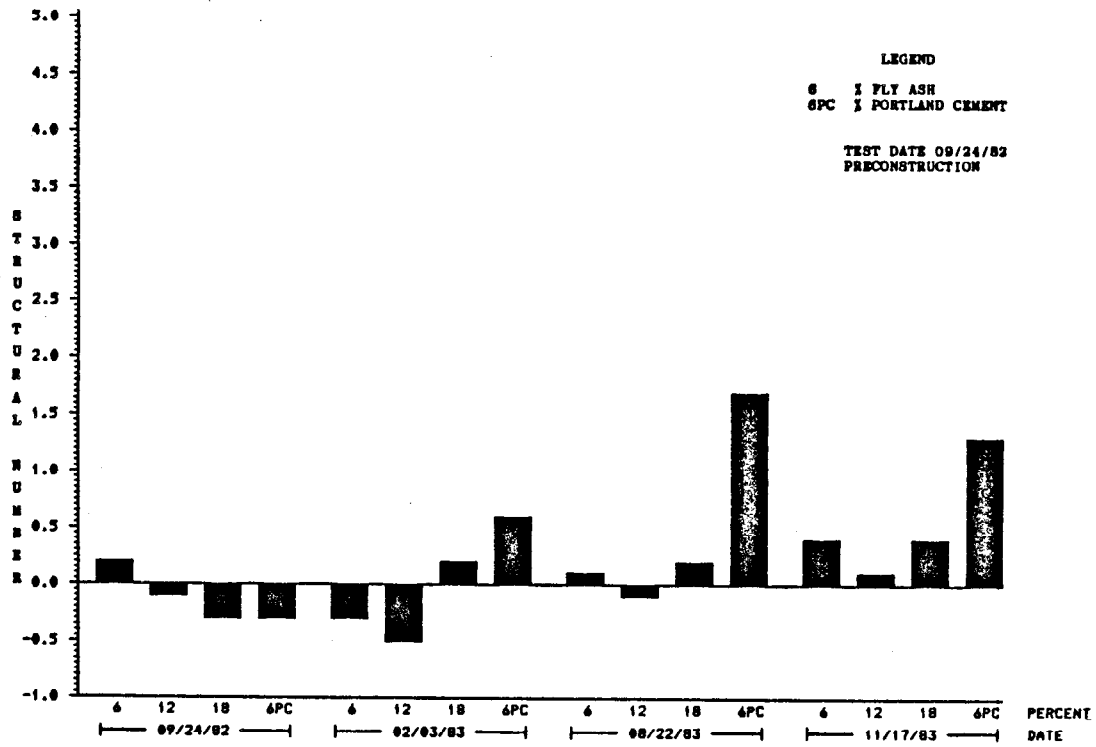
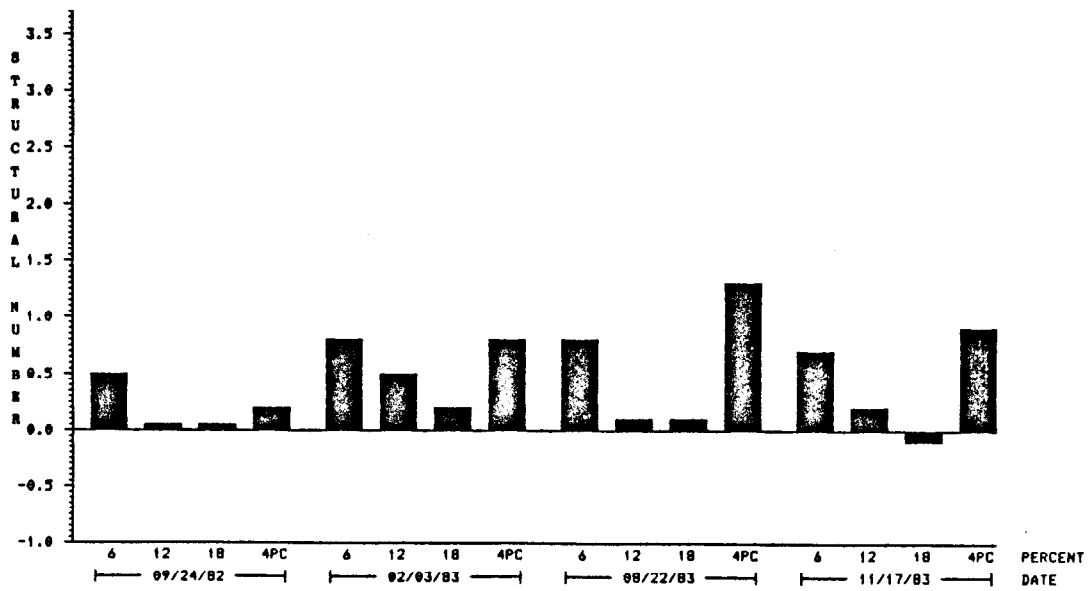
FIGURE 44

The deflection measurements at site 3 were taken between September 1982 and November 1983, inclusive. The mean SN values of each test section obtained at each test interval are shown in Figure 44. Other than the portland cement treated sections, there was no significant increase in SN values as found at site 1. (There was a slight trend of an increase in SN for the 18 percent fly ash test section of the westbound shoulder.) The deflection measurements do not seem to reflect the performance and present physical condition of all test sections at this site. The portland cement test sections, as shown in the condition survey discussion, do not appear to have performed better than the other test sections at this site. There was a saturated layer, 3 to 4 inches thick, found underlying the treated layer scattered in some test sections when checking the depth of treatment. This was particularly common in the 18 percent fly ash section of the eastbound shoulder (fly ash). This layer was not found in either of the portland cement test sections. This layer, where it occurs, may be less dense than that of the overlying treated material, thereby decreasing overall measured stiffness.

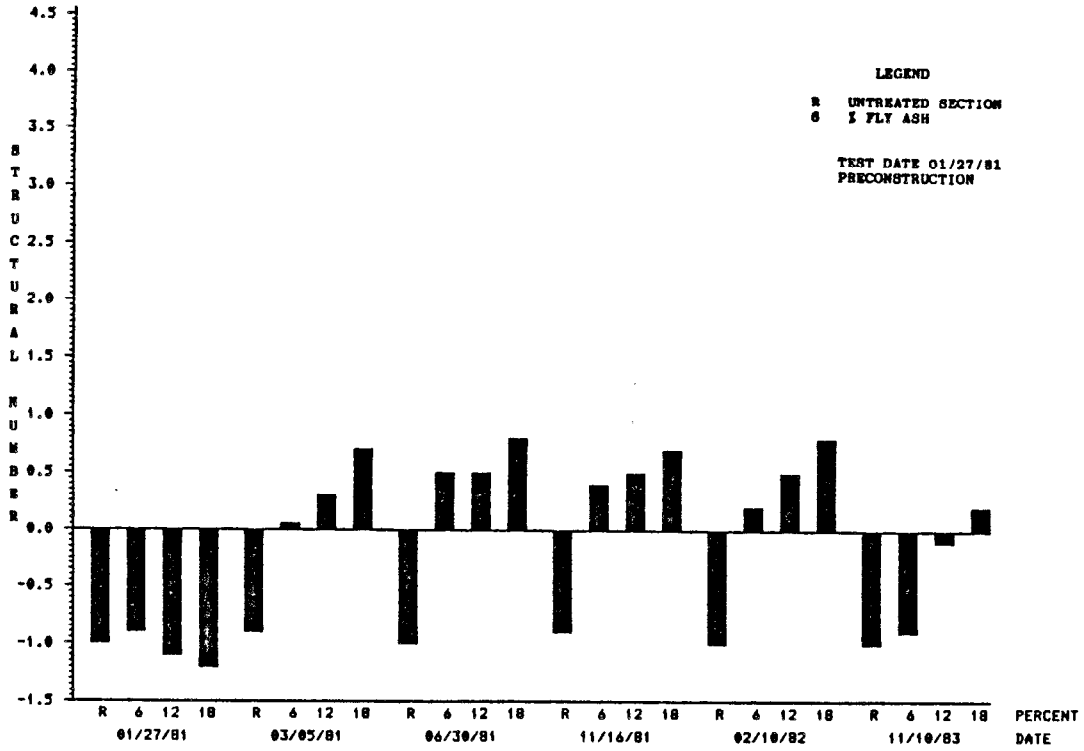
FIGURE 45

Shell Test Sections - Field deflection measurements were obtained at site 2 at various time intervals between January 1981 and November 1983. The mean SN values are shown in Figure 45. The testing was conducted on unsurfaced shoulders at all but the last test date. The results show an increase in SNs in all test sections during the first year after construction. The change, for that time period, in SN units from the preconstruction values range from a + 1.1 in the 6 percent fly ash test section to + 2.0 in the 18 percent fly ash section. The test results at the last test date, 2.75 years after construction, showed a loss of stiffness in the 6 percent section down to the preconstruction level. The SN values for the 12 and 18 percent sections decreased to 1.0. These results reflect the generally good physical condition of the 12 and 18 percent fly ash sections and the deteriorating condition of the 6 percent fly ash test section. Surfacing caused deflection increase in all sections due to its very soft nature.

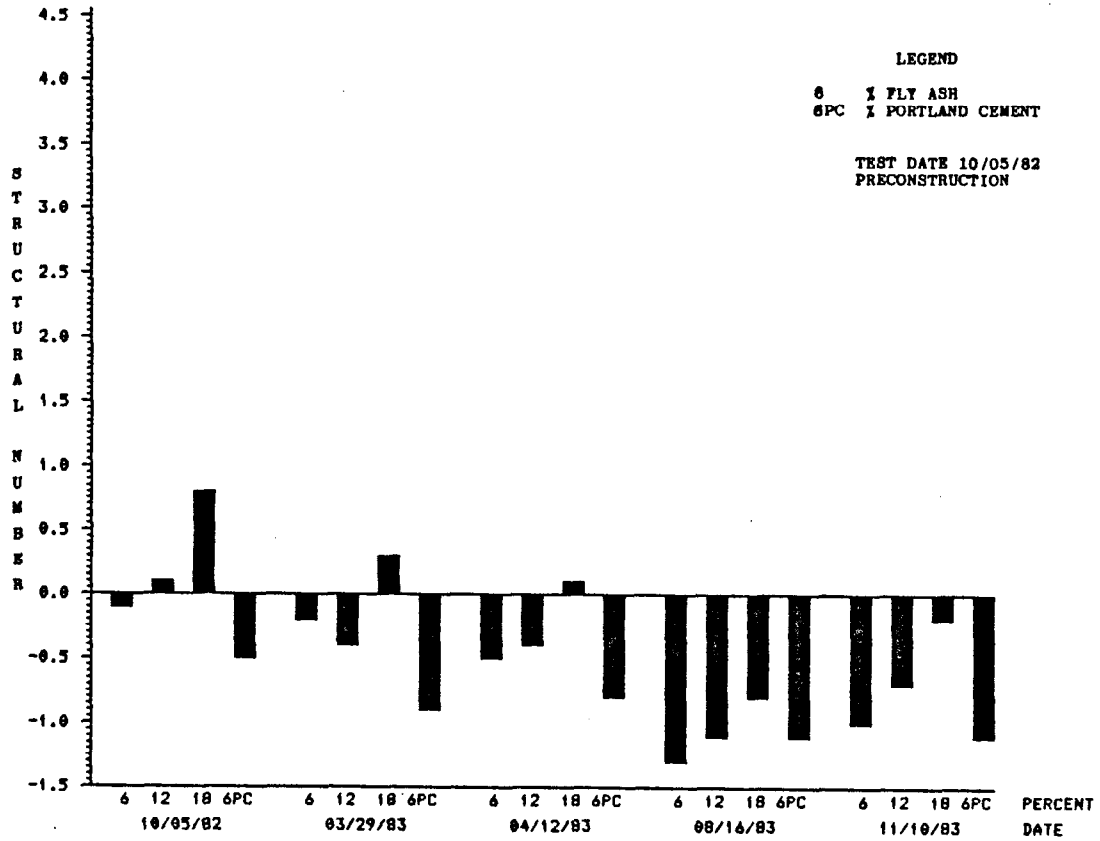
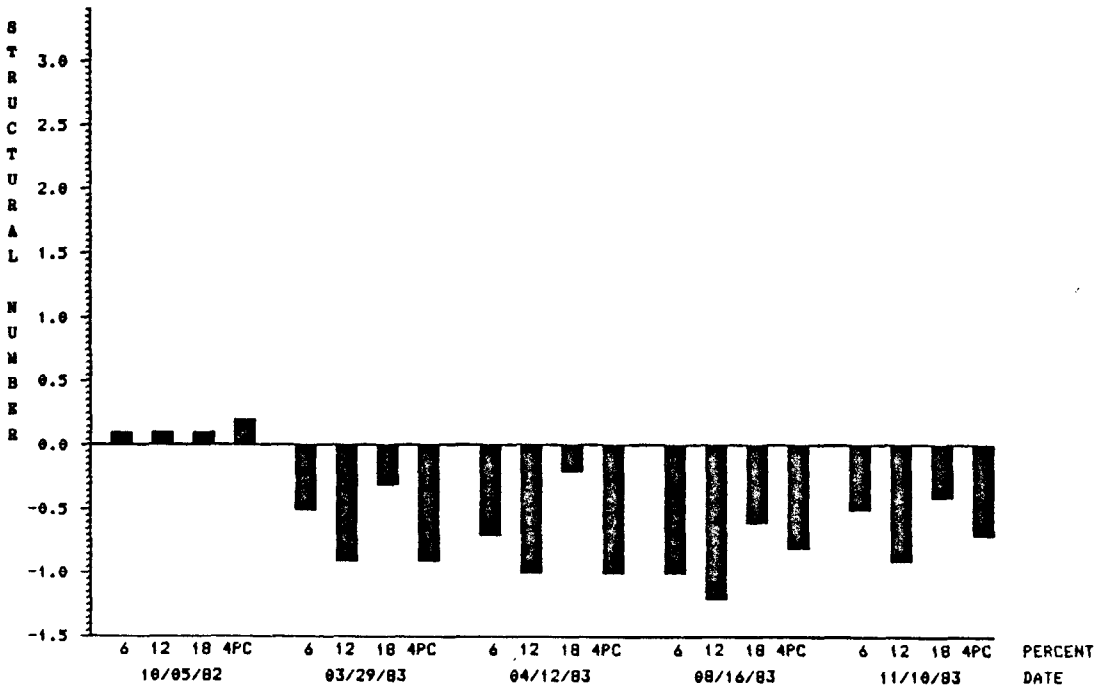
FIGURE 46

The mean SN values for all sections at site 4, fly ash and portland cement, show a decrease from the preconstruction values with time. The decrease is apparent at the first test interval and remains relatively constant at all other test dates as shown in Figure 46. The difference in SN values between test sections of sites 2 and 4 is significant. The major differences between the two test sites are the surfacing at site 2 and more shoulder use by agricultural vehicles and trucks at site 4. As mentioned earlier, the 6 percent portland cement test section was expected to outperform any and all other test sections at site 4 as well as site 2. Crushed shell treated with portland cement has been used as a base course material in many other locations of south Louisiana with relatively good performance. The shell, from site 4, was subjected to laboratory unconfined strength tests with 4 percent and 6 percent portland cement, by volume, prior to construction of the test sections. The results after seven-day moist cure were 614 and 920 psi (Table 6), respectively. This shows normal compatibility of materials (shell

and portland cement) as expected. These tests were run as a check on possible sugar cane juice (sucrose) contamination. There is a history in this region of this contamination problem resulting in weak cementation of particles by the portland cement. The as-built construction data of the 6 percent portland cement section is similar to or better than that of the test sections of test site 2. Holes were dug in selected areas of the 6 percent portland cement test section in an attempt to find a cause for the low deflection values. Investigation of the failing areas showed loose shell with very little cementation for the full depth. The good area, based on visual appearance, showed a weakly cemented layer of approximately one inch in thickness between the soft surface treatment and a dense, well-cemented underlying layer. The construction notes do not indicate anything that would affect cementation. Since the condition of all test sections is virtually the same, it is surmised that the problem is common to all. Heavy use of the shoulders by the local sugar cane haulers combined with sporadic truck usage during the green or early curing period of the treated sections could weaken or break up entirely the cement bounded particles. The actual cause of low cementation was not determined in this study.
