TENSION PILE STUDY

Research Report No. 49

Final Report

Research Project No. 68-4ST(B)
Louisiana HPR 1(8)

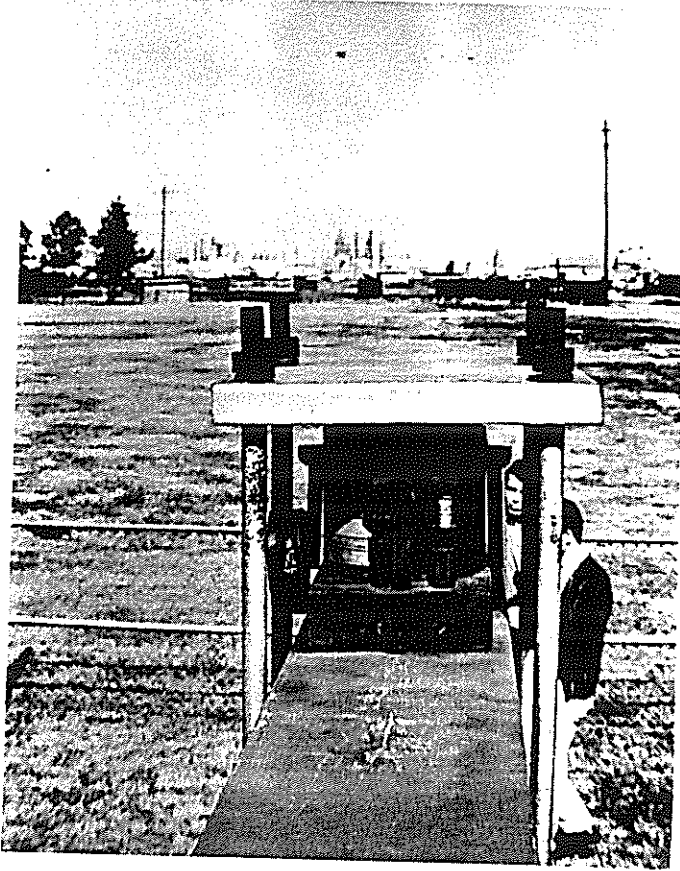
Figure 10
View of bent top plate after
pressure was released

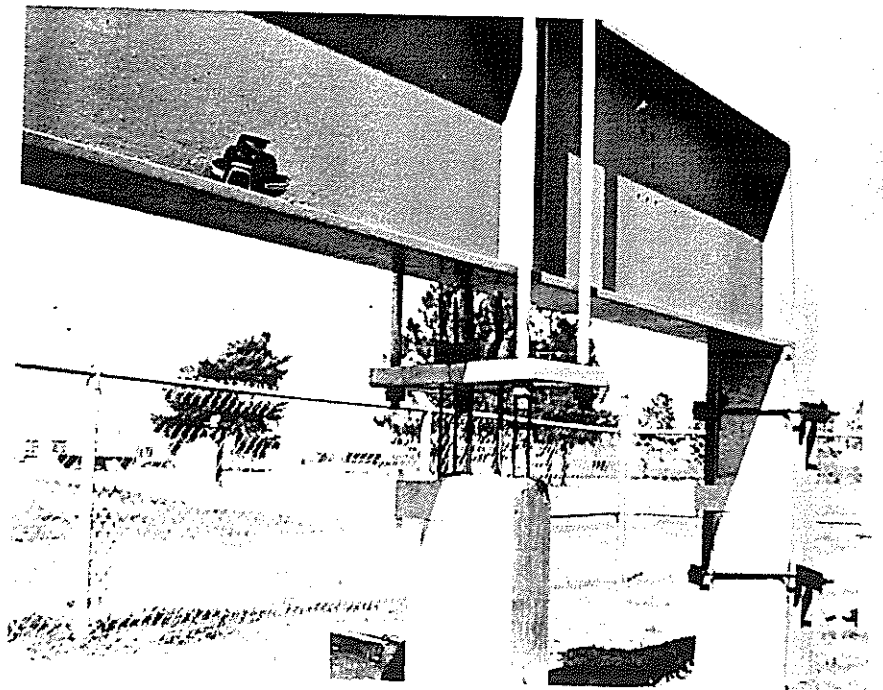
At 97 tons two failures occurred. The first was a third crack in the pile 2 feet 2 inches from the top. Shortly thereafter two of the strands in the tension cable at the corner mentioned above failed (Figure 11). At this point the increase in pressure was stopped. The pile elevation at this time read 2.83 inches or 0.17 inches above normal.

Figure 11
Picture illustrating bending in
bottom plate

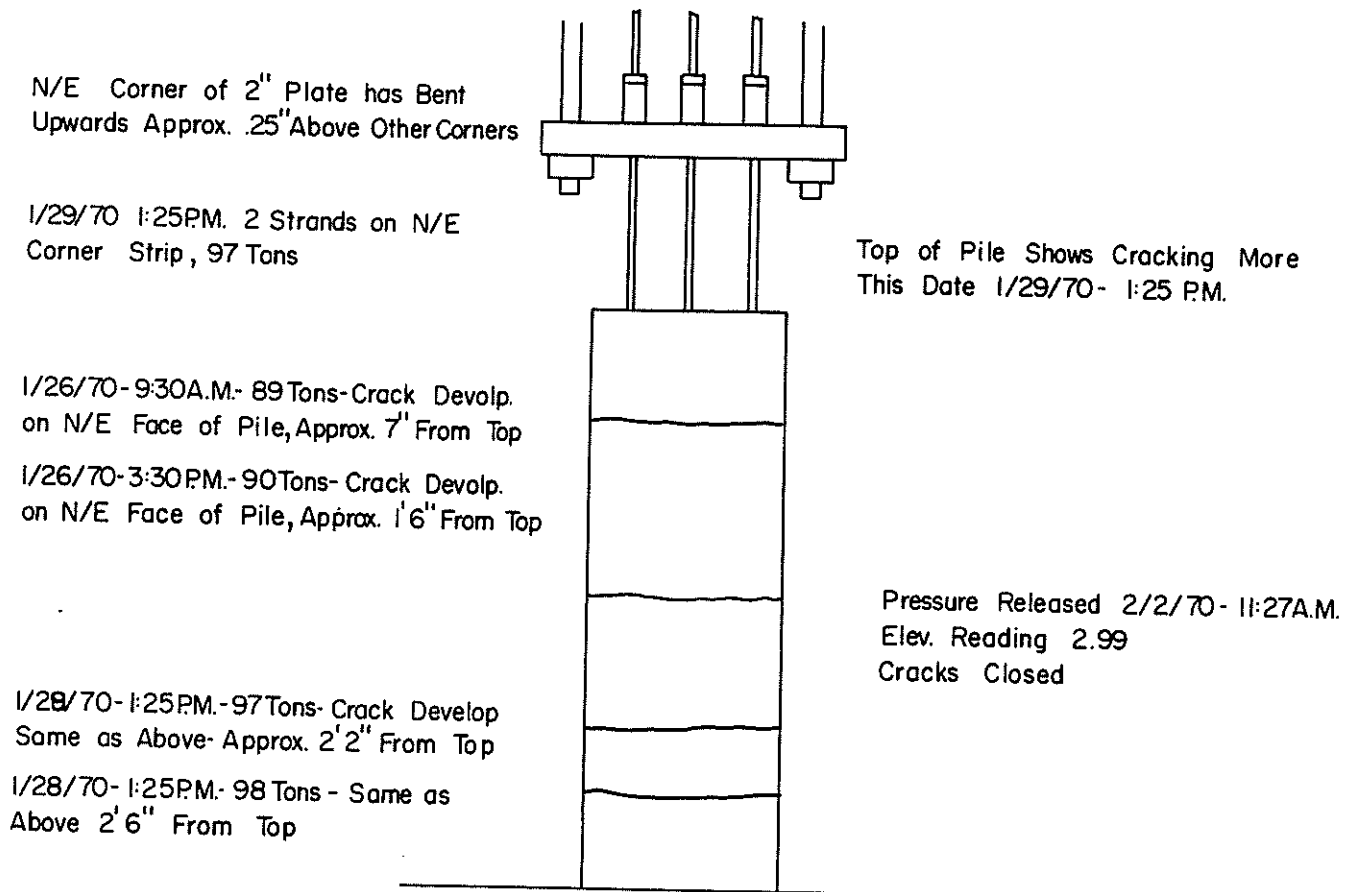
Figure 12

Two days later, again it was decided to increase the pressure. At 98 tons a fourth crack developed two feet six inches from the top and four more tension cables failed bringing the total to five of the eight. The cable failure caused a relaxation of the tension and consequent decrease in pile elevation. Since five of the cables failed, the jack was released. With this release, all the piles returned to their normal elevation of 3.00 inches. Thus it would appear that all movement is attributed to structural deformation.

Sketch of the test pile with description of events

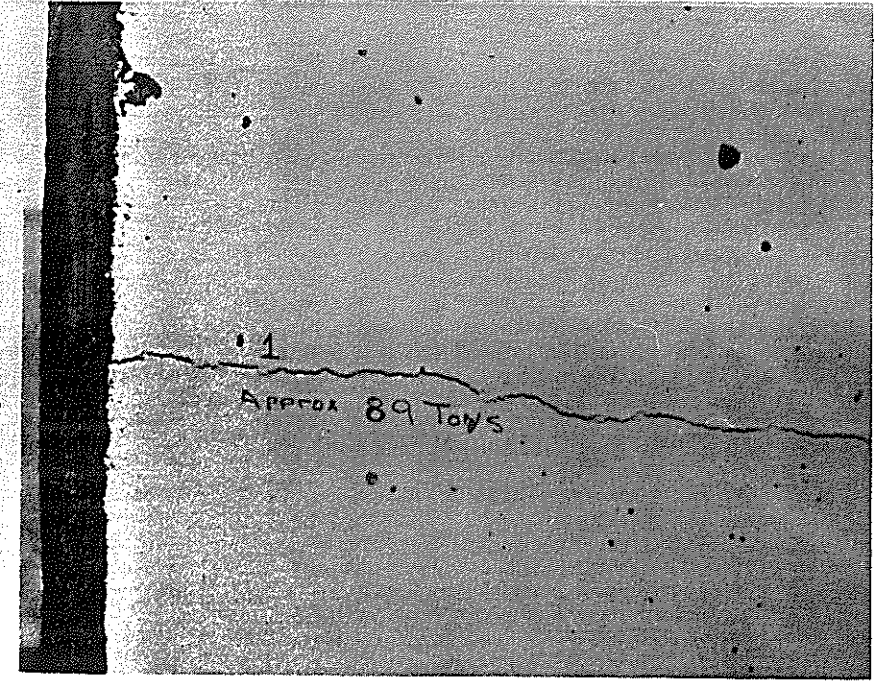
Figure 13 A

Since there was no change over a week's time, the 90-ton load was imposed. At approximately 89 tons a crack developed in the test pile approximately 6 inches from the top. It occurred with a dull thump. Again at 90 tons a similar report was heard and a second crack appeared at about 1 1/2 feet from the top. The elevation reading of the center pile was now 2.89 inches or 0.11 inch higher than originally. It was at this point that both the top and bottom plates of the loading transfer device showed flexure. The top plate seemed to deform symmetrically about the center (see Figure 10) whereas the bottom plate was noticeably bent on one corner (Figure 11). Two days later the reading on the pile had increased to 2.88. Nevertheless it was decided to increase the load.

View of cracks in test pile

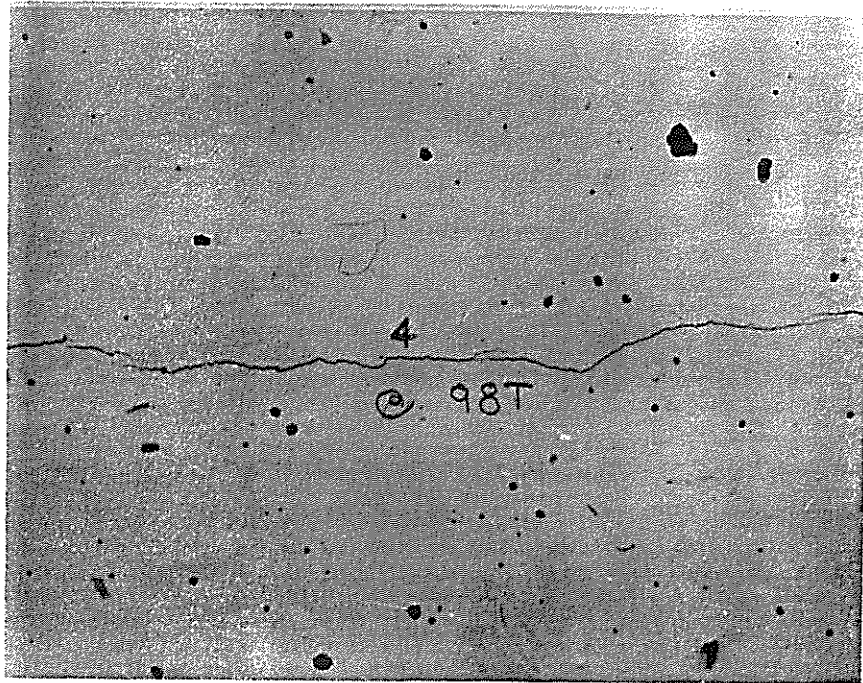
Figure 13 C
Crack developed at
98 tons

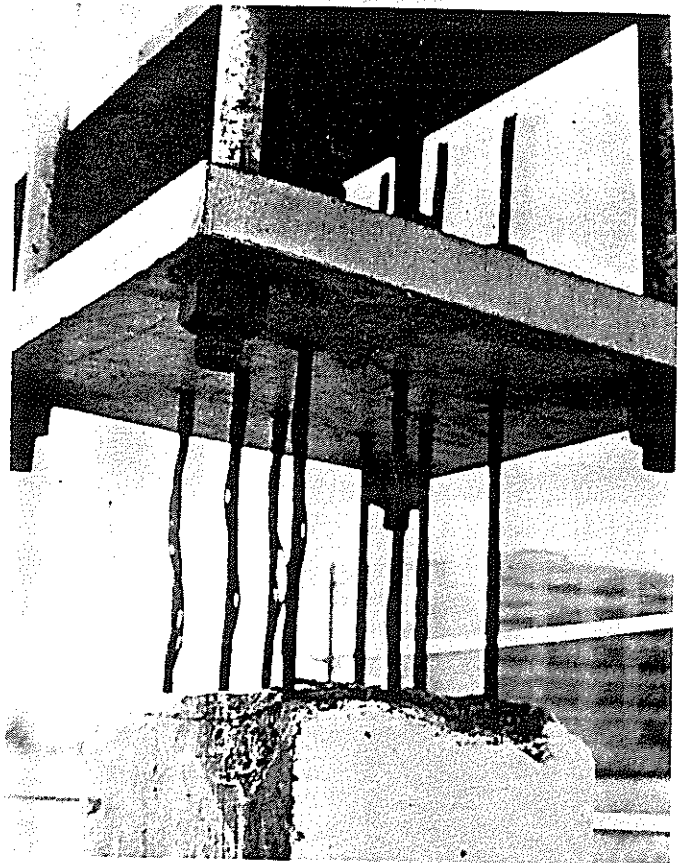
Figure 14
Failure of tension
strands
