EVALUATION OF DRAINAGE PIPE BY FIELD EXPERIMENTATION
AND SUPPLEMENTAL LABORATORY EXPERIMENTATION

Interim Report No. 3

Research Report No. 154

LOUISIANA DEPARTMENT OF TRANSPORTATION AND DEVELOPMENT
Research and Development Section
In Cooperation With
U. S. Department of Transportation
FEDERAL HIGHWAY ADMINISTRATION

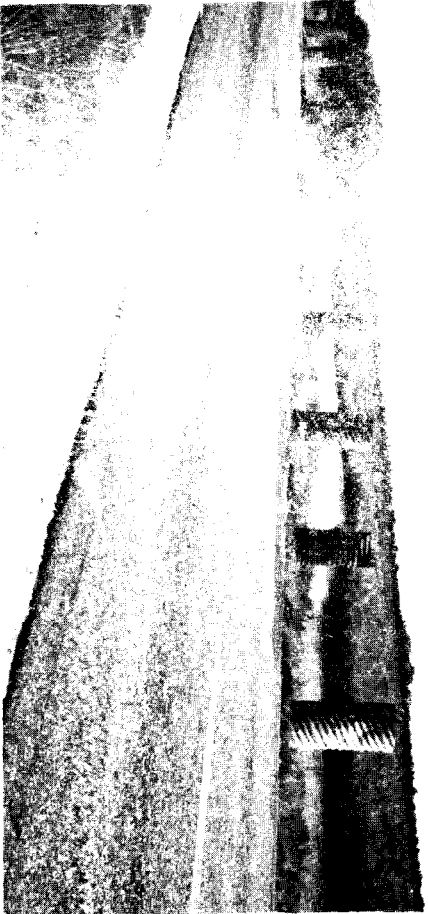
Vertical view of Site 7

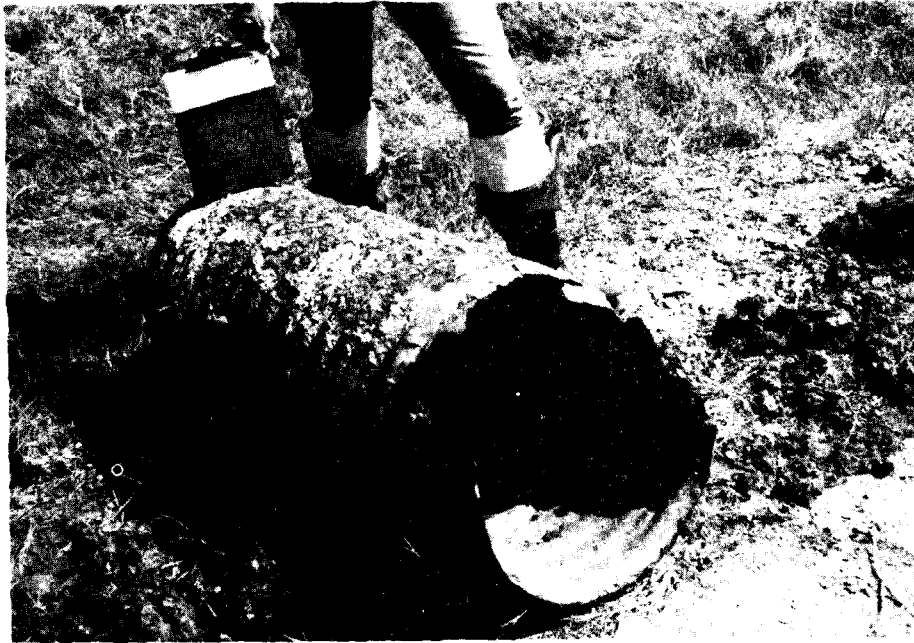
At sites 6, 7, 9, and 10 the soil and effluent both exhibited low electrical resistivity values of less than 1000 ohm-cm. The galvanized steel pipe was completely rusted at these four sites with perforation of the metal at sites 6, 7 & 10. Figure 9 of this appendix shows this type of culvert after four years of in-service field exposure.

Galvanized Steel Culvert at Site No. 7 after Four Years
FIGURE 3
