EVALUATION OF AN ASPHALT-TREATED DRAINAGE BLANKET
IN A RIGID PAVEMENT SECTION

Final Report

Report No. FHWA-LA-78-117

Research Project No. 72-8E(B)
Louisiana HPR 0010(001)

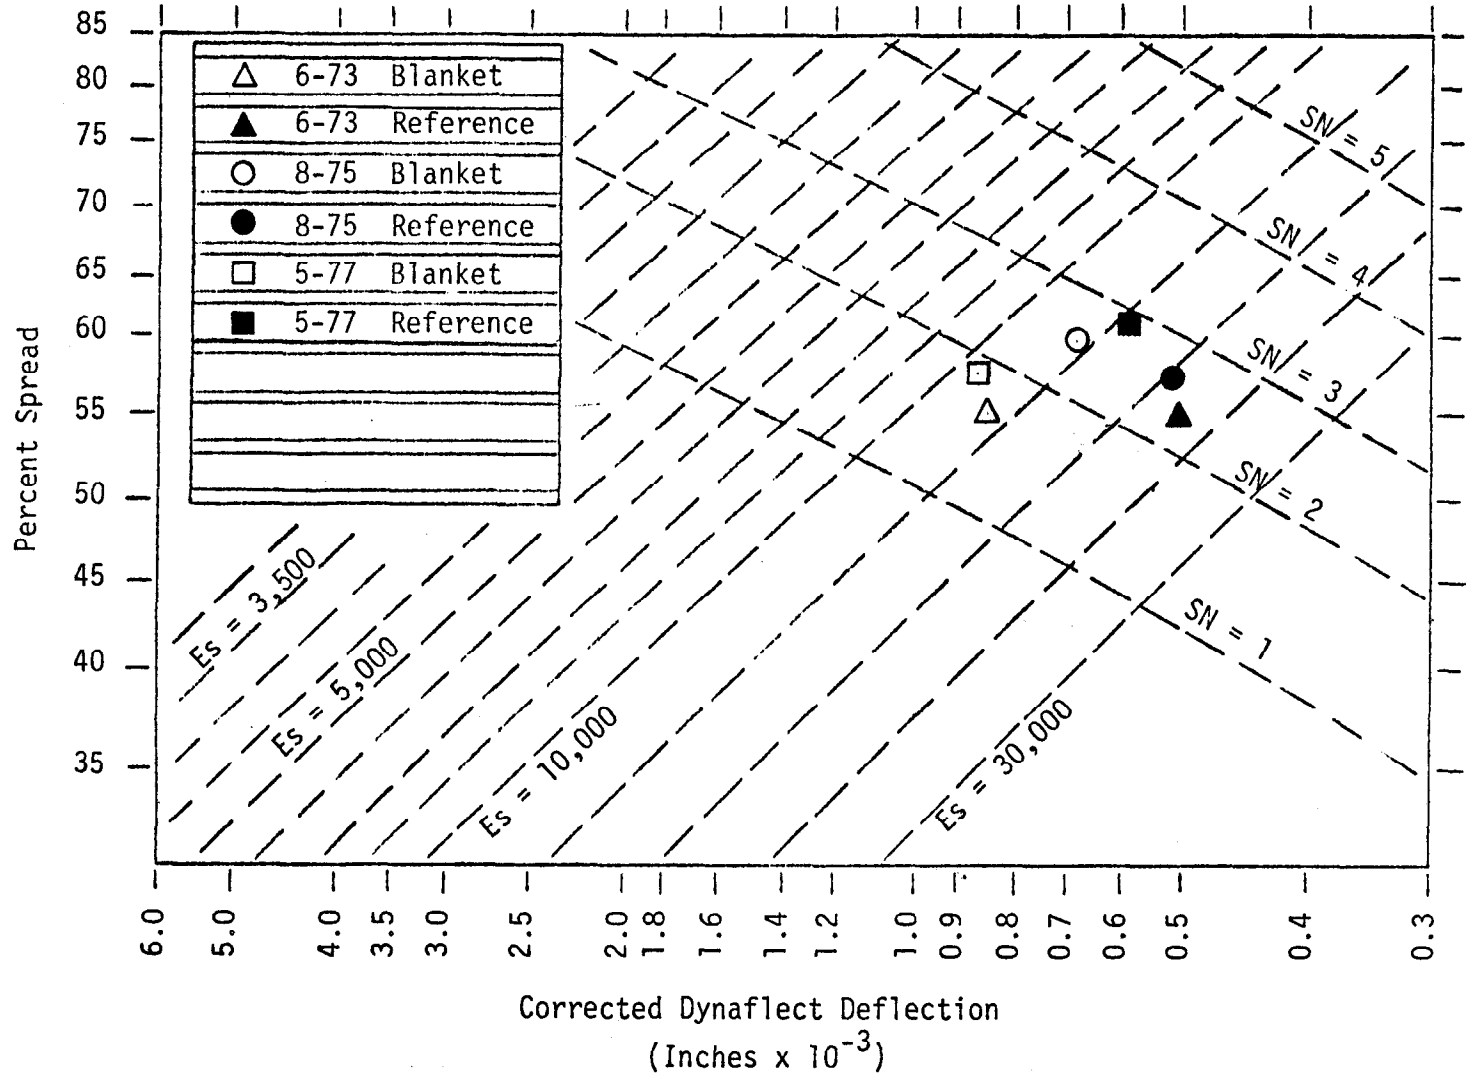
FIGURE 12

Figures 12 and 13 present the Department's Pavement Evaluation Chart (4) annotated to relate deflection data from drainage blankets 1 and 2 respectively. The chart translates deflection data into the more usable parameters of subgrade modulus E_s and structural number SN. The chart is an excellent tool for monitoring time-relative strength changes.

The data points of Figures 12 and 13 represent averages of the deflection values obtained in the sampling program, as previously described in the Methodology. Deflection analyses showed that no structural advantage was obtained by constructing the drainage blanket in separate lifts. Two-year strength in terms of structural number was slightly greater for drainage blanket No. 1 presumably due to the aging of the asphalt. (Insufficient temperature data is responsible for the uncharacteristic data presented in Figure 13 for the March, 1976 evaluation.)

*Pavement Evaluation Chart
Shoulder Drainage Blanket No. 1*

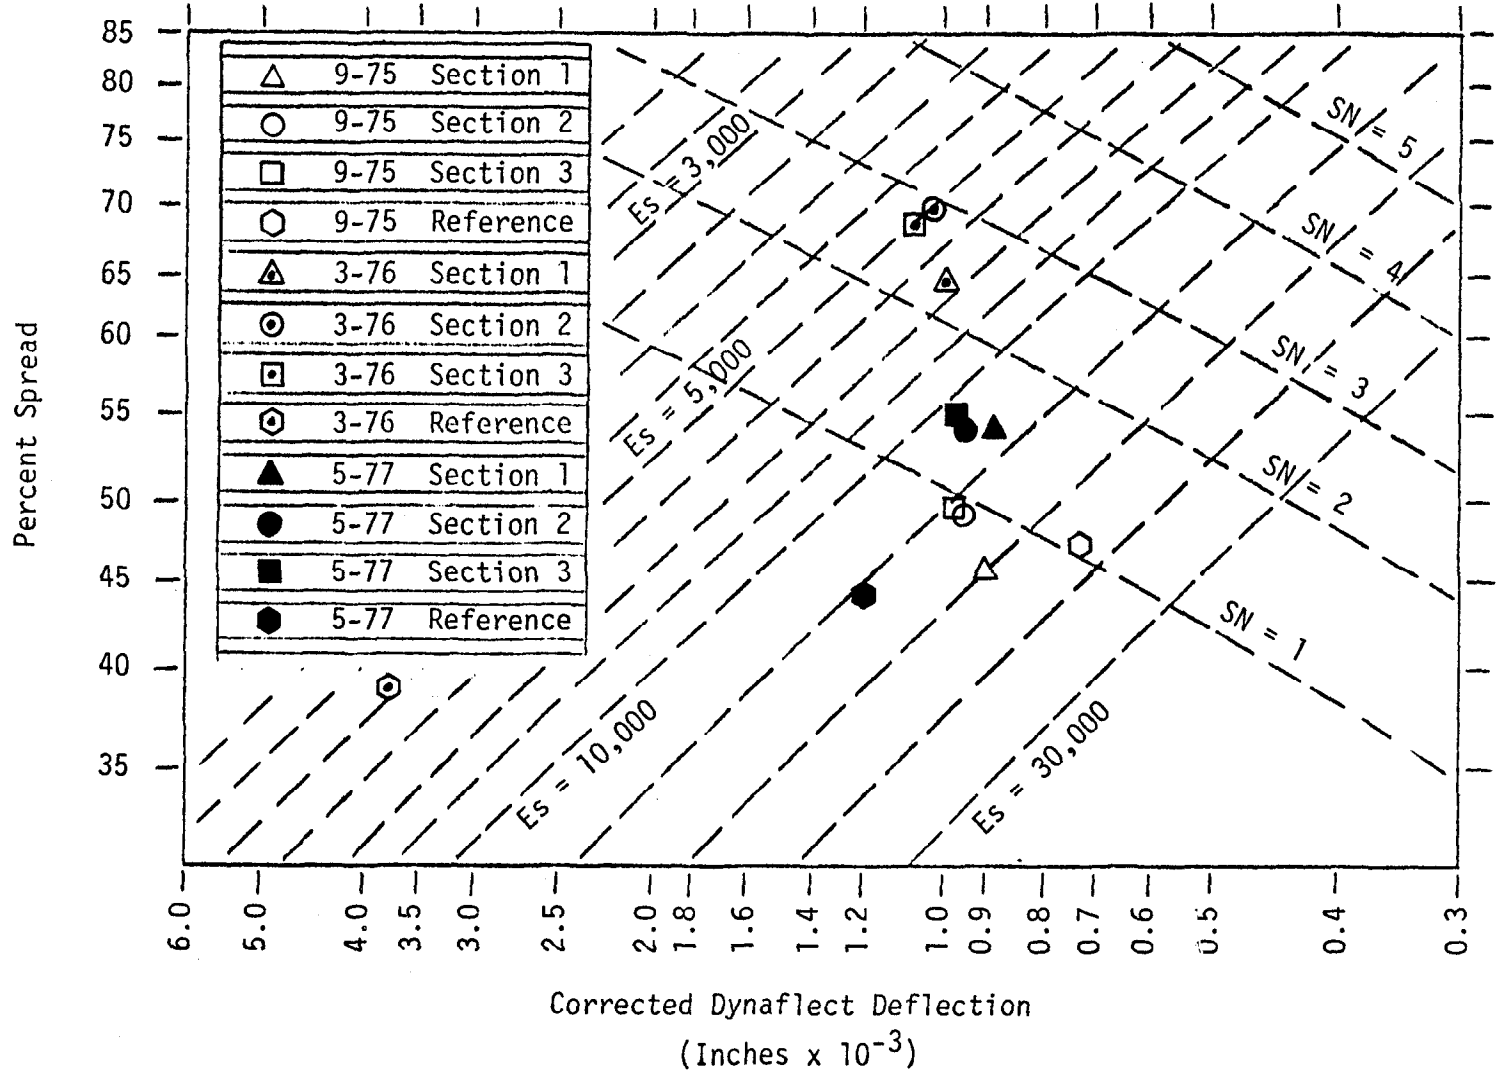
FIGURE 13

Pavement Evaluation Chart
Shoulder Drainage Blanket No. 2
