EVALUATION OF DRAINAGE PIPE BY FIELD EXPERIMENTATION
AND SUPPLEMENTAL LABORATORY EXPERIMENTATION

Interim Report No. 2

Research Report No. FHWA-LA-78-115

Research Project No. 72-1SS
Louisiana HPR 0010(001)

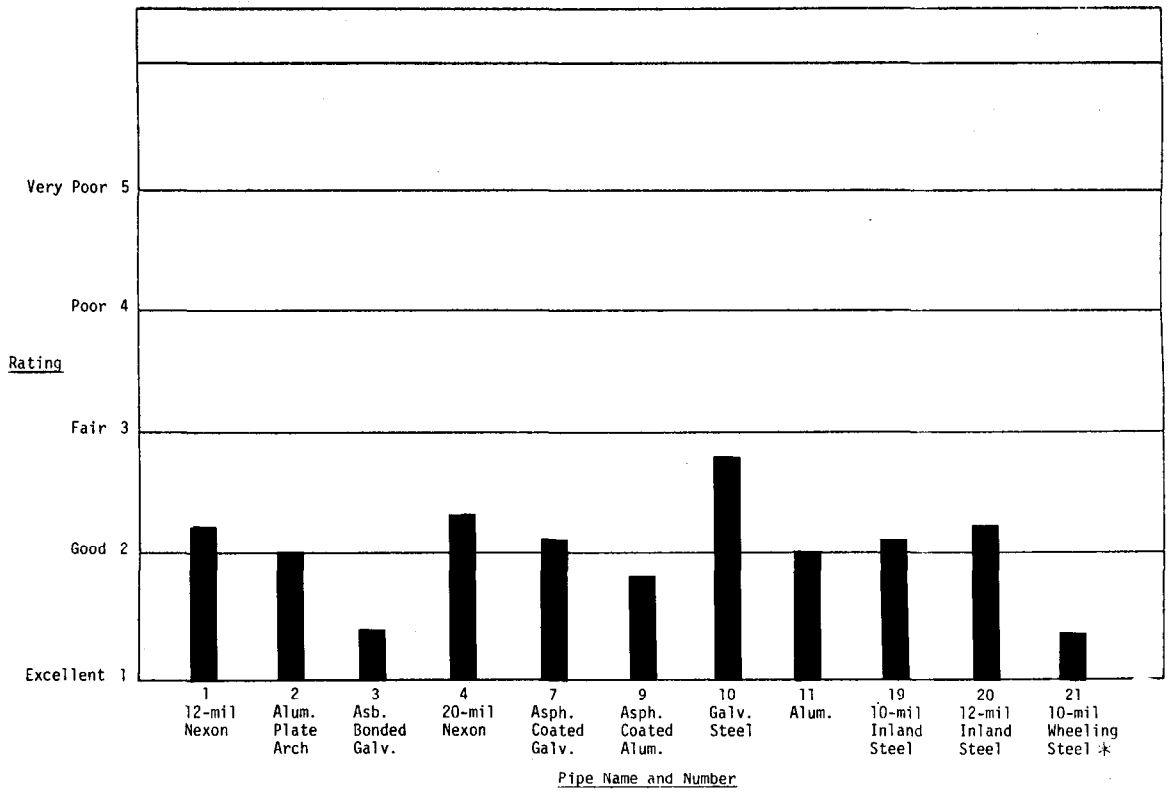
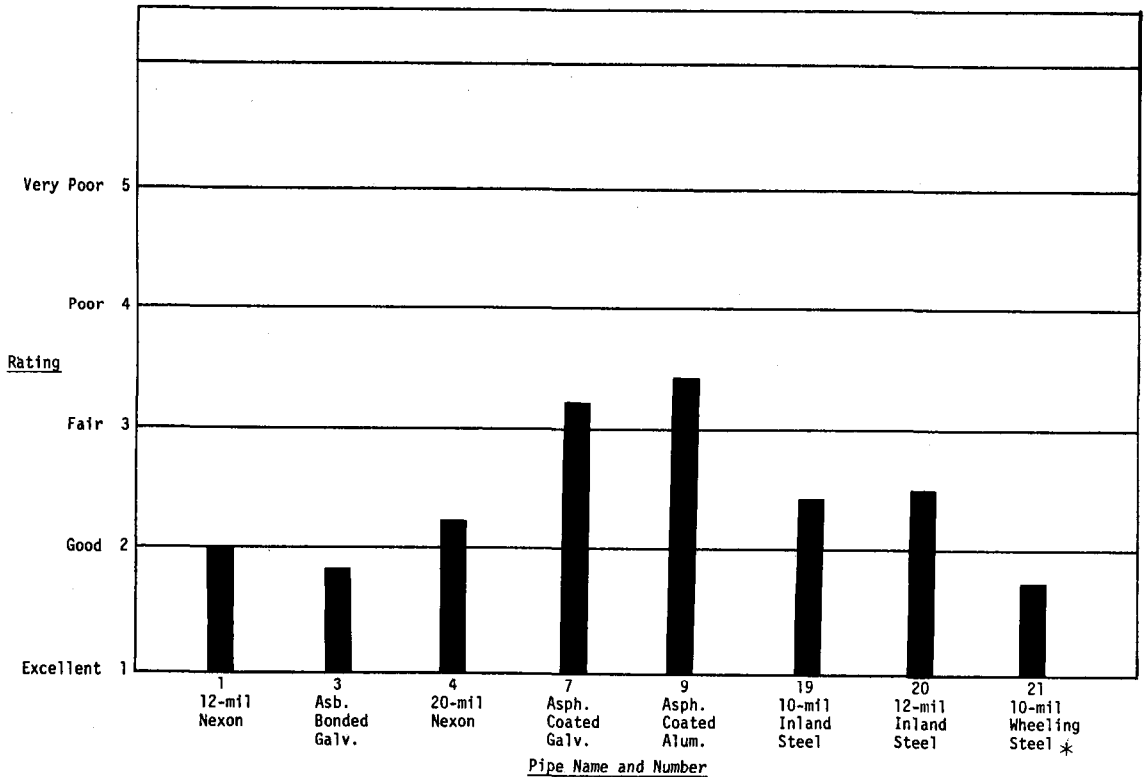
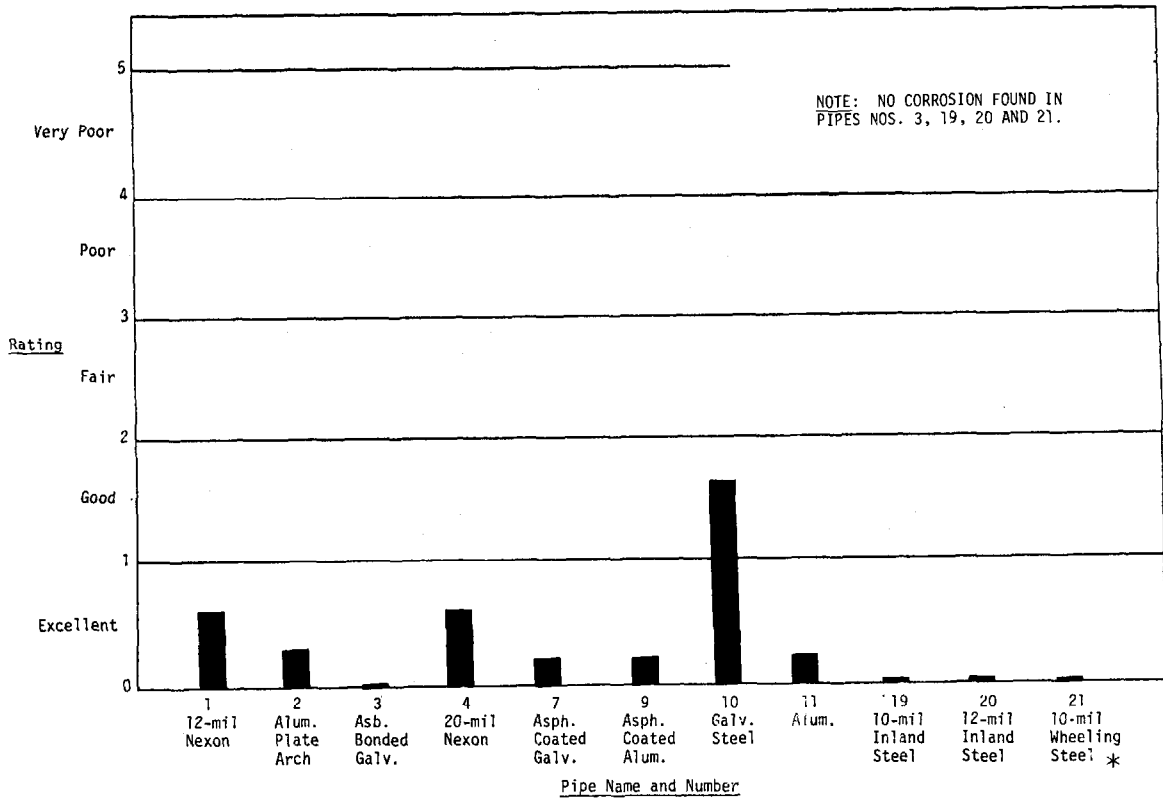
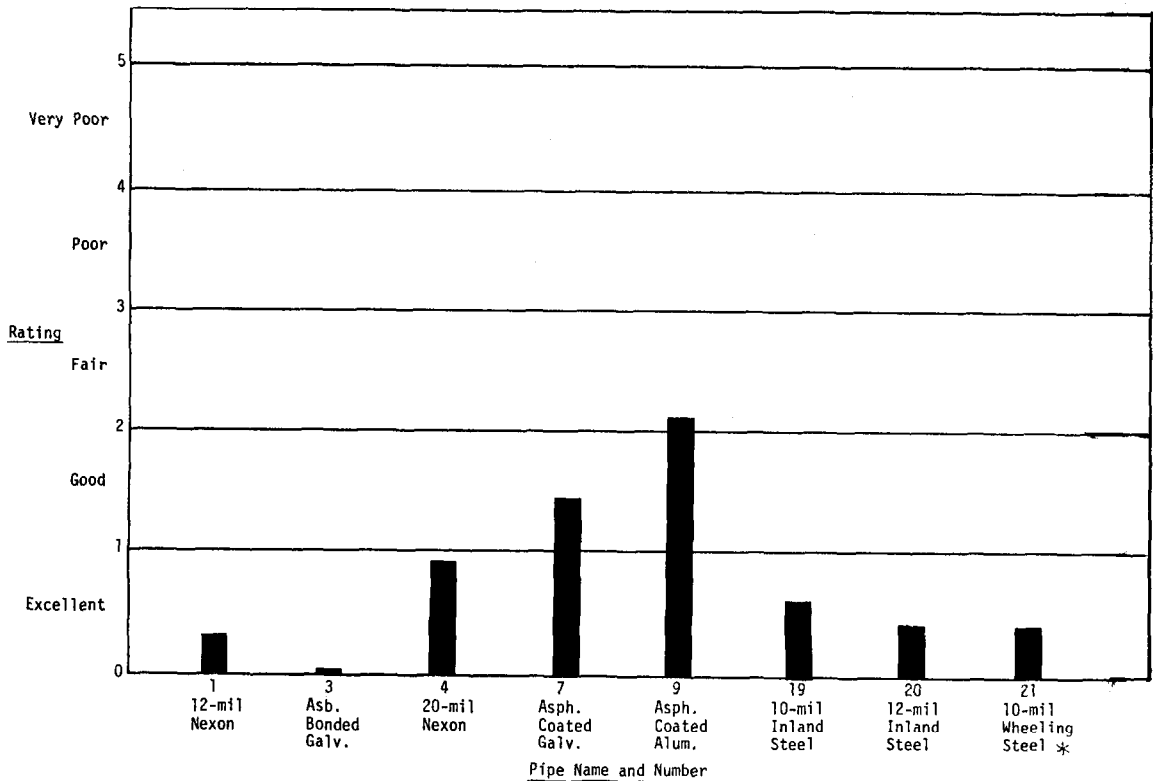
The culvert providing the best performance after four years of field exposure is the asbestos-bonded, asphalt-coated, galvanized steel pipe. The basis of field performance was the ability of the culverts to resist metallic corrosion. An index of corrosion resistance was assigned by a panel inspecting the entire culvert in the field and by an engineer examining a sample of the test culvert in the laboratory.

The field ratings of the test pipes and their individual coatings are summarized in Figures 7 & 8 respectively. The ratings are the collective opinions of a panel of five highway engineering employees who examined the culverts at the ten test locations and assigned a numerical rating ranging from one (excellent) to five (poor) to each culvert. Neither the two highway engineers nor the three engineering technicians comprising the panel are corrosion experts. However, the authors feel that the technical backgrounds of these individuals qualified them to identify signs of corrosion such as rust on steel and pitting on aluminum and to assign valid ratings to the test culverts.

The laboratory ratings are summarized in Figures 9 & 10. These ratings result from a chemical engineer examining each square-inch unit of area of samples from the test culverts in the laboratory and assigning a numerical rating ranging from zero (excellent) to five (poor) to each sample.

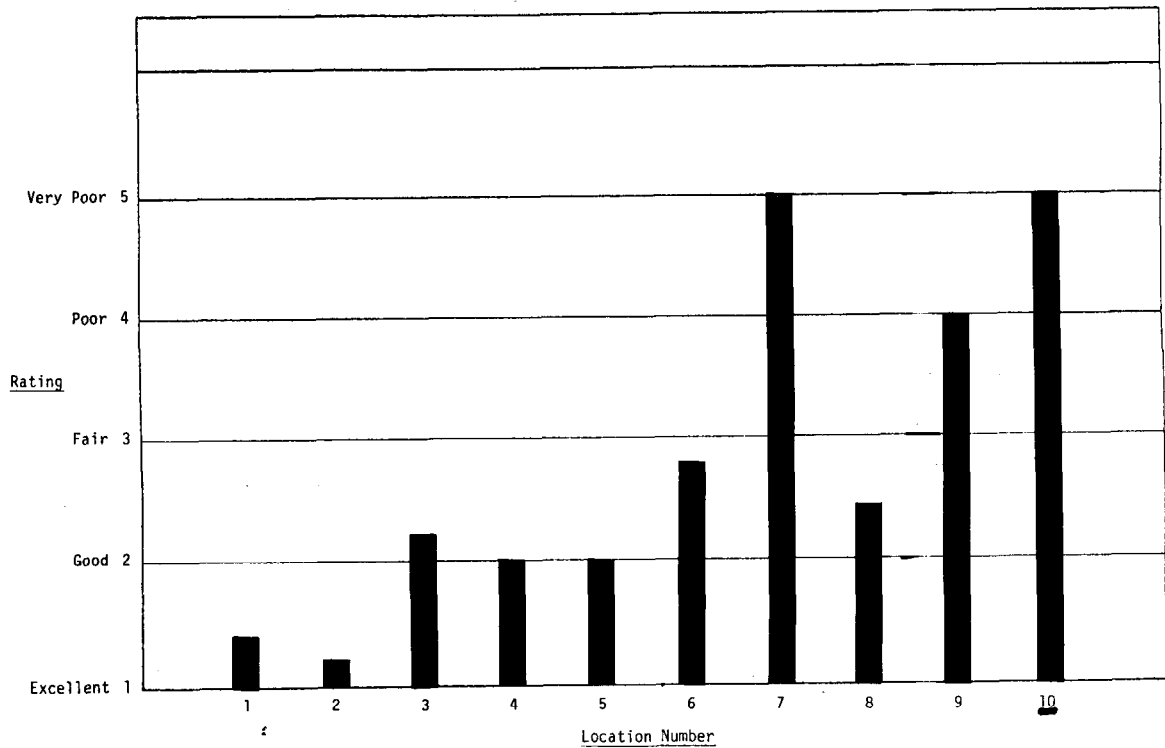
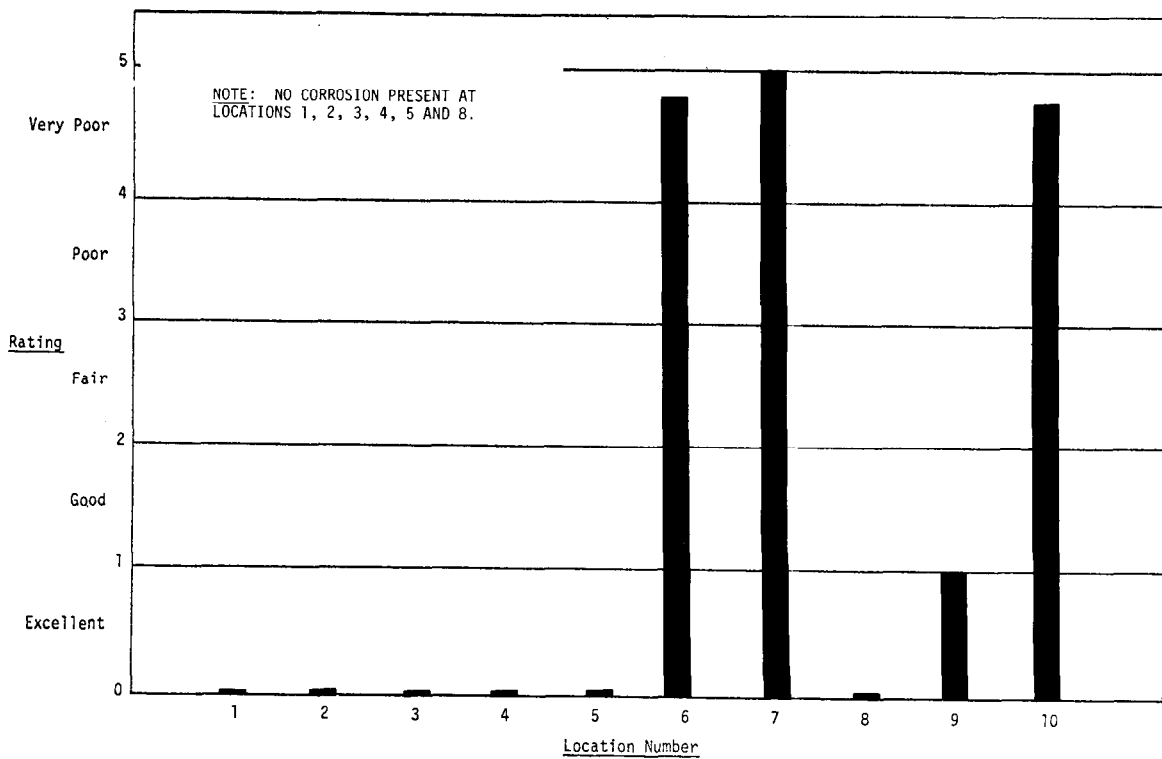
At two of the test sites (number 1 and 2), the galvanized steel pipes are performing very satisfactorily. At sites 3, 4, 5, 6 and 8 the panel noted corrosion spots, rusty rivets, and minor pitting.

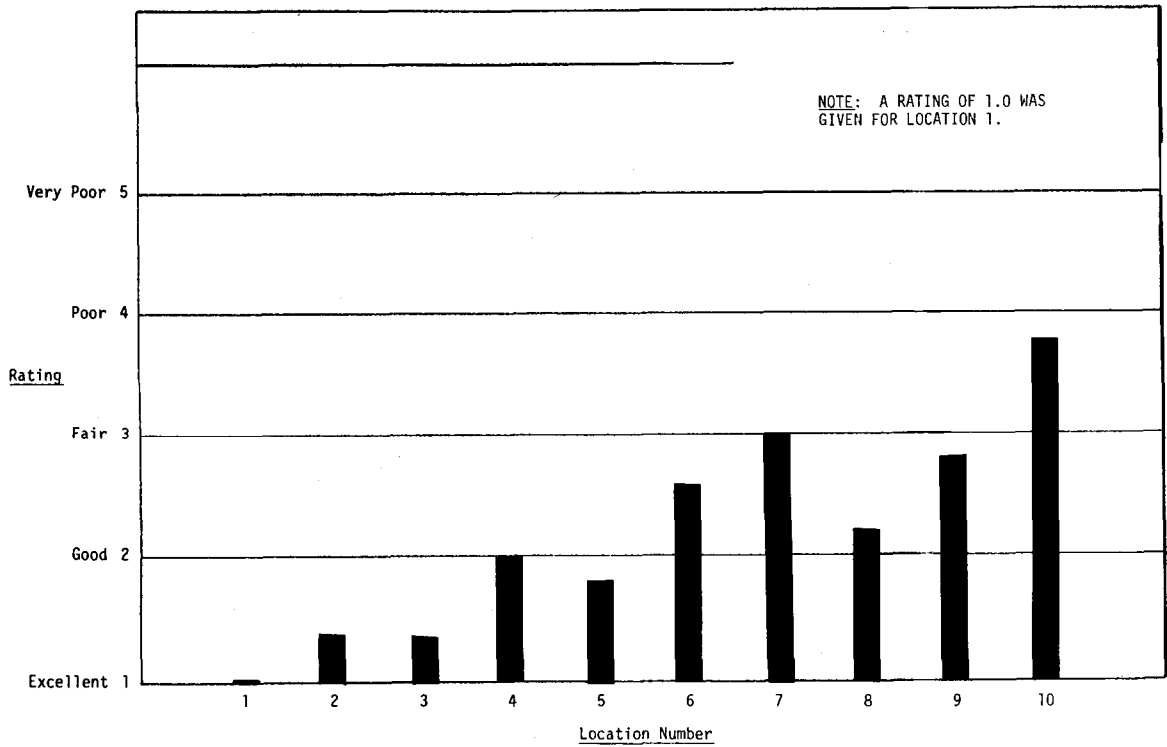
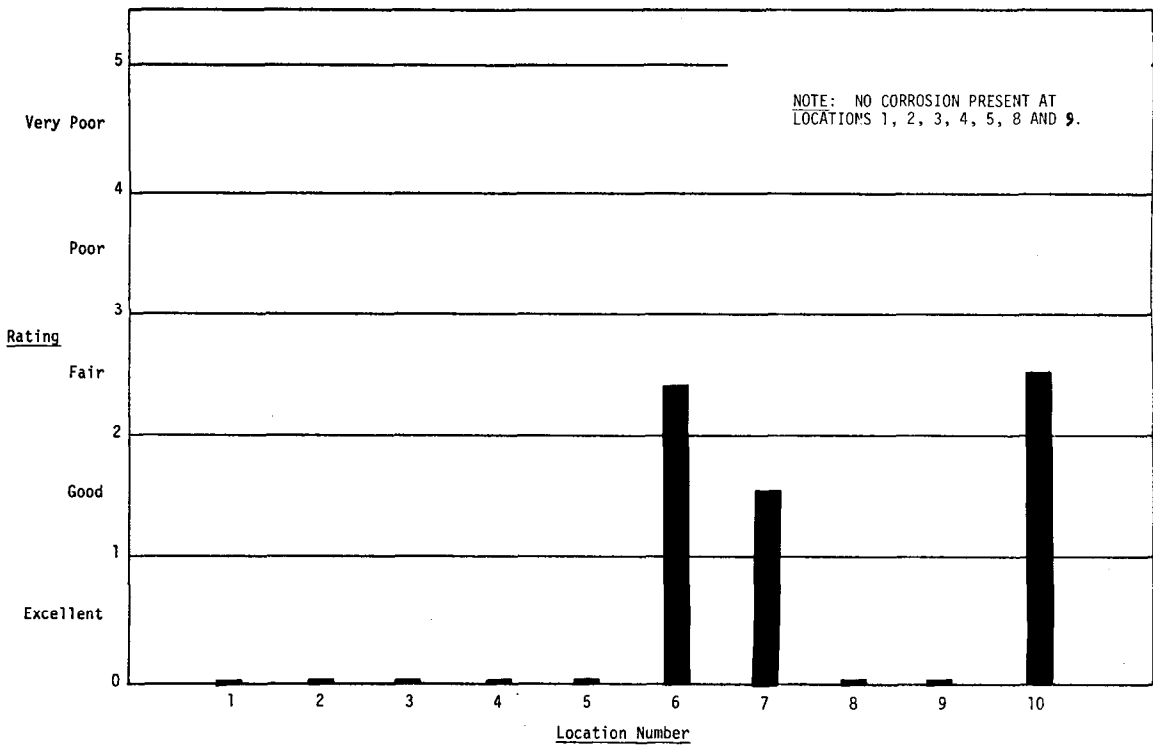
At sites 1, 2, and 3 the field ratings were very favorable for these U. S. Steel Nexon precoated culverts. The test pipes at sites, 4, 5, 6, and 8, showed minor pitting and rust on the inside, plus some corrosion of the rivets. The test culvert at site number 5 also showed some separation of the inside coating.

At site 7 the pipe lies in brackish water with a low electrical resistivity of 200 ohm-cm. The metal comprising the pipe is corroding. The 12-mil protective coating is pitted, separated and partially removed.

At site number 9 the raters noted some corrosion along with thickness loss. The effluent at this location has an electrical resistivity of 300 ohm-cm.

Panel Ratings of U. S. Steel Nexon Precoated Culverts (12-mil Coating)
 FIGURE 14

Laboratory Ratings of Samples from U. S. Steel Nexon Test Culverts (12-mil Coating)
 FIGURE 15

At site number 10 the pipe lies in brackish water with a low electrical resistivity of 200 ohm-cm. The outside coating is partially removed, the inside protective coating is separating from the pipe, and the metal is corroding.

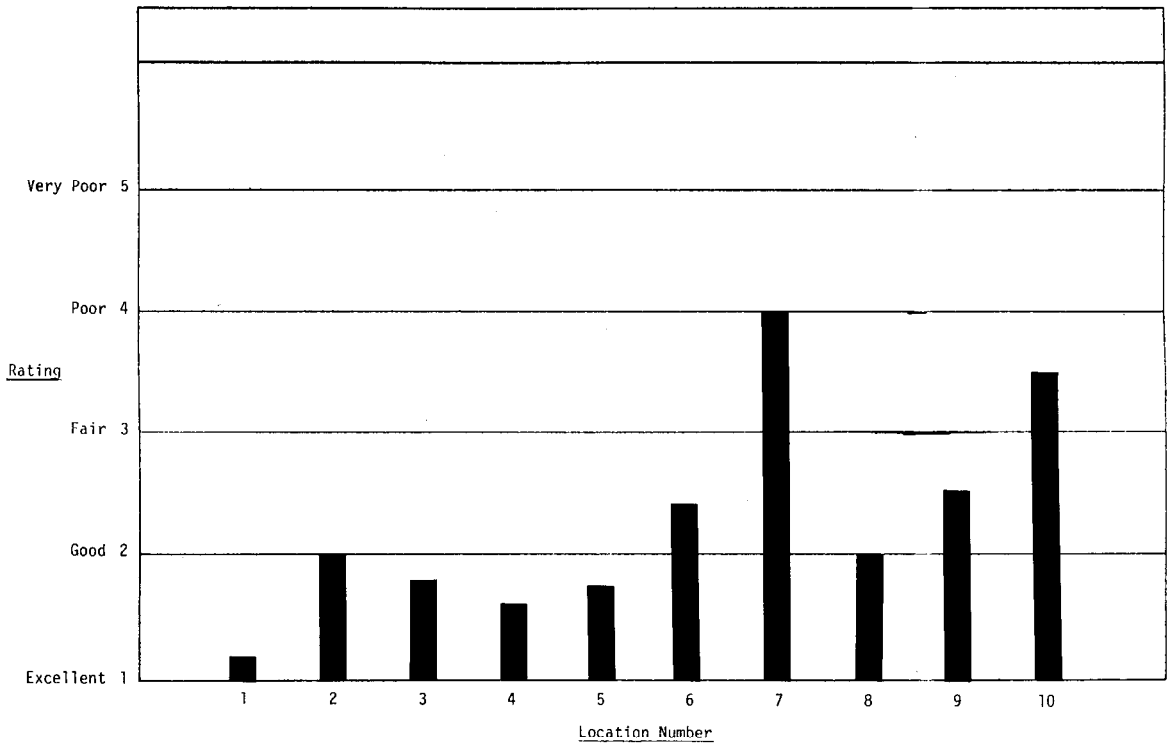
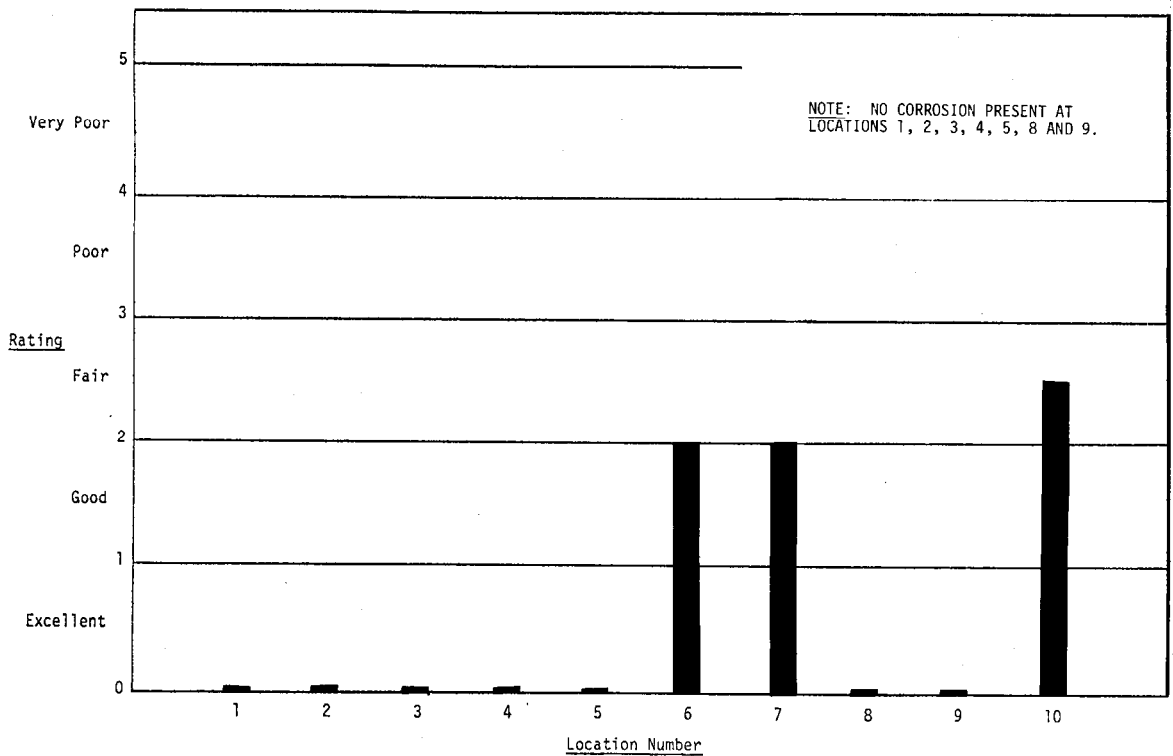
At sites 1, 4, 8, and 9 the rivets were corroding. At sites 2, 3, 5, 7, 8, 9, and 10 the panel observed separation of the inside coating from the pipe. At sites 4, 5, 7, and 8 there are signs of pitting on the inside and outside of the pipe.

At site number 6 (20-mils outside coating) corrosion was noted on the inside thin coating. At site number 7 it was noted that the pipe was rusting and perforated at one edge. At site number 10 the pipe's outside coating is practically all removed.

*Panel Ratings of U. S. Steel Nexon Precoated
Culverts (20-mil Coating)*
FIGURE 16

*Laboratory Ratings of Samples from U. S. Steel
Nexon Test Culverts (20-mil Coating)*
FIGURE 17

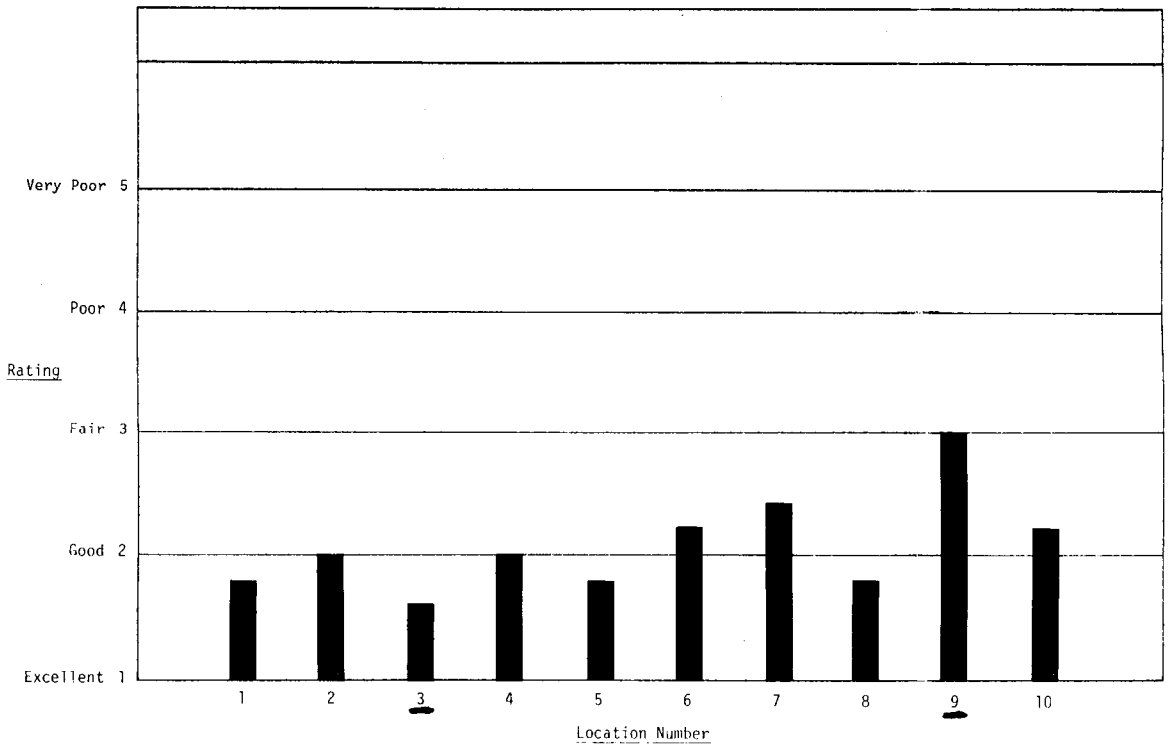
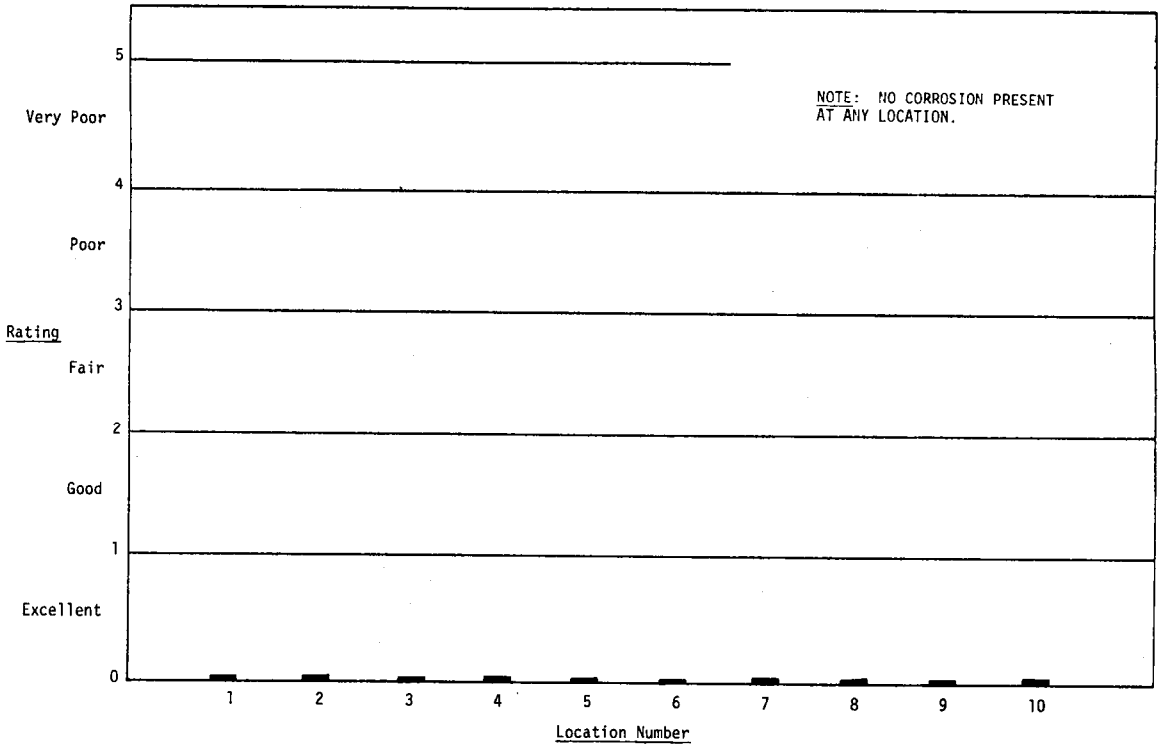
The panel noted that rivets exposed on the exterior of this pipe are corroding at all sites except number 5. The panel was also concerned about the durability of the coating in environments where both soil and effluent have low electrical resistivity values. Typical deterioration at these sites included blistering, pitting, and separation of both inside and outside coatings.

Panel Ratings of Inland Steel Polyethylene-Coated Culverts (10-mil / 3-mil Coatings)
 FIGURE 18

Laboratory Ratings of Samples from Inland Steel Test Culverts (10-mil / 3-mil Coatings)
 FIGURE 19

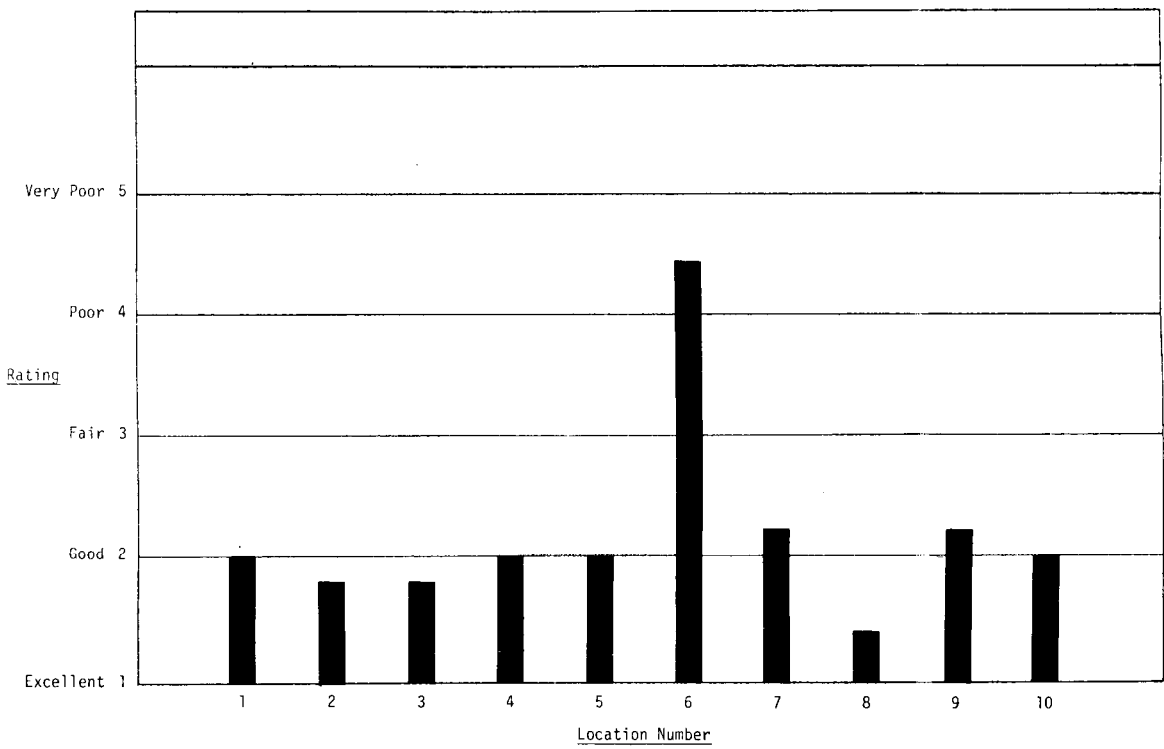
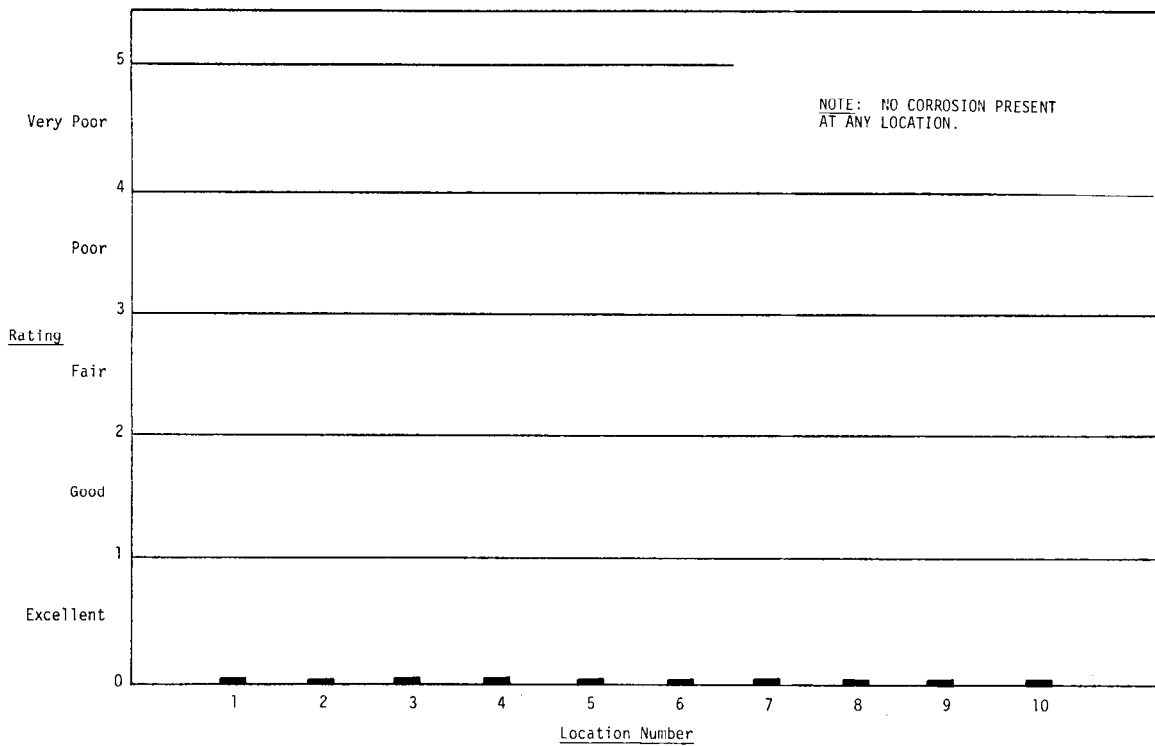
At all sites except number 5 the rivets exposed on the exterior are corroding, and at six of the ten sites the pipe seams are rusty.

At site number 6 the soil and effluent have low electrical resistivity values of 275 and 300 ohm-cm., respectively. Complete perforation of the pipe was noted at this site.

The typical deterioration at sites 6, 7, 9, and 10 (salt-water environments) included pitting, blistering and separation of both the inside and outside coatings.

Panel Ratings of Inland Steel Polyethylene-Coated Culverts (12-mil / 5-mil Coatings)
FIGURE 20

Laboratory Ratings of Samples from Inland Steel Test Culverts (12-mil / 5-mil Coatings)
FIGURE 21

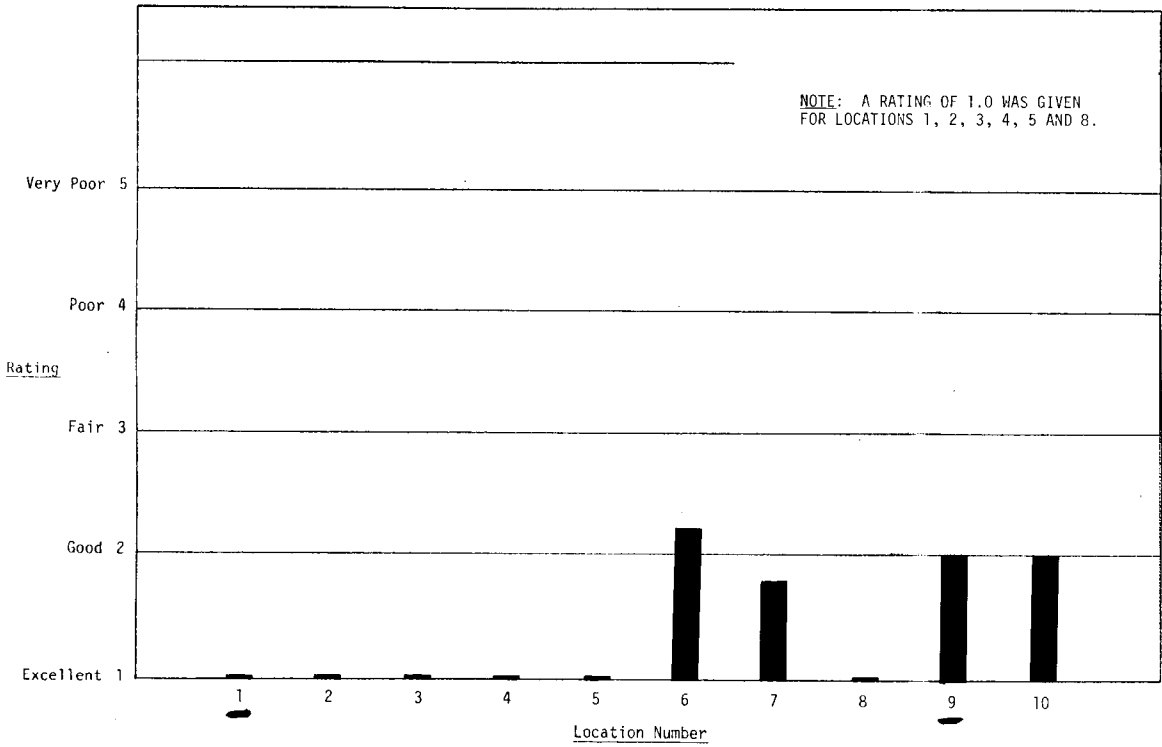
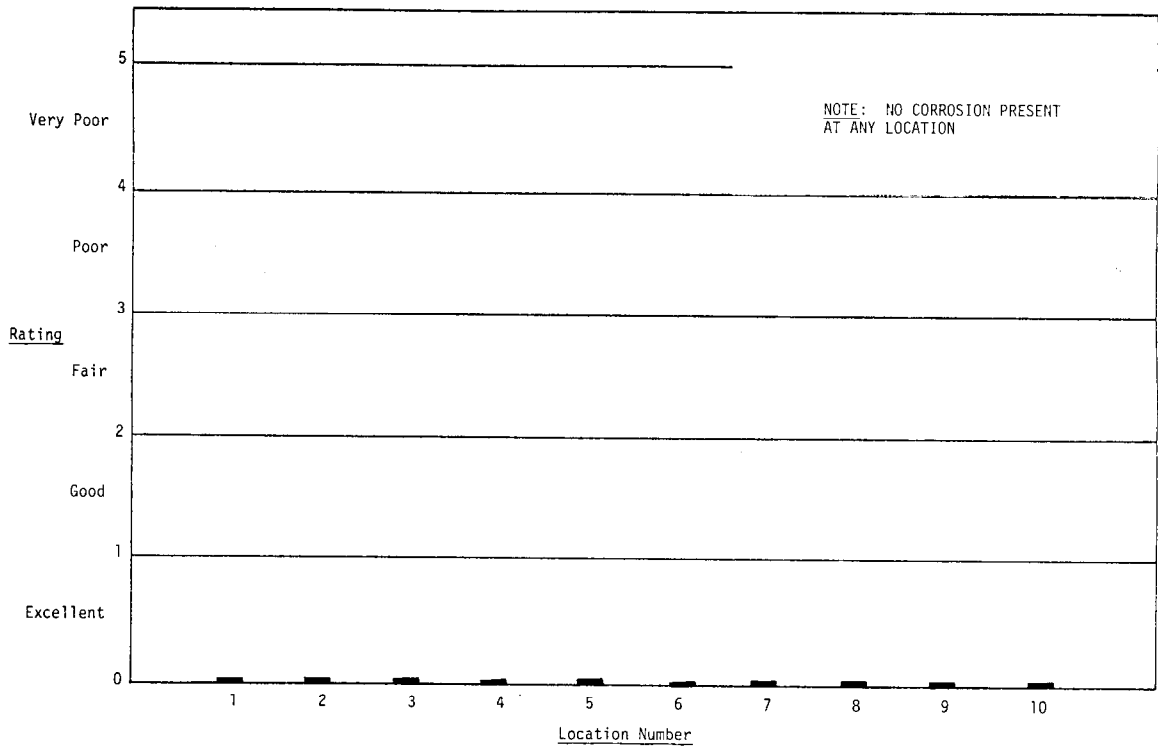
This type of test pipe is resisting corrosion very well after only two years in the variety of environments. The pipe's performance can best be described in Figures 22 and 23.

At sites 6, 7, 9, and 10 the soil and effluent have low electrical resistivity values. Typical deterioration at these sites included blistering and separation of inside and outside coatings.

*Panel Ratings of Wheeling Steel Precoated Culverts
(10-mil / 3-mil Coatings)*
FIGURE 22*

*Laboratory Ratings of Samples From Wheeling
Steel Test Culverts (10-mil / 3-mil Coatings)*
FIGURE 23*

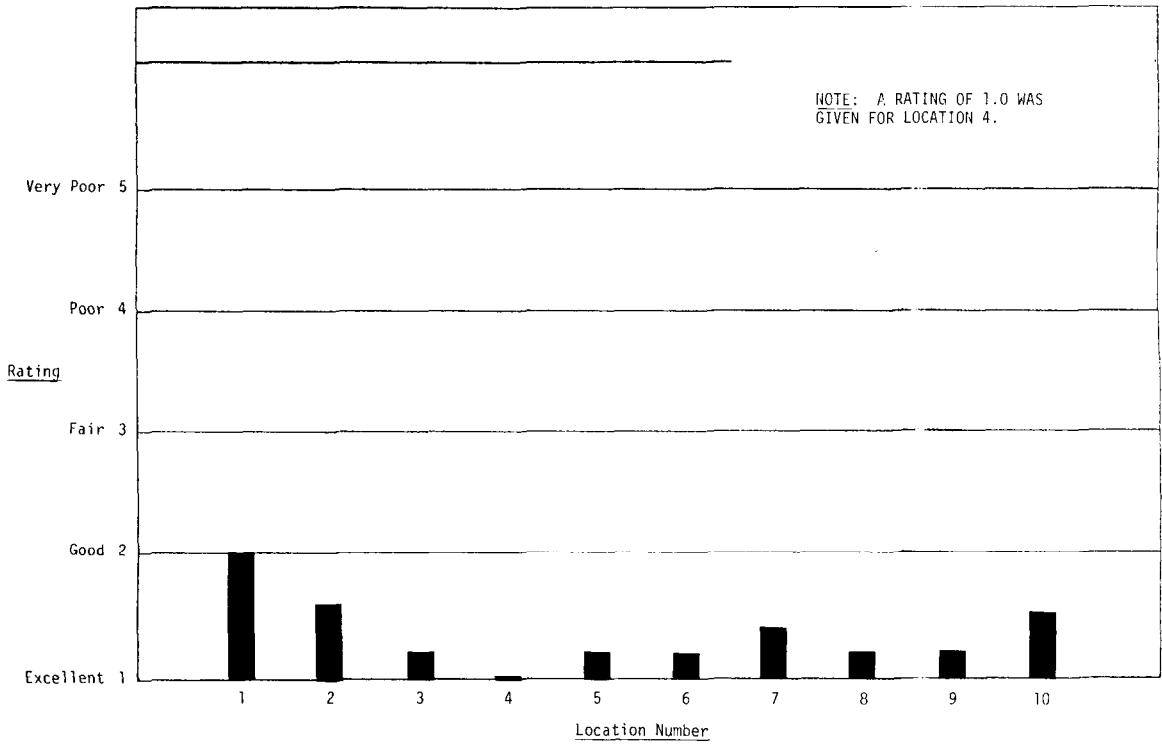
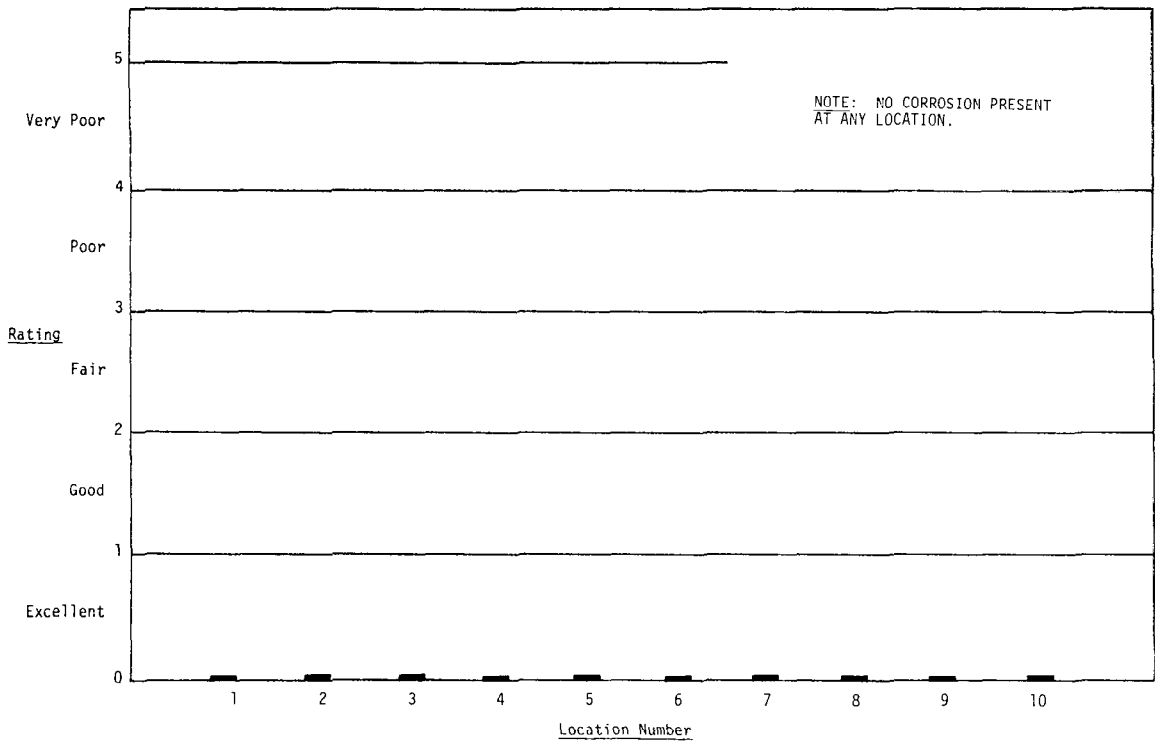
Figures 24 and 25 relate that this type of test pipe is consistently performing very well in regard to corrosion resistance after four years in the field.

At site number 10 the panel noted minor asphalt removal and edge corrosion. However, at 200 mils (5.1-mm.), this is the thickest coating under evaluation (Table 4 in appendix), and it is doing an excellent job of protecting the galvanized steel from corrosion.

Panel Ratings of Asbestos-Bonded Asphalt-Coated Galvanized Steel Culverts
 FIGURE 24

Laboratory Ratings of Samples from Asbestos-Bonded Asphalt-Coated Galvanized Steel Test Culverts
 FIGURE 25

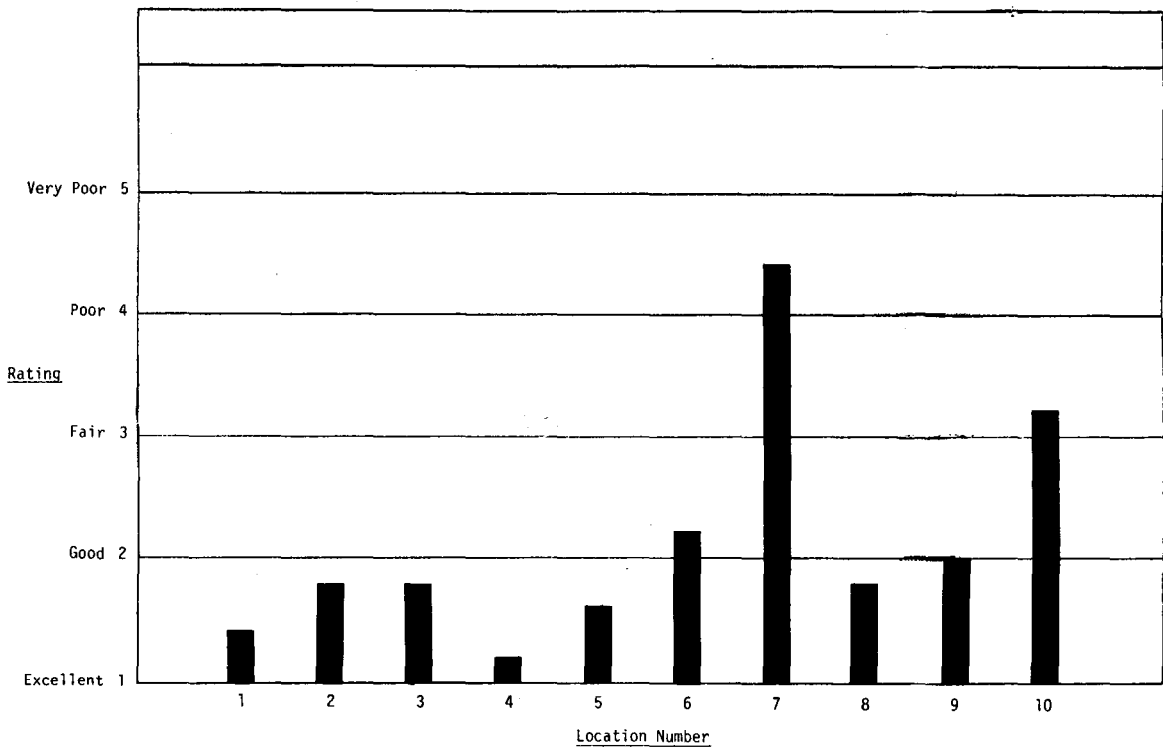
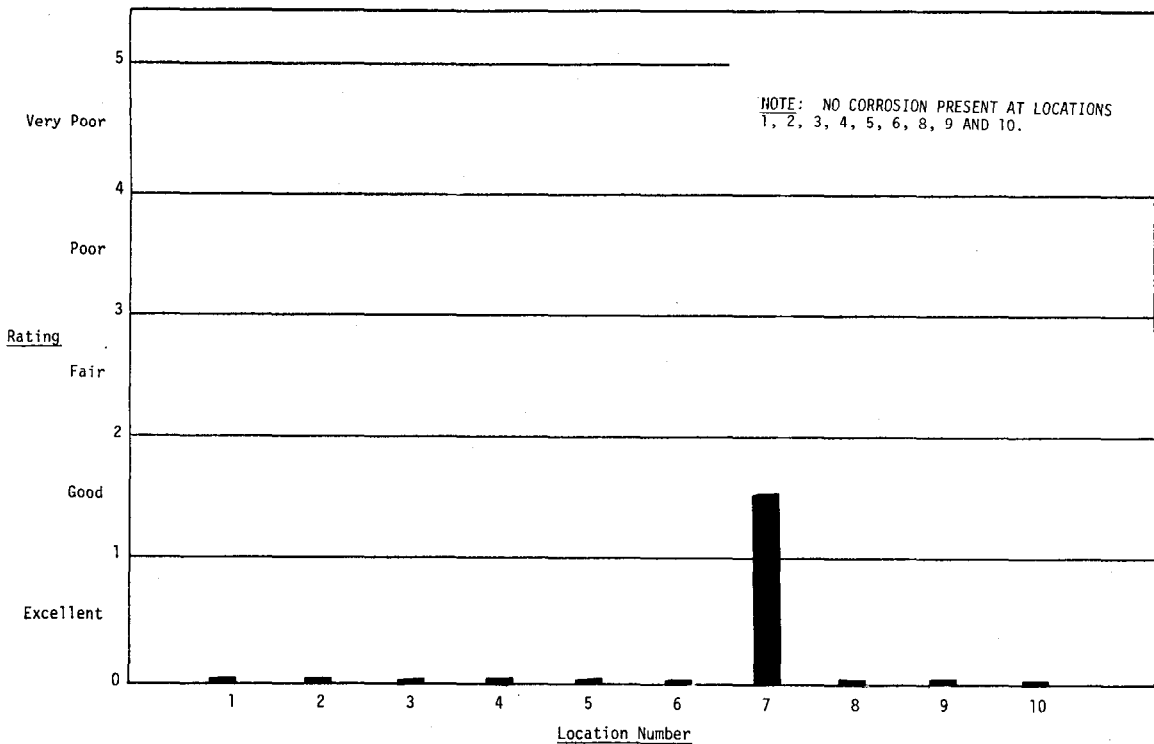
Figures 26 and 27 relate that after four years of field exposure, this type of pipe has resisted corrosion very well at most sites. However, the panel did note some corrosion at sites 7, 9, and 10.

At sites 7 and 10 the panel reported a heavy removal of coating, as well as rust and perforations. At site number 9 the test pipe had minor removal of coating, with very little rust at uncoated spots.

Panel Ratings of Asphalt-Coated Galvanized Steel Culverts
 FIGURE 26

Laboratory Ratings of Samples from Asphalt-Coated Galvanized Steel Test Culverts
 FIGURE 27

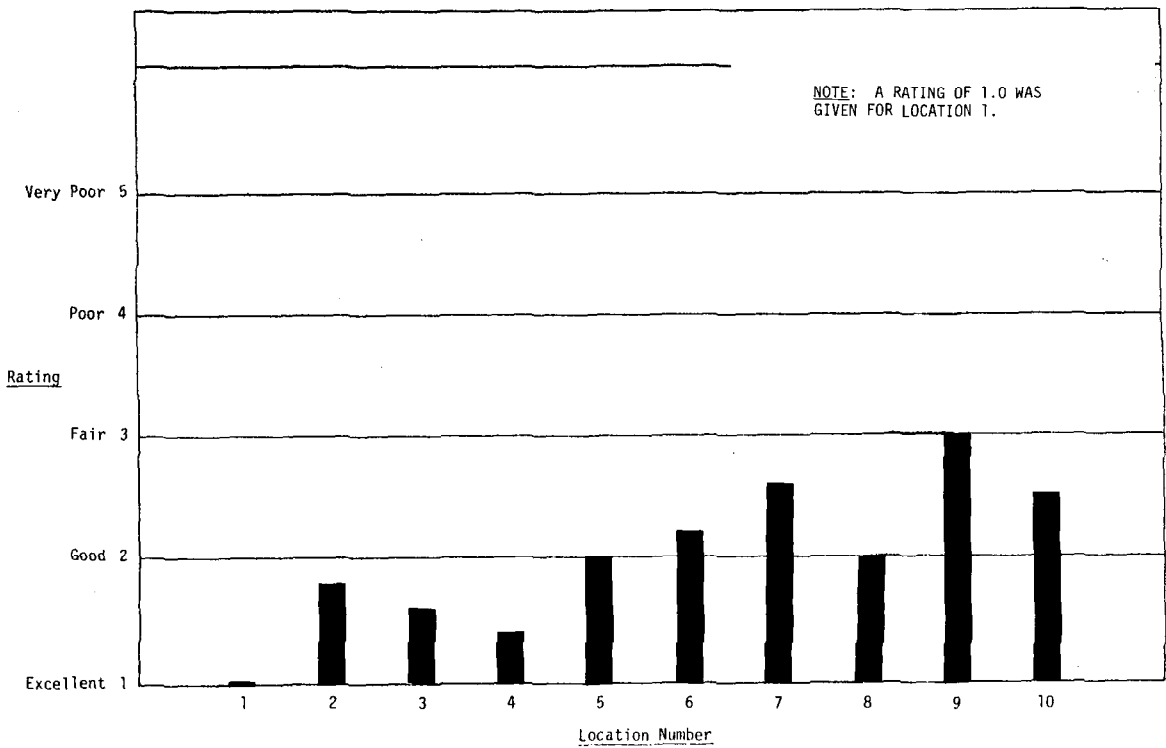
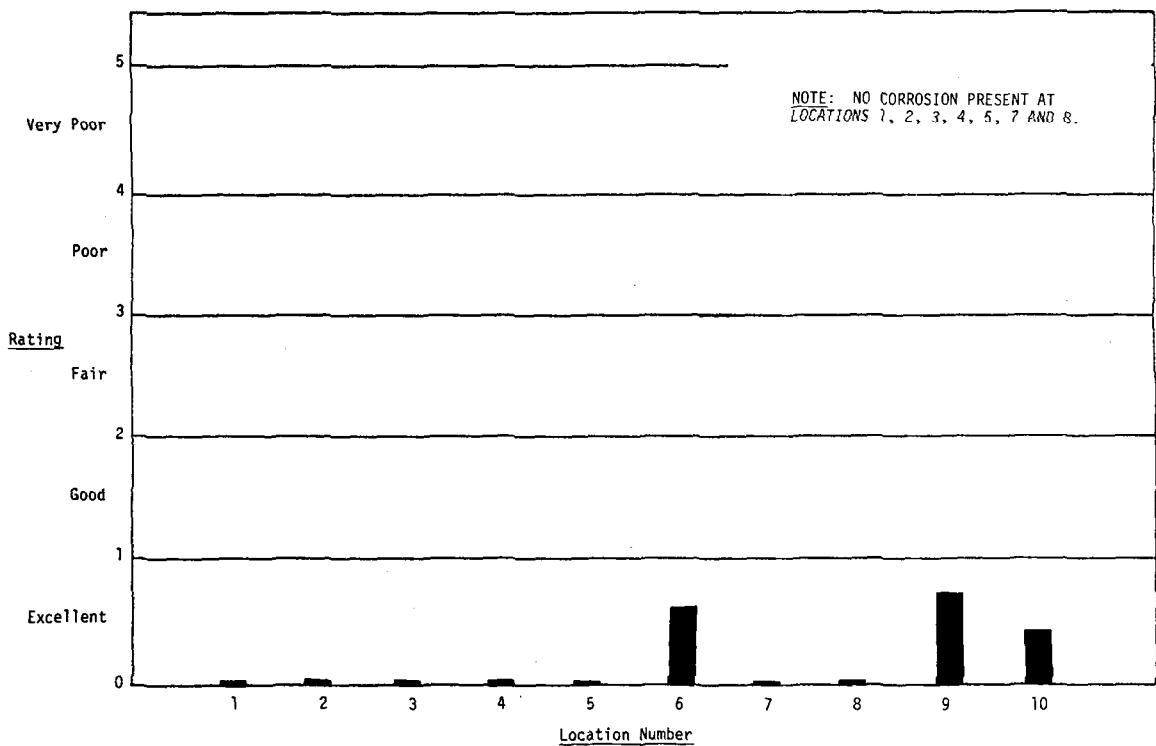
At most of the sites which met the above pH and resistivity criteria, the aluminum pipes have performed very well in resisting corrosion. After 2 years of field exposure, the aluminum pipes exhibited staining, pitting, or localized thickness loss at sites where the soil and/or the effluent possessed electrical resistivity values near or below the threshold of 500 ohm-cm.(6).

After 4 years of field exposure the test pipes at site numbers 1, 2, 3, and 4 are exhibiting the best resistance to corrosion. Test pipes at the other six sites are experiencing pitting and/or thickness loss.

Panel Ratings of Corrugated Aluminum Pipe
 FIGURE 28

Laboratory Ratings of Samples from Corrugated Aluminum Test Pipes
 FIGURE 29

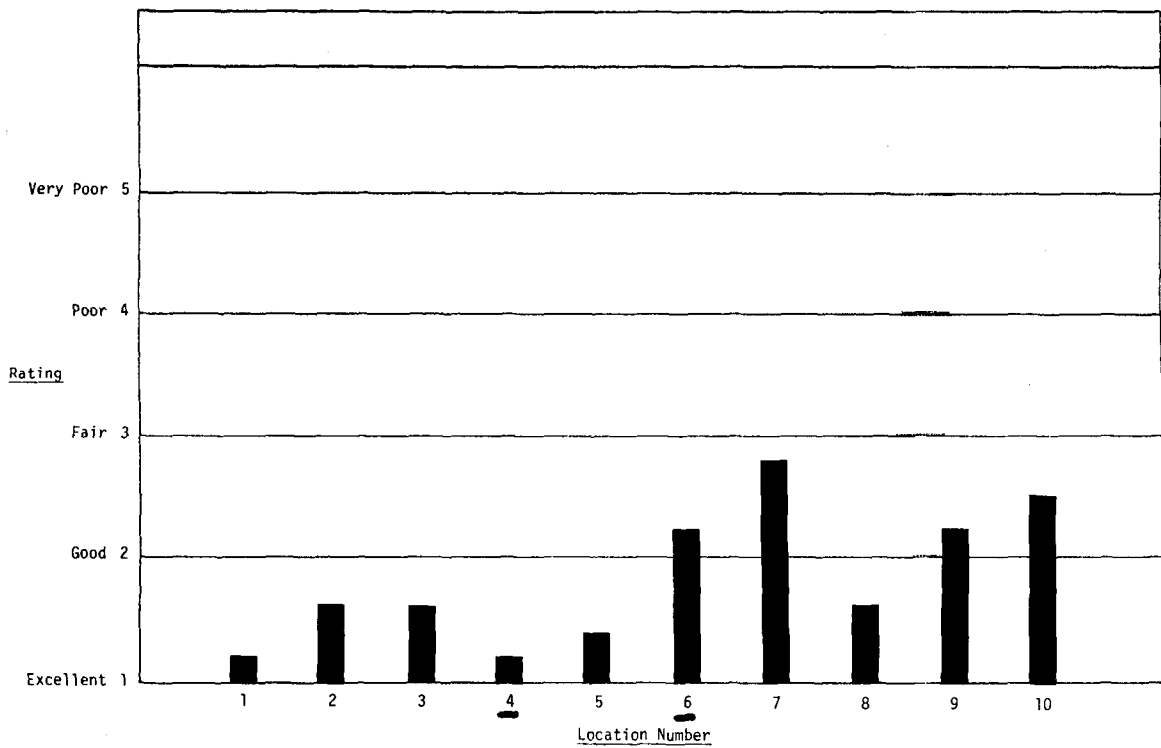
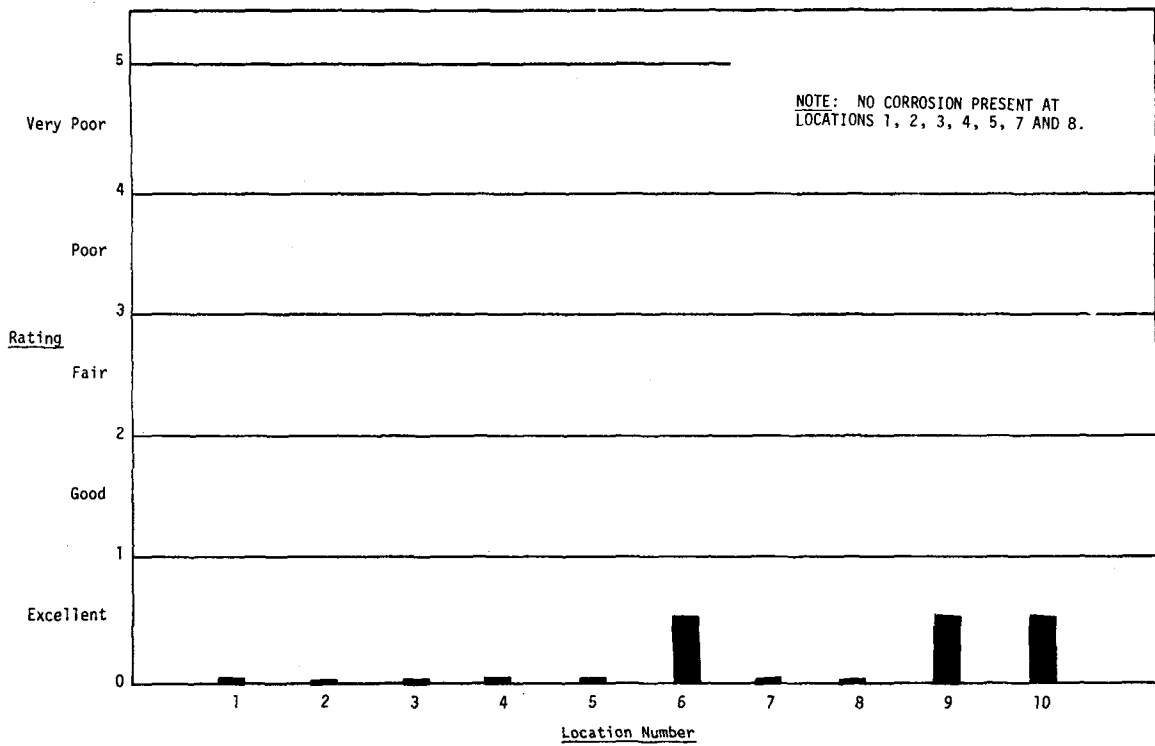
The panel and laboratory ratings for this type of test pipe are shown in Figures 30 and 31. The panel commented that the asphalt coating was extensively removed from these test pipes. The panel made note of pitting and thickness loss at sites 6, 7, 9, and 10.

*Panel Ratings of Asphalt-Coated Corrugated
Aluminum Pipe
FIGURE 30*

*Laboratory Ratings of Samples from Asphalt-Coated
Corrugated Aluminum Test Pipes
FIGURE 31*
