EVALUATION OF DRAINAGE PIPE BY FIELD EXPERIMENTATION
AND SUPPLEMENTAL LABORATORY EXPERIMENTATION

Interim Report No. 2

Research Report No. FHWA-LA-78-115

Research Project No. 72-1SS
Louisiana HPR 0010(001)

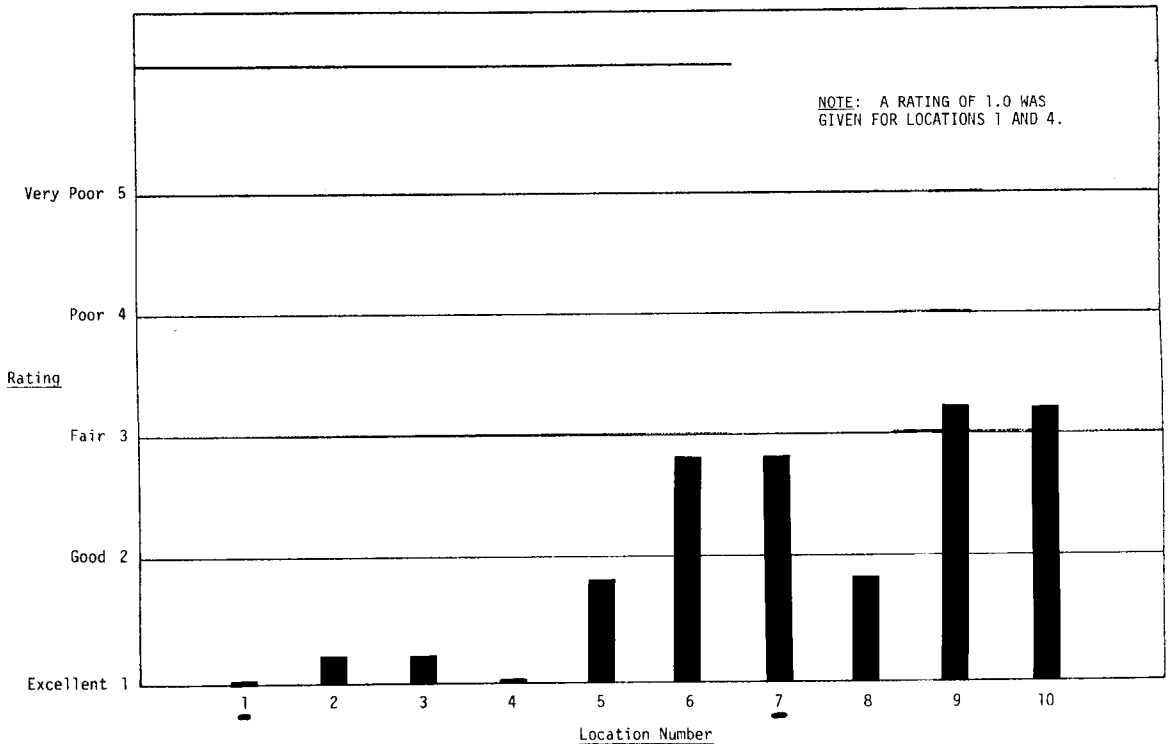
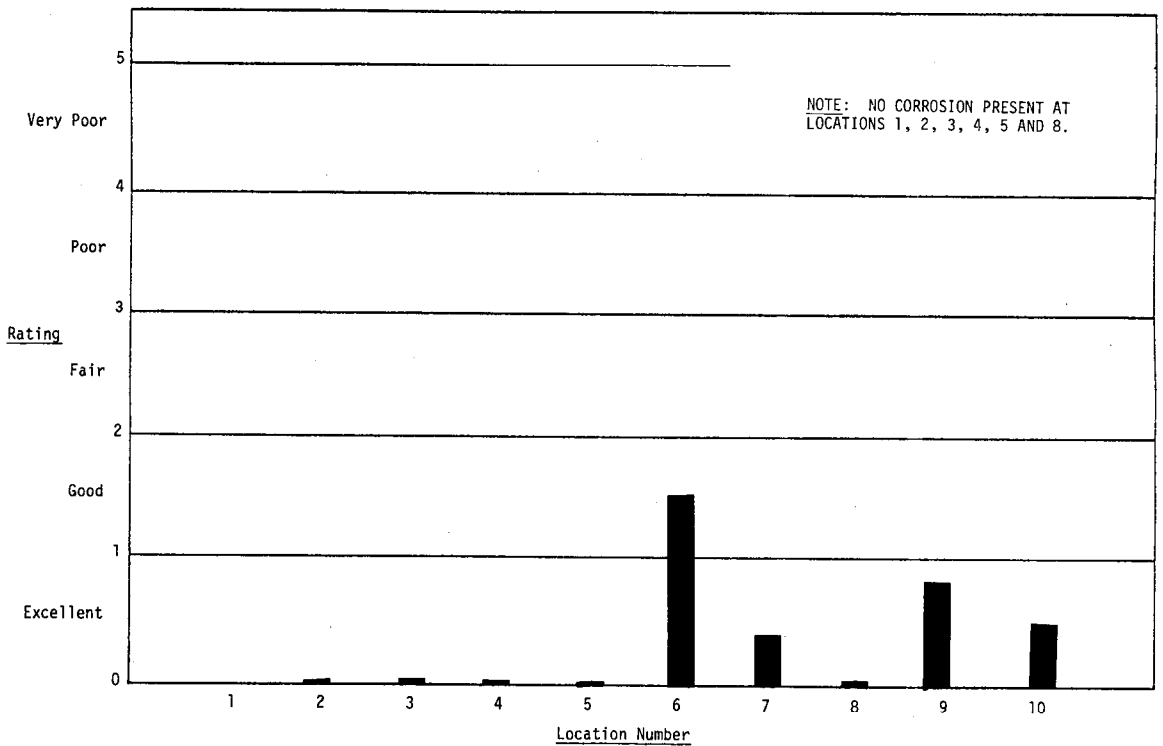
The panel noted that oxidation of this type of culvert was noticeable at all ten sites. Figures 32 and 33 relate that those aluminum plate arches at sites 6, 7, 9, and 10 were in the worst condition. Those at sites 6, 7, 9, and 10 had severe pitting and thickness loss. At site number 7 perforation of the metal was also observed. These four sites are located near the Gulf of Mexico and the electrical resistivity values of soil and effluent are low.

The other six sites had very minor deterioration of the metal.

Panel Ratings of Aluminum Plate Arch
 FIGURE 32

Laboratory Ratings of Samples from Aluminum Test Plate Arch
 FIGURE 33
