EVALUATION OF SYNTHETIC FABRICS
FOR THE REDUCTION OF REFLECTIVE CRACKING

FINAL REPORT

Research Report No.
Research Project No. 70-1B(B)
Louisiana HPR 1 (12)

April 1975

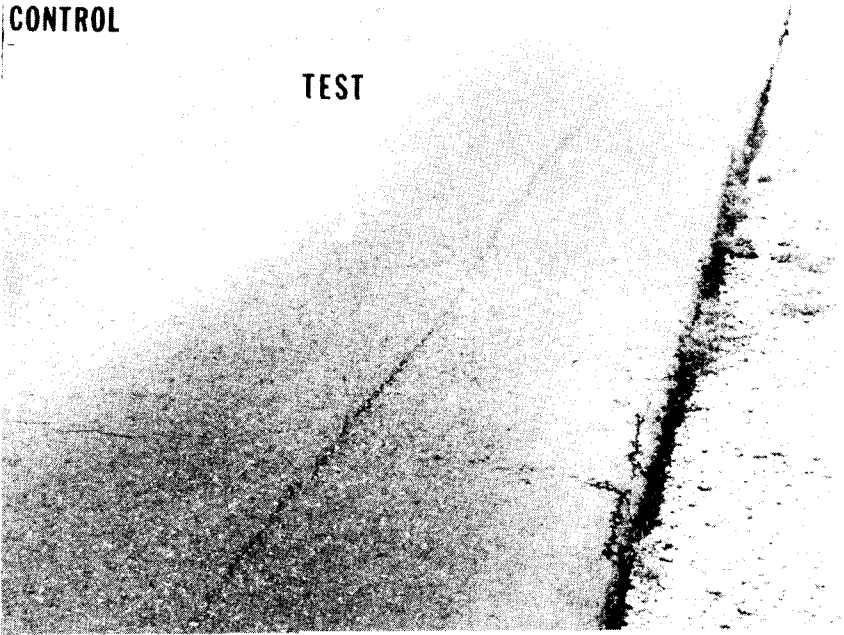
It is believed that these separations were the result of fabric movement, prompted by an excess of high penetration residual emulsion which was softening from the heat of the overlay. To ascertain if such movement seriously affected the degree of compaction of the test section, field densities were taken with a nuclear gage five days after initial compaction of the binder course. Fifteen readings were taken--five immediately south of the test section, five within the test section, and five immediately north of the test section. The results did indicate an apparent loss of initial compaction within the test section--141 lb/ft³ (2258.6 kg/m³) versus 143 lb/ft³ (2290.6 kg/m³)--although such a slight difference may not be statistically significant considering all the variables. However, some movement or shoving of the overlay was visually apparent (Figures 7 and 8). This is probably the result of outer wheel path loads shoving the highly tacked overlay outward to the unconfined shoulder edge.

FIGURE 7
LONGITUDINAL CRACK IN OUTER WHEEL PATH - LA. 19

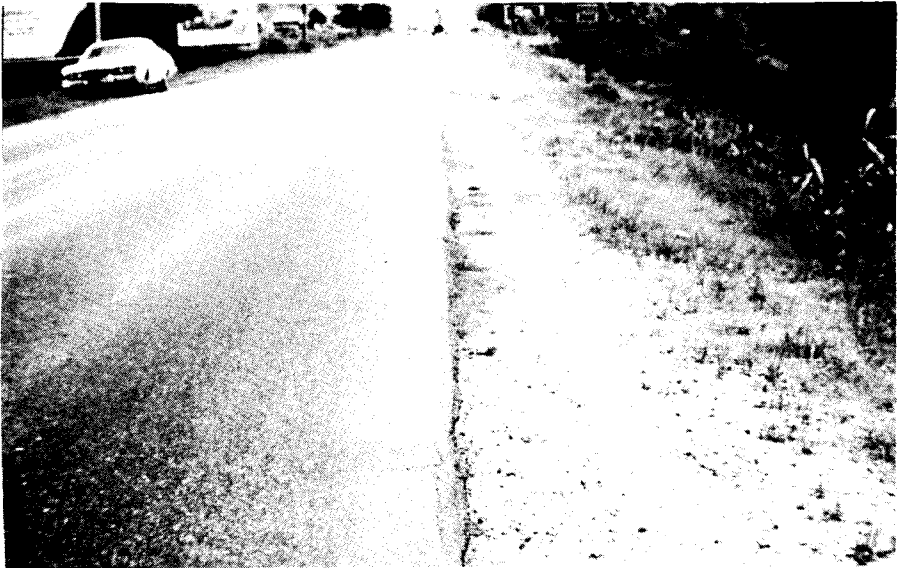
FIGURE 8
SHOVING OF OVERLAY TOWARD SHOULDER EDGE - LA. 19

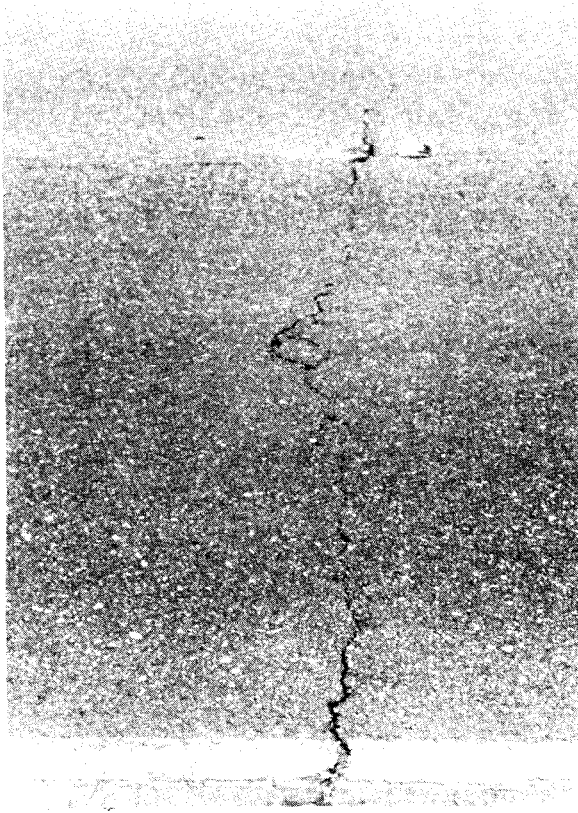
In the case of the polypropylene fabric, there was no evidence of any reflection cracking in either the test or the control section after the first six months. After one year, slight hairline cracks appeared in both test and control sections; there was no appreciable difference between the sections. This trend of similarity between test and control sections continued throughout the remaining months of observation. Photographs taken 3-1/2 years after construction confirm surface cracking consistent with the joint separation of the original concrete pavement. This is true to the same extent for both the control and test sections (Figures 9 and 10). There was also evidence of non-joint distress cracks reflecting through (Figures 11 and 12). At the present time, no further significant changes have taken place in either the test or control sections; both sections are performing equally well.

FIGURE 9
REFLECTION OF TRANSVERSE JOINT IN CONTROL SECTION - U. S. 61

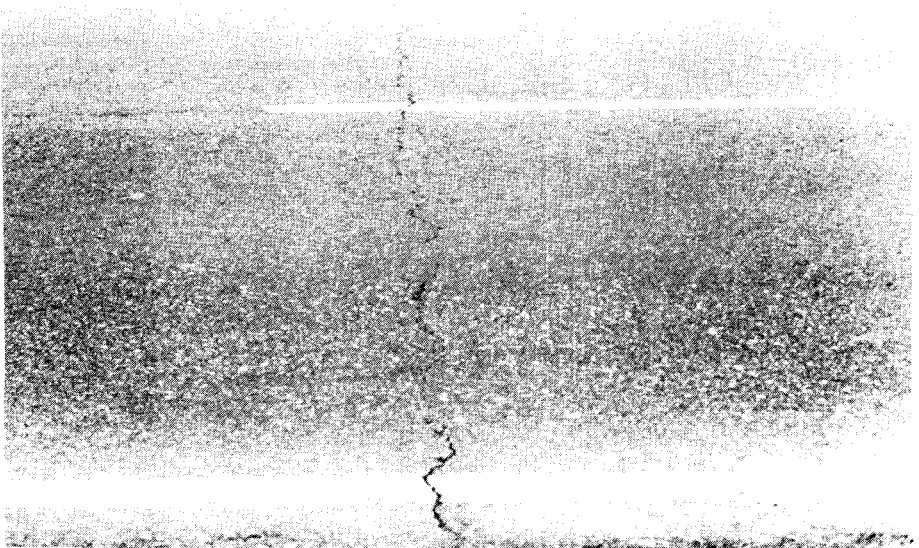
FIGURE 10
REFLECTION OF TRANSVERSE JOINT IN TEST SECTION - U. S. 61

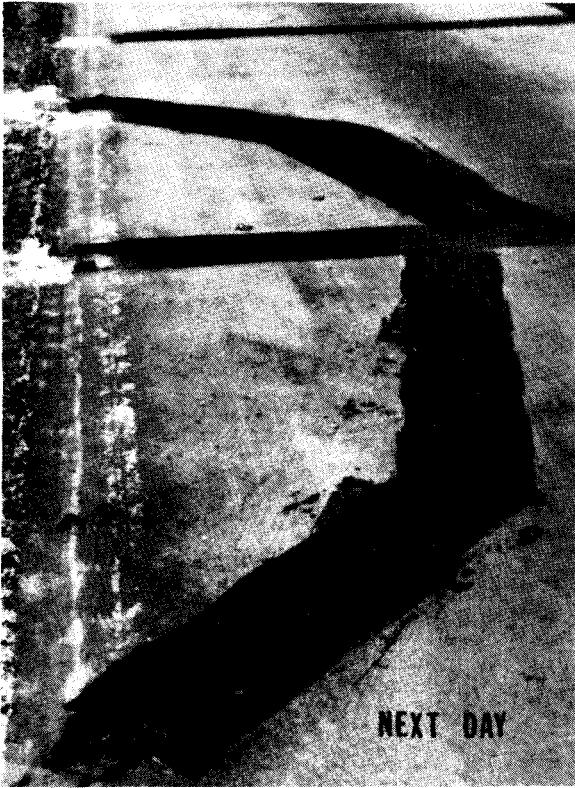
FIGURE 11
DISTRESSED CONCRETE PAVEMENT IN TEST SECTION - U. S. 61

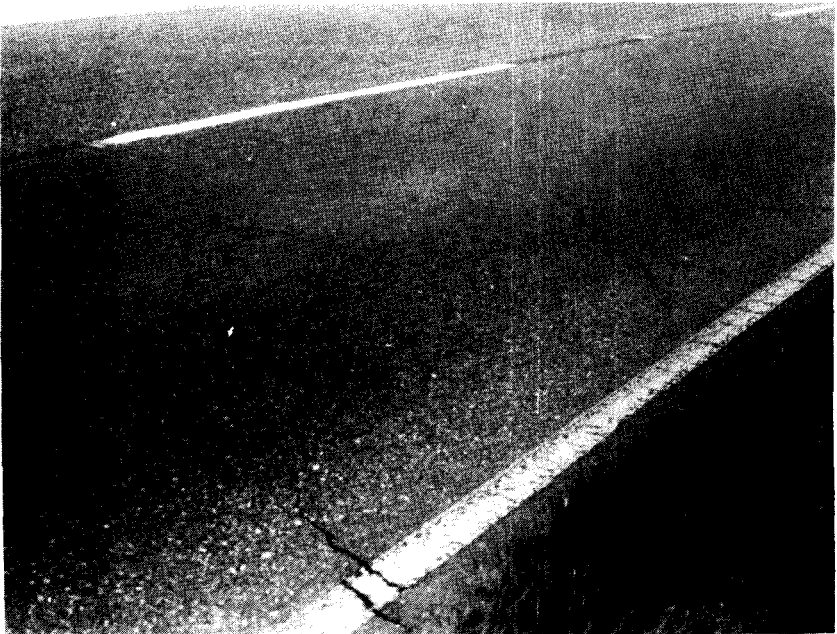
FIGURE 12
REFLECTION OF ORIGINAL CRACK SHOWN ABOVE

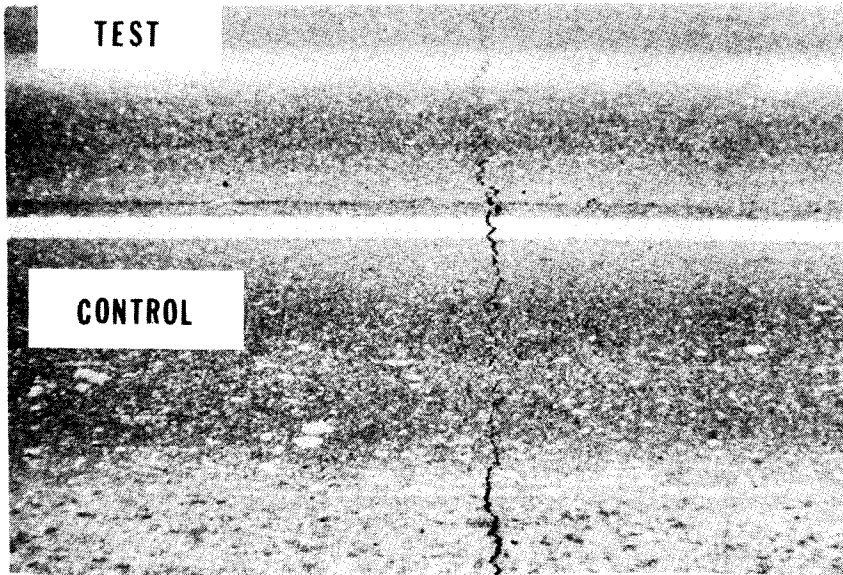
The sections with the nylon fabric under observation were quite similar to those with the polypropylene, in that joint cracks reflected through the overlay both in the control and test sections to the same extent (Figure 13). However, unlike the previously examined U. S. 61 location, the reflection of cracks on La. 19 occurred within the first 4 months (Figures 14-17). Photographs of these and similar transverse cracks were taken to record their growth at 7 months and 15 months after fabric installation and overlay (Figures 18-20). It is apparent from the observations made on these test and control sections that surface cracking of the overlay is consistent with the transverse joint separations of the original concrete. It has been observed, and can be seen in the above designated figures, that the longitudinal joint

*FIGURE I3
REFLECTION OF TRANSVERSE JOINT IN BOTH CONTROL AND TEST SECTION - LA. I9*

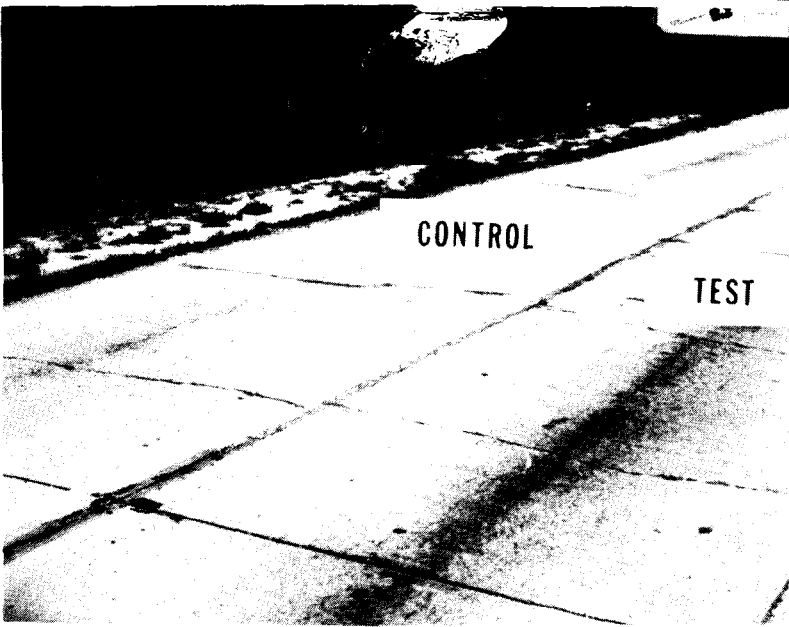
FIGURE I4
ORIGINAL CRACK PATTERN OF CONTROL AND TEST SECTION - LA. I9

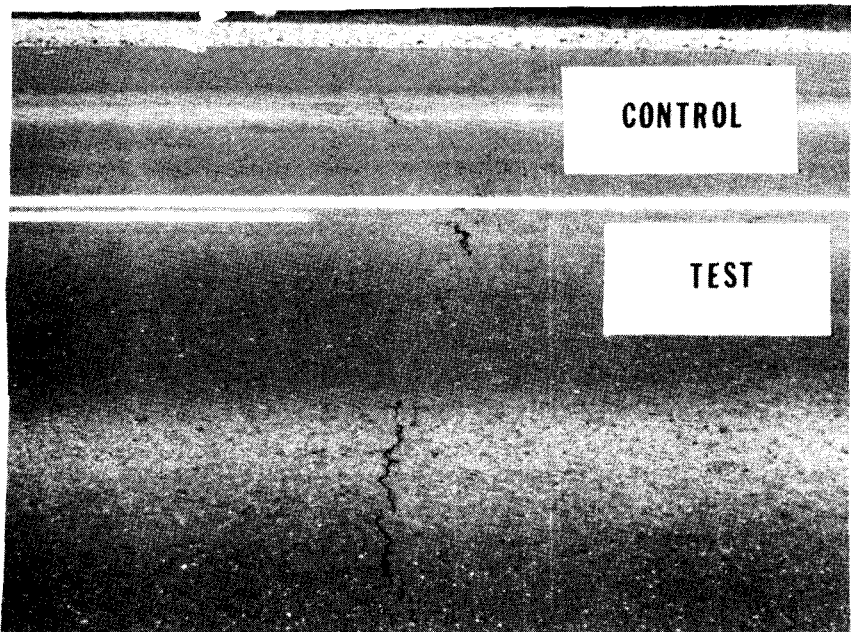
FIGURE I5
REFLECTION OF ORIGINAL CRACK SHOWN ABOVE AFTER 4 MONTHS

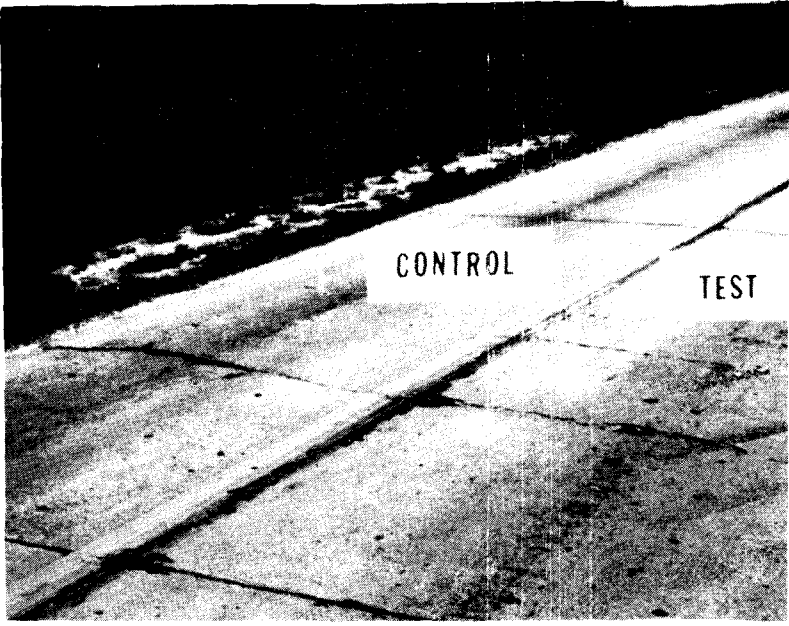
FIGURE I6
ORIGINAL CRACK PATTERN OF CONTROL AND TEST SECTION - LA. I9

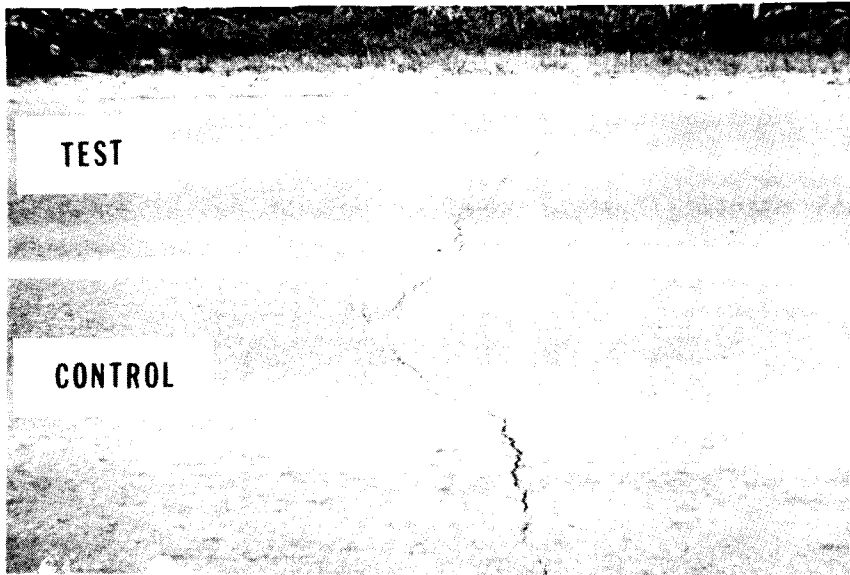
FIGURE I8
REFLECTION OF FIGURE I4 AND I5 CRACK AFTER 15 MONTHS - LA. I9

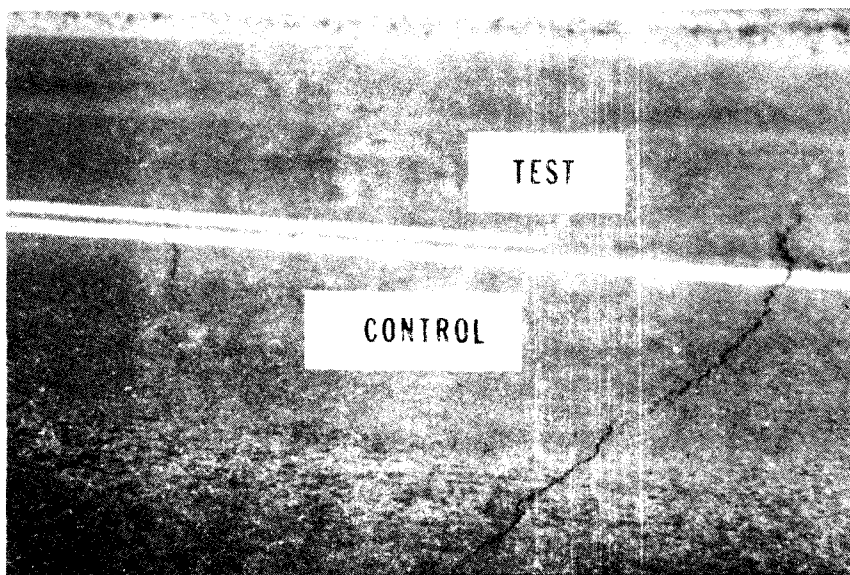
FIGURE I9
REFLECTION OF FIGURE I6 AND I7 CRACK AFTER 7 MONTHS - LA. I9

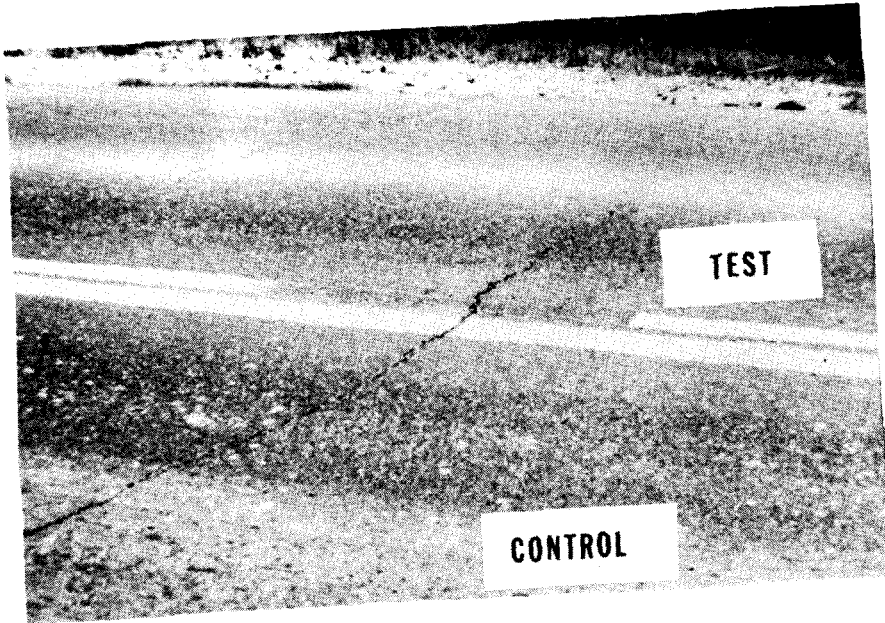
FIGURE 20
REFLECTION OF FIGURE I6 AND I7 CRACK AFTER I5 MONTHS - LA. I9
