BRIDGE DECK DETERIORATION STUDY

FINAL REPORT

Research Report No. 85

Research Project No. 72-2C(B)
Louisiana HPR 1 (12)

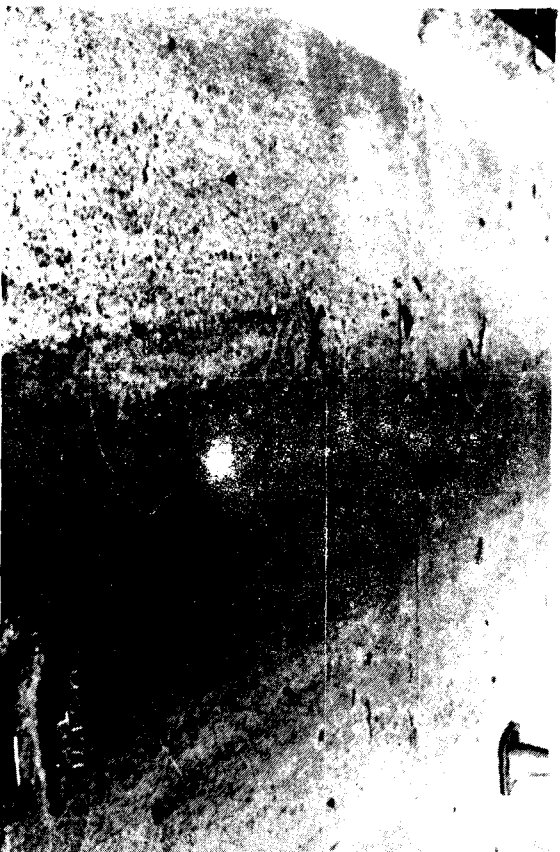
FIGURE 3
Bridge No. 1: Cracking and spalling is evident over the reinforcing steel in which corrosion is occurring.

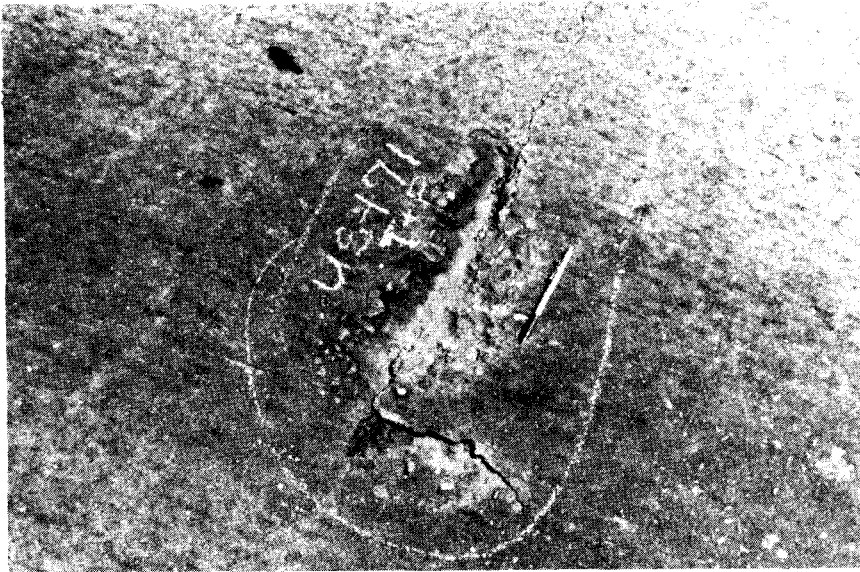
FIGURE 4

Bridge No. 1: A close-up of the lower right corner of Figure No. 2.

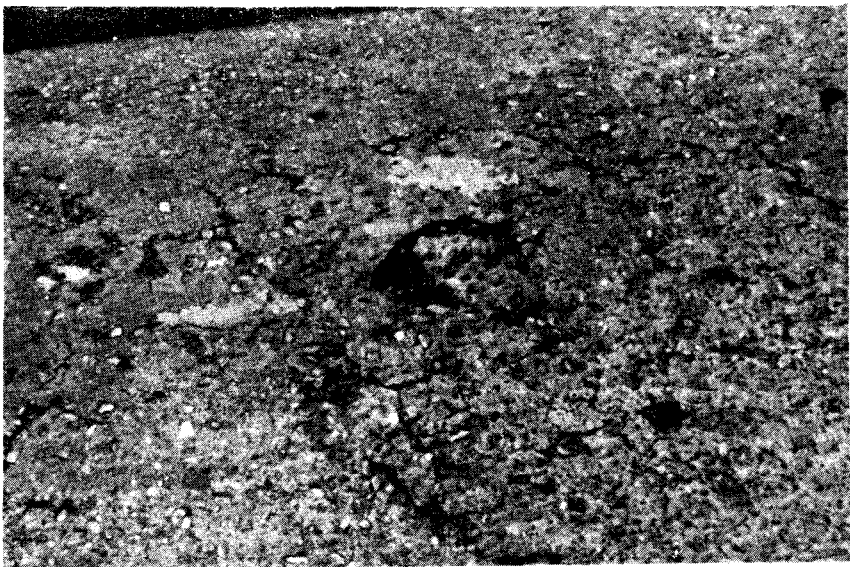
FIGURE 5

Bridge No. 1: Surface scaling is occurring at this section.

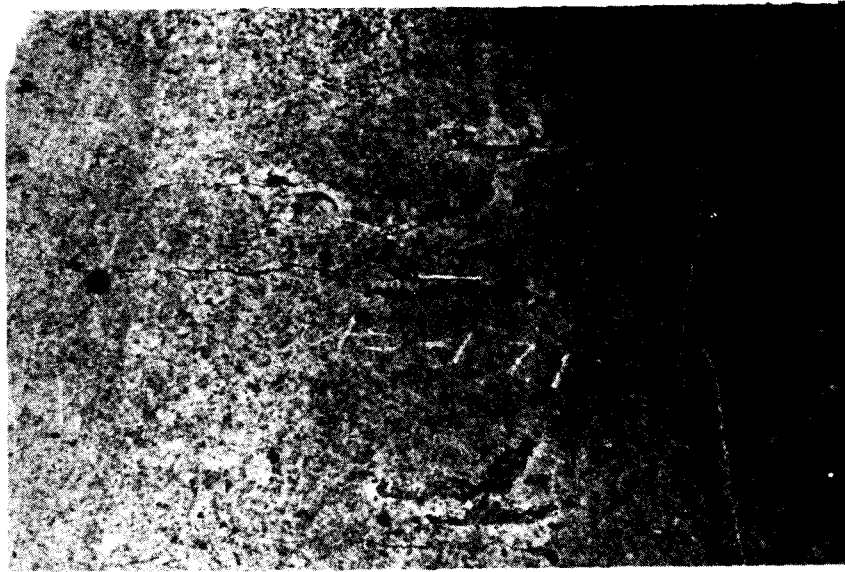
FIGURE 6
Bridge No. 1: Delamination has occurred to this area.

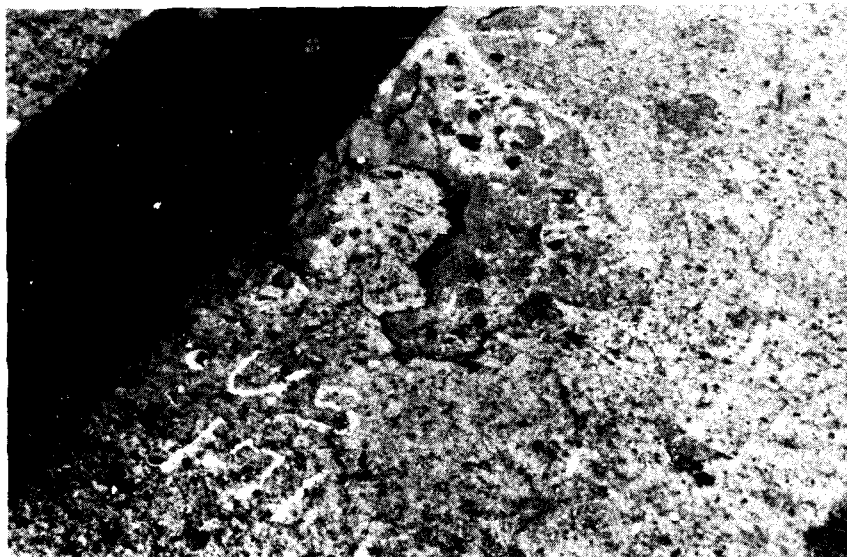
FIGURE 7
Bridge No. 1: Spalling at the armor joint is a troublesome maintenance problem.

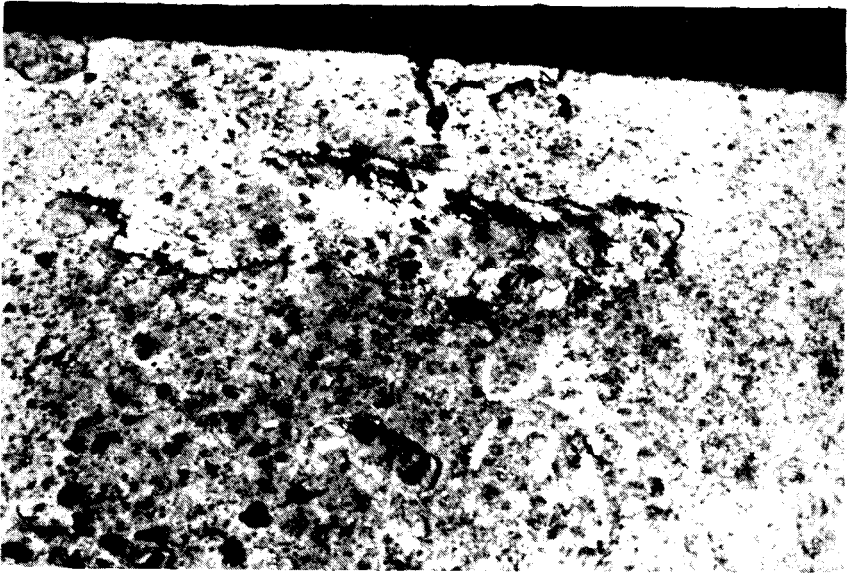
FIGURE 8

Bridge No. 1: This area will spall out in time.

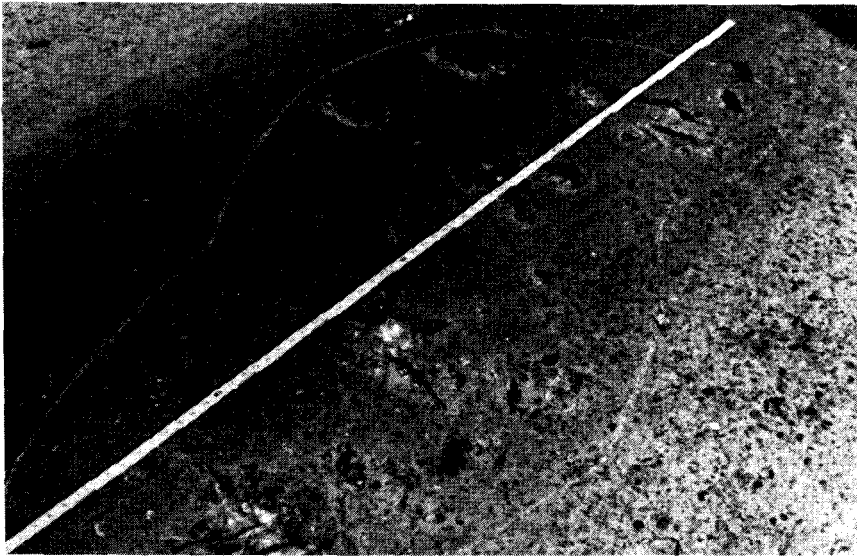
FIGURE 15

Bridge No. 2: Delamination is outlined in chalk. Spalling occurs within the delaminated area.

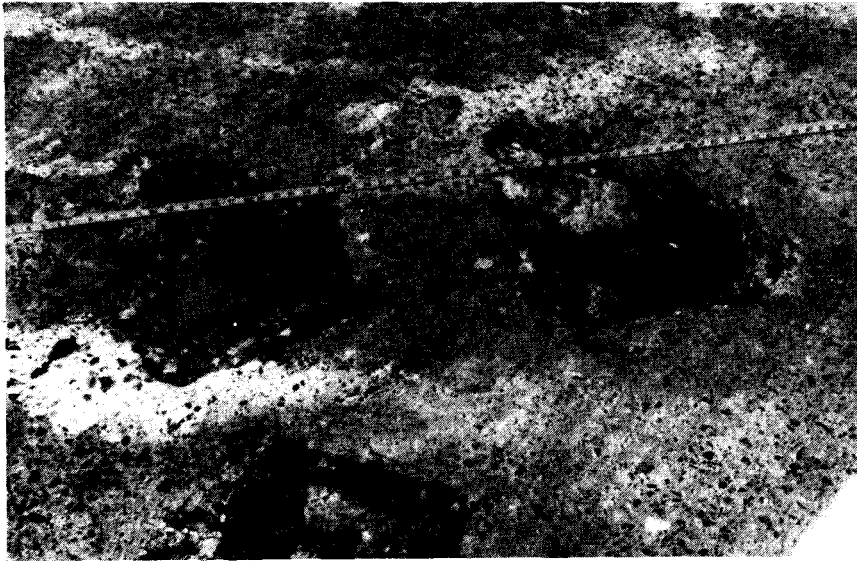
FIGURE 16

Bridge No. 2: Spalled areas

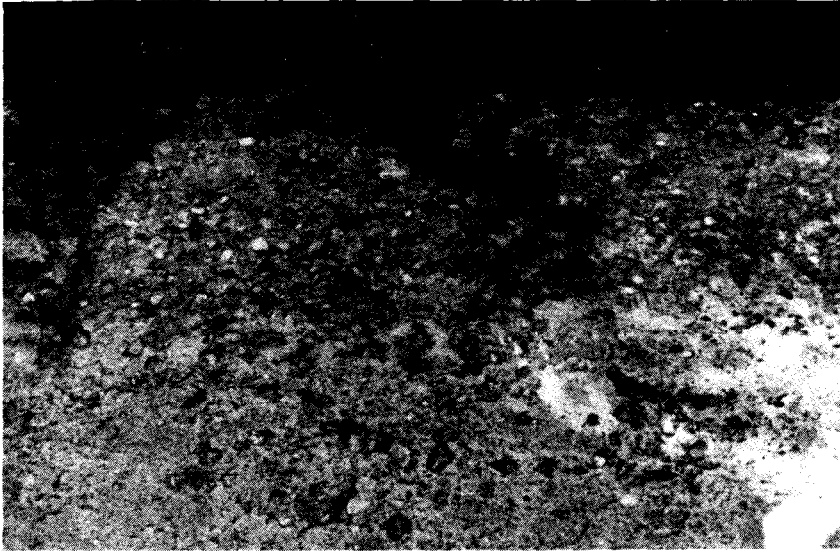
FIGURE 24
Bridge No. 3: Heavily scaled area

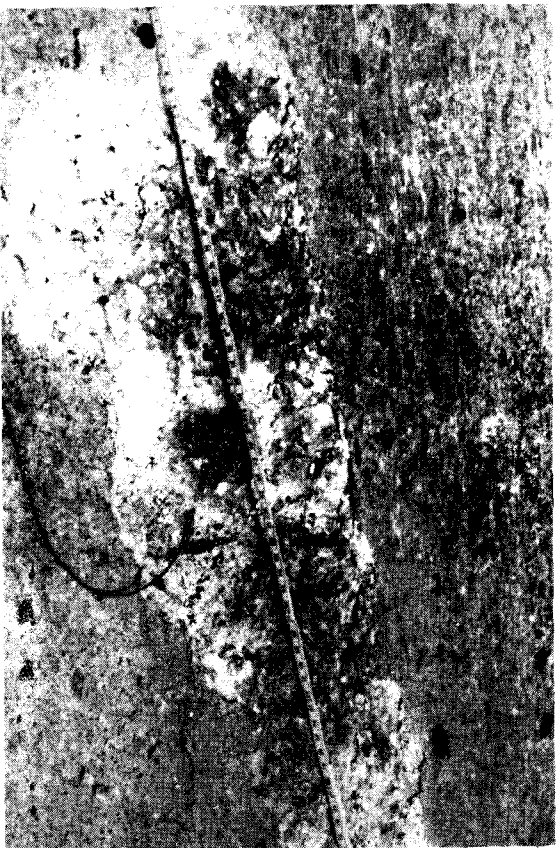
FIGURE 26
Bridge No. 3: Spalled area. Note exposed reinforcing steel with active corrosion.

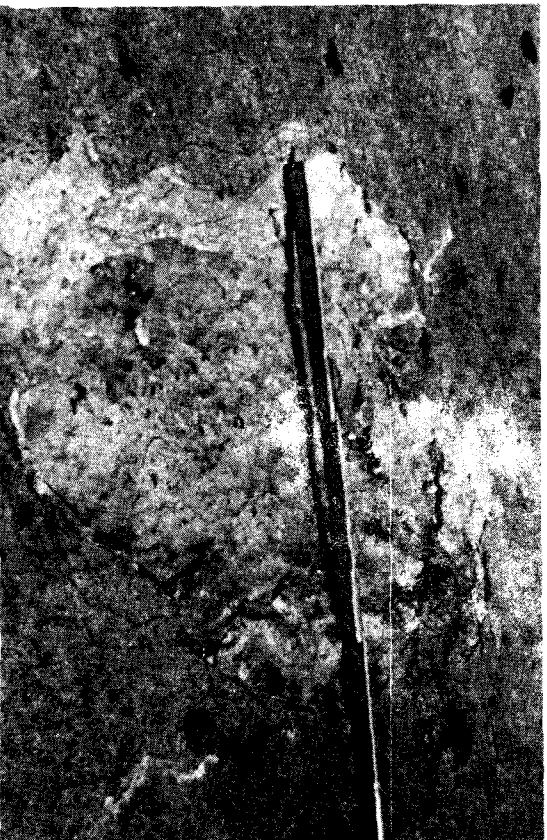
FIGURE 27
Bridge No. 3: Spalled area

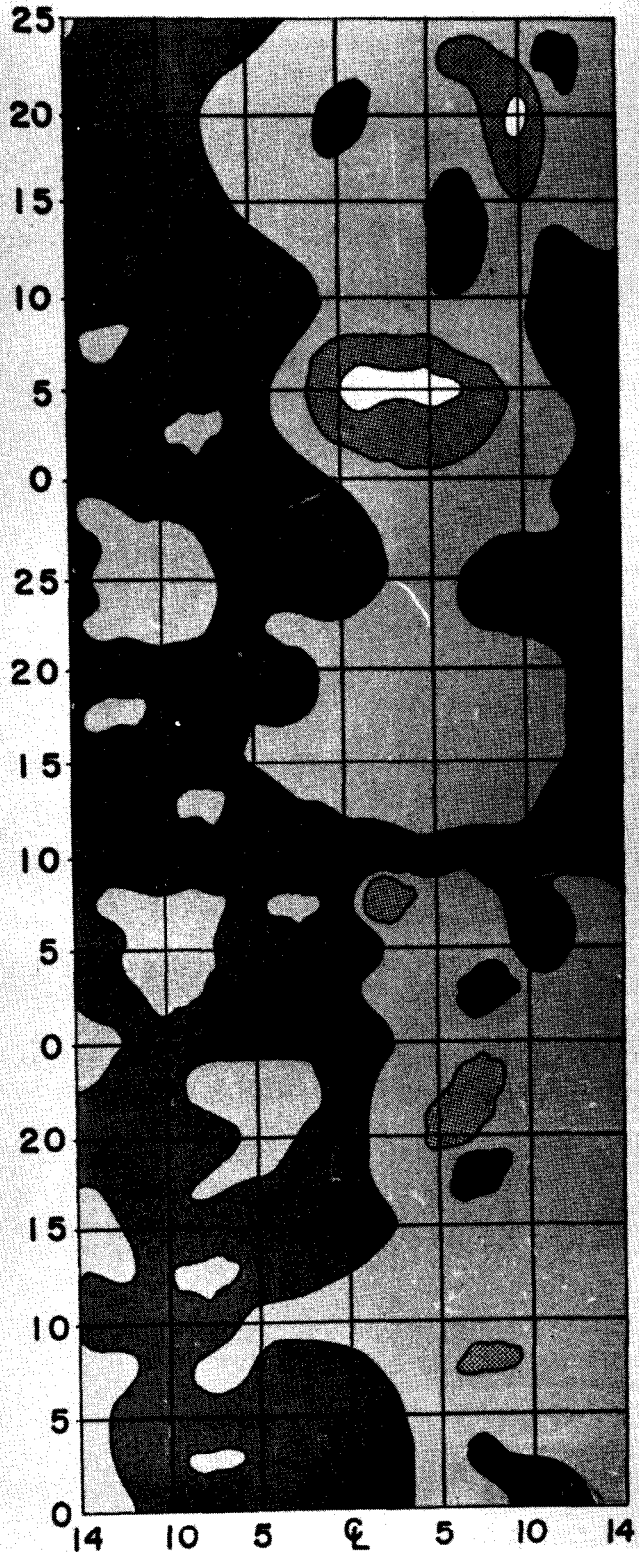
FIGURE 28
Bridge No. 3: Half-Cell Corrosion Chart

1. There is active corrosion occurring over approximately 95 percent of the deck.
2. There is ample chloride ion content for corrosion to continue.
3. The corrosion is not confined to an area near the gutter line.
