LUMINAIRE VIBRATION SUPPRESSION STUDY

FINAL REPORT

RESEARCH REPORT NO. 75
RESEARCH PROJECT NO. 71-3C(B)
LOUISIANA HPR 1 (11)

Conducted by
LOUISIANA DEPARTMENT OF HIGHWAYS
Research and Development Section
In Cooperation with
U. S. Department of Transportation
FEDERAL HIGHWAY ADMINISTRATION

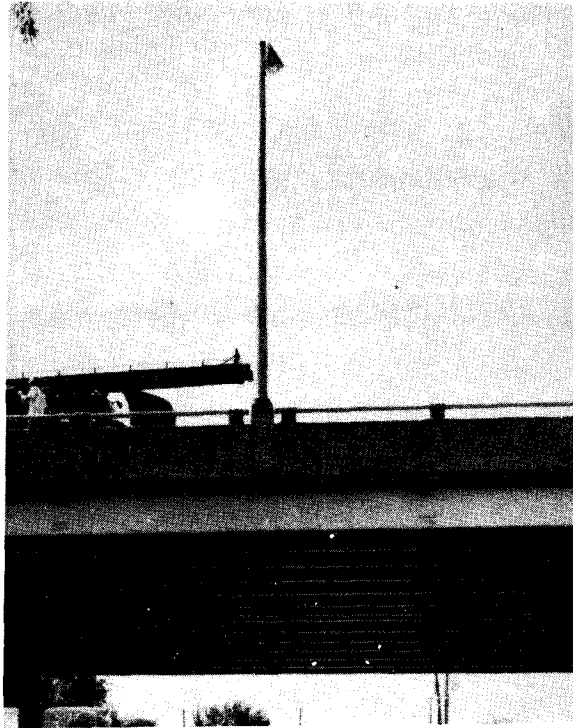
Location at Which Highest Readings Were Obtained During Initial Field Testing
FIGURE 5

The highest peak and highest average G-level readings were obtained from a steel pole located on the east approach (westbound) to the I-10 Mississippi River Bridge (see Figure 5).

The luminaire in this instance was located at the approximate midpoint of a span in the overhead roadway. This factor was believed to be the greatest single cause of higher readings obtained at this location since the points of maximum roadway rigidity are directly over the pilings.

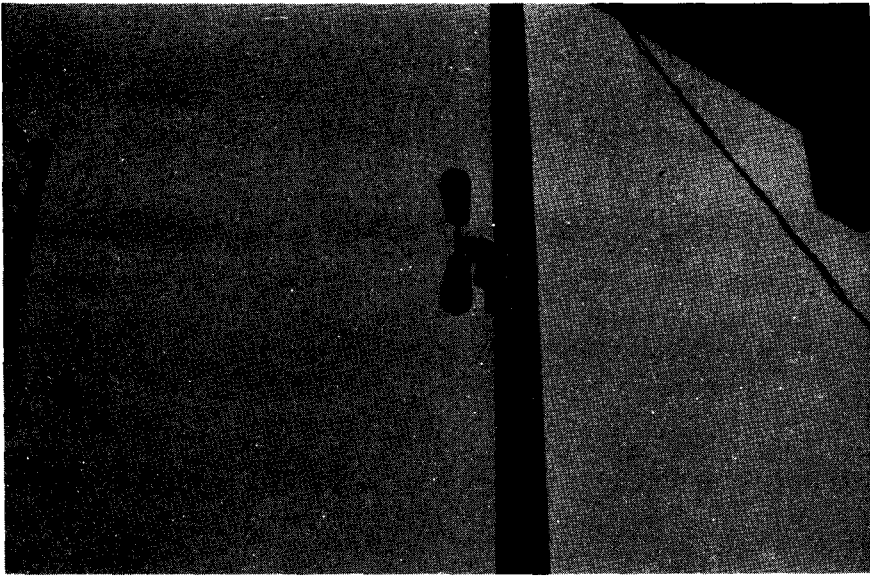
FIGURE 12

The heaviest device tested, a 35 pound Alcoa damper, (see Figure 12) produced the greatest overall reduction in decay time. A comparison with decay time on both poles in an undamped condition revealed that this damper caused a 74 percent reduction in first modal decay time of the steel luminaire and an 85 percent reduction in first modal aluminum luminaire decay time.

Thirty-Five Pound Alcoa Damper at Mid-Pole Position on Steel Luminaire

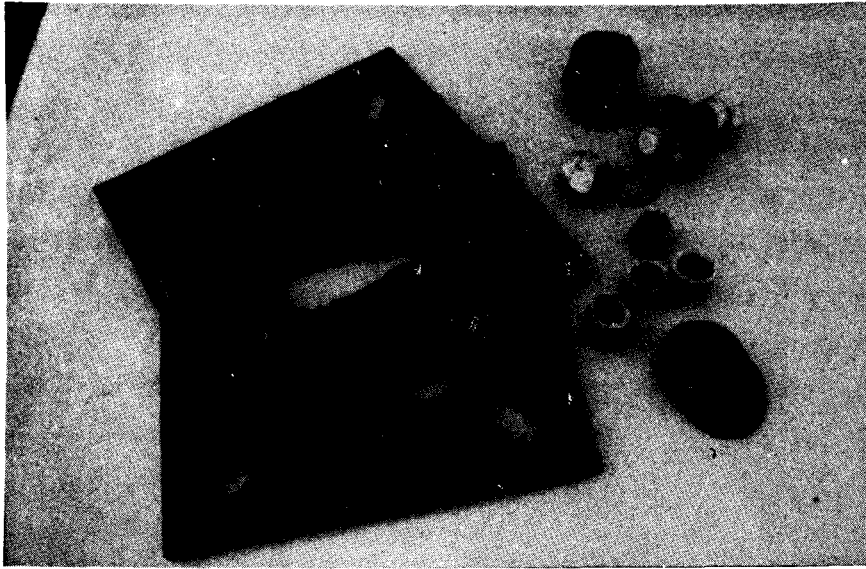
FIGURE 16

Fabco Material and Associated Hardware Used in Installation

The Fabreeka Pad test results were disappointing. Readings taken before and after pad installation showed no clear cut differences, as can be seen in Table 4 of the Appendix. Two thicknesses of Pads were tried on the steel luminaire, but there was no noticeable difference in their effect on the high frequency energy reaching the bulb.

It should be stated in all fairness that even though the Fabreeka distributor's installation instructions were followed to the letter and a poor display of performance was the result, this product, or a similar one may still have potential as a luminaire vibration suppressor. When details of pad installation were discussed with the distributor, it was pointed out that loading of the pads would be very pertinent to the amount of damping obtained at any one installation. Using graphs supplied by Fabreeka Products Company for damping factor prediction, it was theorized that optimum high frequency vibration isolation of luminaire assemblies in the weight class to be tested would require a thinner pad than was available from the manufacturer. The graphs also indicate that actual intensification of incident vibration levels can occur if minimum loading is not present.

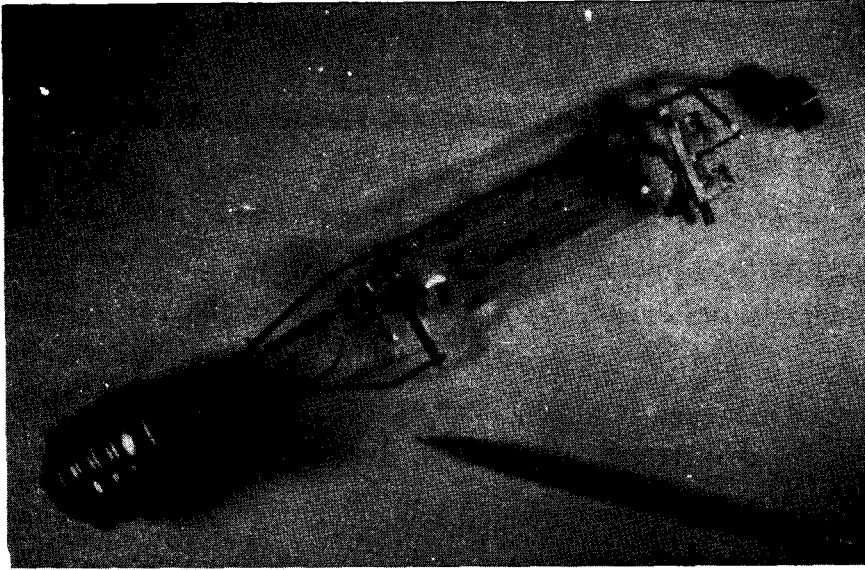
FIGURE 17

400 watt mercury vapor bulb showing early failure from vibration damage. Large outer envelope was removed and broken inner assembly re-positioned to show inner components. Failure occurred when continuous traffic vibration caused a fatigue break in one of the wires supporting the small inner light emission envelope. This was in all probability caused by higher frequency vibration.
