DRAINAGE PIPE STUDY

Research Report No. 57

Research Project No. 64-1Ch
Louisiana HPR 1 (8)

Conducted by
LOUISIANA DEPARTMENT OF HIGHWAYS
Research and Development Section
In Cooperation with
U. S. Department of Transportation
FEDERAL HIGHWAY ADMINISTRATION

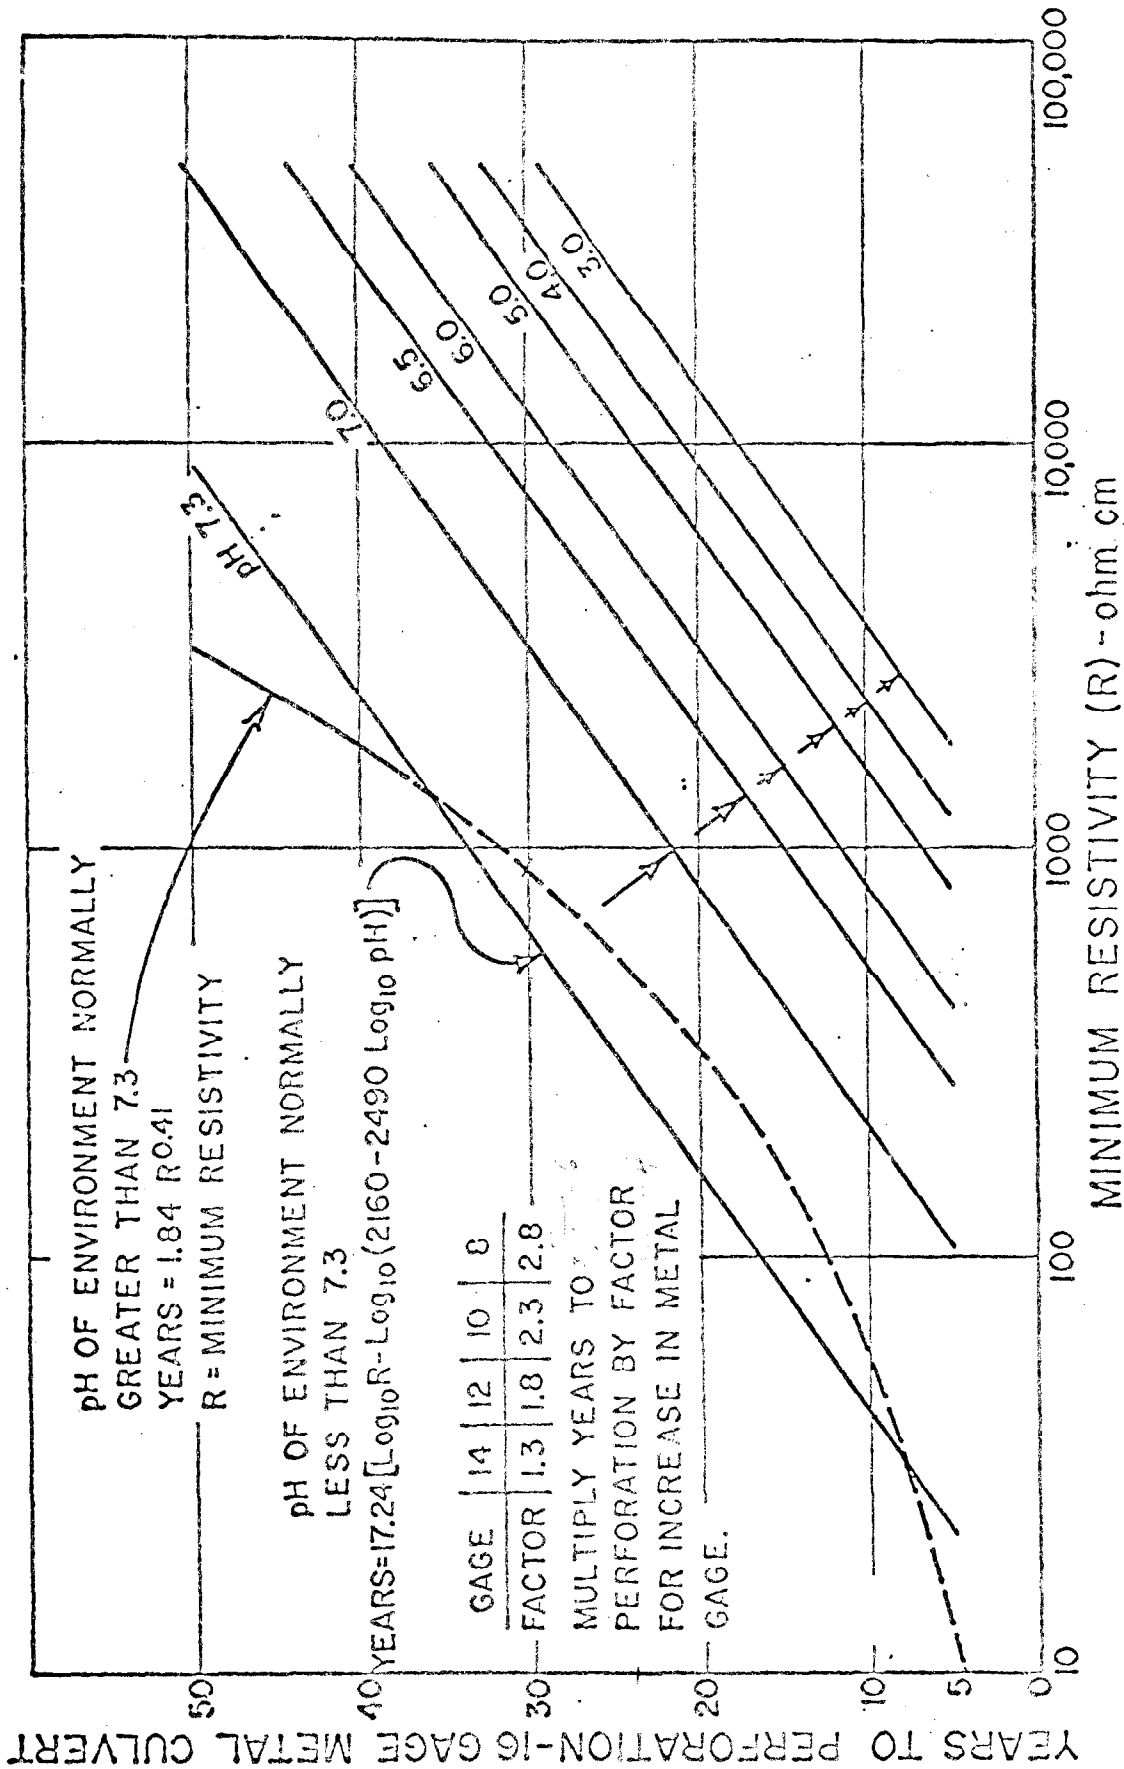
FIGURE 1A

Figure 1A is the chart for estimating metal culvert life as produced in California Test Method, California No. 643-B, 1963 and Figure 1B is an adaptation of the graph provided in California Test Method, 643-B, 1963. By substituting the varying pH values for the years to perforation along the dependent axis and the minimum resistance (ohm/cc) along the independent axis, Figure 1B was obtained.

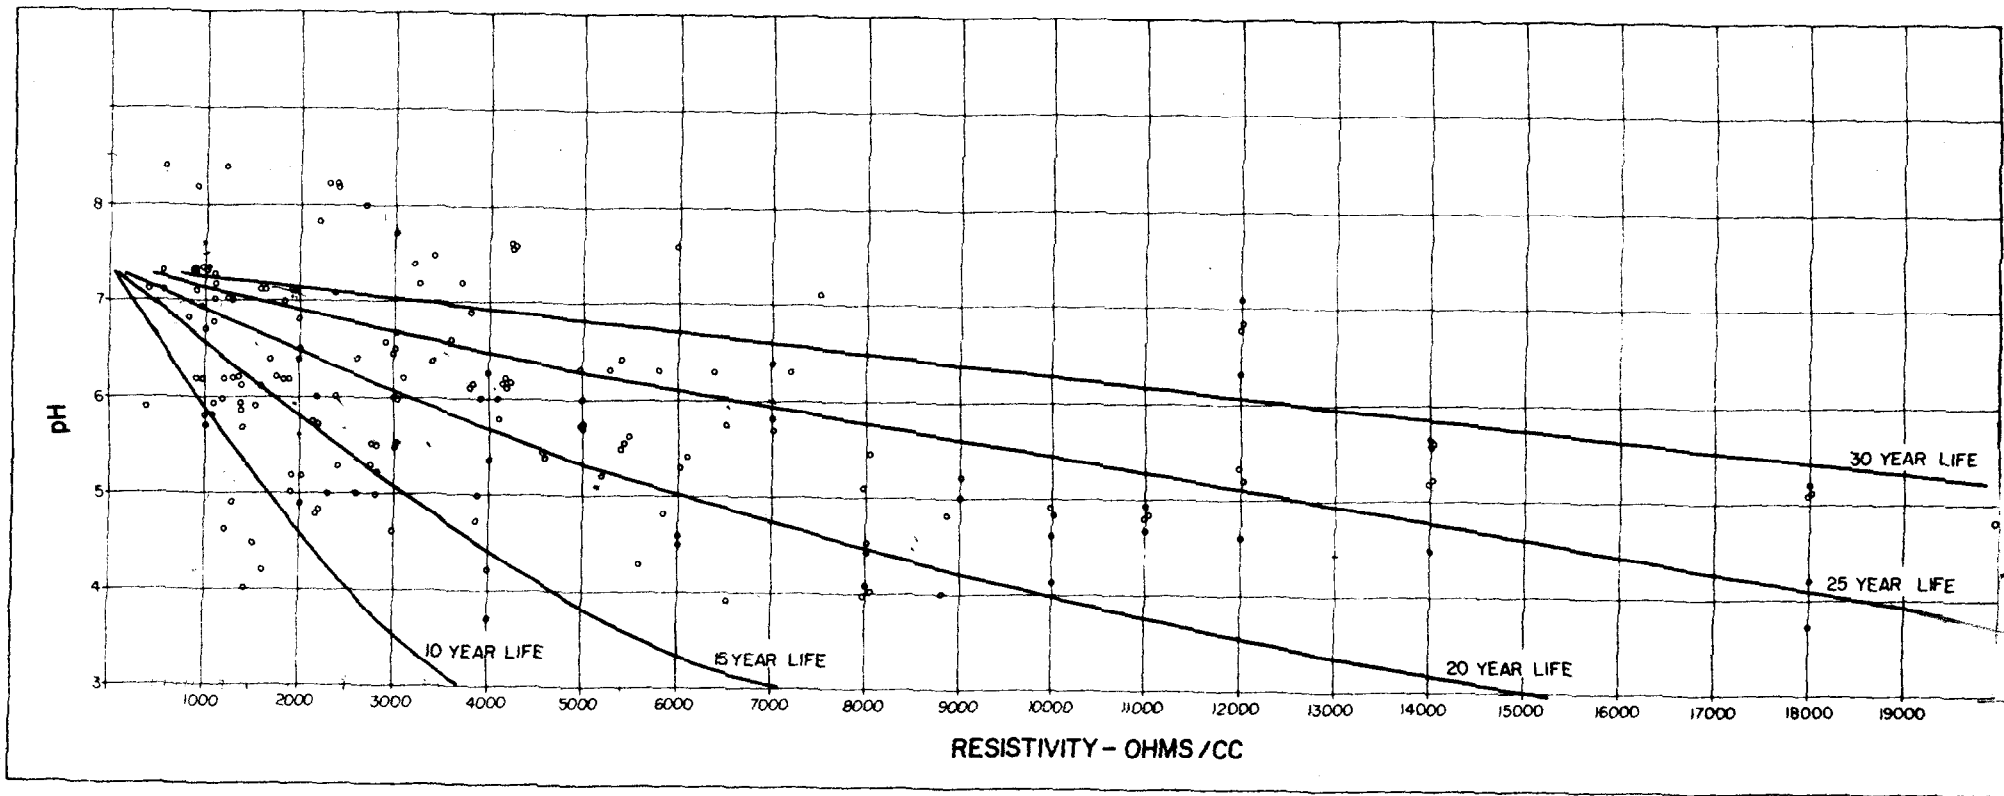
Figure 1B - An adaptation of California graph as produced in California Test Method 643B.

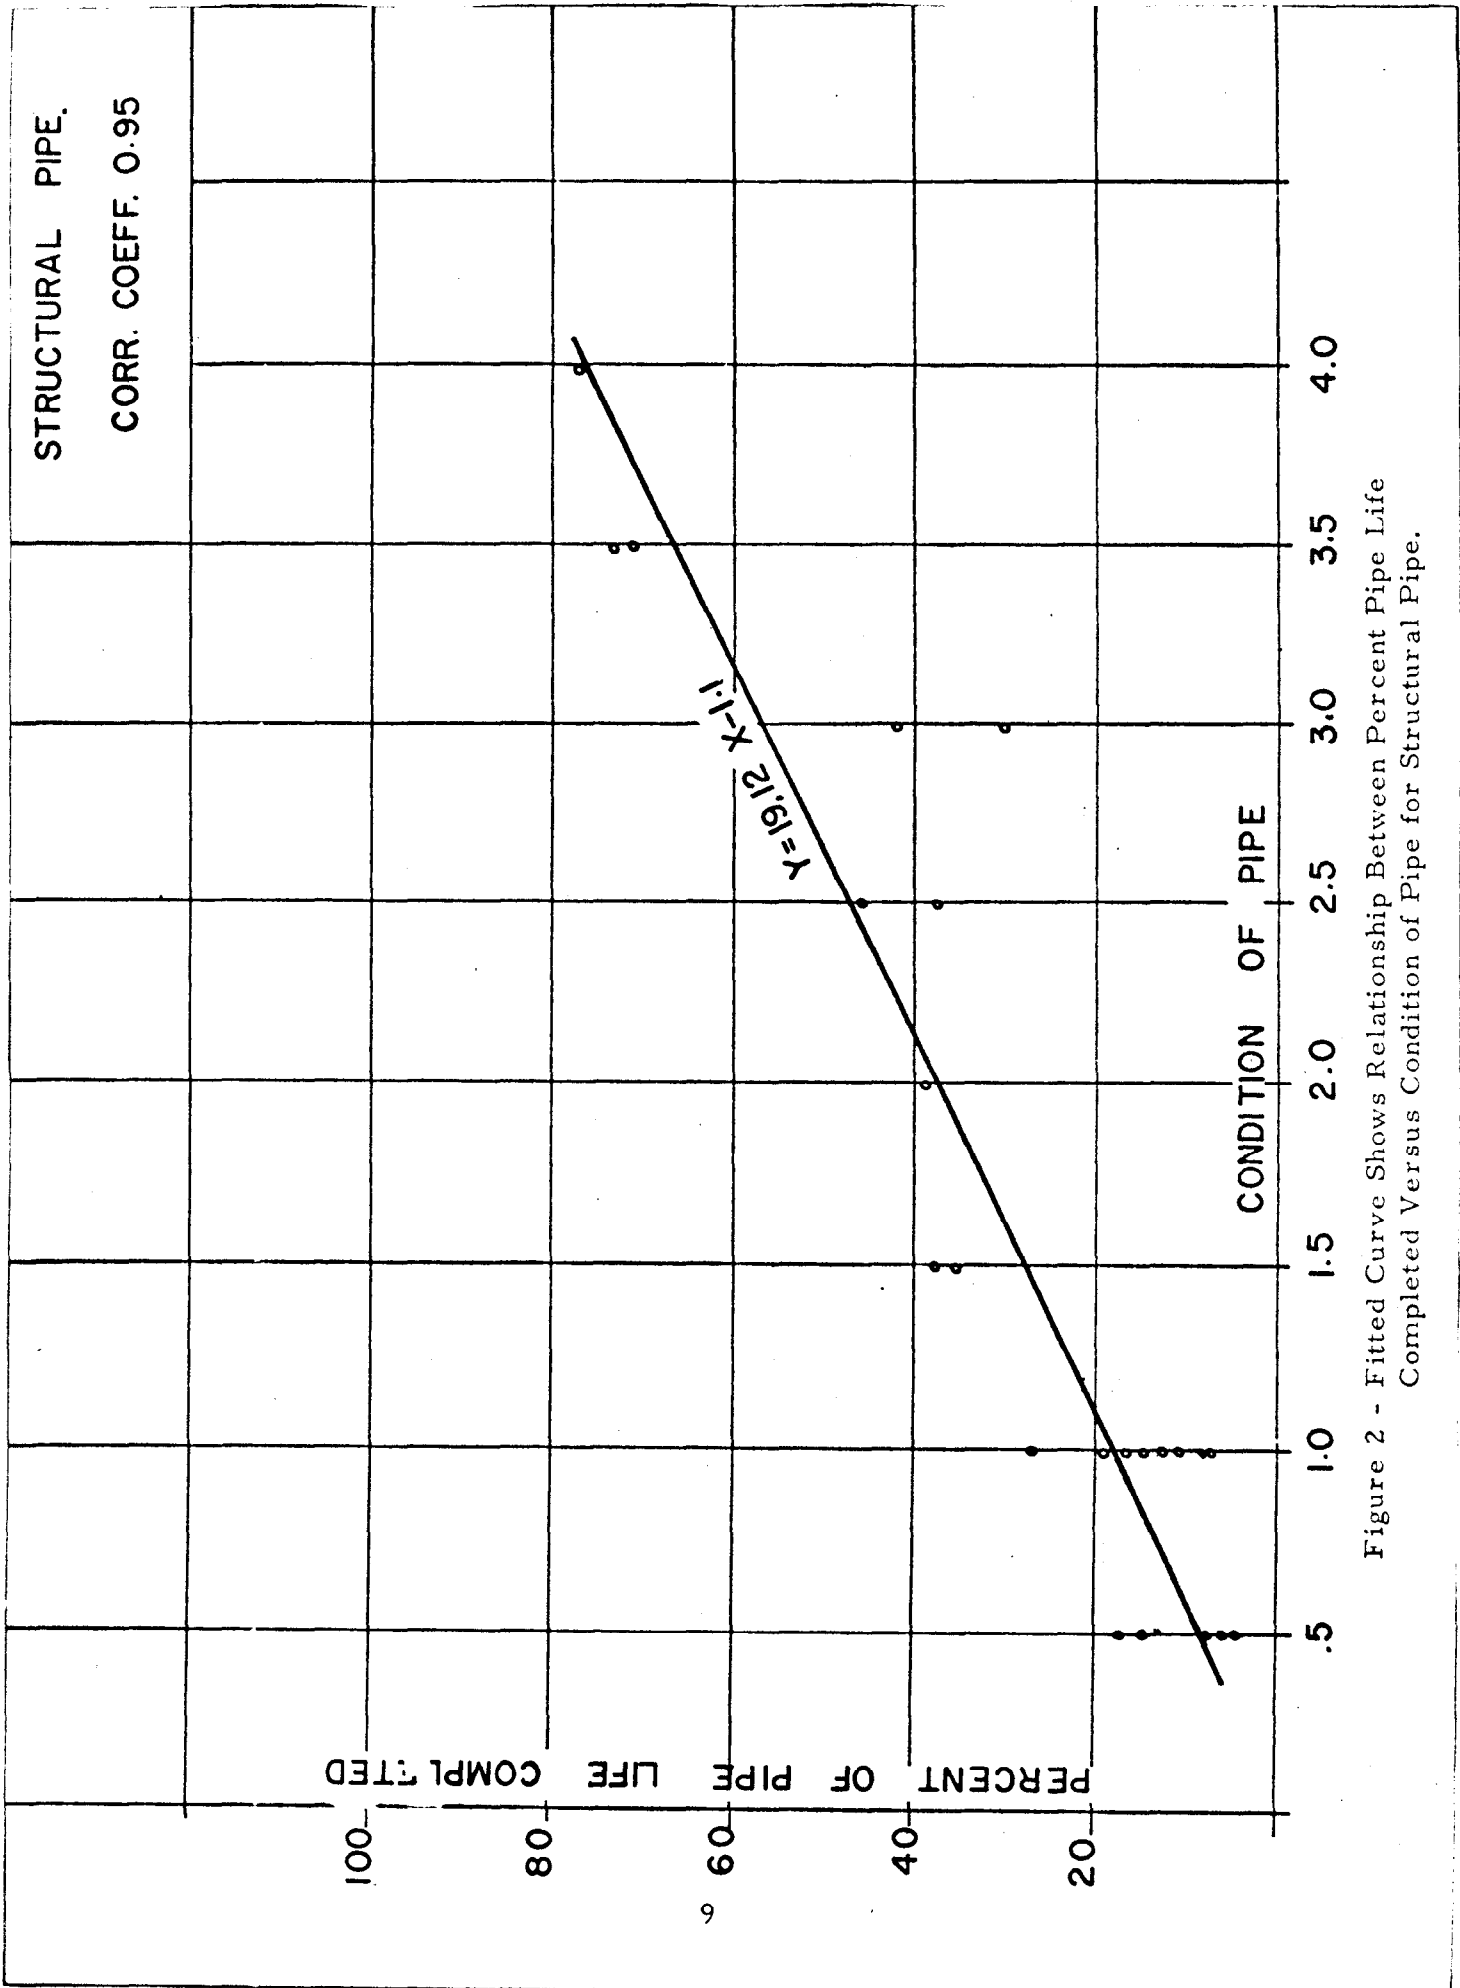
Figure 2 is a graph of percent pipe life completed versus condition of pipe for structural pipe. By using the method of least squares, the slope of the line governed by the points plotted was computed. The line which gave the best correlation coefficient did not pass through the origin, but rather gave an intercept along the dependent axis. The correlation coefficient of the graph, 0.95 was very good. Therefore, for estimating the service life of structural pipe in Louisiana soils, it is apparent that California's Test Method, California No. 643-B, 1963, may be used.

Figure 2 - Fitted Curve Shows Relationship Between Percent Pipe Life Completed Versus Condition of Pipe for Structural Pipe.

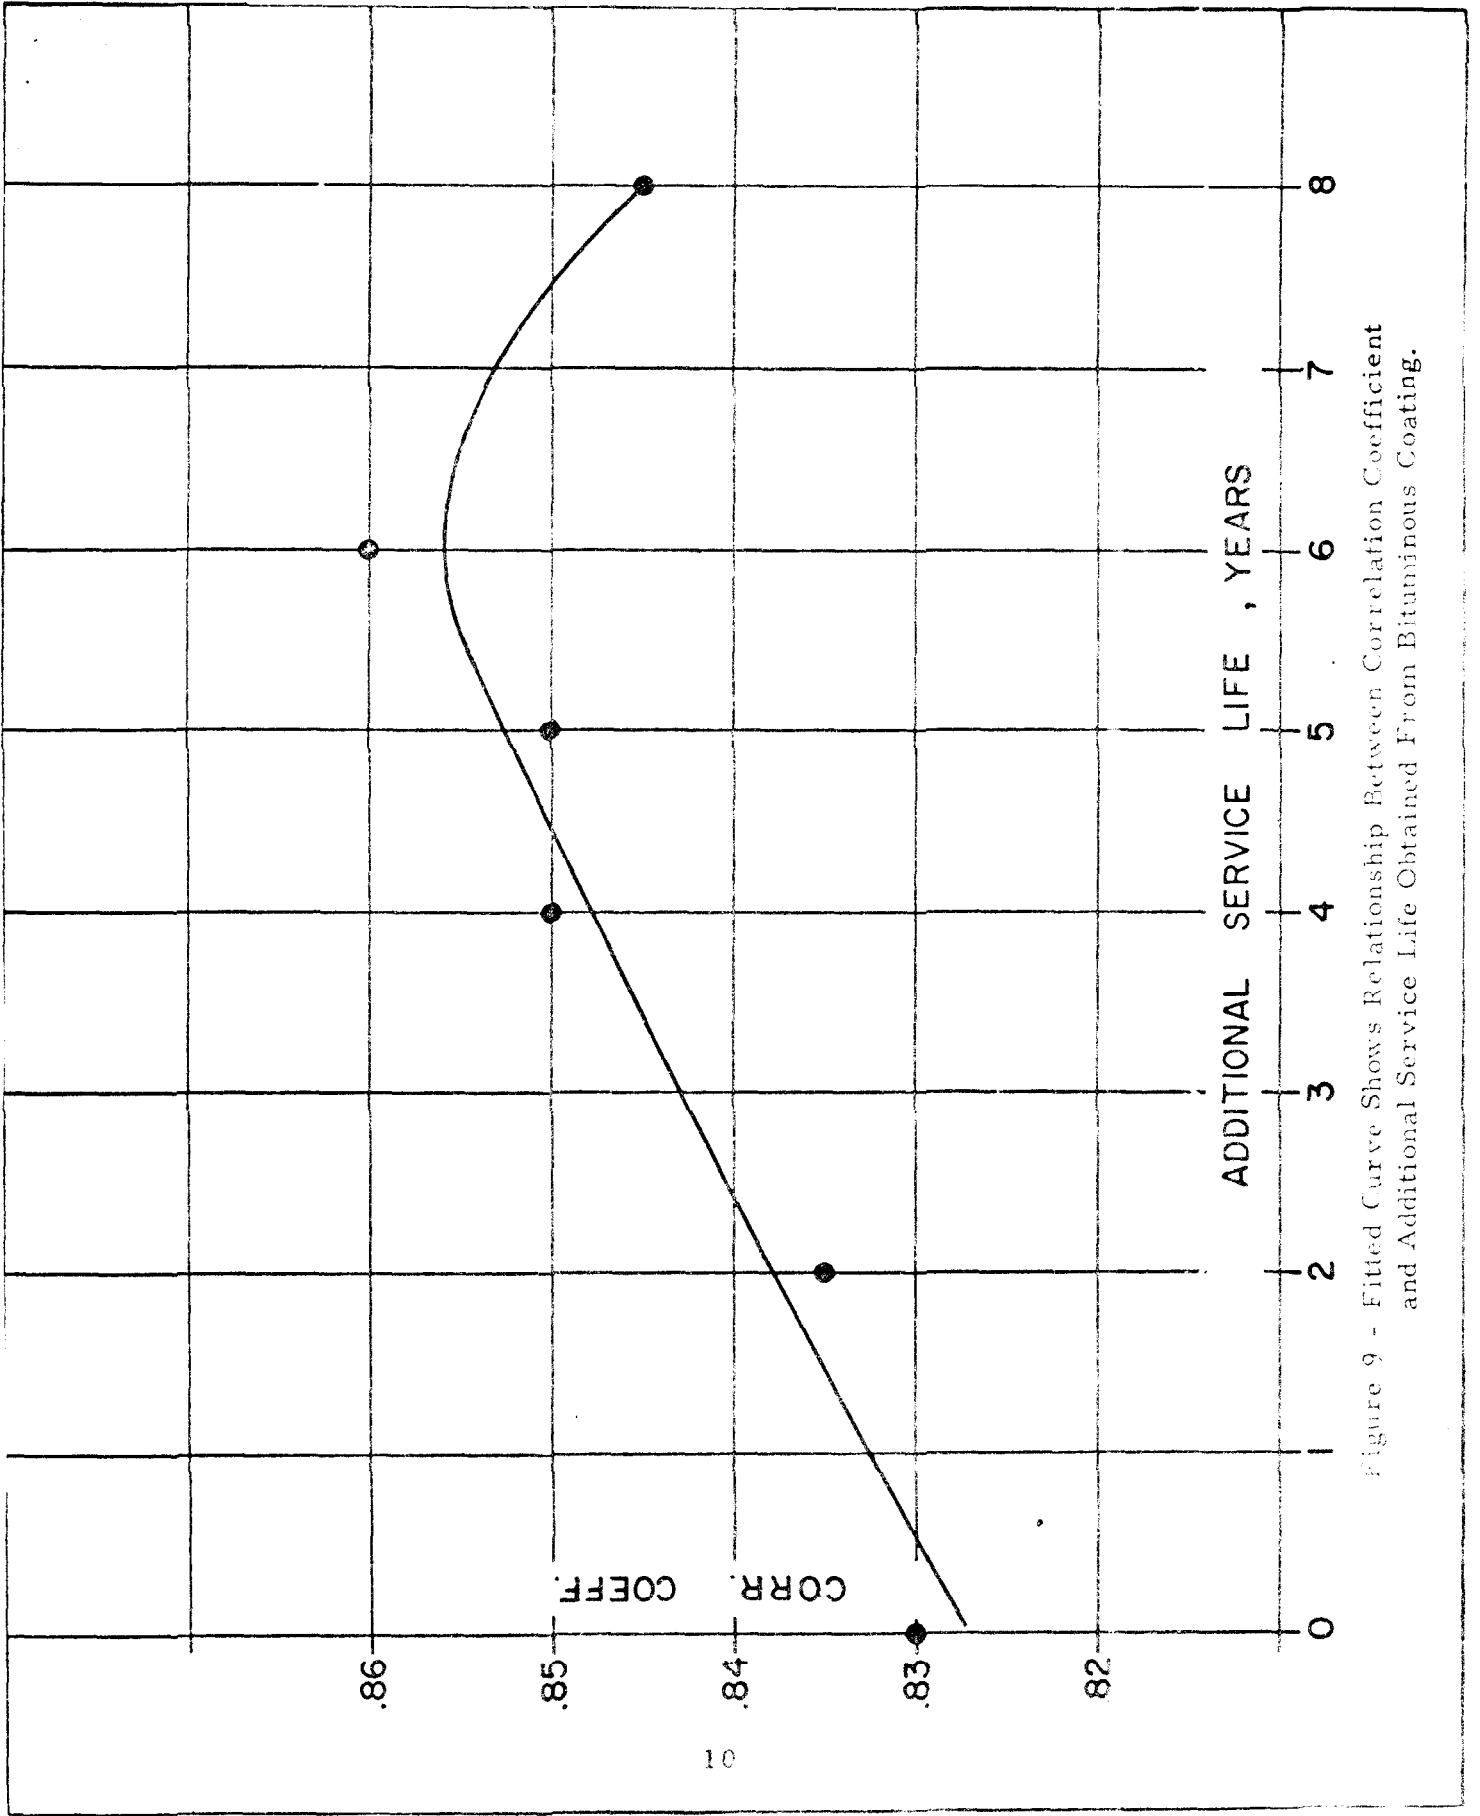
The results of the initial field inspection indicated that in Louisiana Soils an additional 6 years of service life of metal culverts (see Figure 9) was obtained by using a bituminous coating over the galvanized coating of the metal pipe. Graphs 3 through 8 are the results of assuming various values of increased life from bituminous coatings. Figure 9 is a graph of added service life from bituminous coatings versus correlation coefficient. From this graph it can be readily seen that the maximum service life from bituminous coatings is 6 years which is in agreement with California No. 643-B, 1963.

Figure 9 - Fitted Curve Shows Relationship Between Correlation Coefficient and Additional Service Life Obtained From Bituminous Coating.

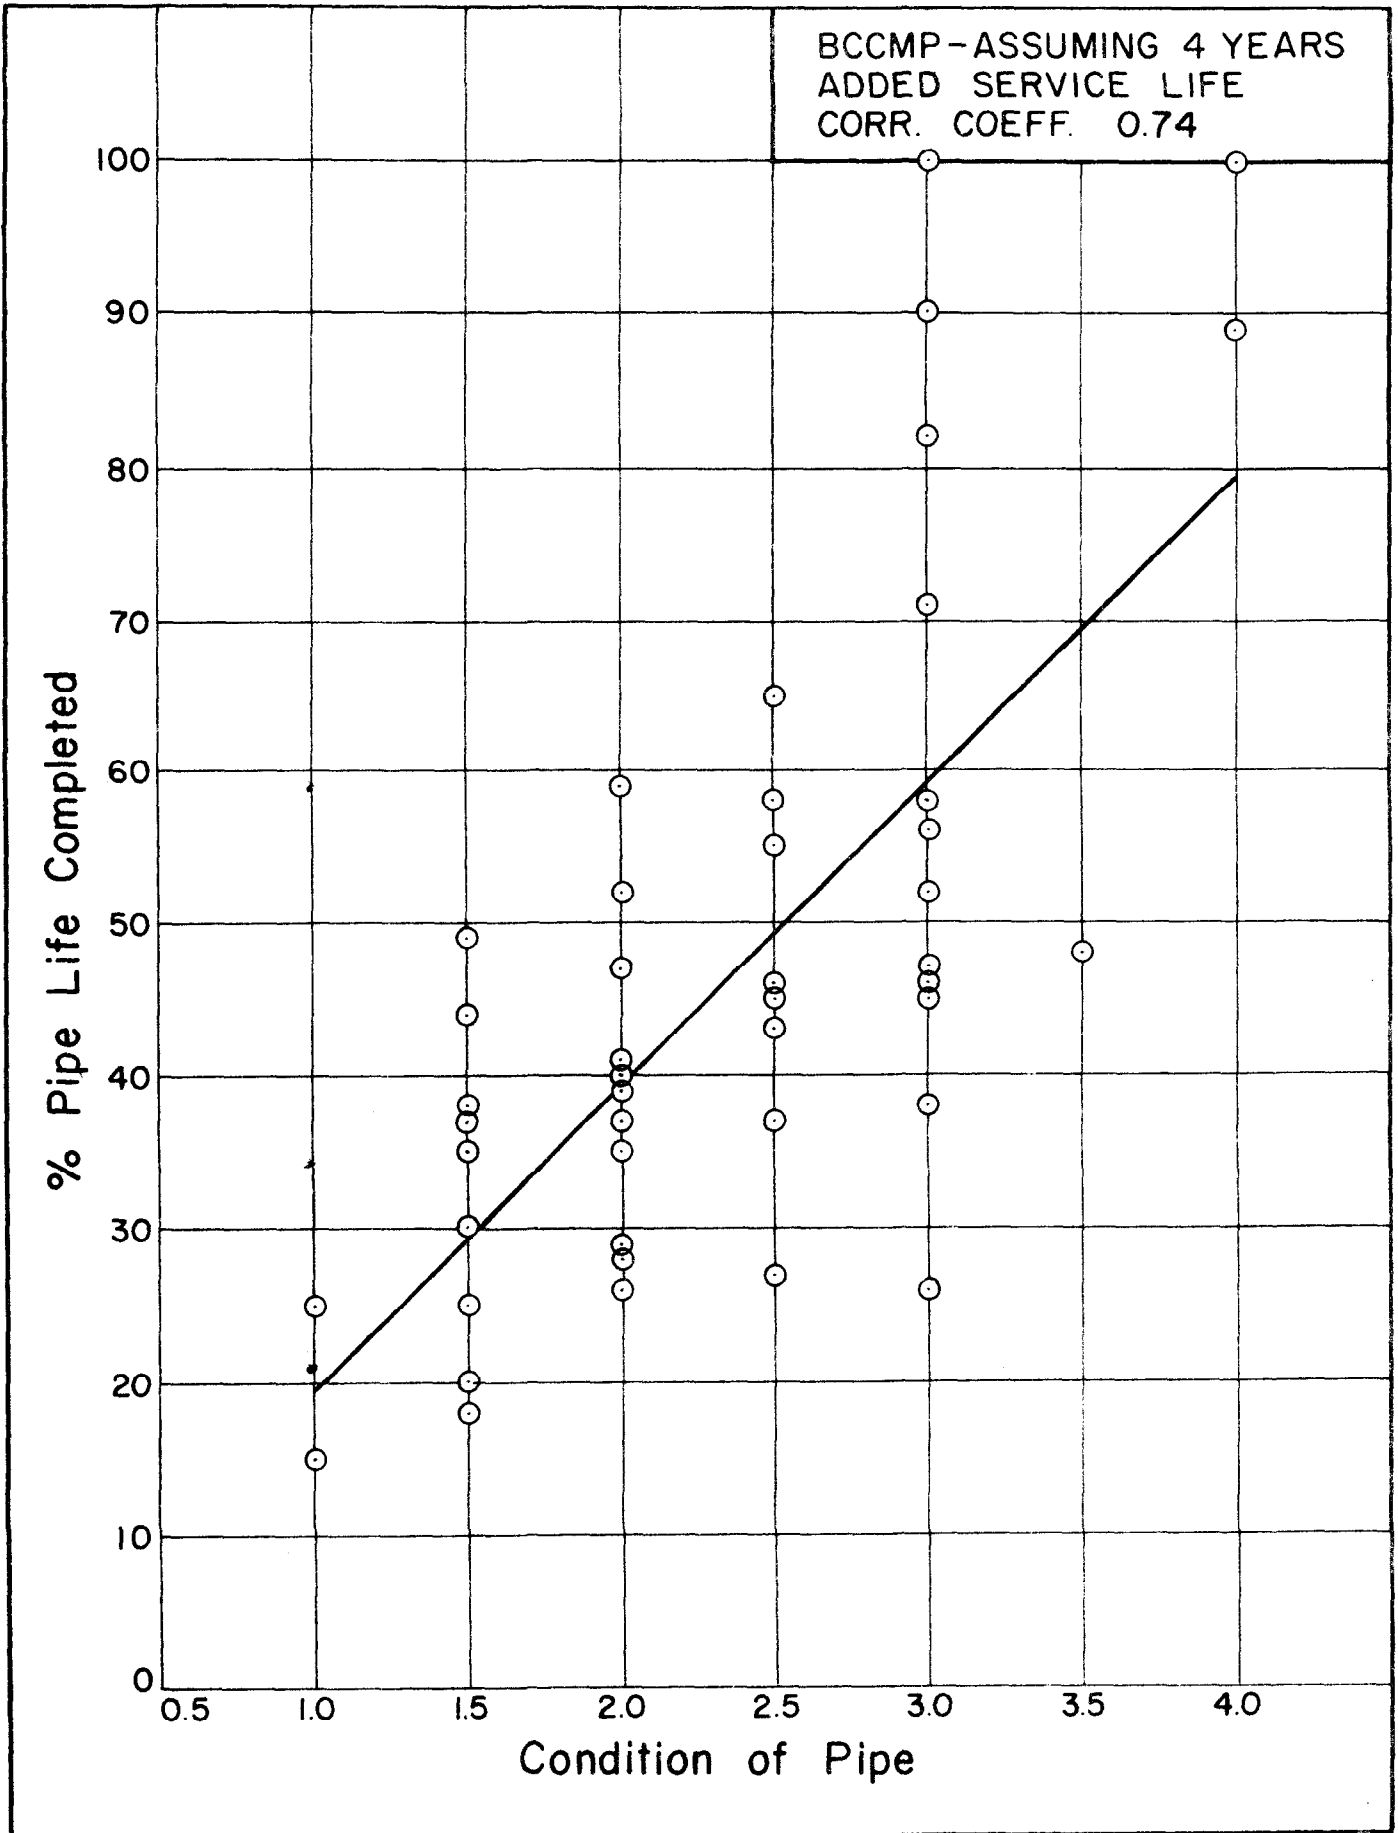
Figure 10 which is a graph of percent pipe life completed versus condition of pipe, assumed that an added service life of 4 years is obtained from the bituminous coating. By using the method of least squares, the slope of the line, the intercept and the correlation coefficient was computed. The correlation coefficient of 0.74 was obtained.

FIGURE 10- Graph of Condition of Pipe versus Percent Pipe Life.
BCCMP- Assuming 4 Years Added Service Life

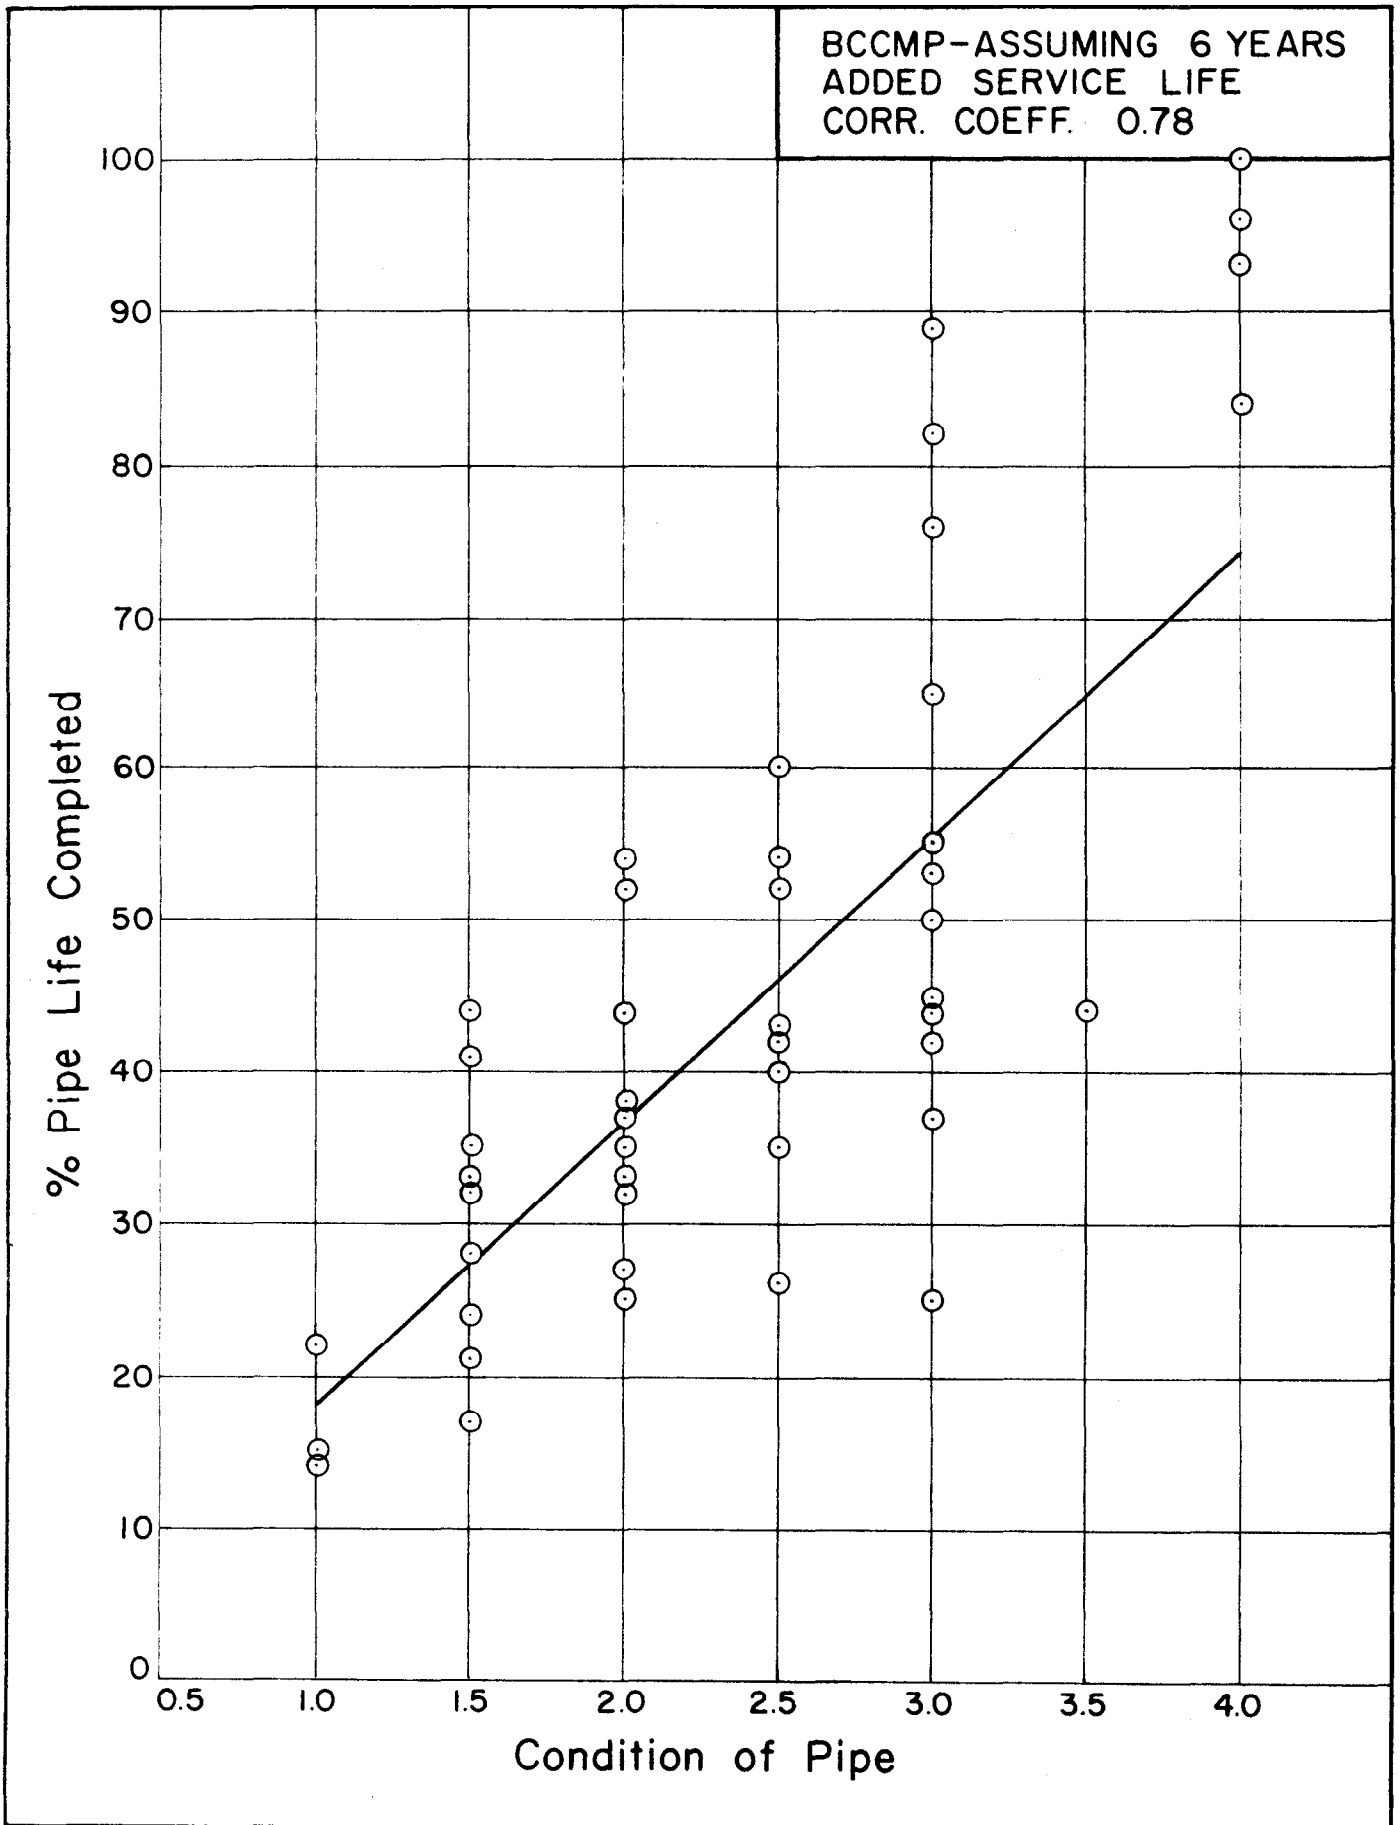
Figure 11 which is a similar graph to Figure 10 assumed an added service life of 6 years was obtained for metal pipe from the bituminous coatings. Again the slope of the line, the intercept and the correlation coefficient were completed by the method of least squares. The correlation coefficient of 0.78 was higher than the aforementioned figure.

FIGURE 11 - Graph of Condition of Pipe versus Percent Pipe Life.
BCCMP- Assuming 6 Years Added Service Life

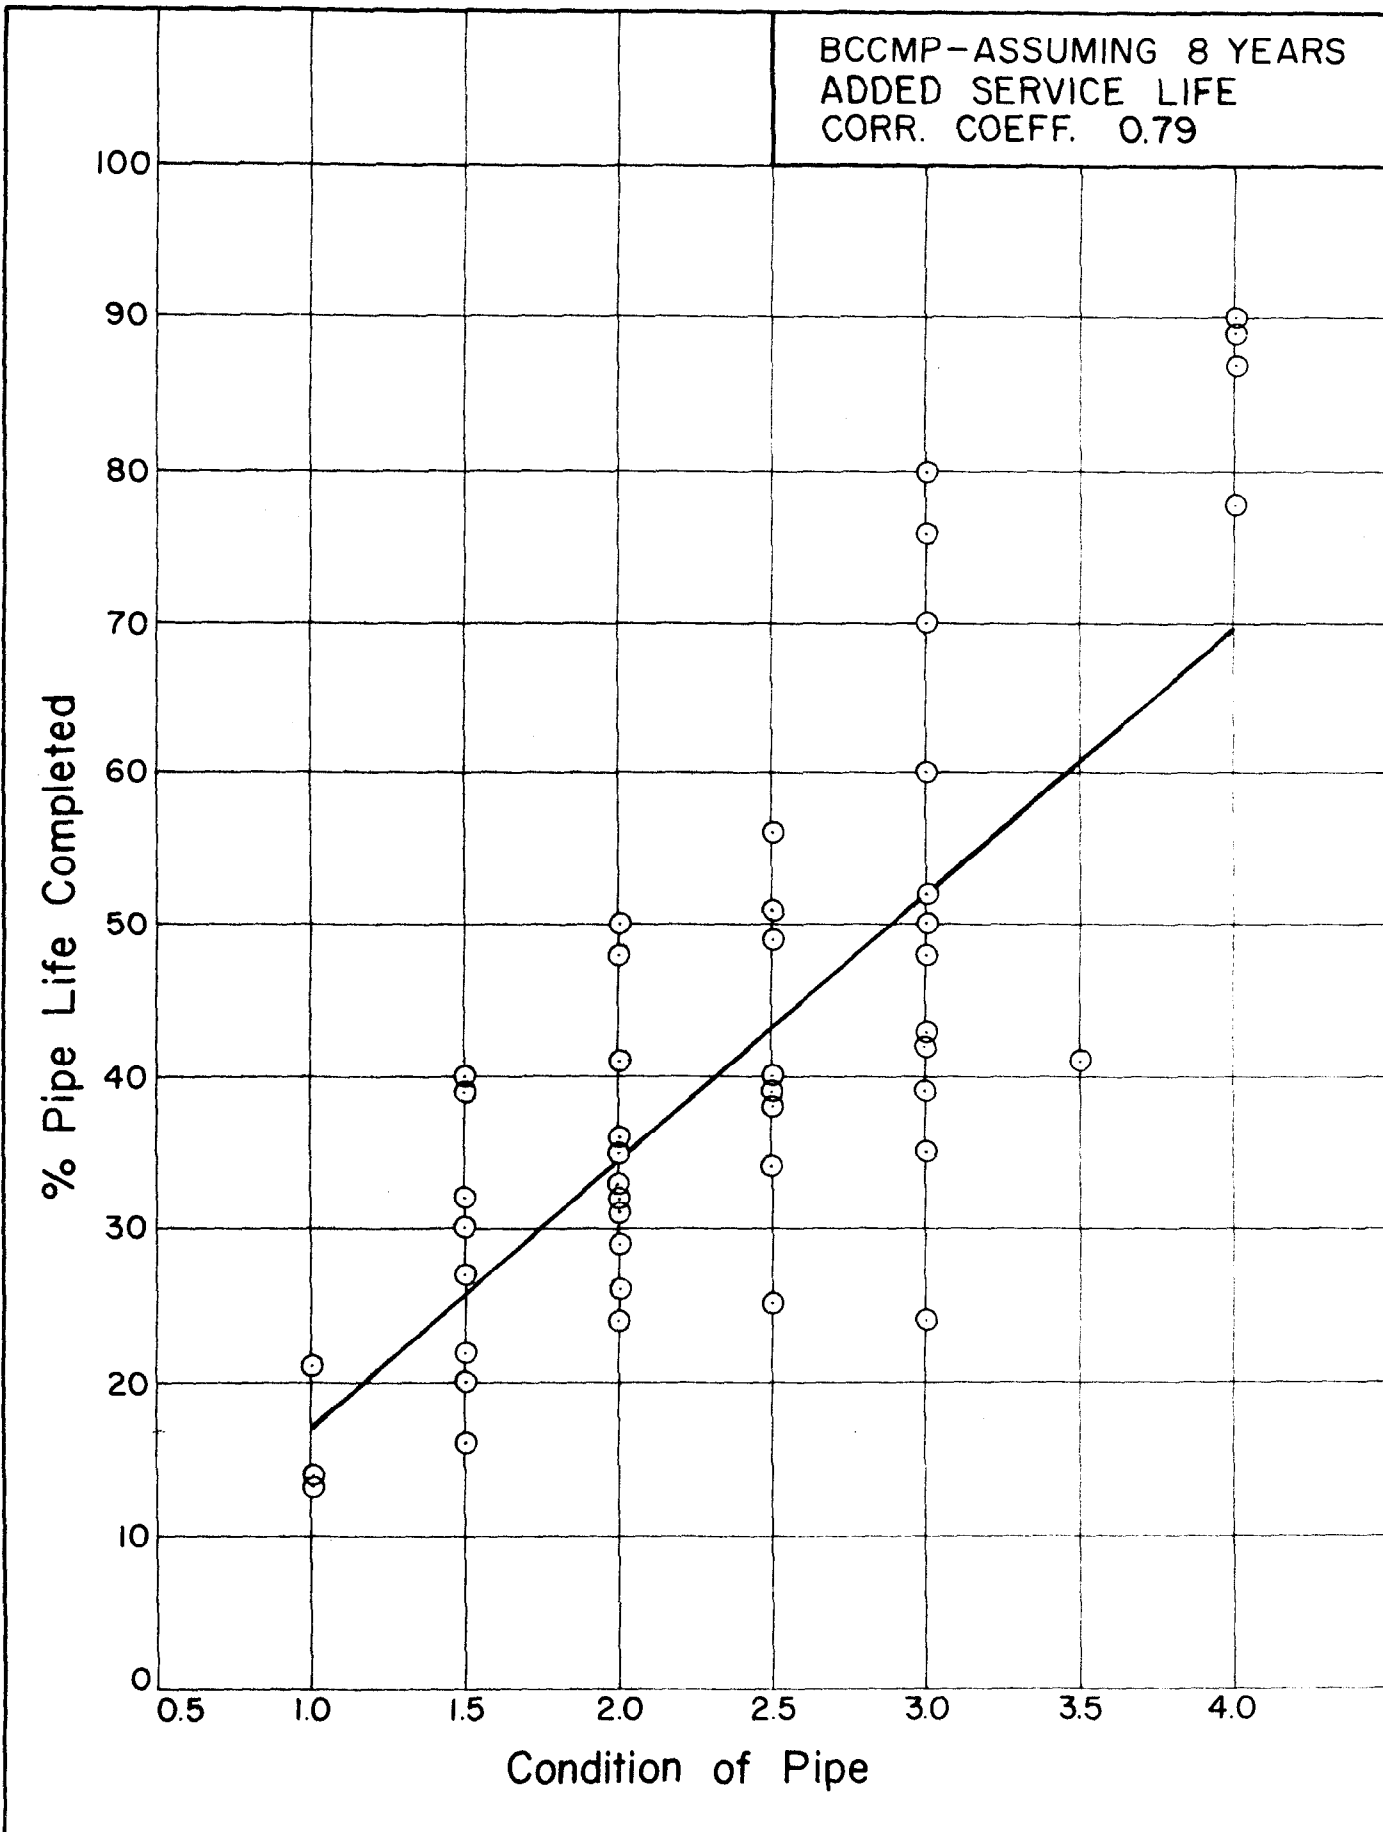
Figure 12 which is a similar graph to Figures 10 and 11 assumed an added service life of 8 years was obtained for metal pipe from the bituminous coatings. After computing the slope of the line, the intercept and the correlation coefficient, it was observed that the correlation coefficient of 0.79 was higher than the previous correlation coefficient of Figure 11.

BCCMP-ASSUMING 8 YEARS
ADDED SERVICE LIFE
CORR. COEFF. 0.79

FIGURE 12- Graph of Condition of Pipe versus Percent Pipe Life.
BCCMP - Assuming 8 Years Added Service Life

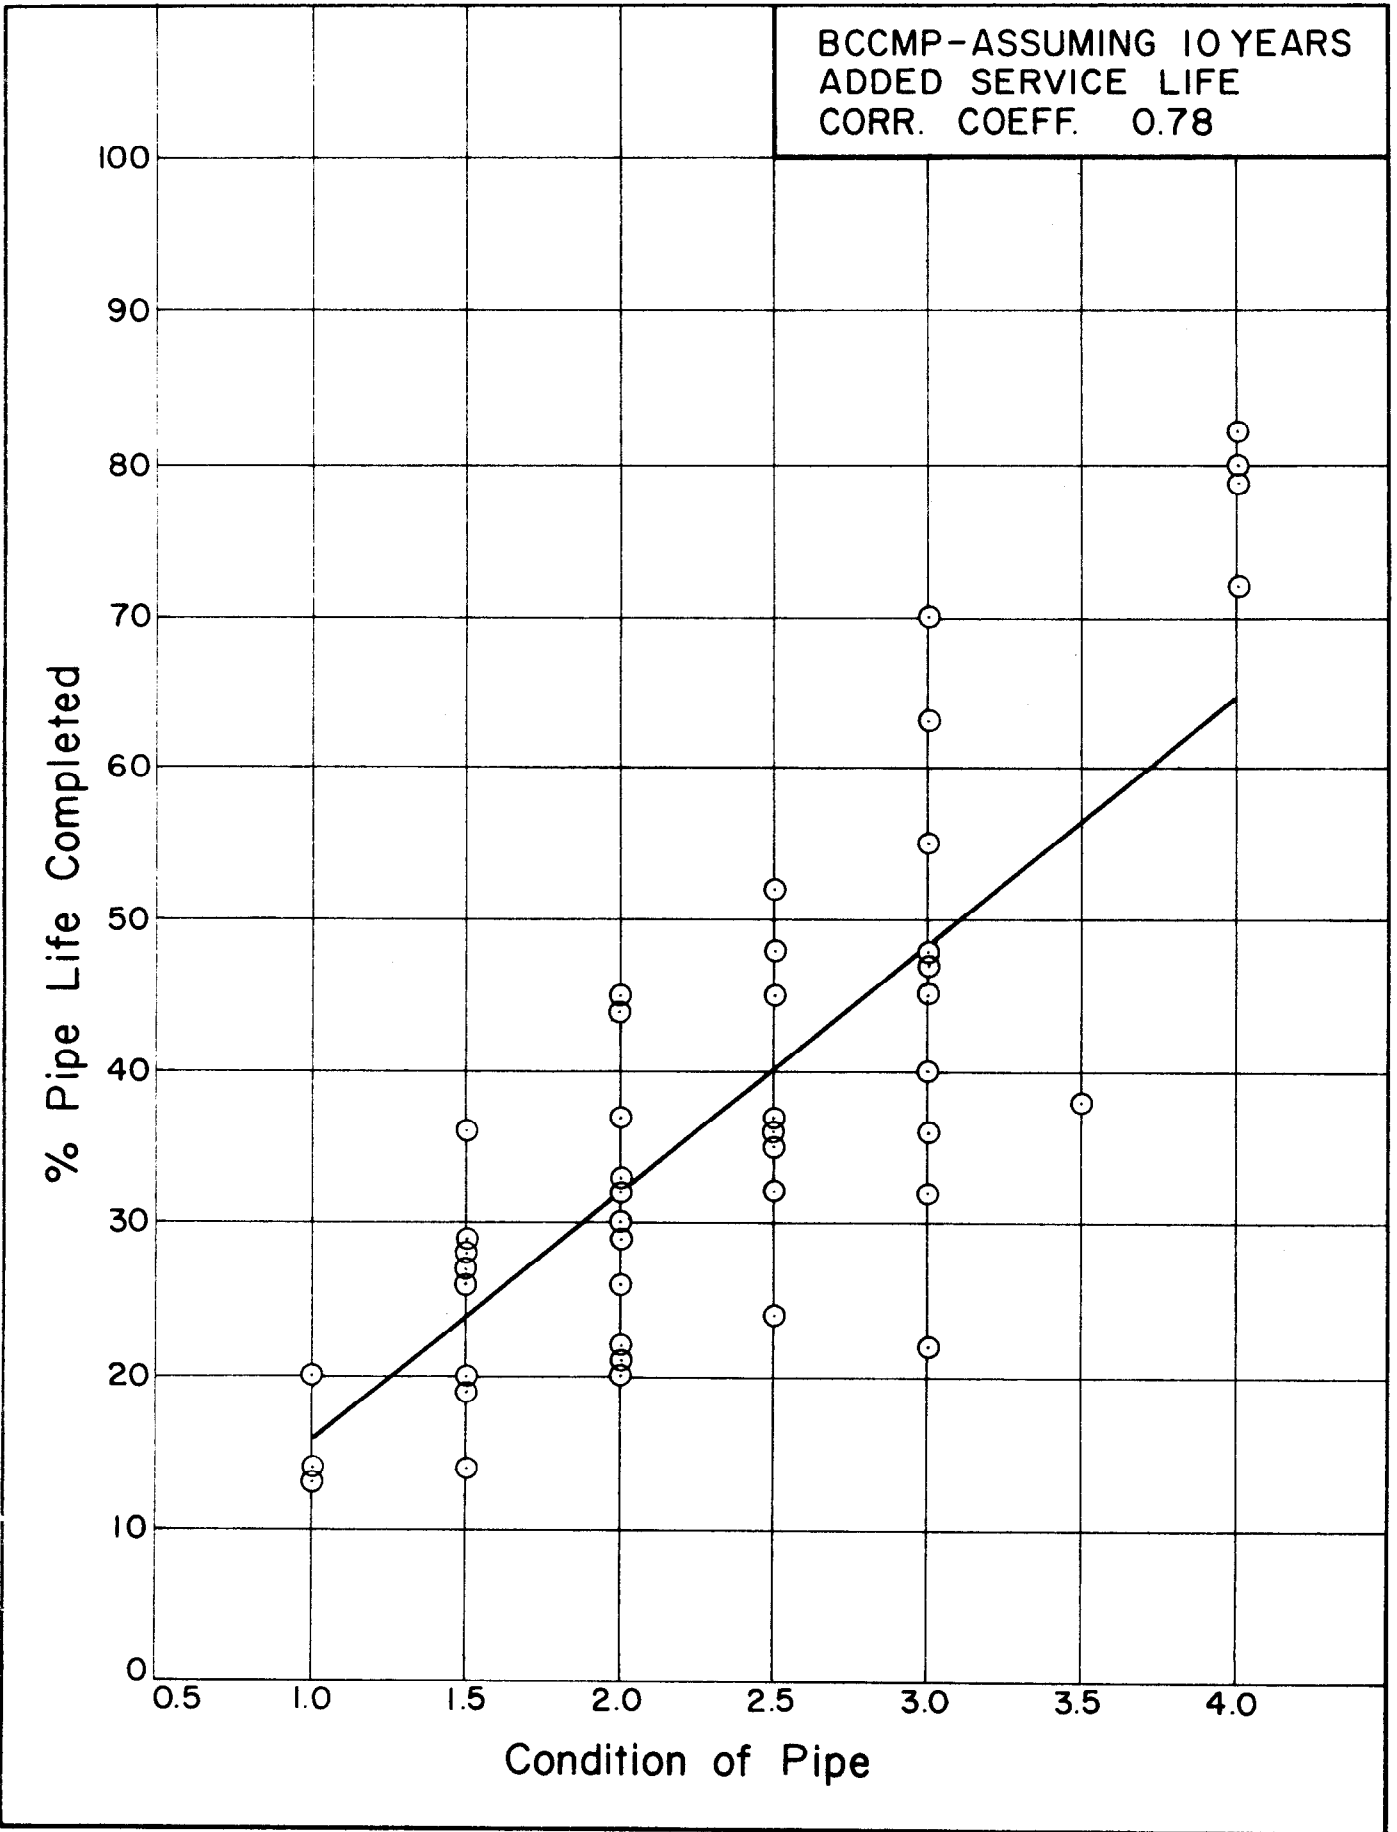
Figure 13 which is a similar graph to Figures 10, 11, 12 assumed an added service life of 10 years was obtained for metal pipe from the bituminous coating. After computing the slope of the line, the intercept and the correlation coefficient, it was observed that there was a decrease in the correlation coefficient to 0.78.

FIGURE 13- Graph of Condition of Pipe versus Percent Pipe Life.
BCCMP - Assuming 10 Years Added Service Life
