DRAINAGE PIPE STUDY

Research Report No. 57

Research Project No. 64-1Ch
Louisiana HPR 1 (8)

Conducted by
LOUISIANA DEPARTMENT OF HIGHWAYS
Research and Development Section
In Cooperation with
U. S. Department of Transportation
FEDERAL HIGHWAY ADMINISTRATION

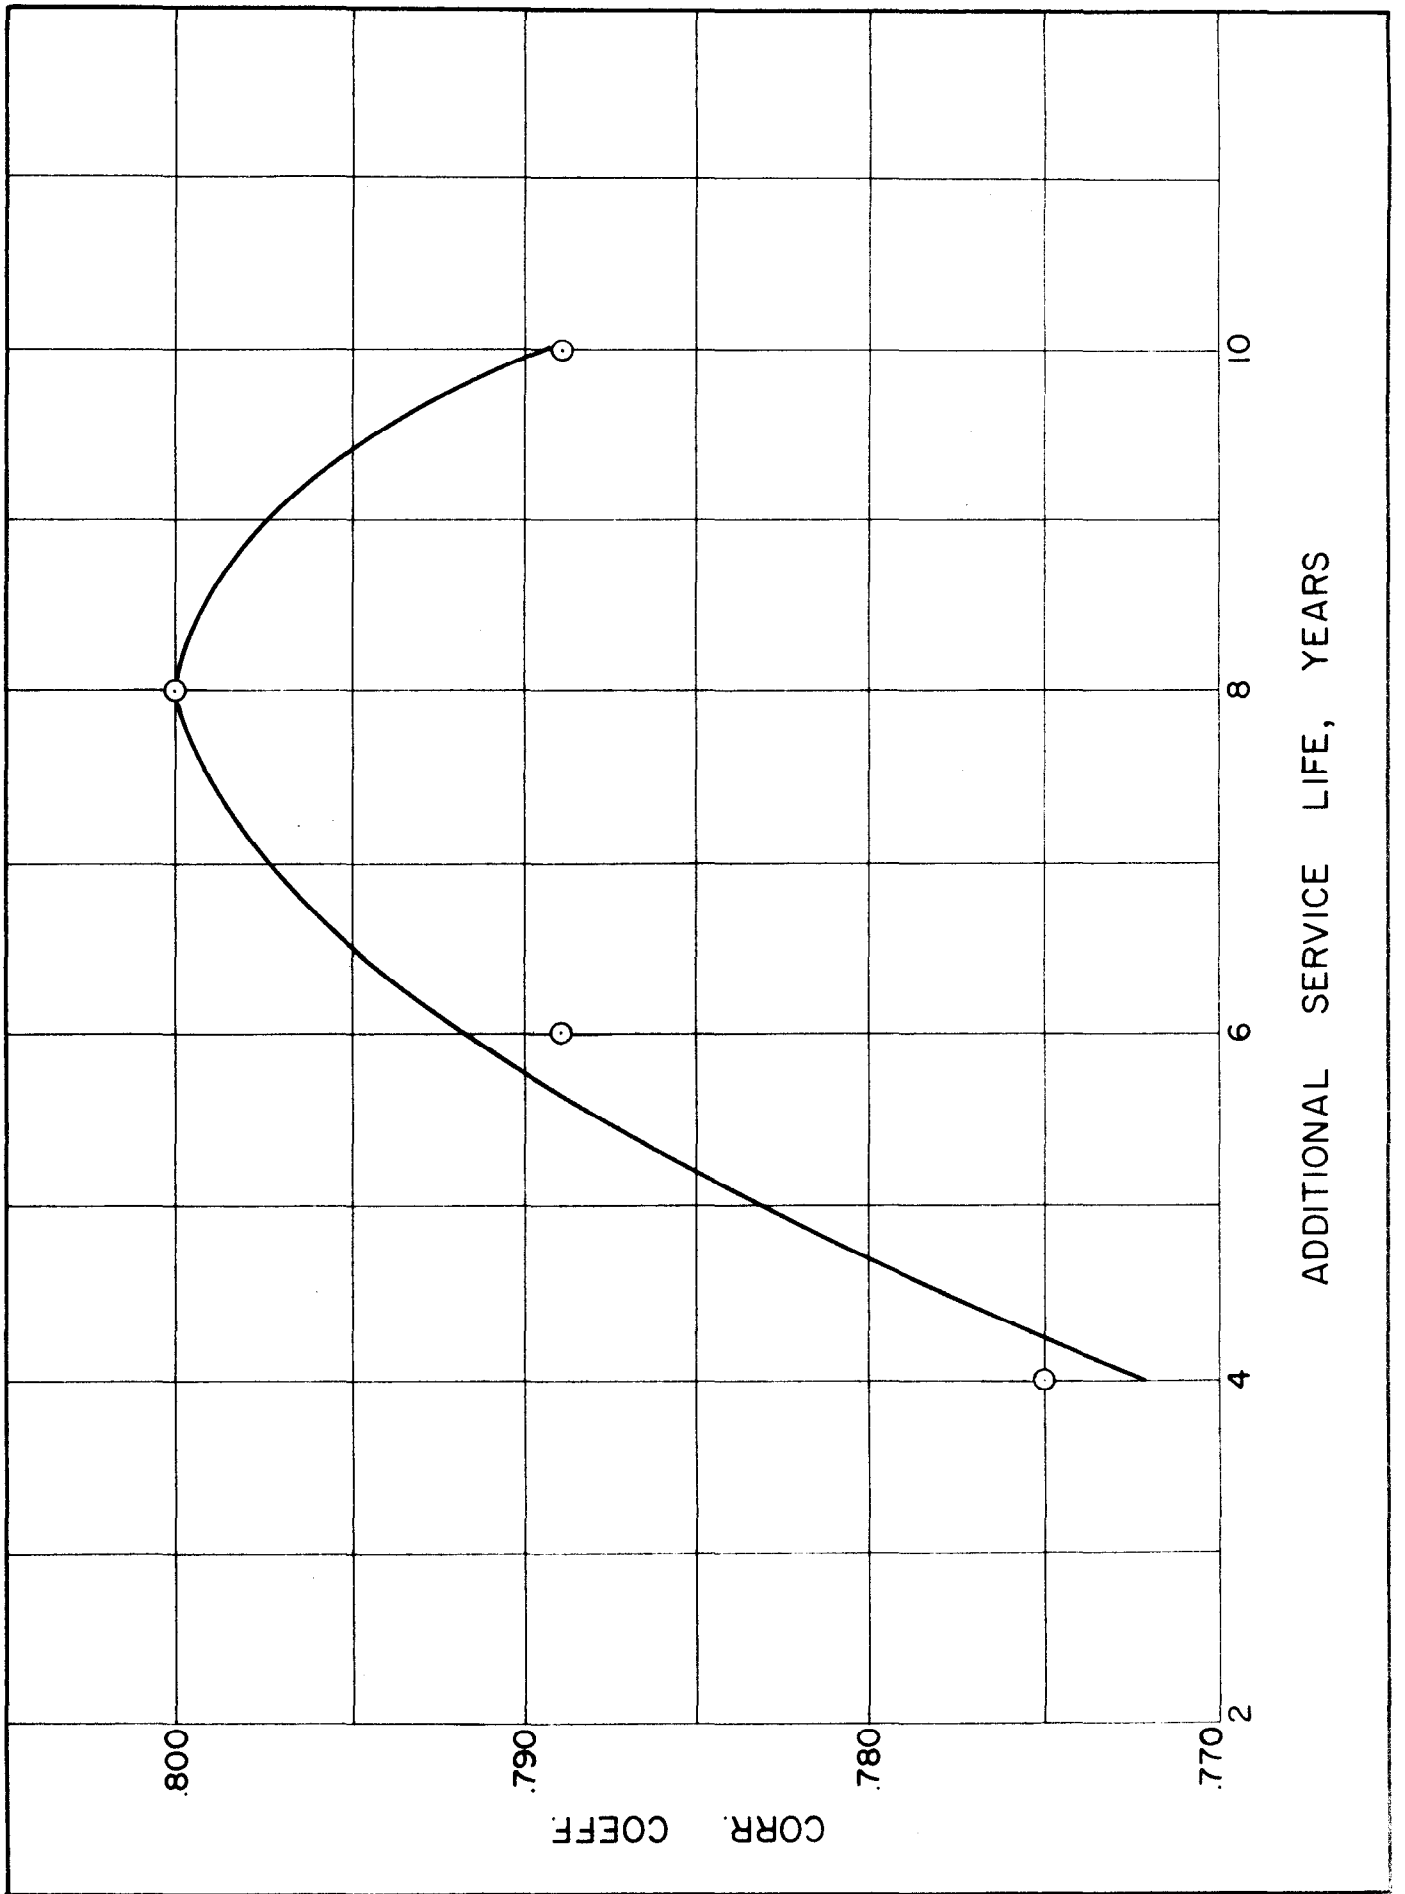
Figure 14 which is a graph of correlation coefficient versus added service life of metal pipe with bituminous coating, indicated that metal culvert life in Louisiana soils was increased 8 years by coating the surface of the metal structure with asphalt. The 8 years of added service of metal structure in Louisiana soils were slightly greater than the normal 6 years chosen by California in Test Method, California No. 643-B, 1963.

FIGURE 14 - Graph of Correlation Coefficient versus Additional Service Life

1. Adoption of California's method of predicting the behavior pattern of submerged metal structures, California No. 643-B, 1963, except that 8 years added service life is obtained from an asphalt coating in lieu of 6 years.
2. Whenever it is impractical to conduct pH and resistivity tests then the Summary of Service Life Expectancy may be used.

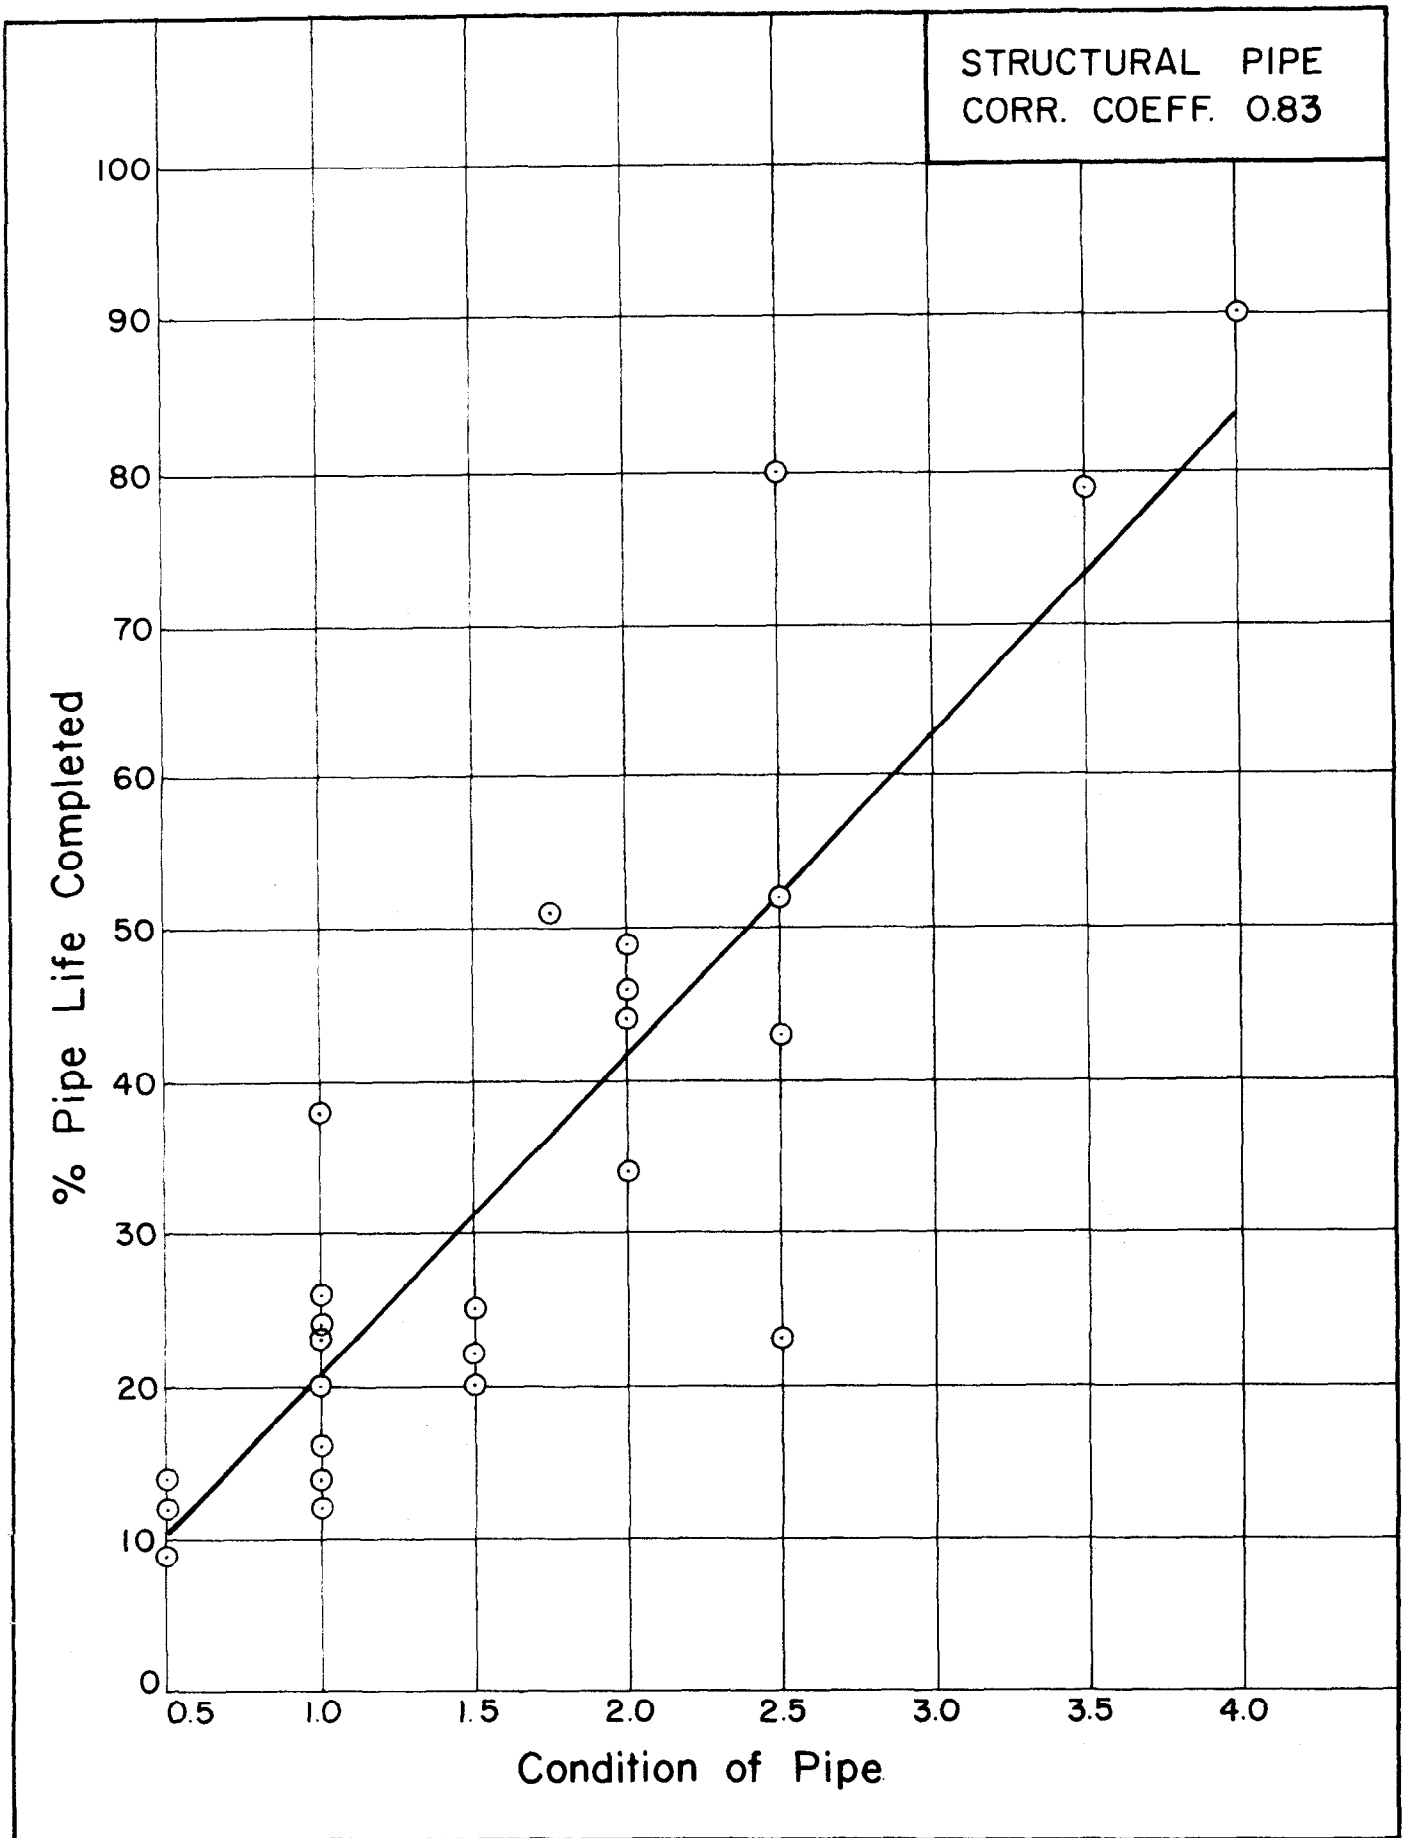
Figure 15 is a graph of percent pipe life completed versus condition of pipe for structural pipe. By using the method of least squares, the slope of the line governed by the points plotted was computed. The correlation coefficient of the graph, 0.830, was good. This correlation coefficient indicated that correlation of the data obtained during the initial field evaluation with the data from California's Test Method, California No. 643-B, 1963, was adequate. For estimating the service life of structural pipe in Louisiana soils, it is apparent that California's Test Method, California No. 643-B, 1963, may be used.

FIGURE 15 - Graph of Condition of Pipe versus Percent Pipe Life Completed of Structural Pipe

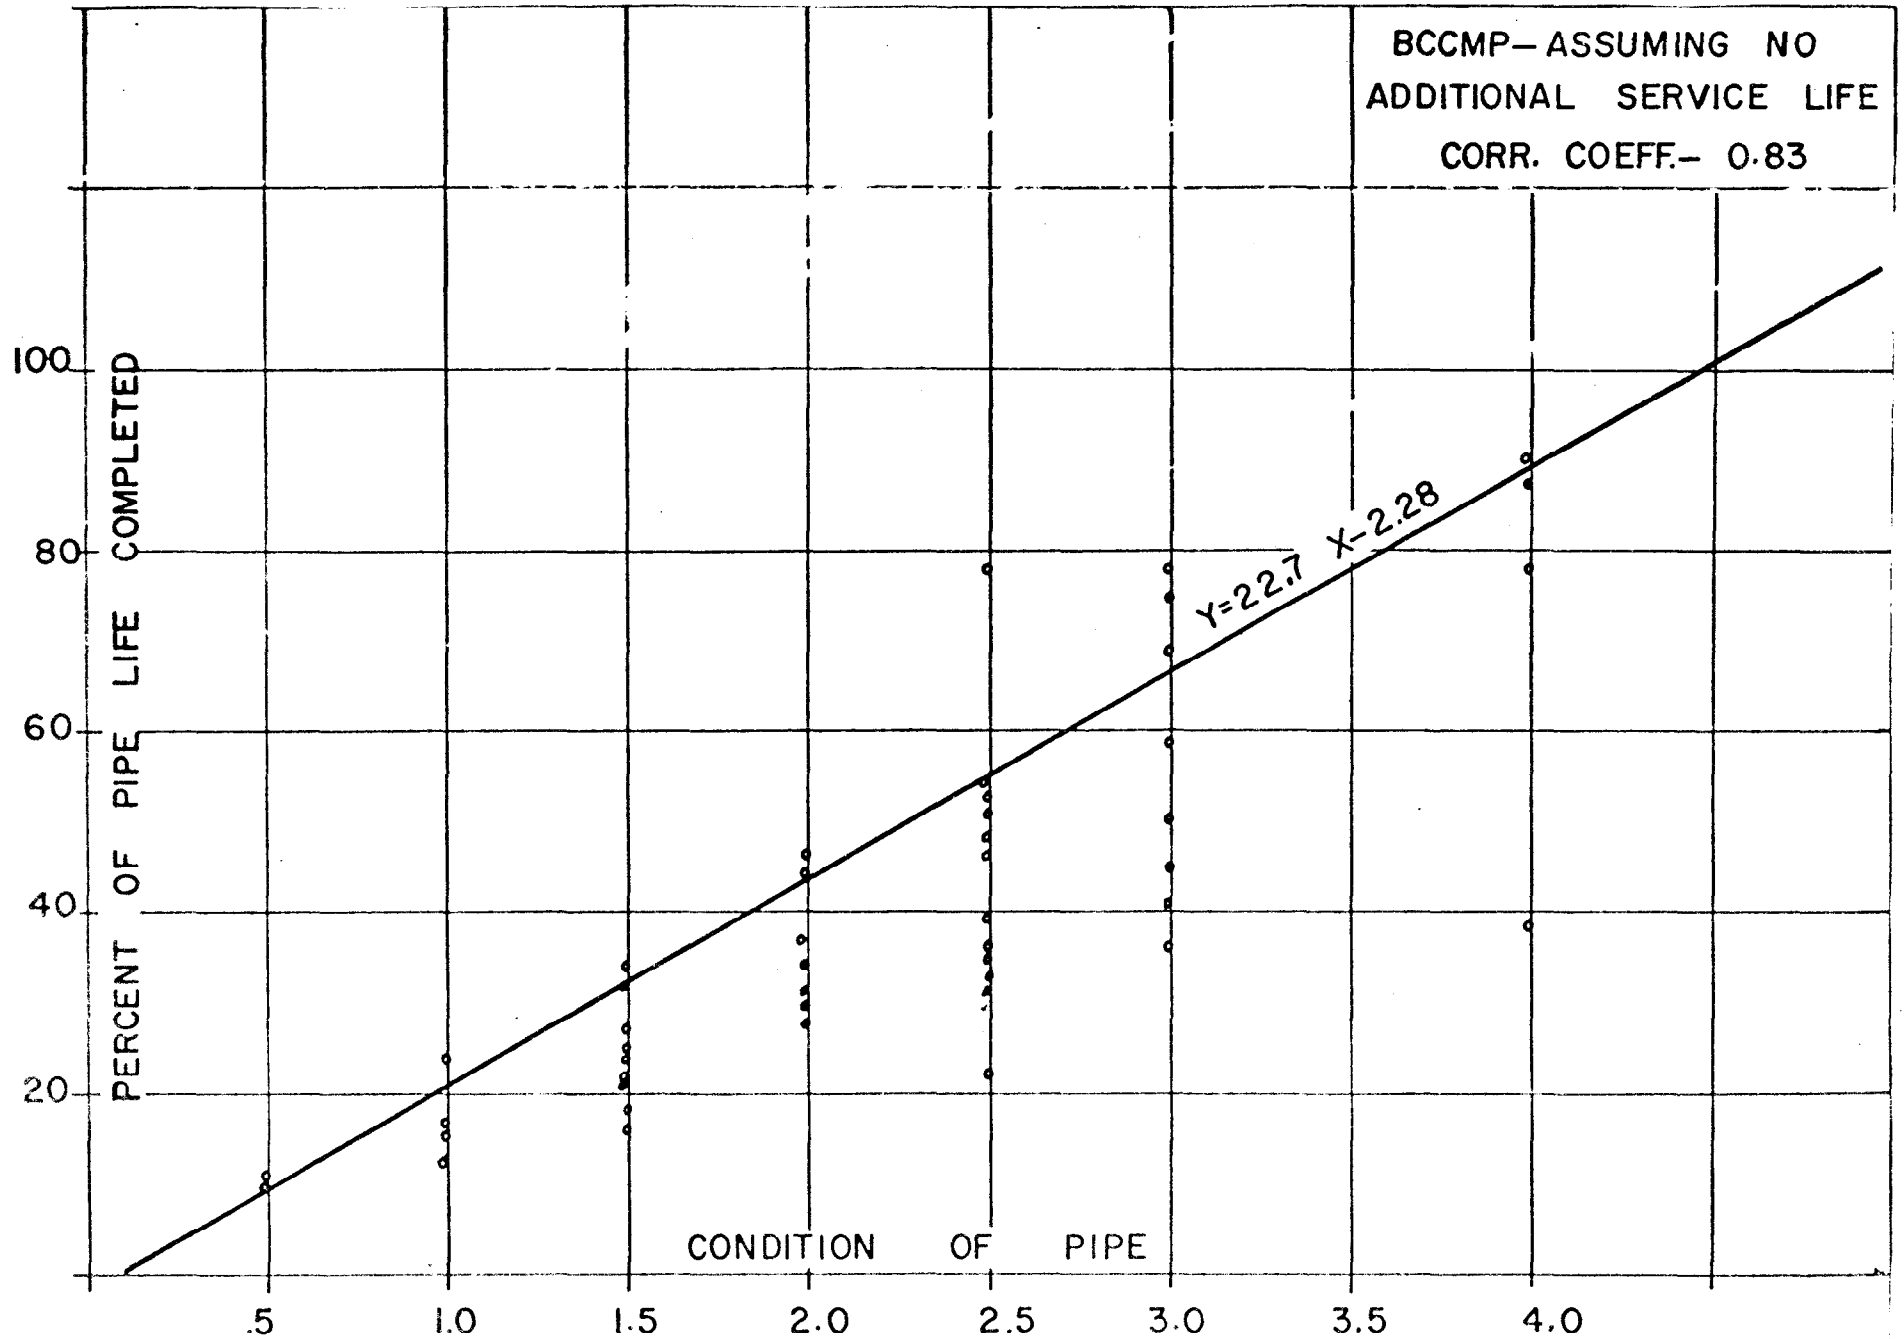
Figure 3 through 8 in the Appendix are graphs of percent pipe life completed versus condition of pipe for BCCMP. According to California's Test Method, California No. 643-B, 1963, an additional 6 years service life of metal culverts was obtained by using a bituminous coating over the galvanized coating of the metal pipe.

Figure 3 - Fitted Curve Shows Relationship Between Percent Pipe Life Completed Versus Condition of Pipe for BCCMP - Assuming No Additional Service Life is Obtained From Bituminous Coating.

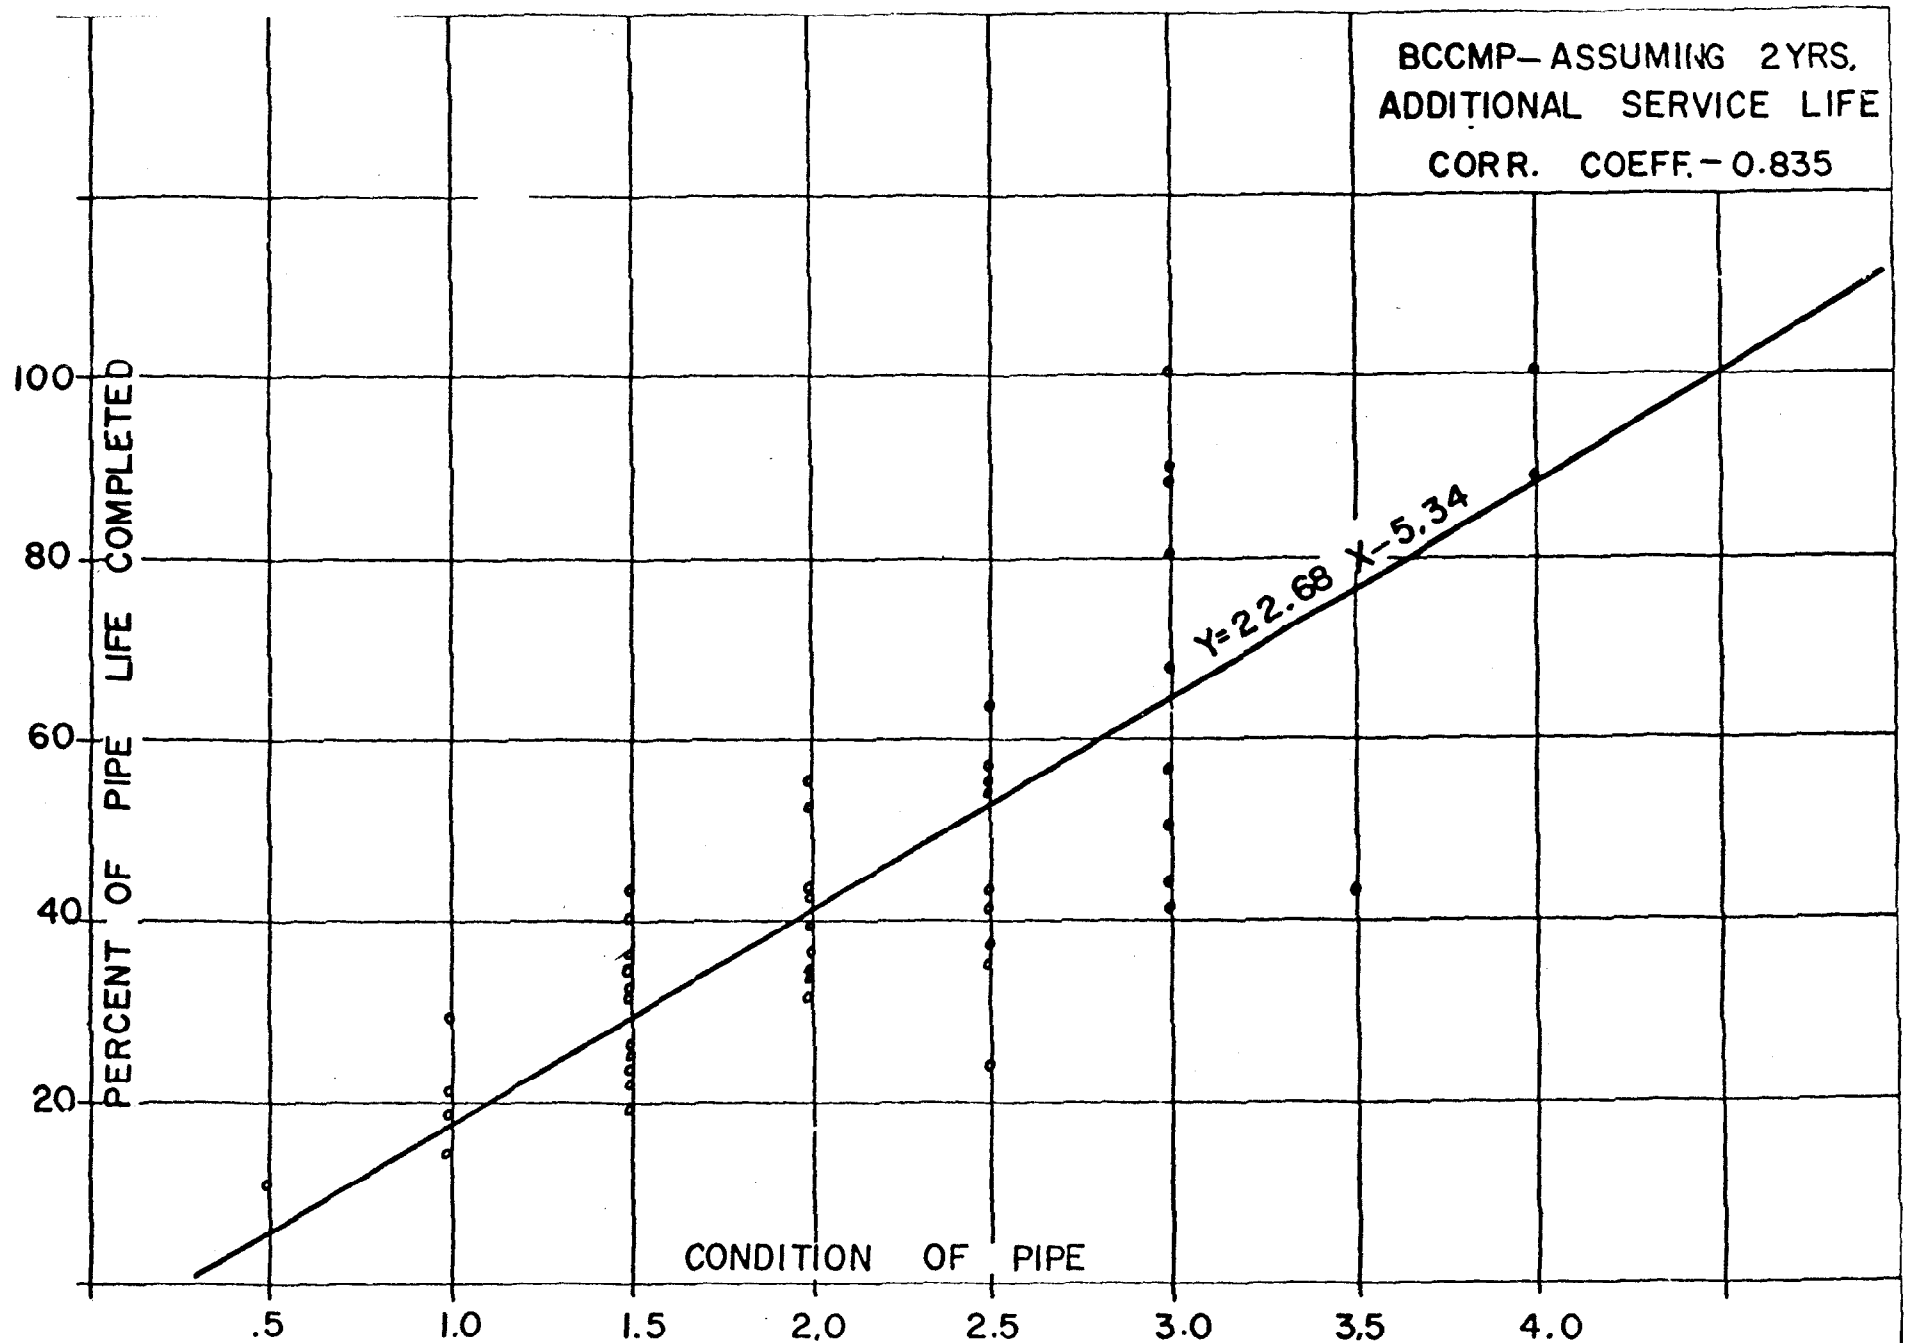
Figure 4 - Fitted Curve Shows Relationship Between Percent Pipe Life Completed Versus Condition of Pipe for BCCMP - Assuming Two Years Additional Service Life is Obtained From Bituminous Coating.

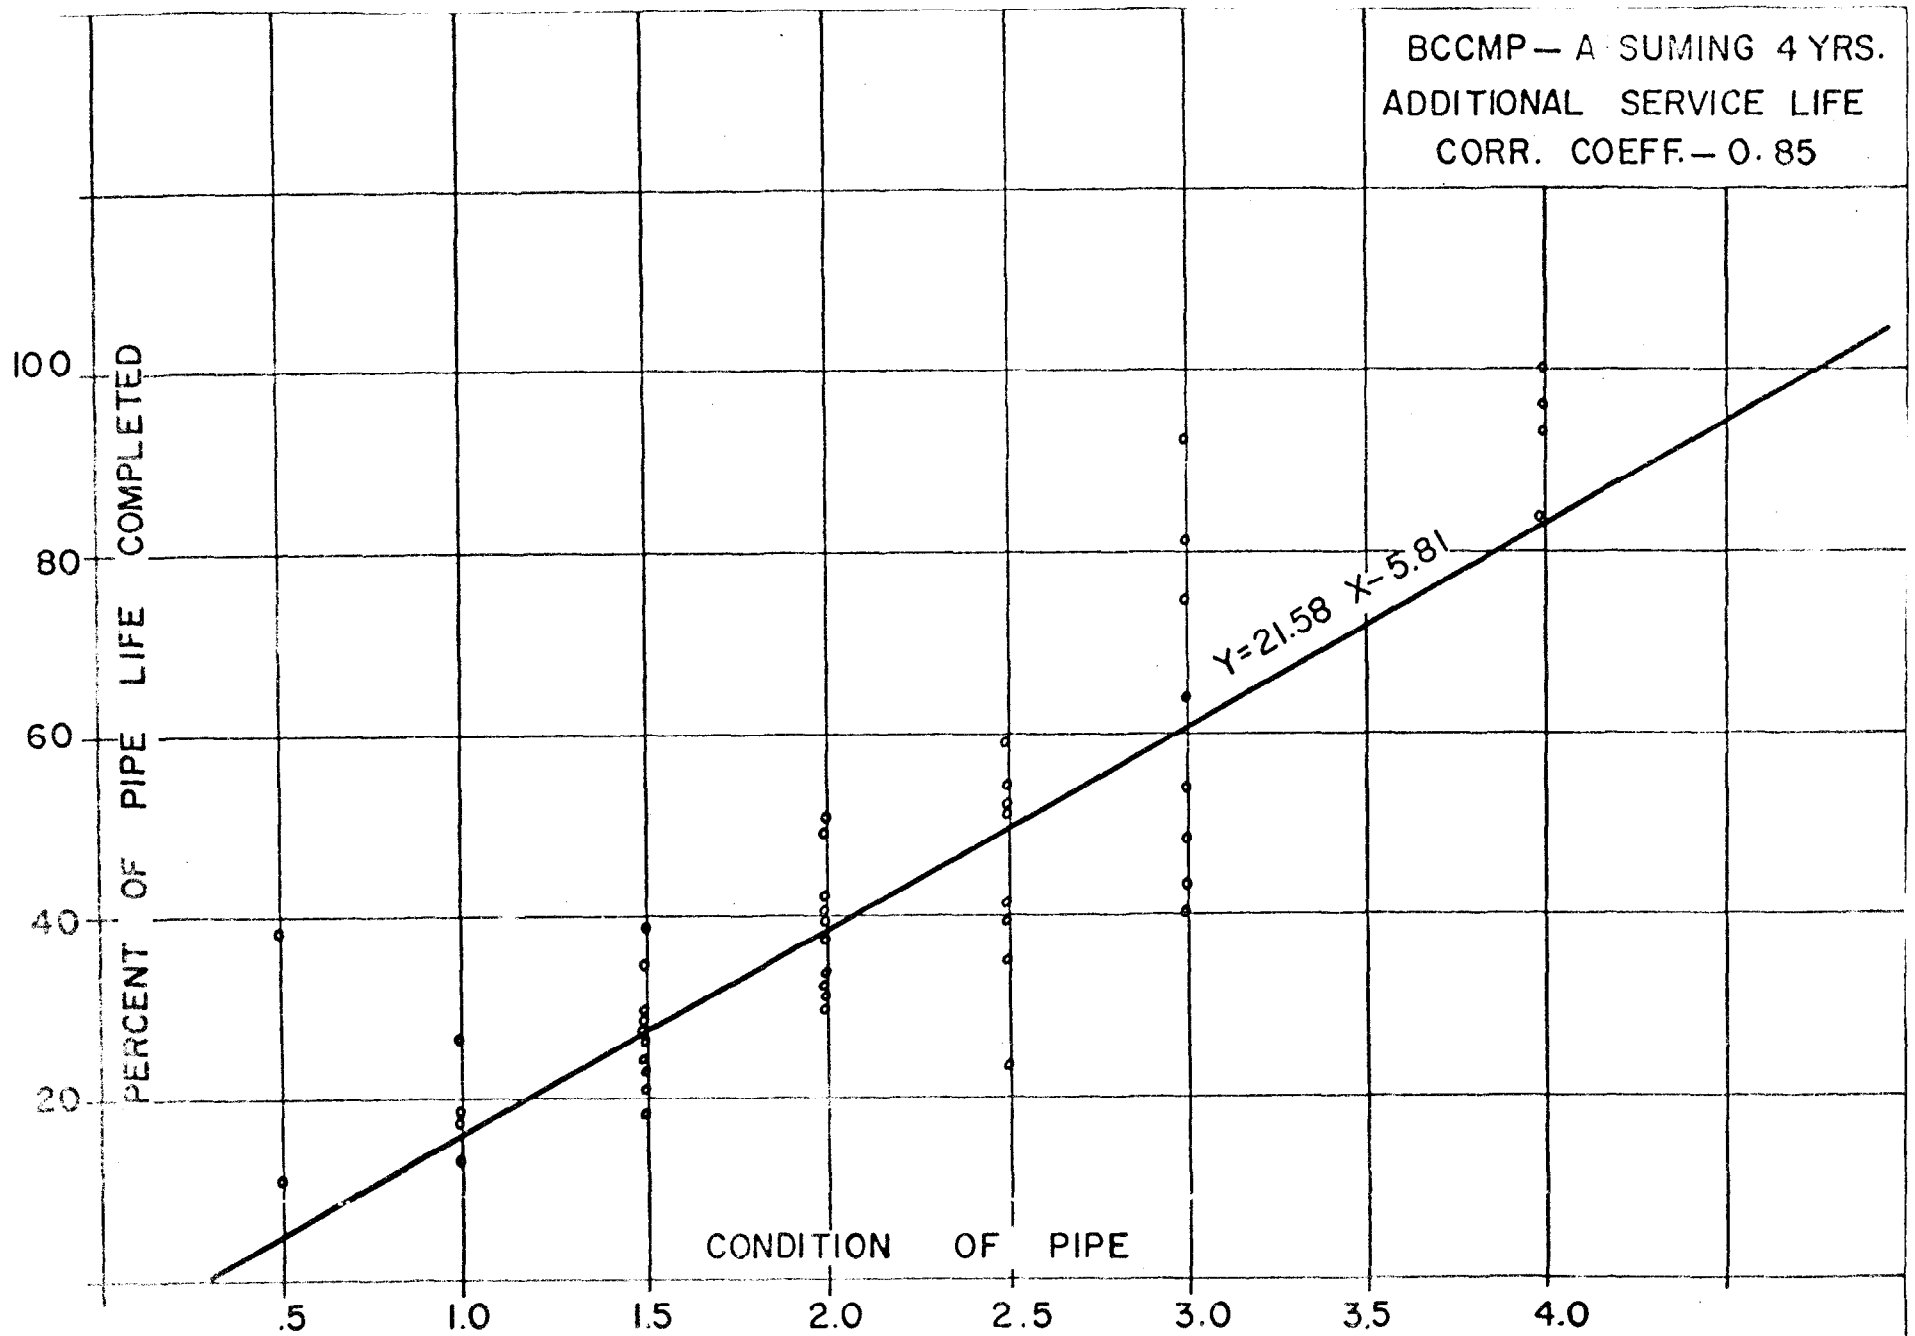
Figure 5 - Fitted Curve Shows Relationship Between Percent Pipe Life Completed Versus Condition of Pipe for BCCMP - Assuming Four Years Additional Service Life is Obtained From Bituminous Coating.

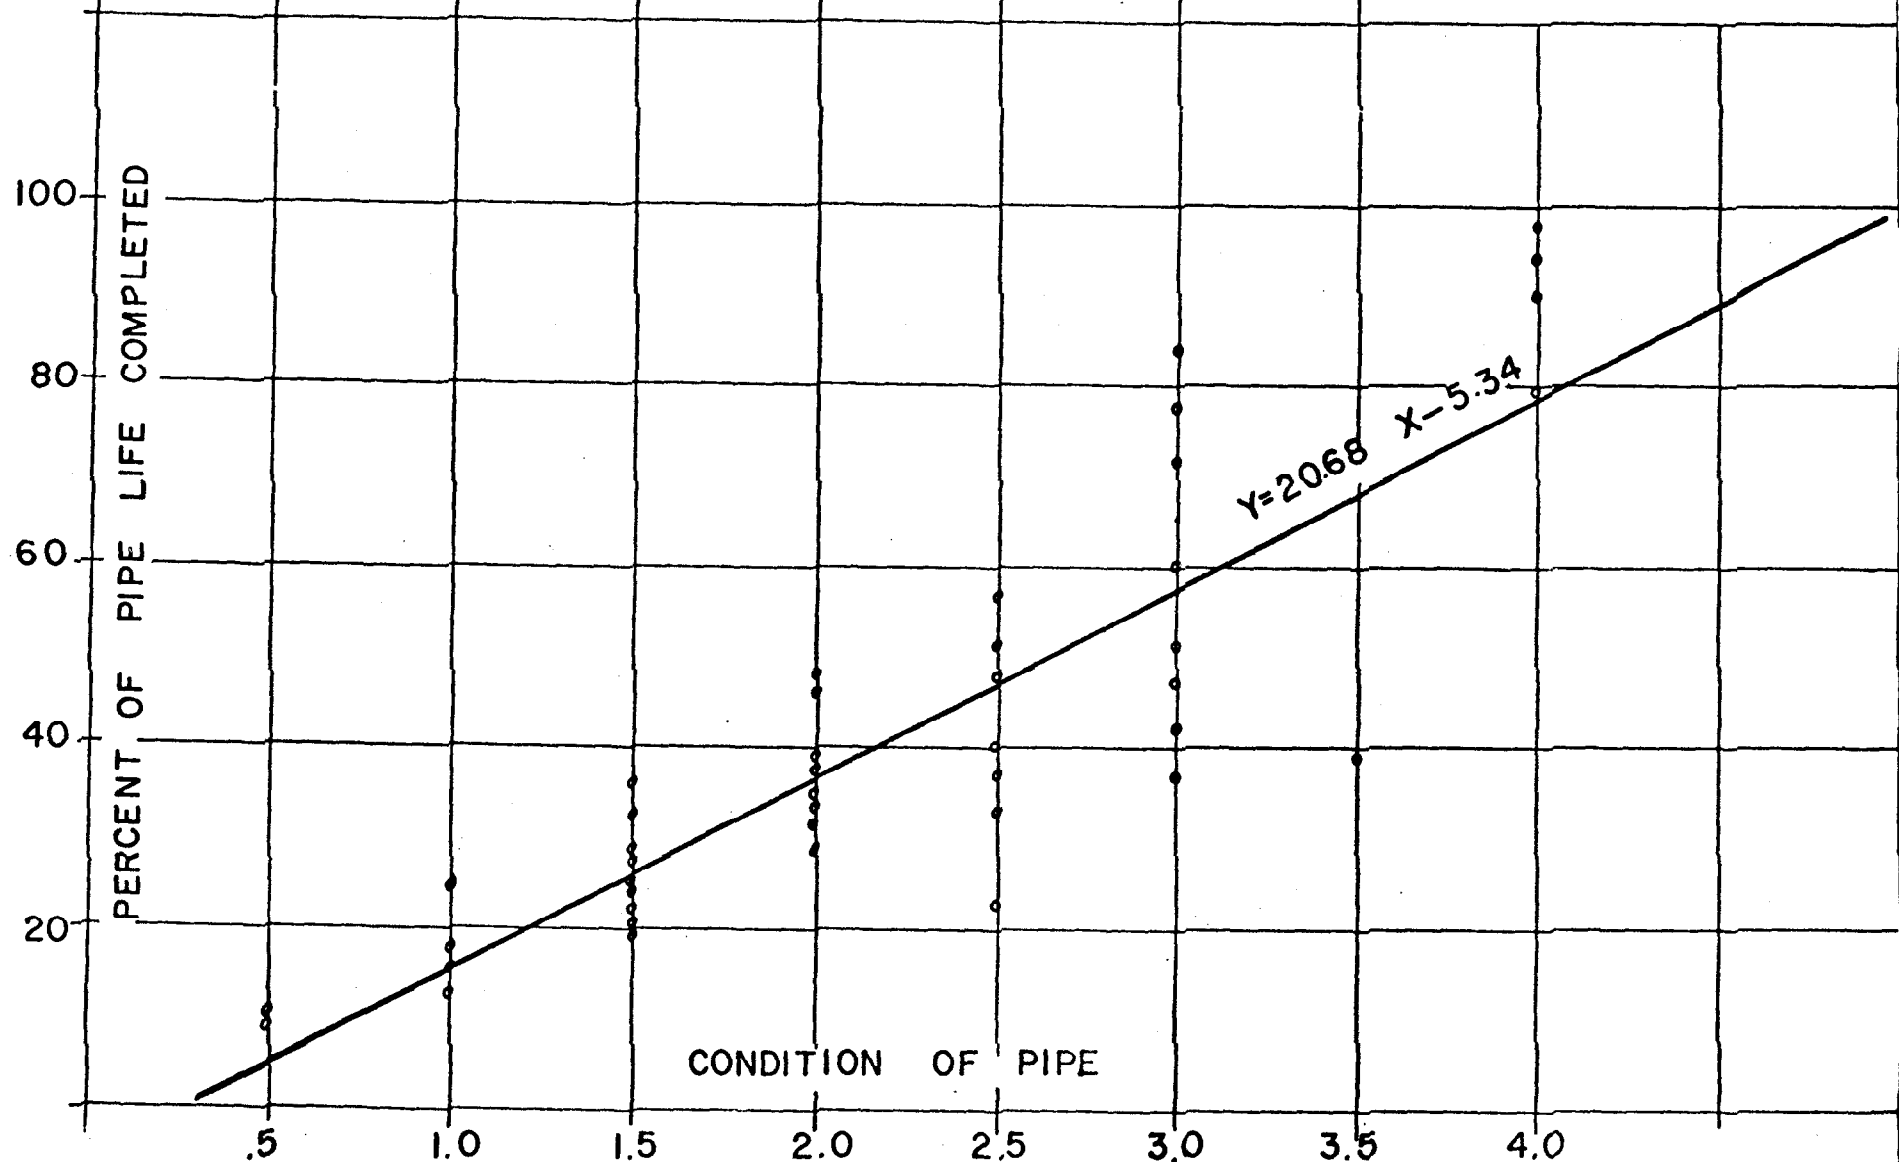
BCCMP - ASSUMING 5YRS.
ADDITIONAL SERVICE LIFE
CORR. COEFF.-0.85

Figure 6 - Fitted Curve Shows Relationship Between Percent Pipe Life Completed Versus Condition of Pipe for BCCMP - Assuming Five Years Additional Service Life is Obtained From Bituminous Coating.

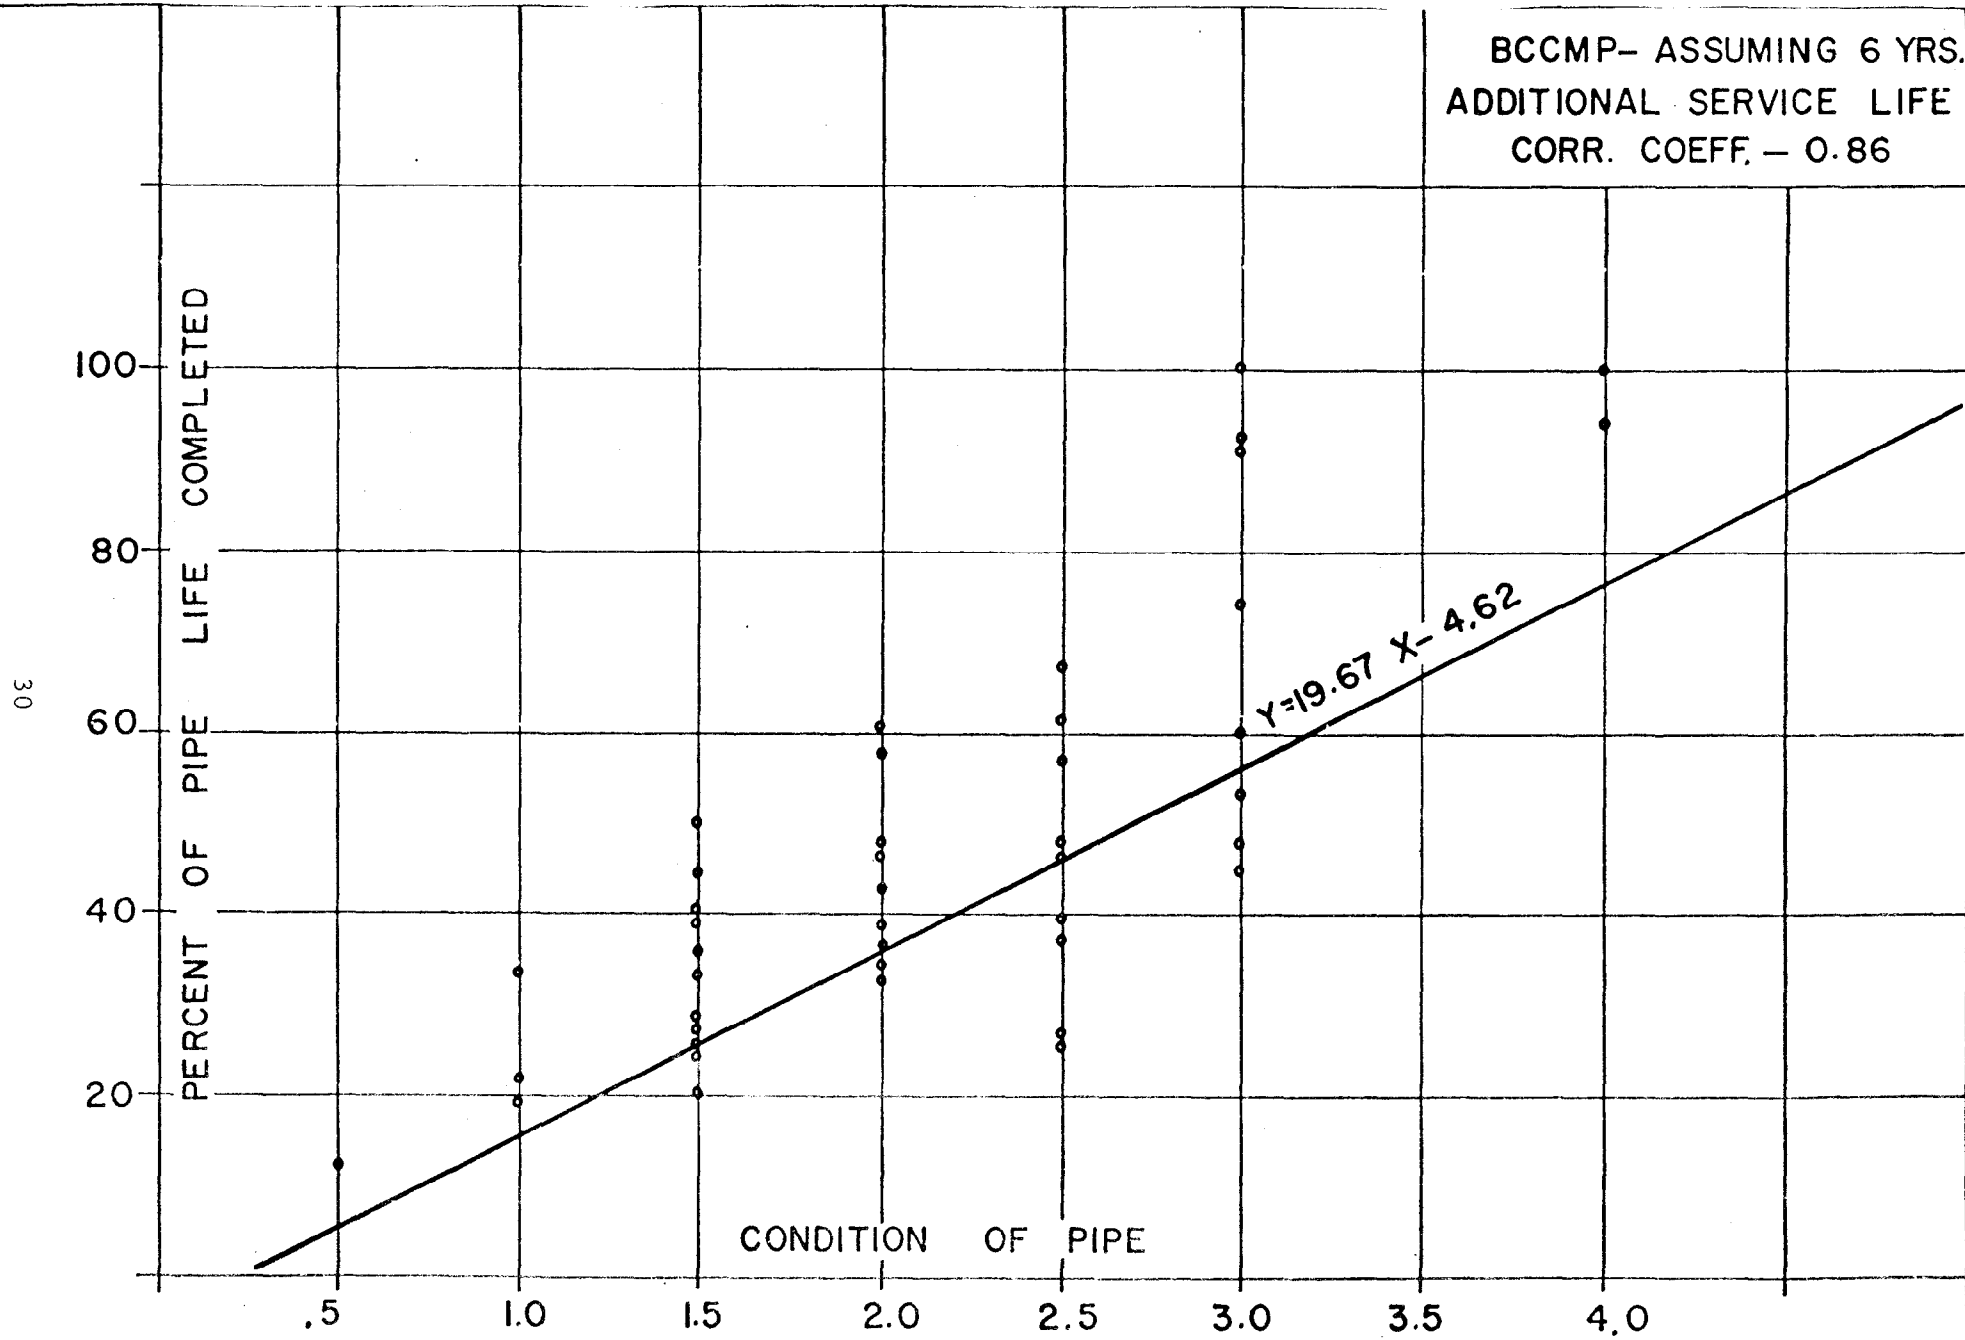
Figure 7 - Fitted Curve Shows Relationship Between Percent Pipe Life Completed Versus Condition of Pipe for BCCMP - Assuming Six Years Additional Service Life is Obtained From Bituminous Coating.

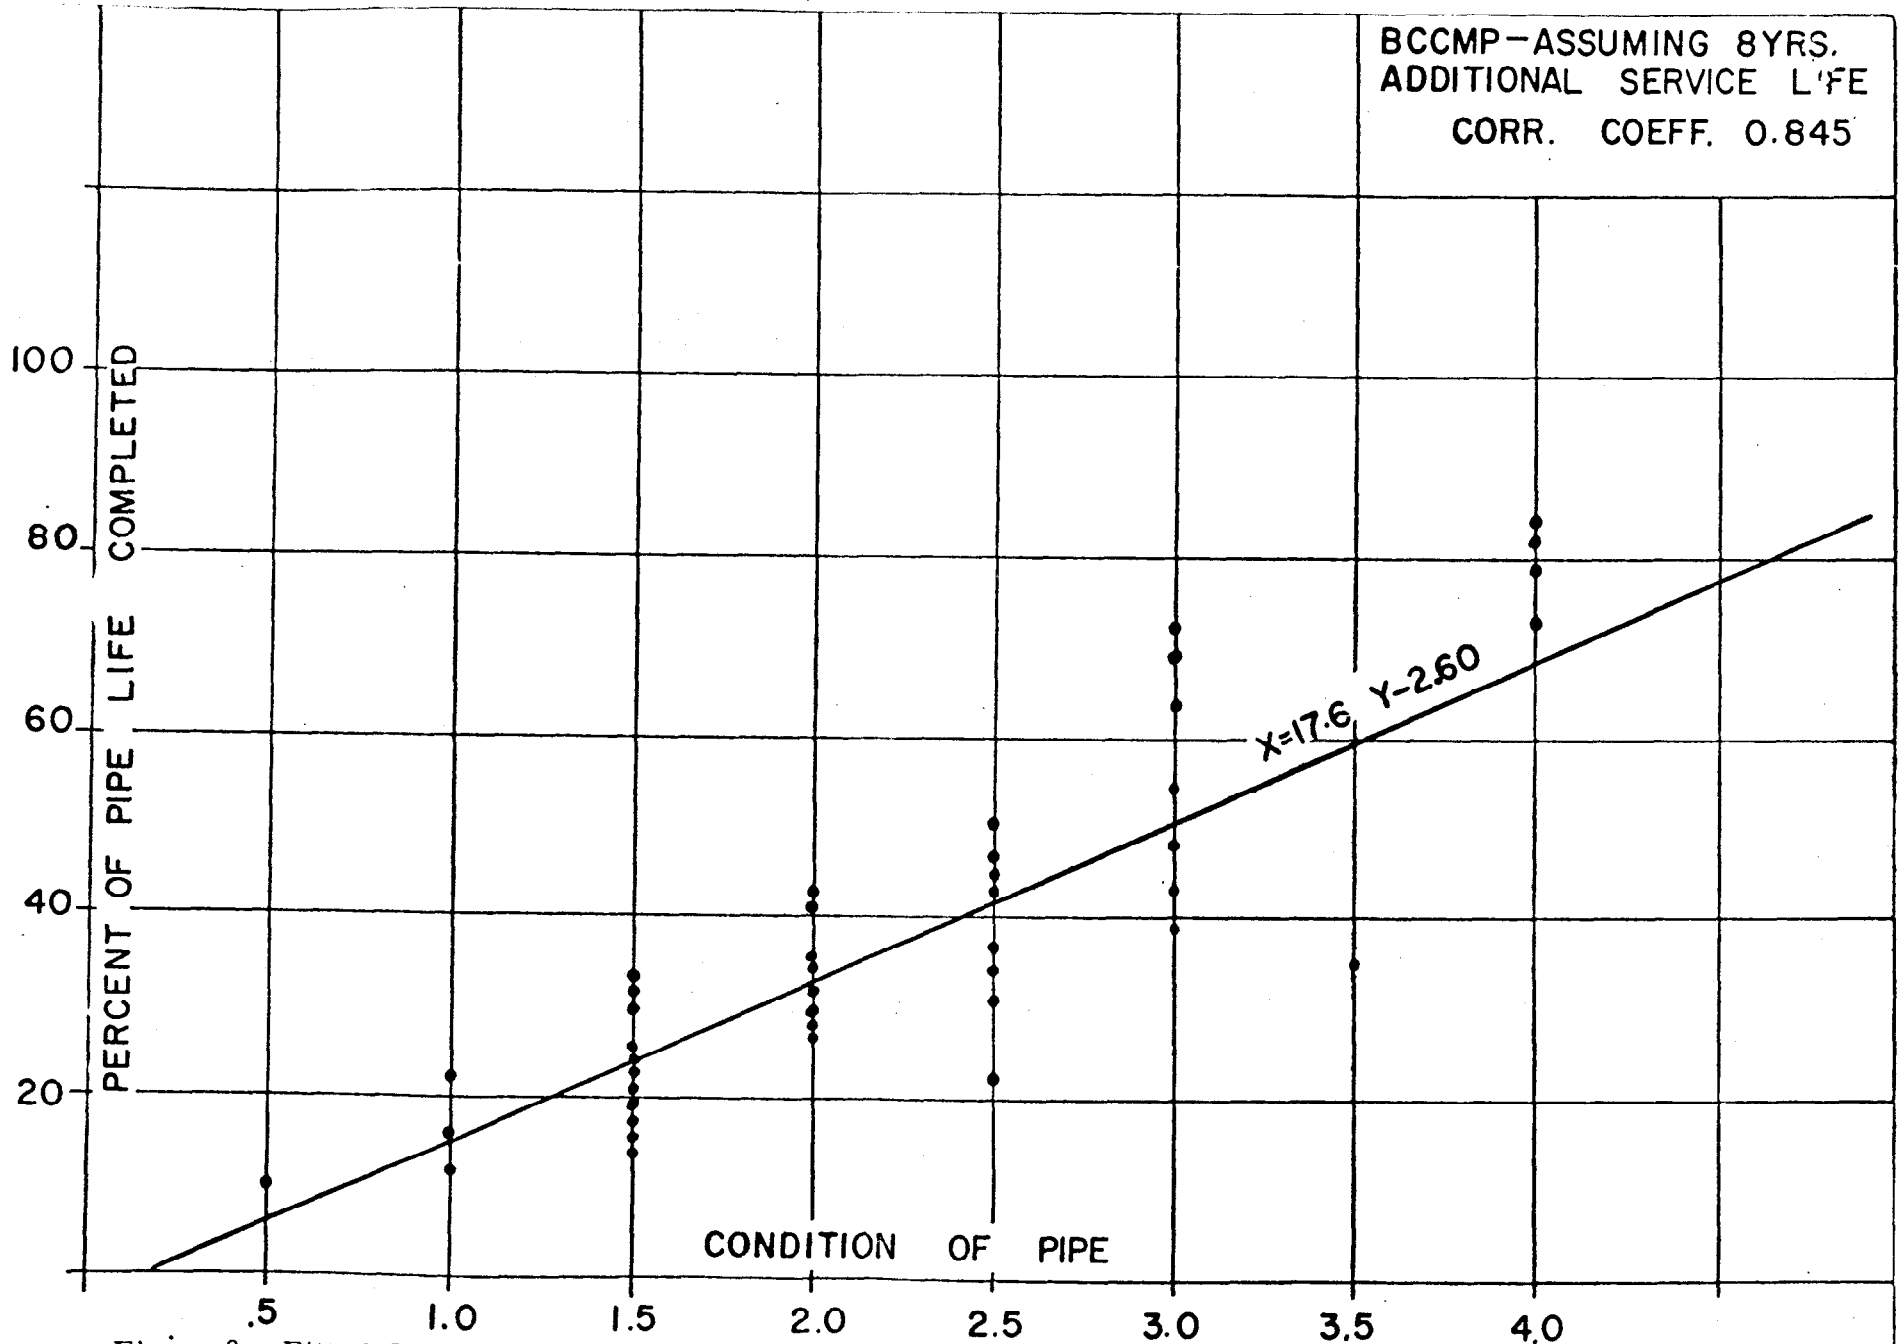
Figure 8 - Fitted Curve Shows Relationship Between Percent Pipe Life Completed Versus Condition of Pipe for BCCMP - Assuming Eight Years Additional Service Life is Obtained From Bituminous Coating.
