1. Report No. 363		2. Government Accession No.		3. Recipient's Catalog No.	
4. Title and Subtitle Evaluation of Louisiana's Maintenance Chip Seal and Micro-Surfacing Program		5. Report Date July 2002		6. Performing Organization Code

**EVALUATION OF LOUISIANA'S MAINTENANCE CHIP SEAL
AND MICRO-SURFACING PROGRAM**

LTRC NO. 97-6B
STATE PROJECT NO. 736-99-0457

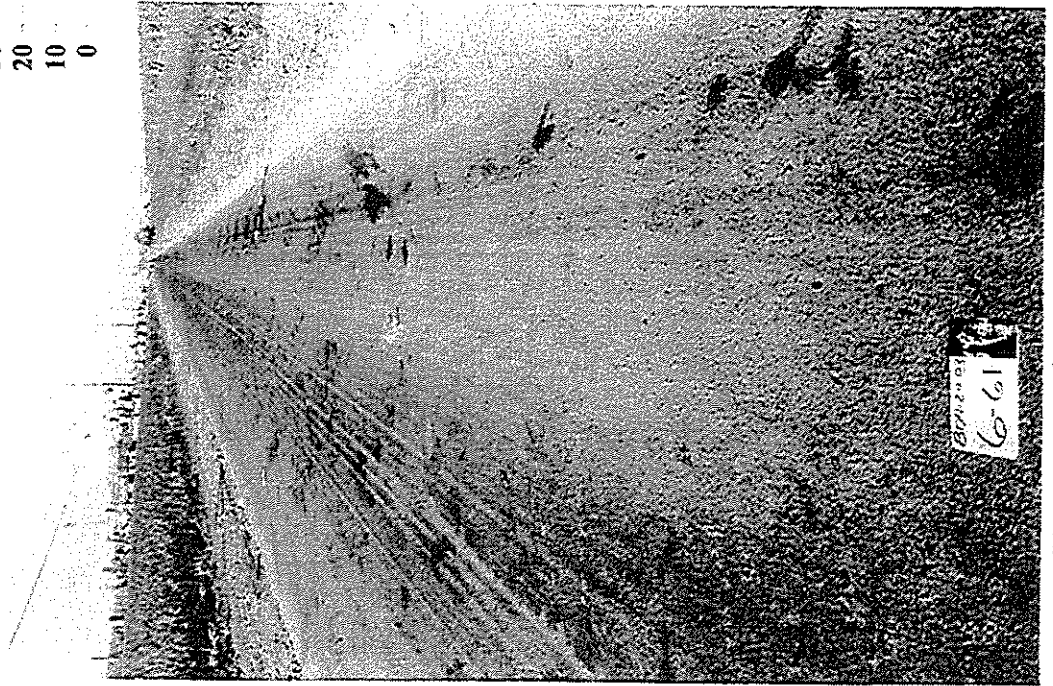
LA 999 Chip Seal

December 1998

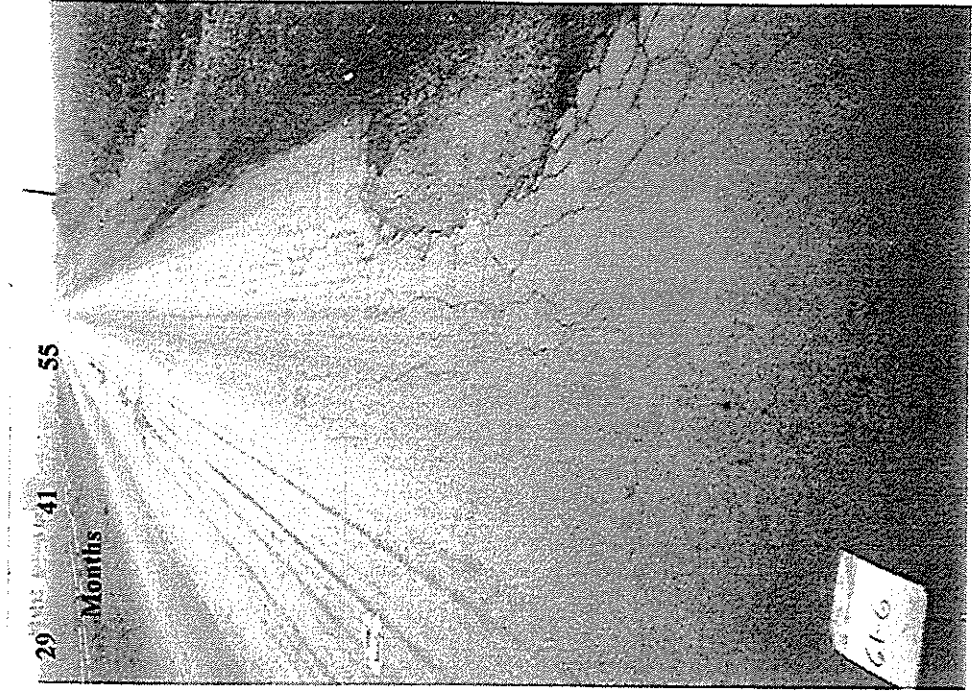
February 2001

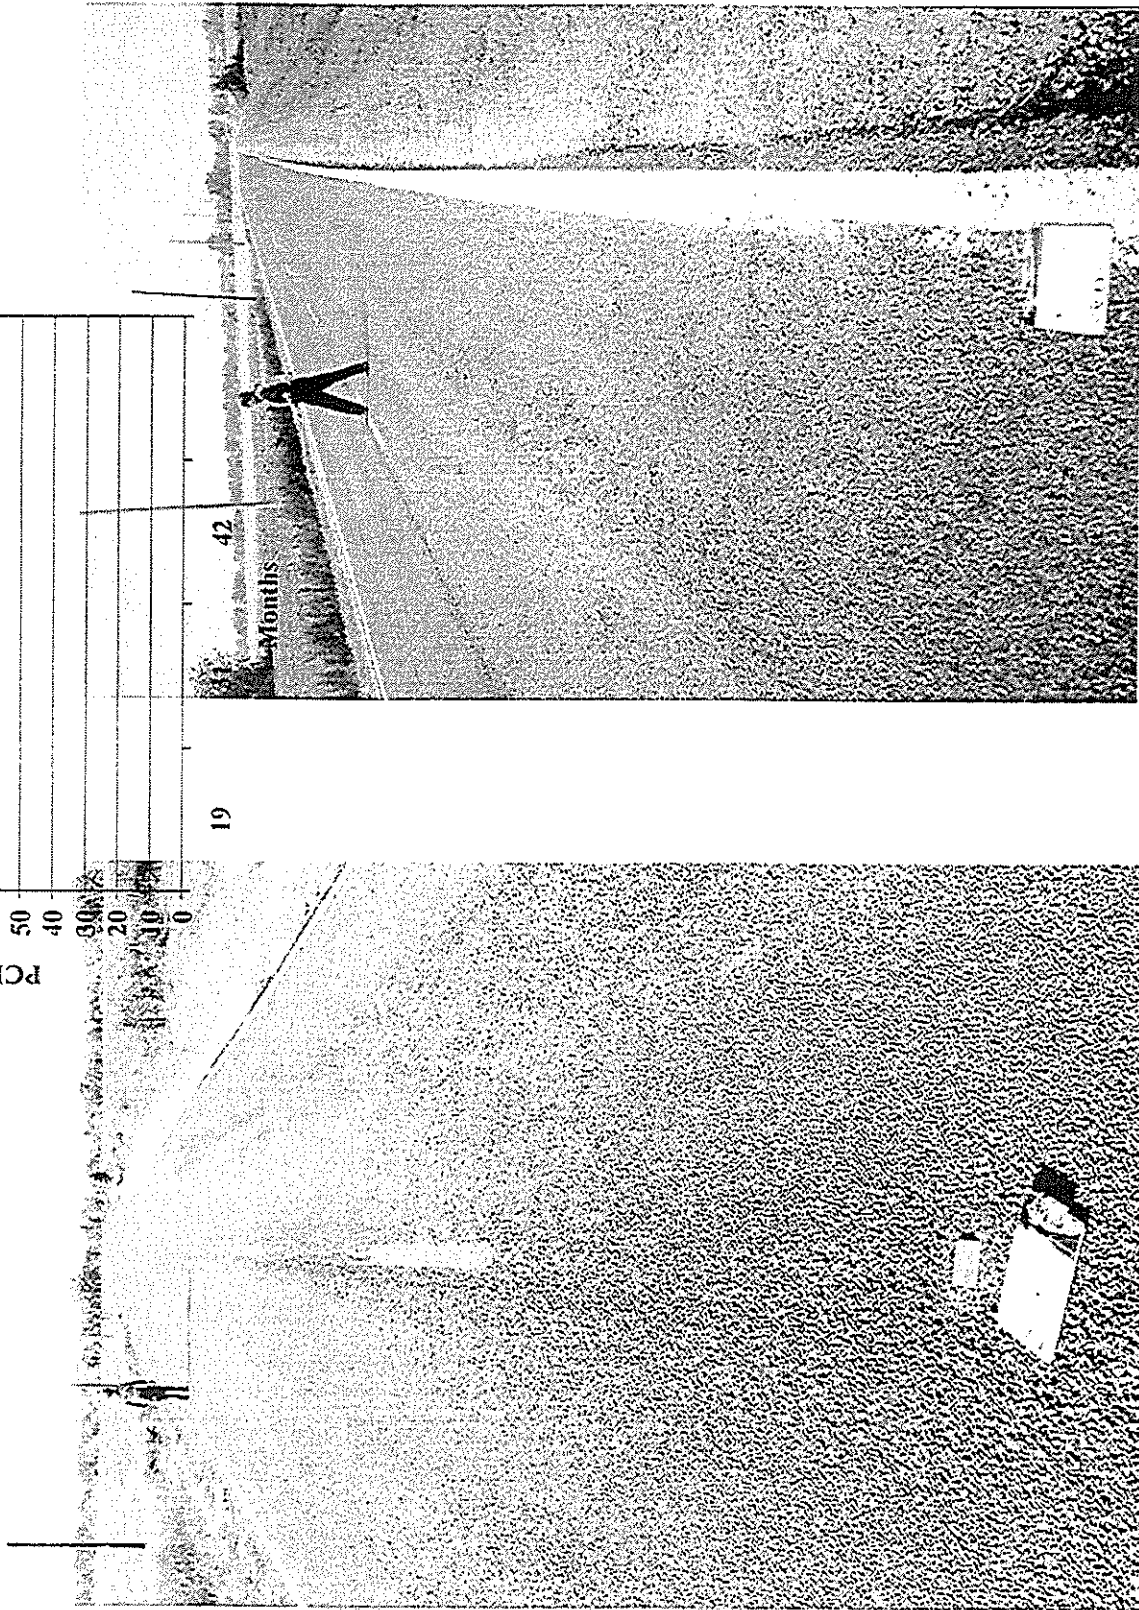
LA 4 Chip Seal

November 1998

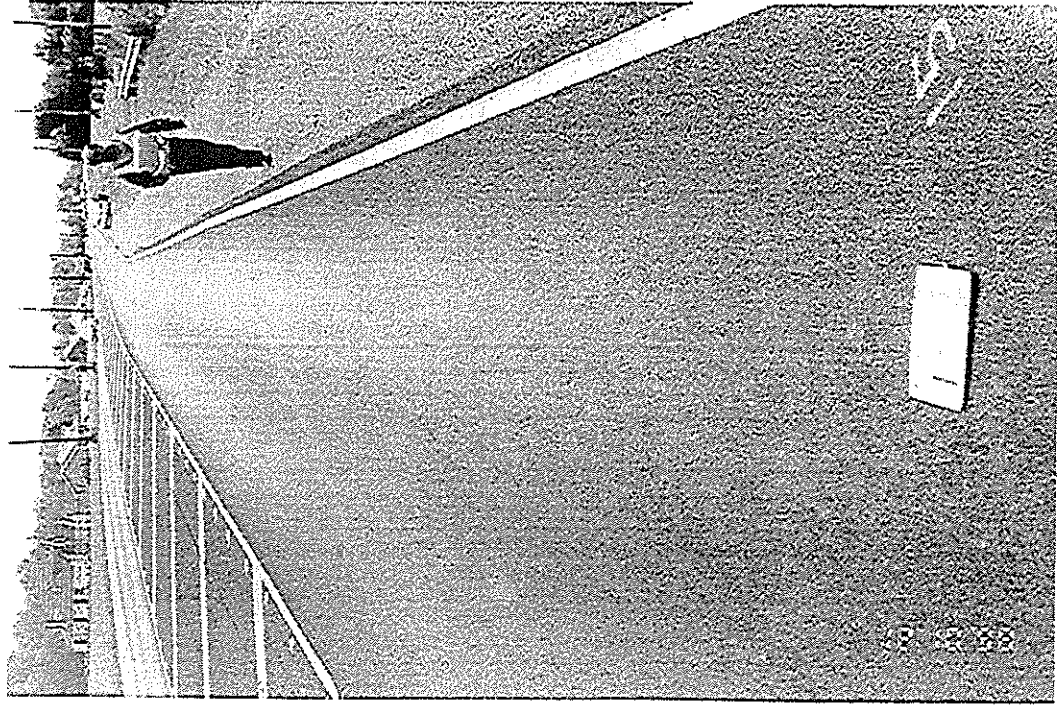
LA 659 Micro Surfacing, Houma

December 1998

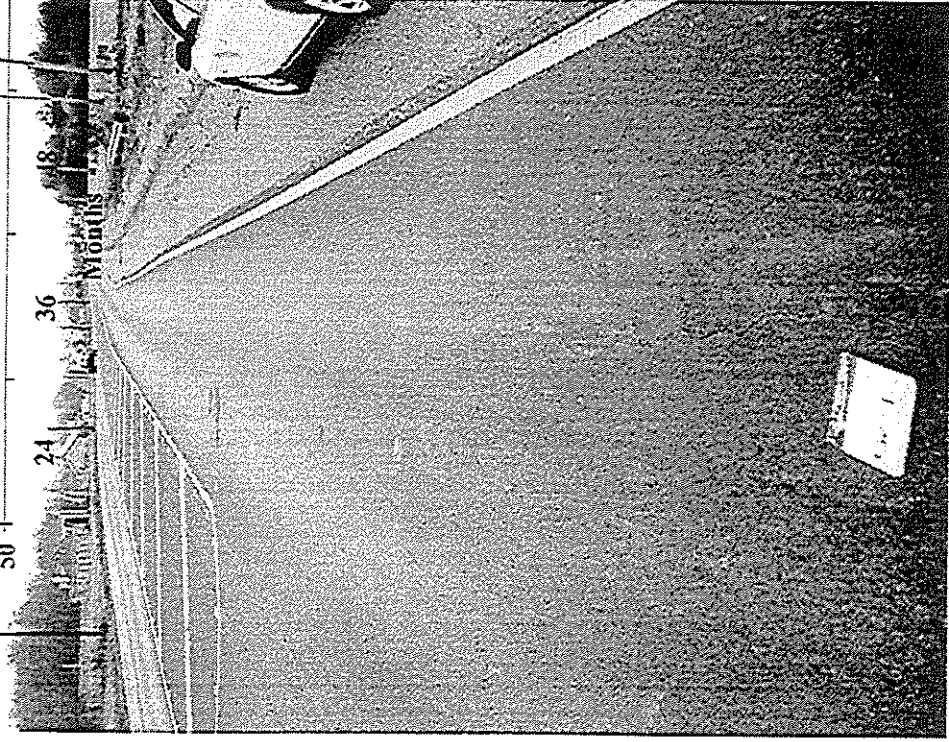
February 2001

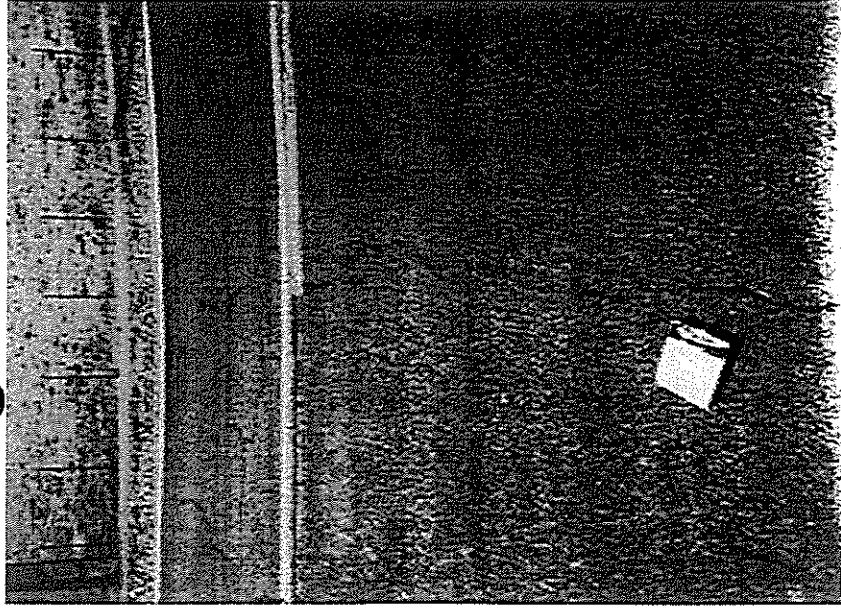
Alligator

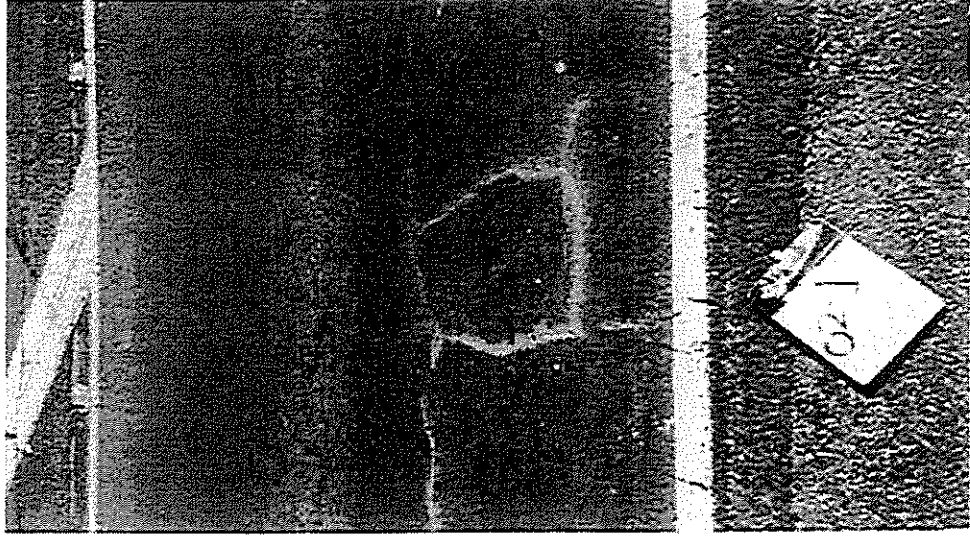
Longitudinal/Transverse

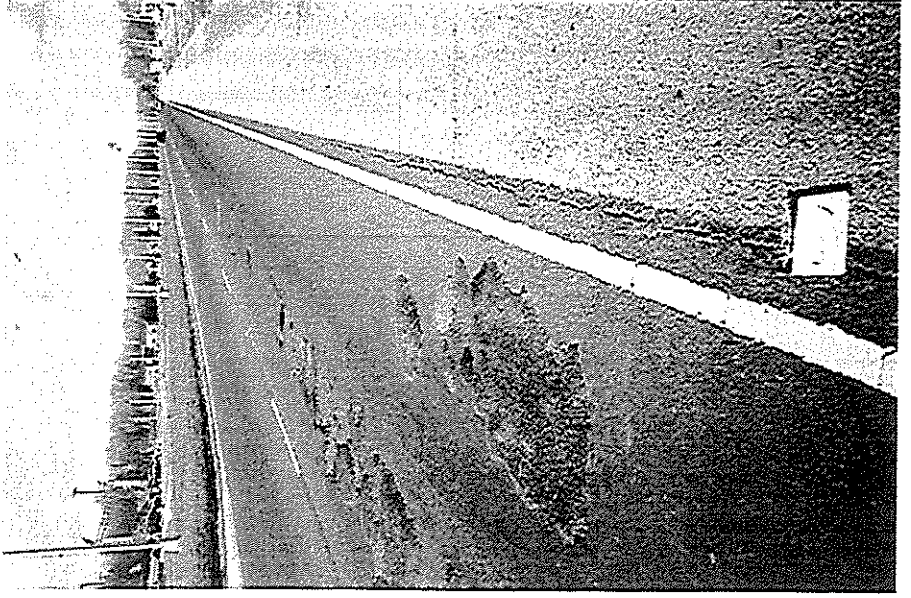
Bleeding
