EVALUATION OF THE LULING BRIDGE RETROFIT DETAILS UNDER SERVICE LOADS

FINAL REPORT

August 1991

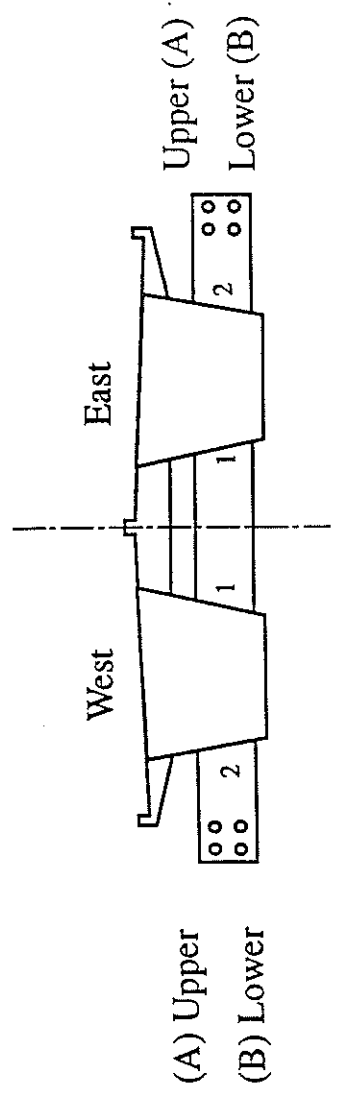
Figure 1.1. Profile and cross section of bridge.

The cables of the bridge are attached to two towers and cross girders. Figure 1.1 shows the locations of the cross girders, and the relative position of the cross girders with respect to the longitudinal girders. At the cross girders, the trapezoidal boxes were split into two half sections (upper and lower), longitudinally, so that the cross girders could be bolted in place.

Electrical resistance strain gages were attached to the webs of the web trapezoidal box at cross girders CG3, CG4 and CG5 (see Figure 1.1 for designation). All strain gages were inside the box girder. Most of these gages were at the crack arresting holes; a few were placed at the webs and bottom flange plates of the longitudinal box in transverse cross sections. The latter strain gages were used for detecting the response of the box girder to service loads.

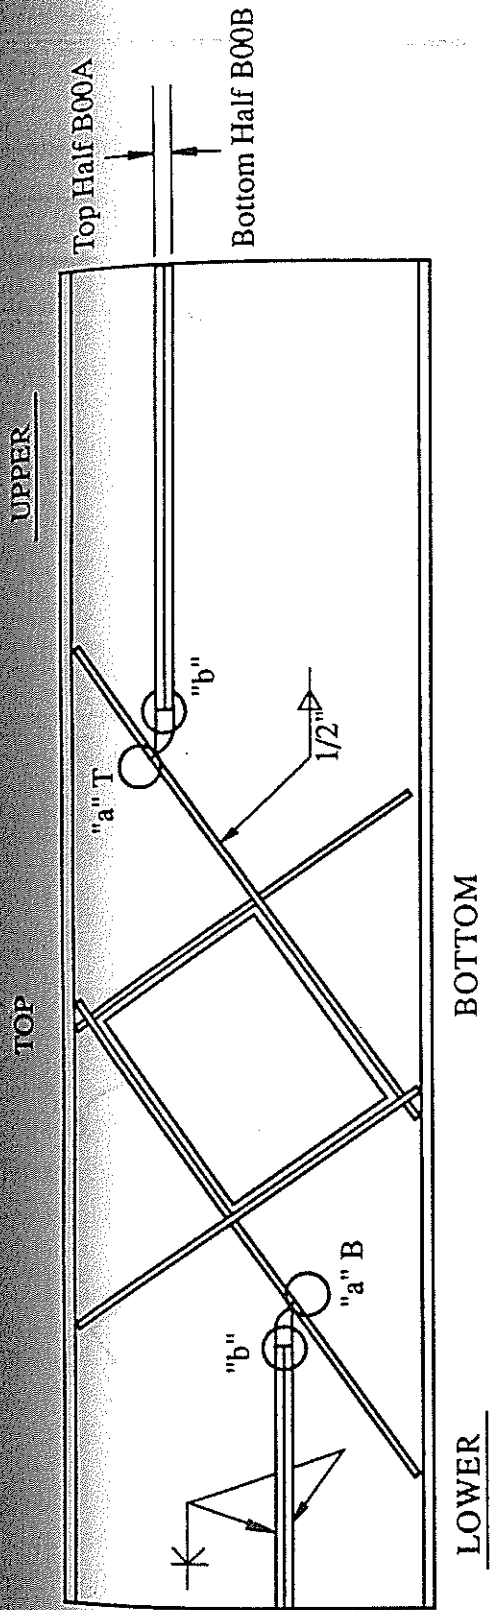
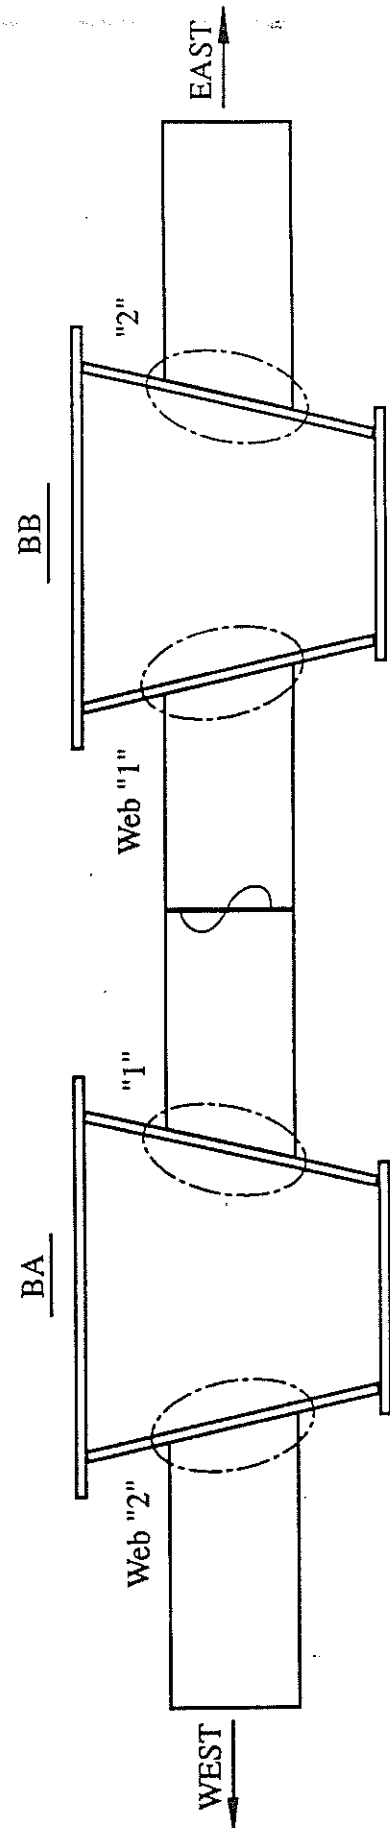
Figure 1.2. Identification of locations.

During construction, cracks were discovered in the webs of the trapezoidal box girder at several details at cross girder locations. The details have been designated as "a", "b", "c" and "d", as shown in Figure 1.2 and 1.3. Details "a" and "b" are shown in more detail in Figure 1.4. Examination and evaluation of these cracked details and core samples were made⁽¹⁾, and coring out the web plate at the cracks to create a crack arrest hole was adopted as the method of retrofit.

The locations of the cracked details were identified by an alphanumeric system prior to this study. This identification system was maintained in the study, and is revealed in Figures 1.1 to 1.4. When two or more strain gages were placed at a detail the locations were designated by top or bottom (T or B), or numerically. Furthermore the strain gages were also numbered for simplicity during testing. Tables 2.1 to 2.3 summarize the gage identification and numbers. Figures 2.1 to 2.25 depict the location of these gages.
