1. Report No. LA-98/320		2. Government Accession No.		3. Recipient's Catalog No.	
4. Title and Subtitle Investigation of Cracks in Cylindrical Spun-Cast Concrete Piles in a Marine Environment		5. Report Date 12/31/98		6. Performing Organization Code

Investigation of Cracks in Cylindrical Spun-Cast Concrete Piles in a Marine Environment

by
R. Richard Avent
David J. Mukai

December 1998

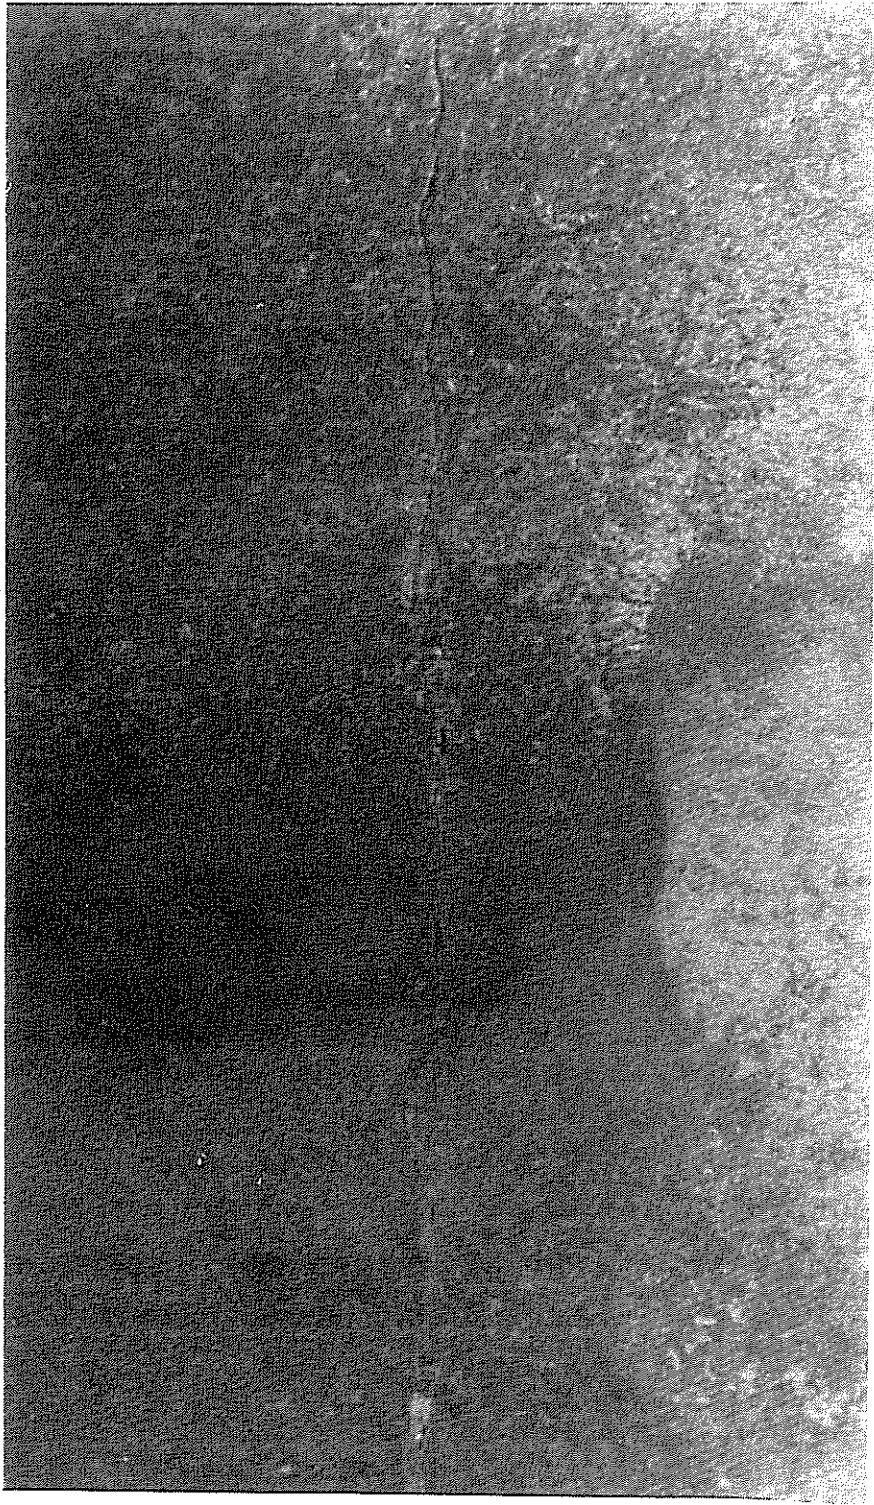
The level I above water inspections revealed that hairline cracking was confined to relatively few piles and in a few isolated instances to cracks approaching 1/8 inches at the surface that necked down to hairline cracks not far from the surface. These cracks were limited to I-10 over the Reserve Relief canal and I-10 between Ramah and Whiskey Bay. A database of piles with cracks was developed and a printout can be found in appendix A. Typical hairline cracks are shown in figures 11 to 14. These cracks are so small they do not show well in photographs except when highlighted by efflorescence. Cracks that appear at the junction with the pile cap girder are typically from piles supporting I-10 between Ramah and Whiskey Bay. Cracks found near the waterline are typically from I-10 over the Reserve Relief Canal.

Figure 11
Typical hairline crack near waterline

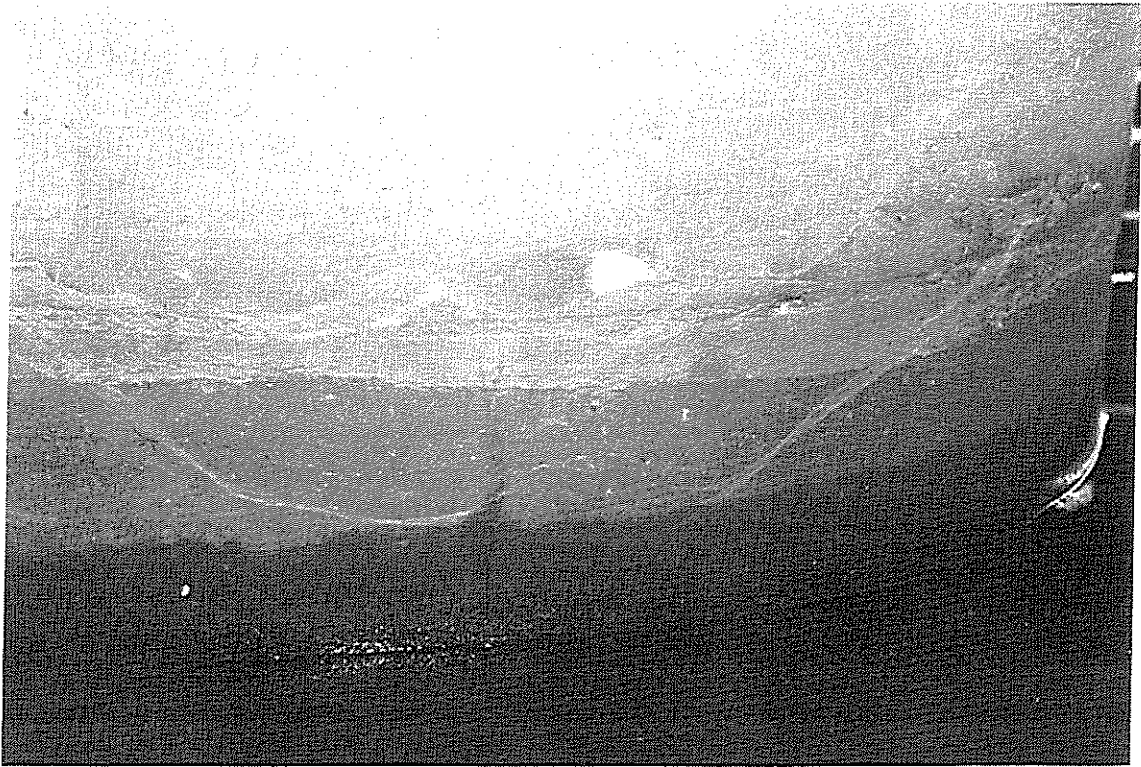
Figure 12
Typical hairline crack near waterline

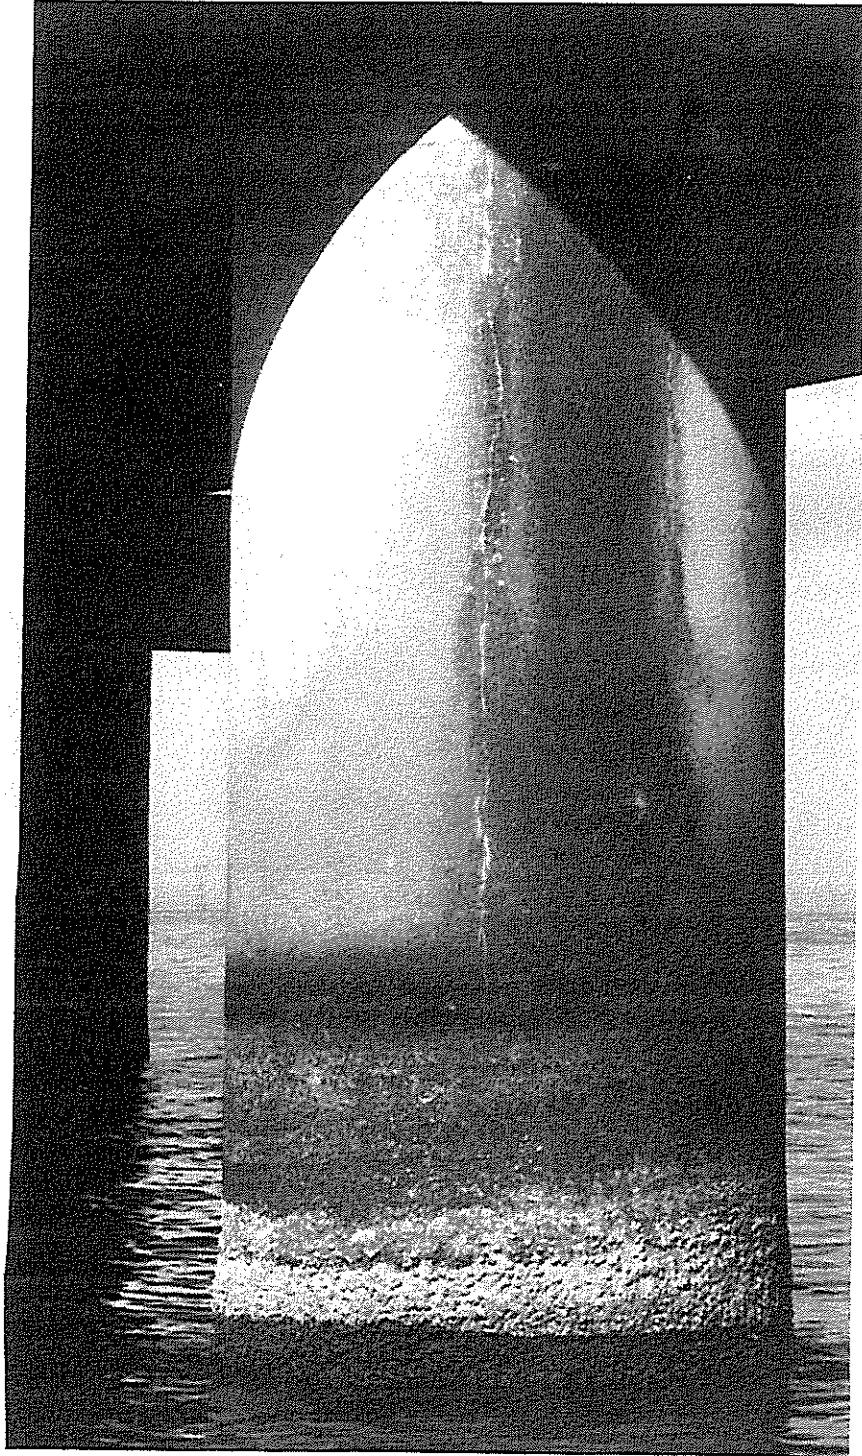
Figure 13
Typical hairline crack near pile cap

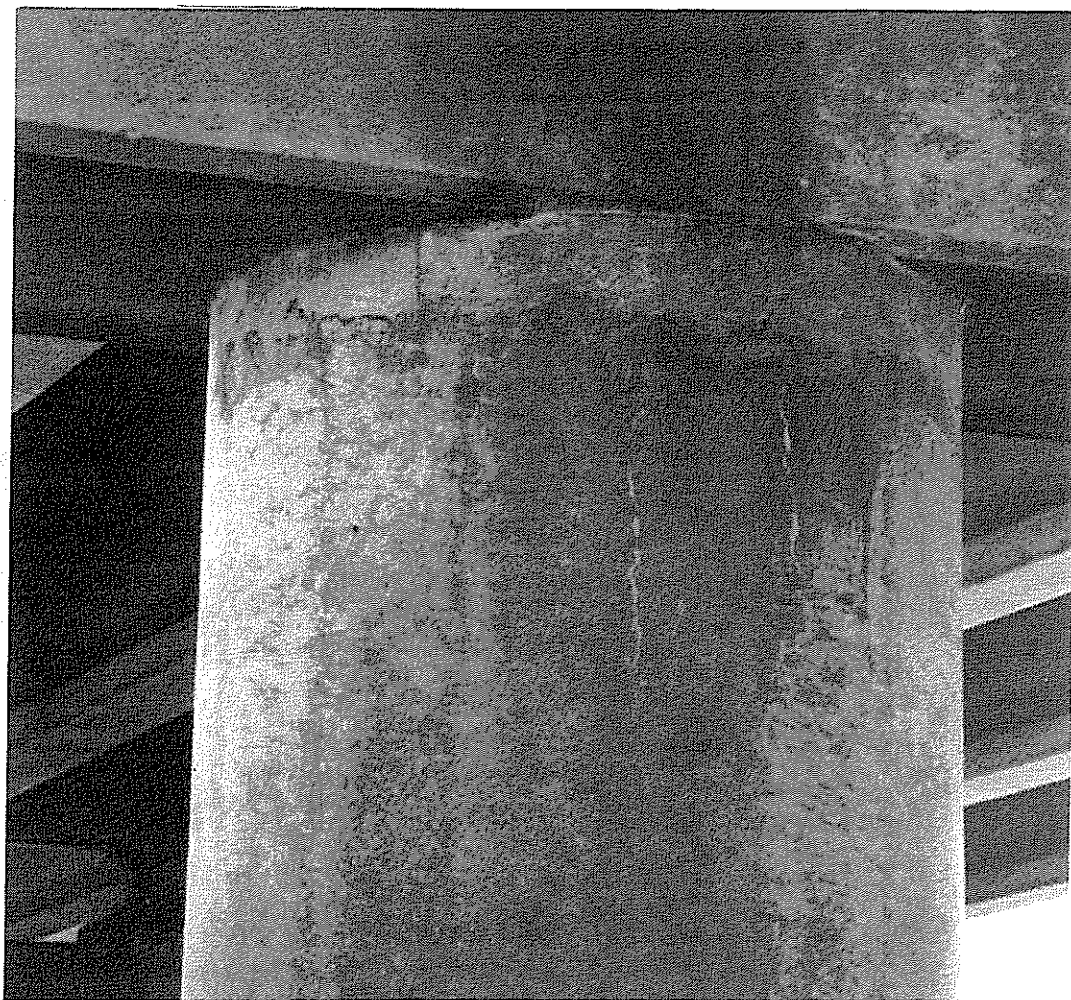
Figure 14
Typical hairline crack near pile cap

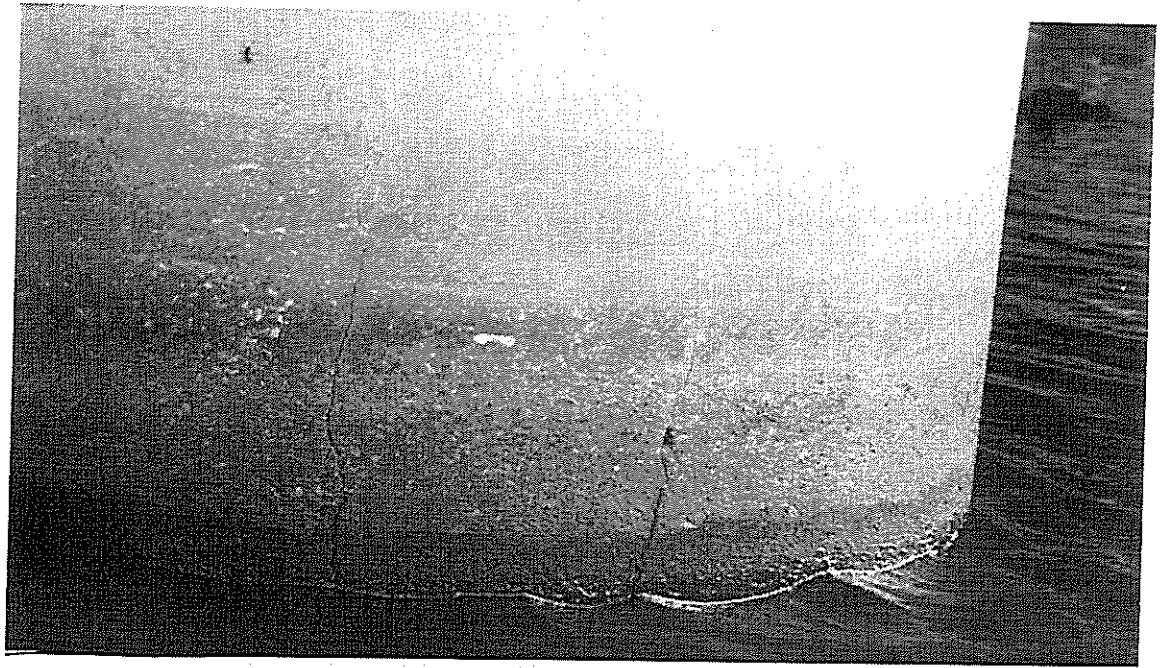
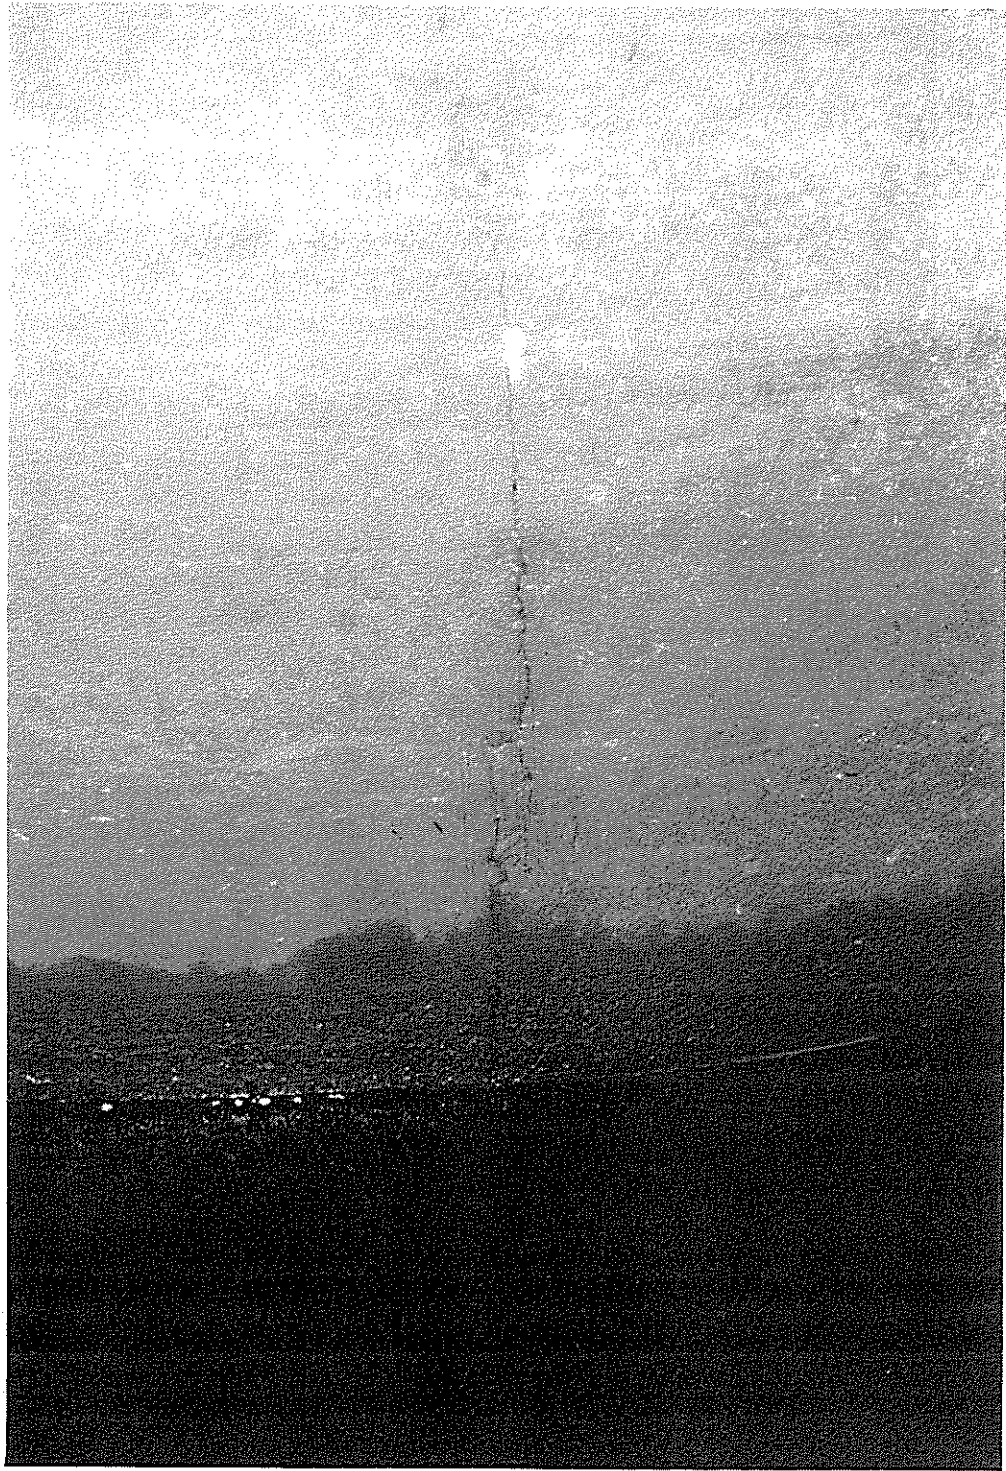
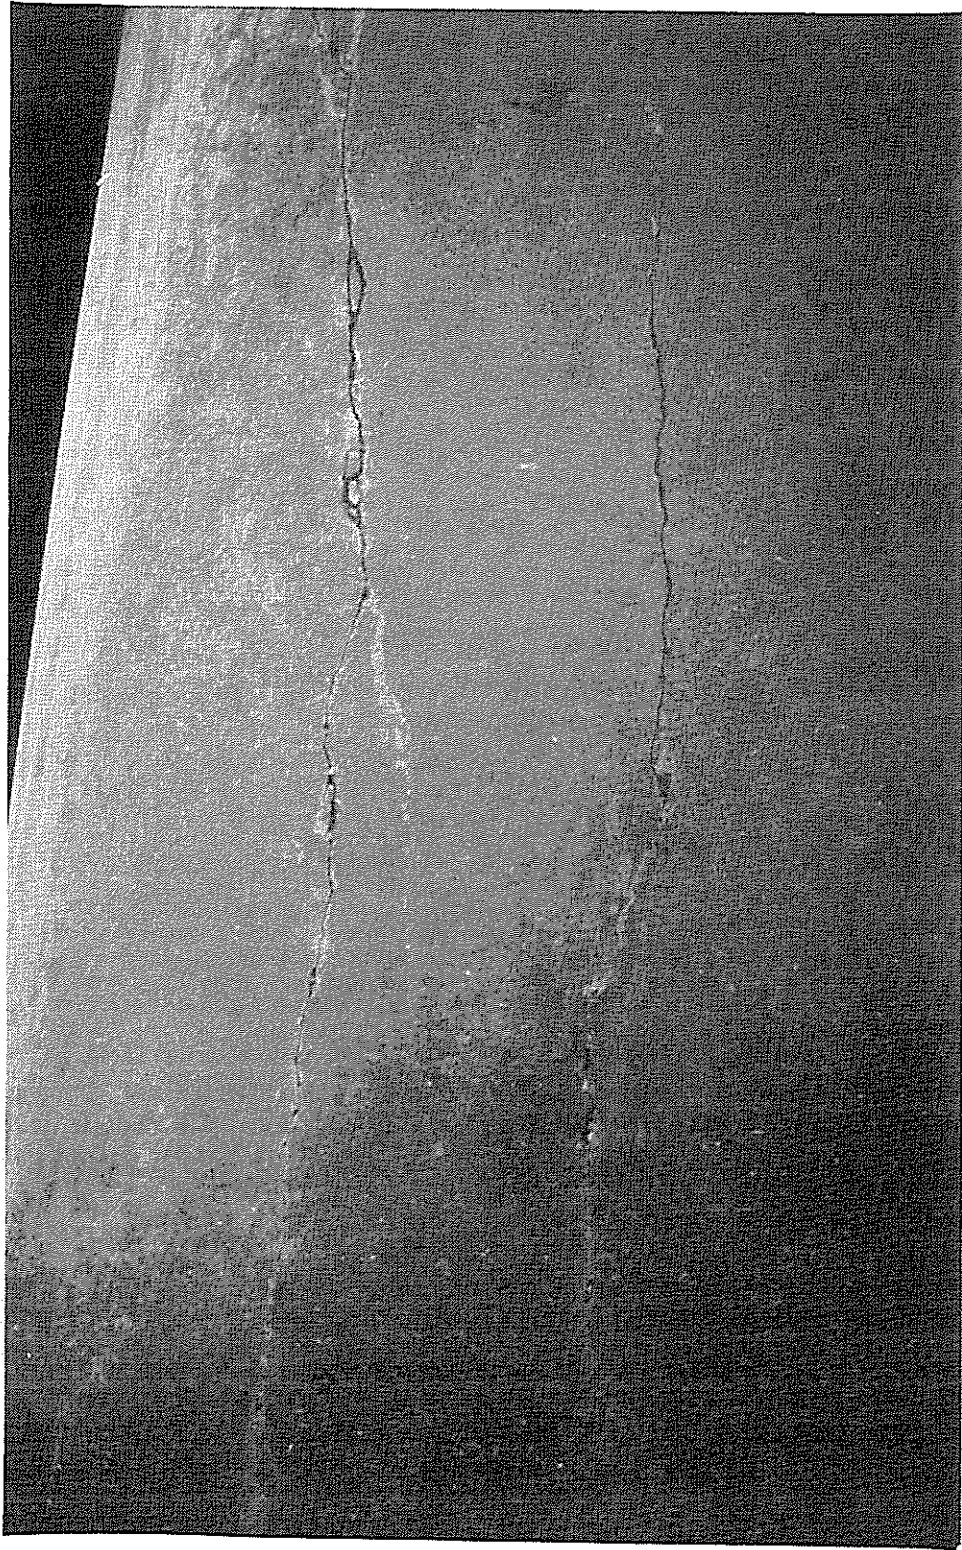
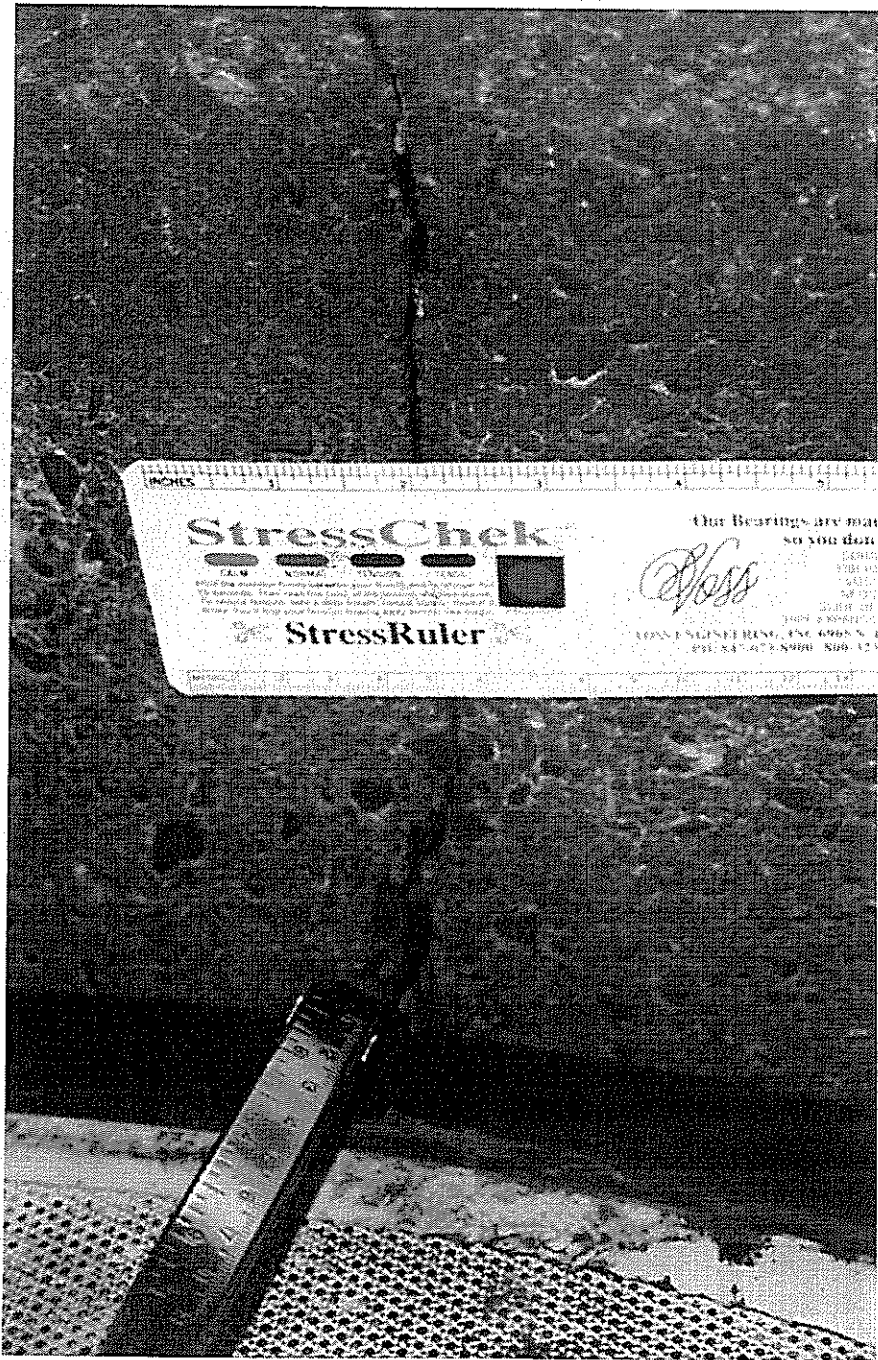
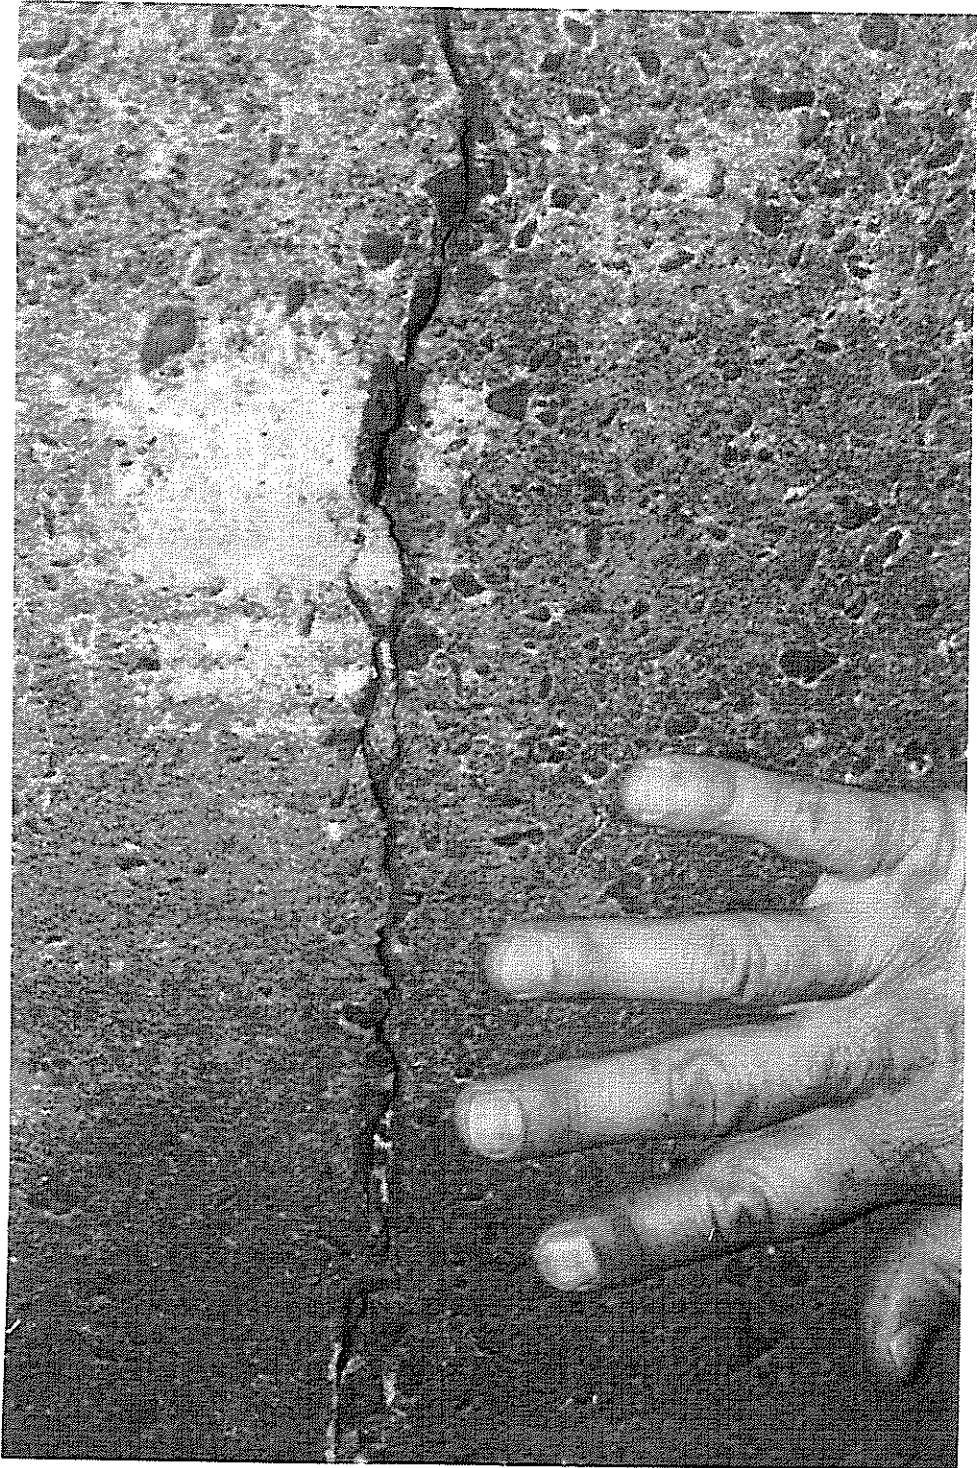
Reserve Relief Canal
I-10 Copser
62484501305151
Bent 101

Pictures of the most severe cracks are shown in figures 15 to 19. These cracks were found on piles supporting I-10 over the Reserve Relief Canal near the waterline. These cracks were concentrated over a consecutive series of bents, centered on Bent 101. The complete information on this bent is:

Figure 15
Crack near waterline on Reserve Relief Canal

Figure 16
Crack near waterline on Reserve Relief Canal

Figure 17
Crack near waterline on Reserve Relief Canal

Figure 18
Crack near waterline on Reserve Relief Canal

Figure 19
Crack near waterline on Reserve Relief Canal

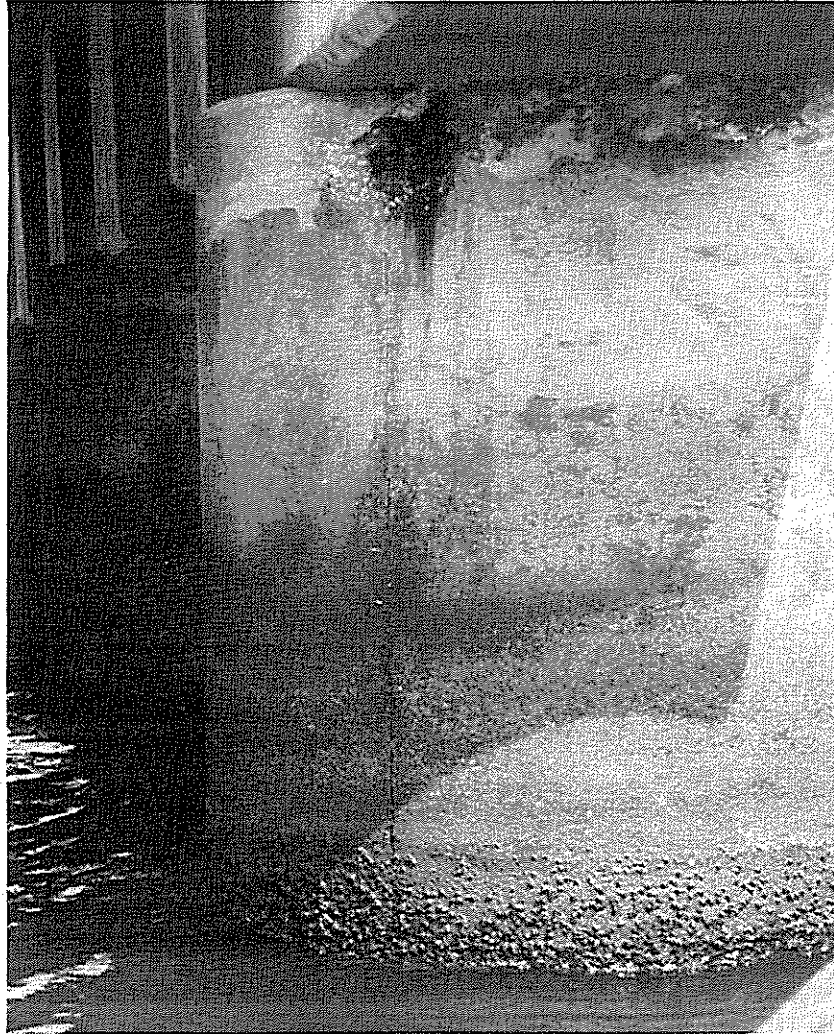
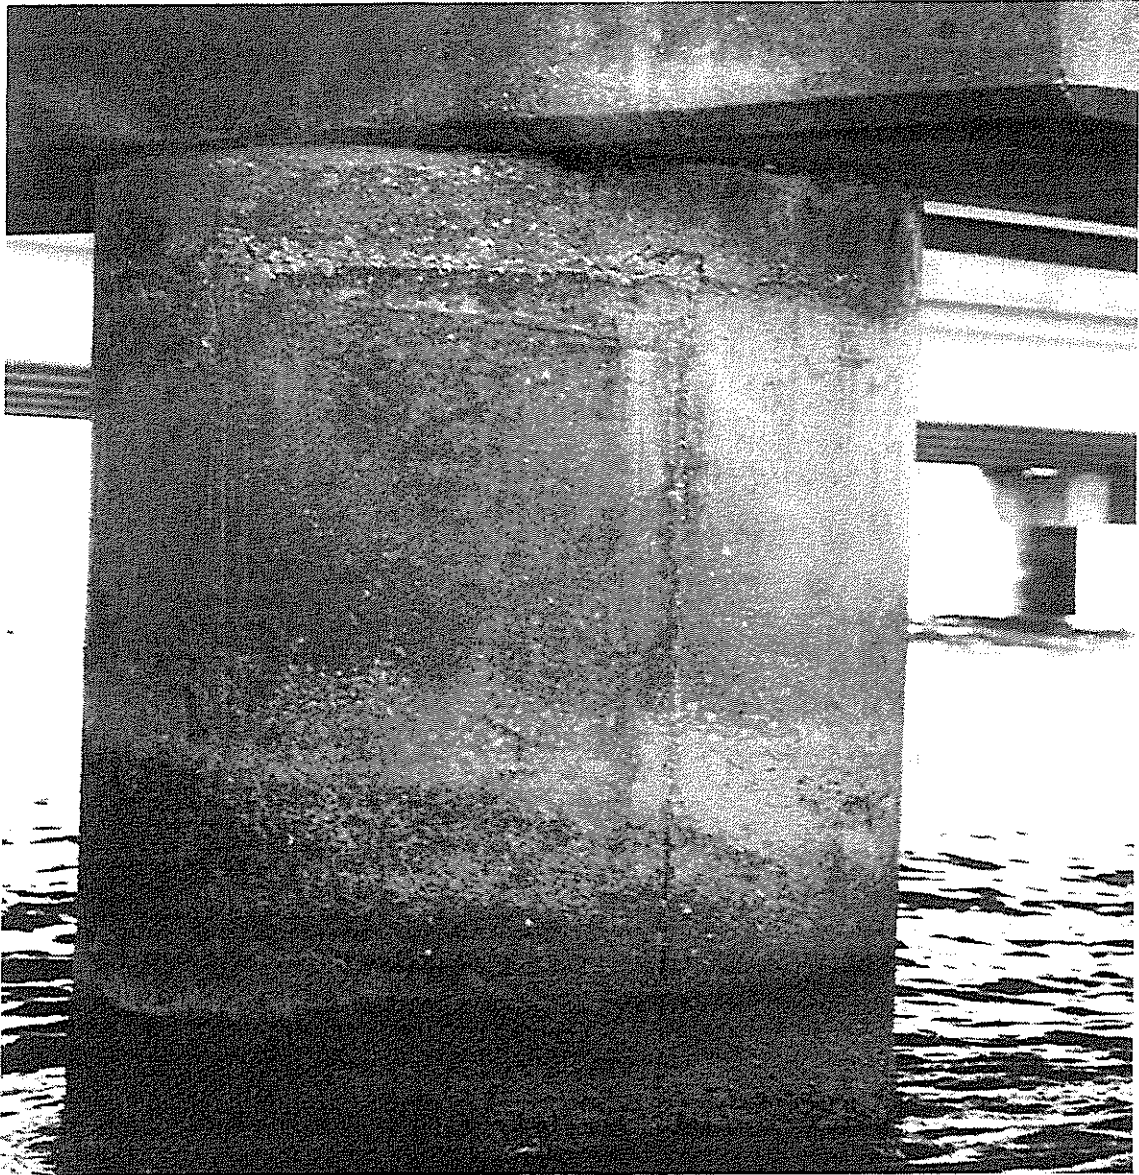
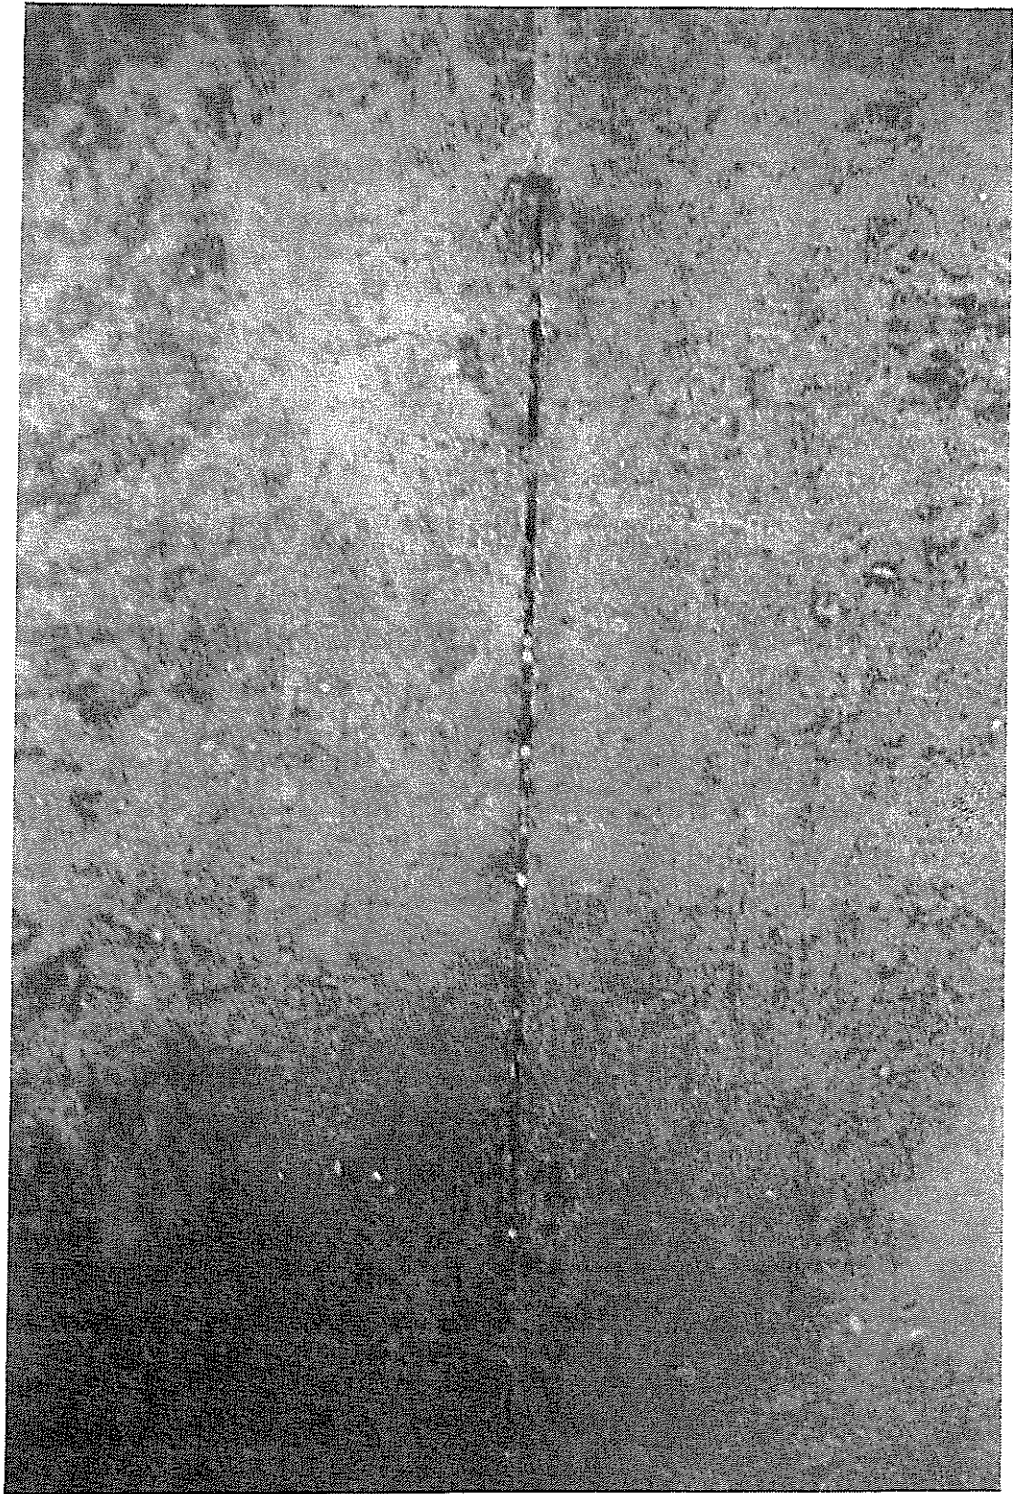
Apparent cracks on the Twin-Spans between New Orleans and Slidell turned out to be depressions made from the forms used in the rolling process. These seams, which did not penetrate into the concrete, are shown in figures 20 to 22.

Figure 20
Seam in pile that looks like a crack

Figure 21
Seam in pile that looks like a crack

Figure 22
Close-up of seam in pile that looks like a crack

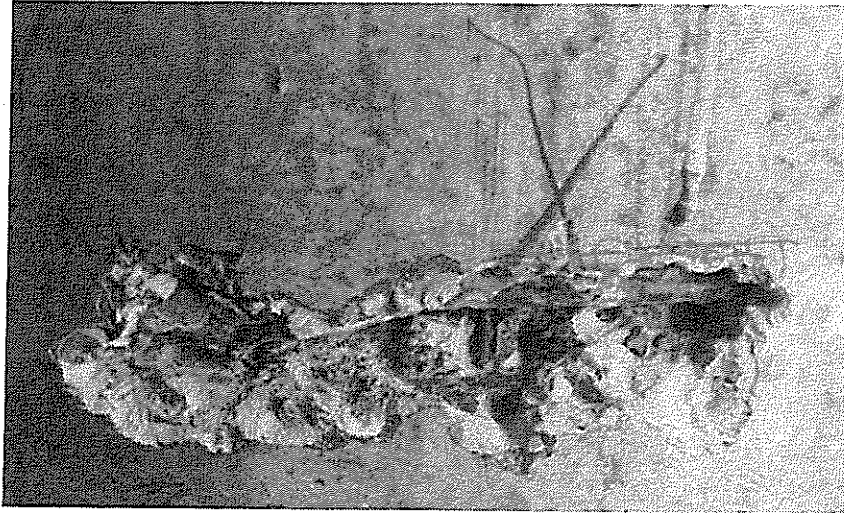
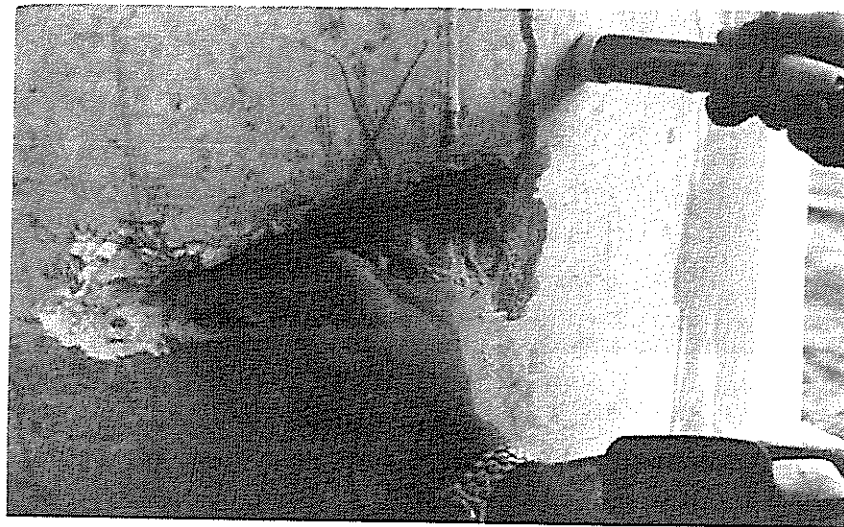
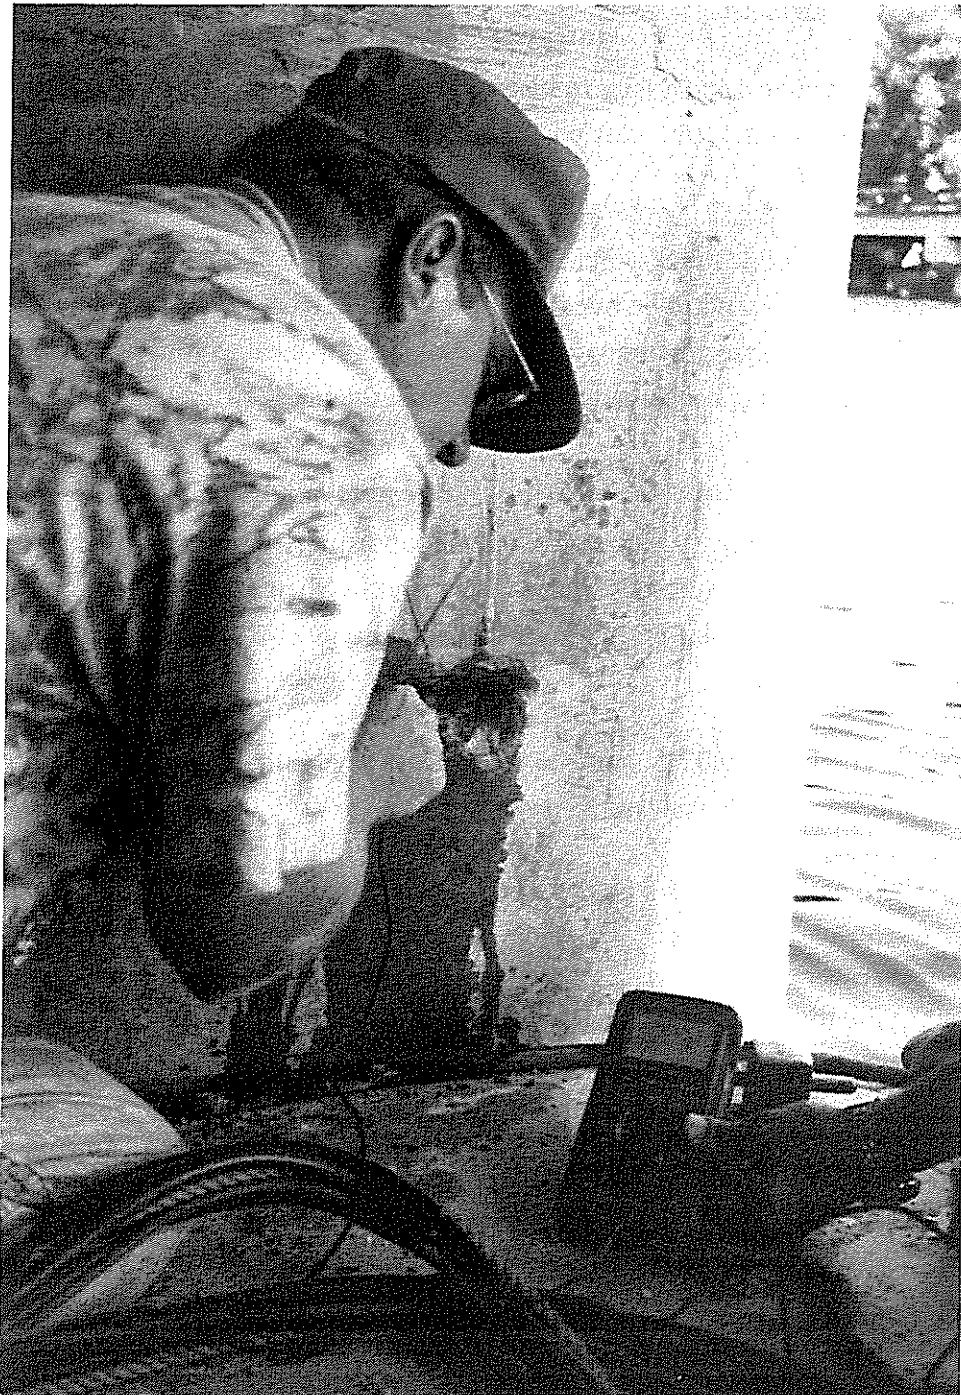
confined near the outer surface of the pile and quickly necked down with depth into the pile. In addition to conducting an underwater inspection, half-cell potential readings were taken at two locations. The process is illustrated in figures 26 to 28.

The results of the test shown in the figure were 3.2 above water and 5.5 under water. Both these results are on the borderline of corrosion beginning to occur.
