1. Report No. FHWA/LA-92/258		2. Government Accession No.	3. Recipient's Catalog No.
4. Title and Subtitle CRASH TESTING OF LOUISIANA'S MULTI-DIRECTIONAL, SINGLE STEEL POST, SMALL SIGN SUPPORT		5. Report Date JUNE 1992

CRASH TESTING OF LOUISIANA'S
MULTI-DIRECTIONAL, SINGLE STEEL POST,
SMALL SIGN SUPPORT

JULY 1992

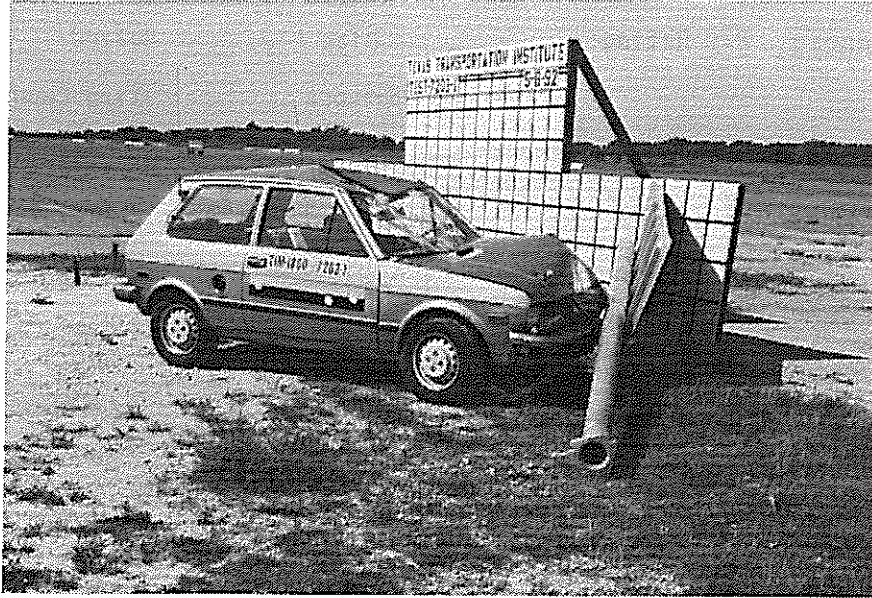
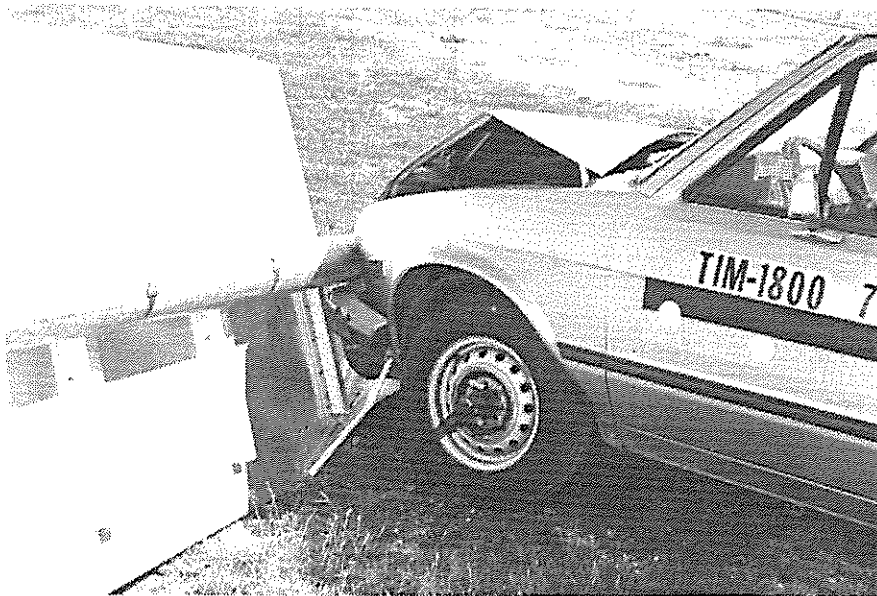
Figure 7. Final rest position of vehicle and sign installation after test 7203-1.

The vehicle was free wheeling and unrestrained just prior to impact. Shortly after impact, the sign support displaced the bolts in the slip-base and began to rise up off the base plate. By approximately 0.068 seconds, the vehicle had reached maximum engagement with the support. As the support released, the vehicle yawed counterclockwise. The vehicle lost contact with the sign support temporarily at approximately 0.147 second. As the vehicle continued to move forward, the support was displaced over the hood of the vehicle. The sign panel impacted the roof (over the occupant compartment) of the vehicle at approximately 0.929 second. The vehicle came to rest 23.0 ft (7.0 m) from the point of impact and against the displaced sign installation as shown in Figure 7. Sequential photographs of the test are shown in Figure 8.

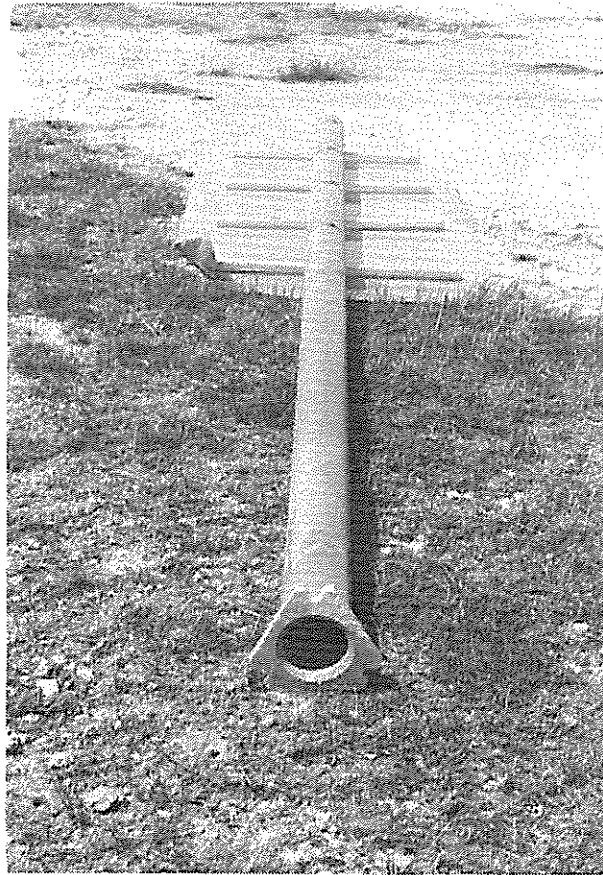
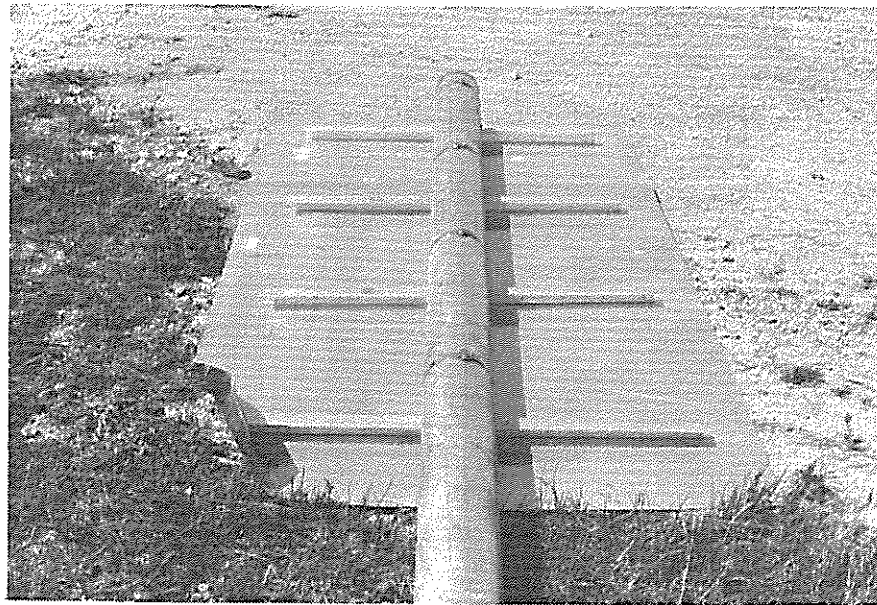
Figure 9. Multi-directional slip-base, single steel sign support installation after test 7203-1.

The installation yielded to the vehicle. Damage sustained to the sign installation is shown in Figure 9. The sign support and vehicle came to rest 23 ft (7.0 m) from the point of impact. The vehicle sustained moderate damage to the bumper, hood and roof as shown in Figure 10. In addition, the left front strut assembly and wheel were pushed rearward 3.3 in (8.3 cm). Maximum horizontal crush to the vehicle was 4.3 in (10.8 cm), located at the front left side of the hood and bumper. Maximum vertical crush was 4.8 in (12.1 cm) located over the front occupant flail space area.

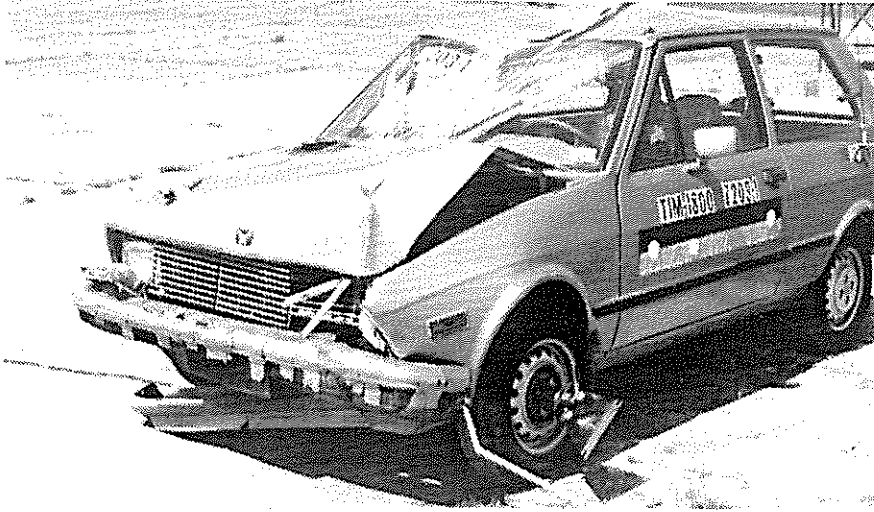
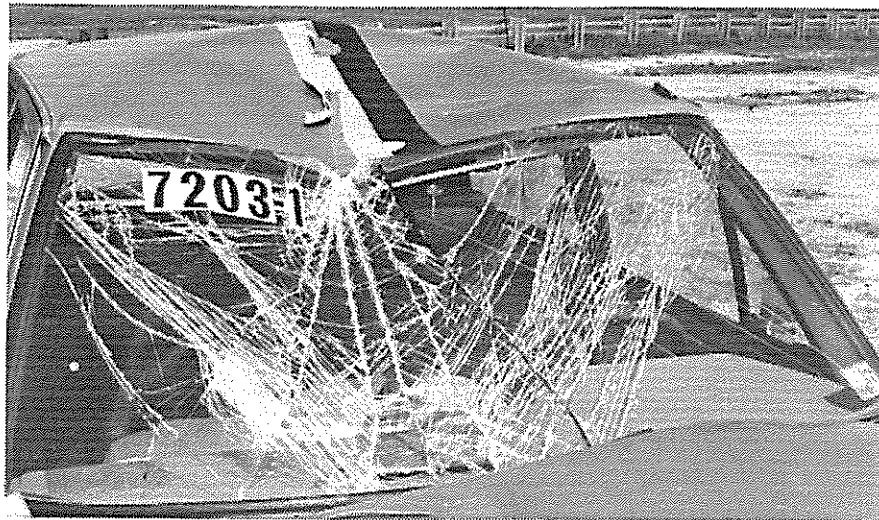
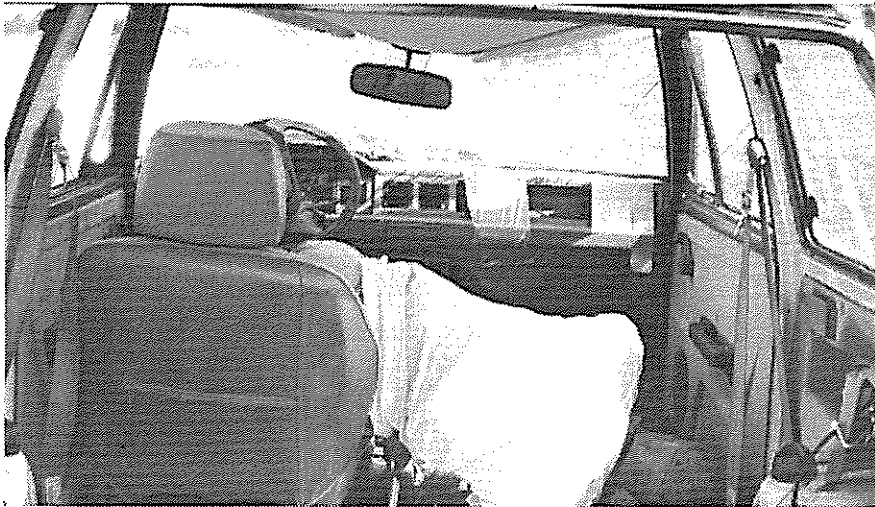
Figure 10. Vehicle after test 7203-1.

The sign installation yielded to the vehicle. The vehicle sustained moderate damage and did not present undue hazard to other traffic. Occupant ridedown accelerations were within the recommended design limit of 15 g's, as specified in NCHRP 230. However, occupant impact velocity in the longitudinal direction (16.2 ft/s) was above the recommended limit of 16 ft/s as specified in NCHRP 230. In addition, an unacceptable amount of deformation was sustained to the roof over the occupant compartment. The integrity of the occupant compartment was violated due to the sign panel impacting the roof. It should be noted, it is permissible for any part of the sign installation to strike the roof as the vehicle passes. However, excessive deformation or intrusion that may present risk to the occupants is unacceptable. The damage sustained to the roof of the vehicle was located over the front occupant flail space area, thereby presenting a potentially severe hazard to the driver and potential occupant (See Figure 10).
