# **FACTORS FOR IMPROVED FISH PASSAGE WATERWAY CONSTRUCTION**

**Final Report**

**SPR 654  
OTREC-RR-11-19**

**ODOT/OTREC**

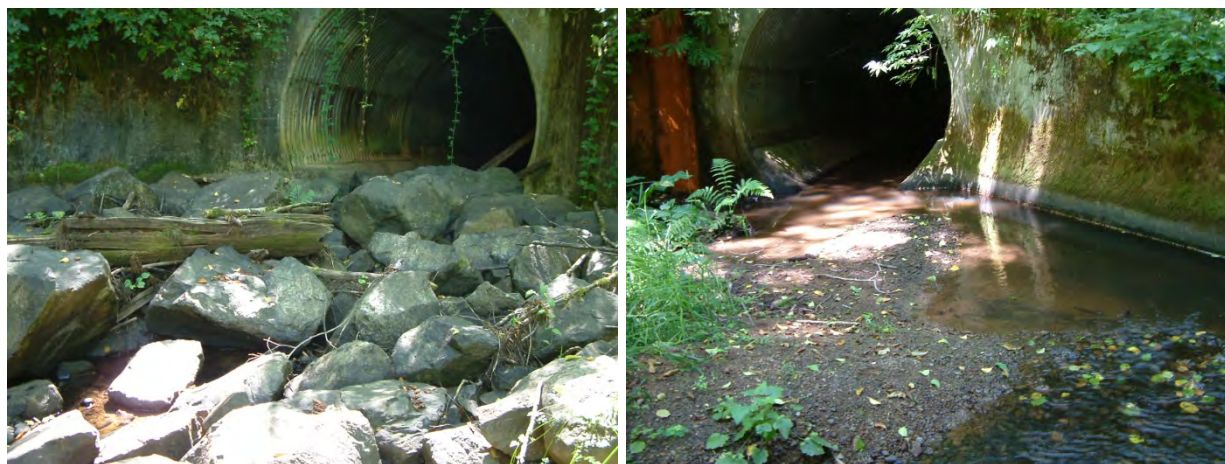
Figure 4.5: Site 02 – Mill Creek downstream and upstream

The upstream side was only accessible after walking through the culvert. There was an accumulation of sand and gravel at the upstream channel.

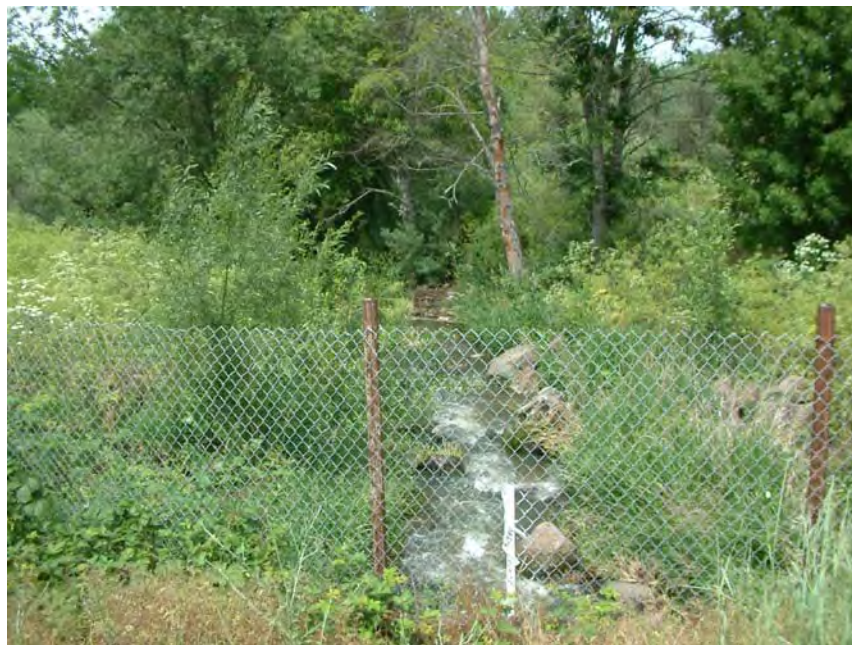
Figure 4.8: Site 06 – Roughened channel at Griffin Creek

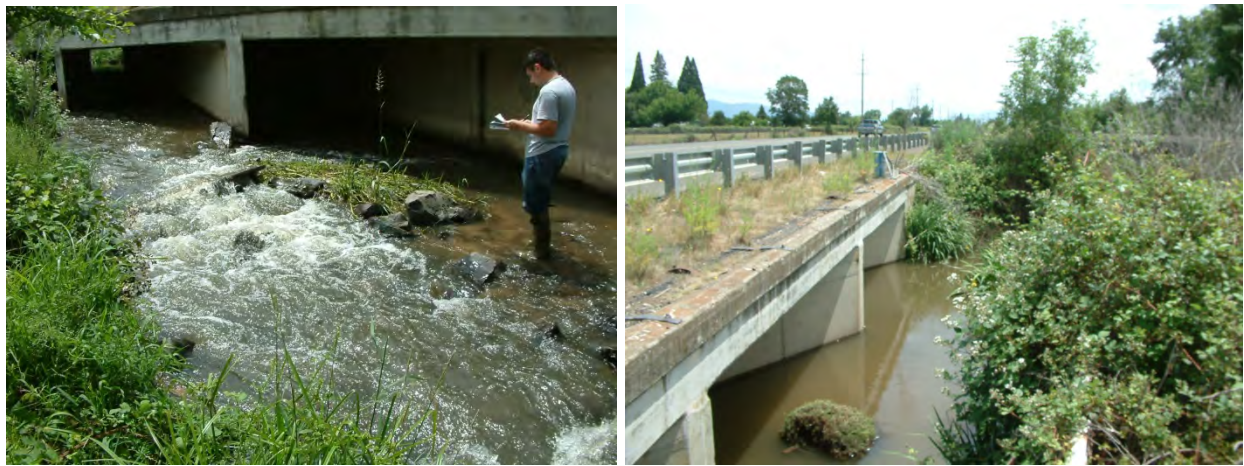
Figure 4.9: Site 07 - Jackson Creek (1) downstream and upstream

There are three culverts in parallel at the site. There was a lot of gravel accumulation and in all three culverts. All the weirs in the middle culvert were covered by this accumulation.

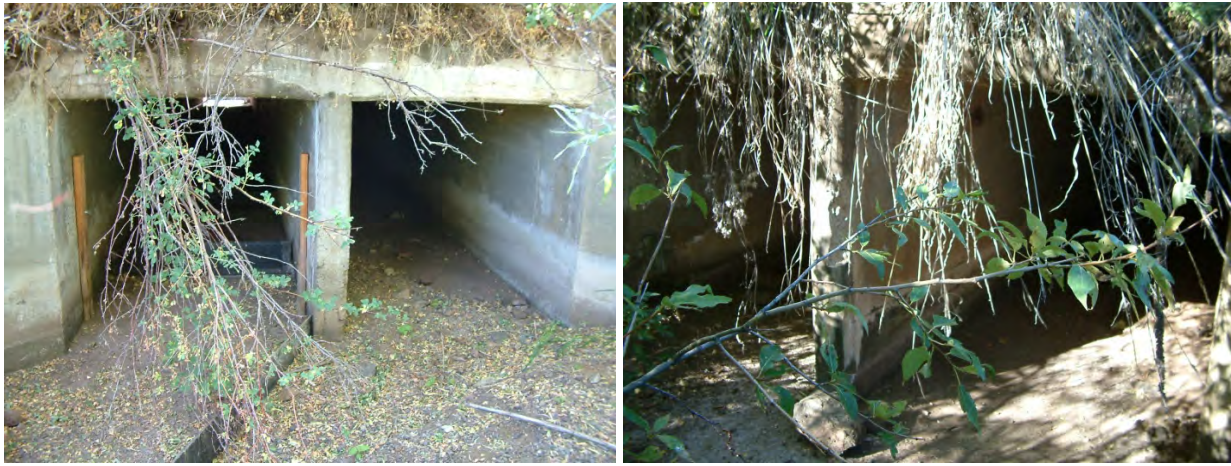
Figure 4.11: Site 09 - Wiley Creek downstream and upstream

Wiley Creek is located in Grant County and crosses Highway 395 at MP 101.8. The culvert is easily accessible from both sides of the road and the investigators had no problem performing measurements, except for cross-sections of the river could not be performed due to heavy bank vegetation. As can be seen in Figure 4.11, the river was dry.

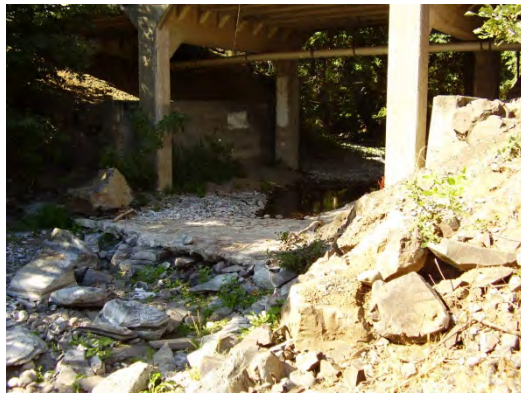
Figure 4.13: Site 10 – Chenoweth Creek failed under-structure concrete lining

Some history was available for this structure: Repairs to the channel located under the remnant bridge were performed in September of 2006 by applying concrete to the eroded streambed and placement of compacted streambed materials over the concrete base to provide fish passage to steelhead and salmon. Chenoweth Creek had exceptional winter flows in 2006 just after the concrete bed was installed. This resulted in structural failure of the concrete, extensive streambed material movement and loss of fines. In August 2007, subsurface flow was observed under the concrete channel liner and remaining streambed material immediately downstream of the structure as shown in Figure 4.13. Large boulders served to concentrate stream flow, created backwater and flow vortexes in the channel. In September 2007, ODOT made further repairs to this passage by removing the mid portion of the concrete bed and replacing streambed materials (NMFS Washington 2008).

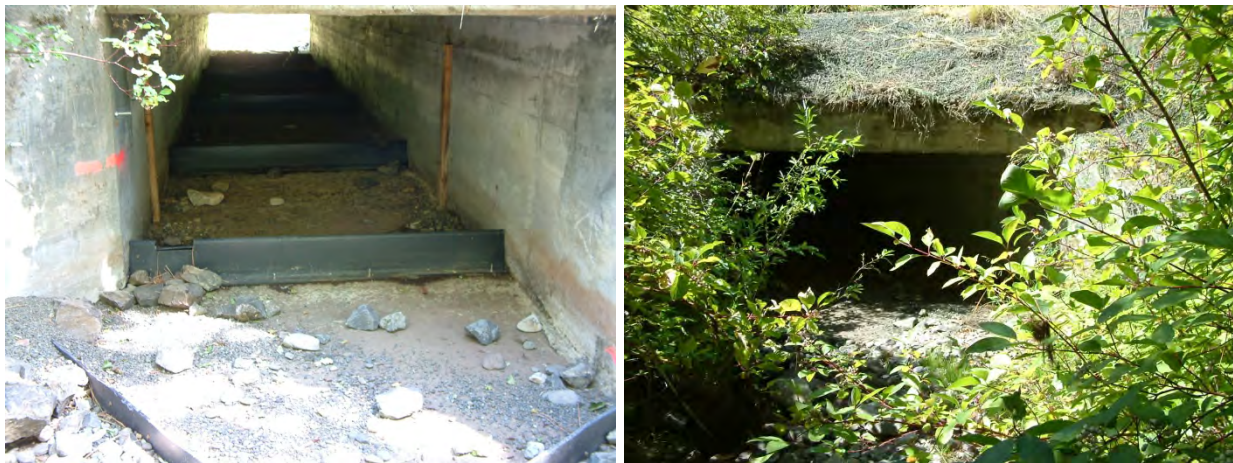
Figure 4.14: Site 11 - Cottonwood Creek upstream and downstream

The structure consisted of one culvert, which had baffles and weirs. There was no water flowing in the creek. Photos of Cottonwood Creek are shown in Figure 4.14 below.

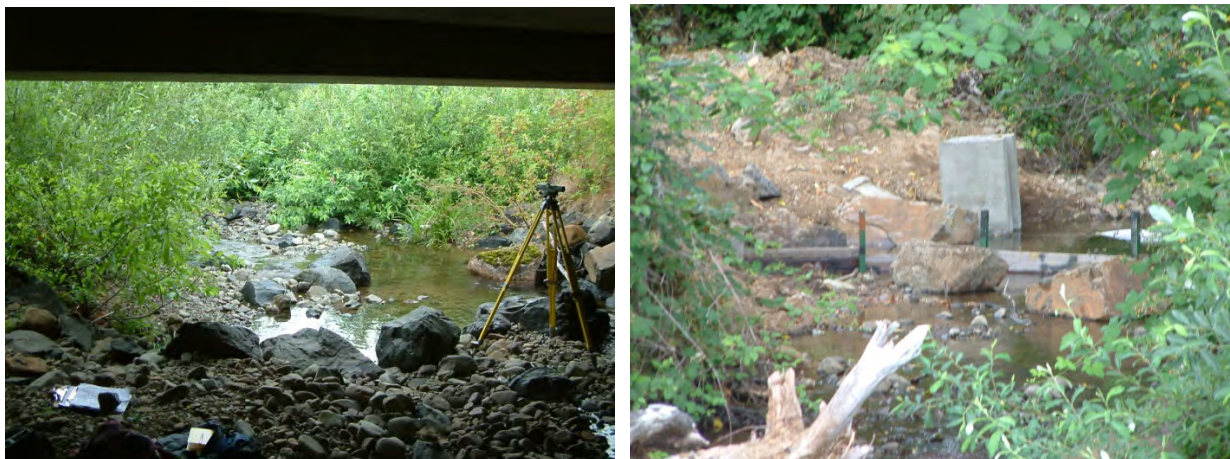
Figure 4.18: Site 16 - Jackass Creek downstream and upstream

Jackass Creek is located in Polk County and crosses highway 18 at MP 19.16. Access to the creek was from the downstream side (Figure 4.18 left) and was not particularly difficult. There were no problems in gathering any of the information and slopes and cross-sections were obtained easily. The upstream side of the creek (Figure 4.18 right) had an artificial block that created a small pool. In addition, the upstream channel had several high jumps (greater than 12 inches (30 cm)).

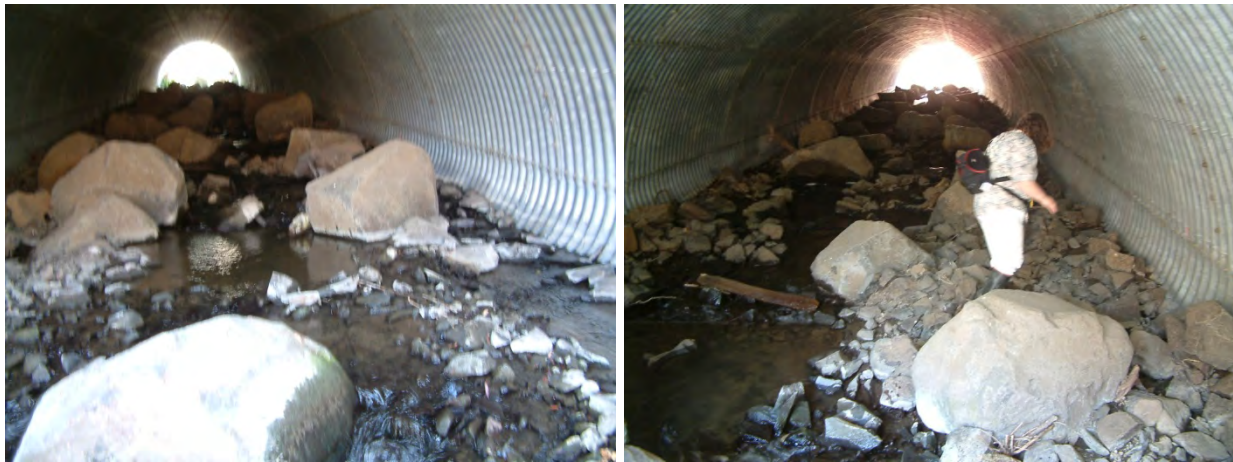
Figure 4.21: Site 19 - Three Mile Creek structure looking downstream and upstream

The upstream side was not accessible from the road, since the approach was very steep. There were no measurements taken for the upstream side of the culvert due to the large amount of vegetation that was present. Photos of the inside of the culvert are shown below in Figure 4.21.

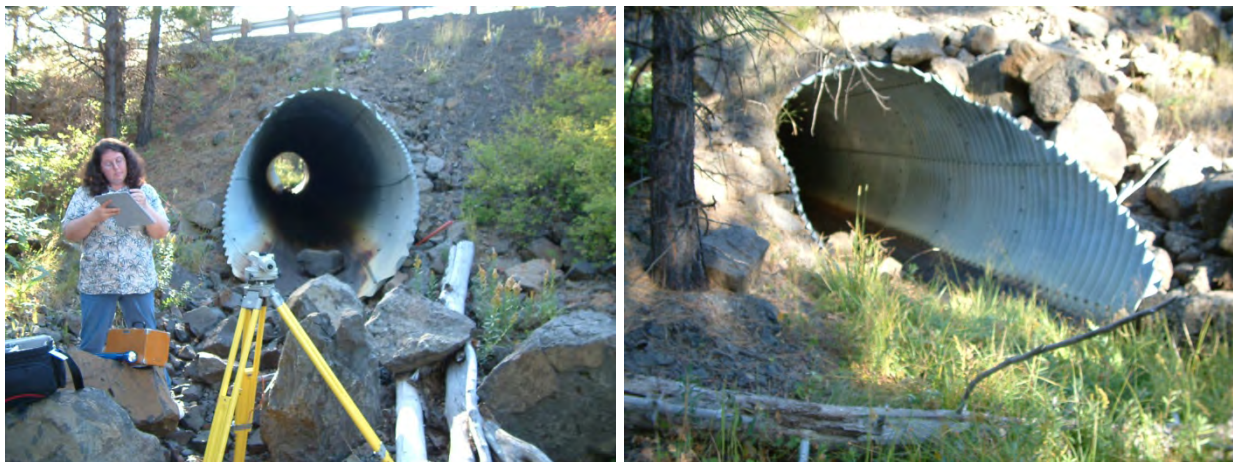
Figure 4.23: Site 21 - Porter Creek downstream and upstream

Porter Creek is located in Wheeler County and intersects Highway 207 at the county border line. Access to the creek was easier from the downstream side and it was a little steep. There was no water flowing and the slopes could be measured easily. The culvert, which was made of corrugated metal, had no baffles or weirs inside. The downstream side (Figure 4.23 right) had a large accumulation of boulders, which seems to have been placed intentionally. There were no obvious water marks for estimating the high flow elevations of the water in the downstream side of the culvert, while the upstream side (Figure 4.23 left) had a lot of vegetation.

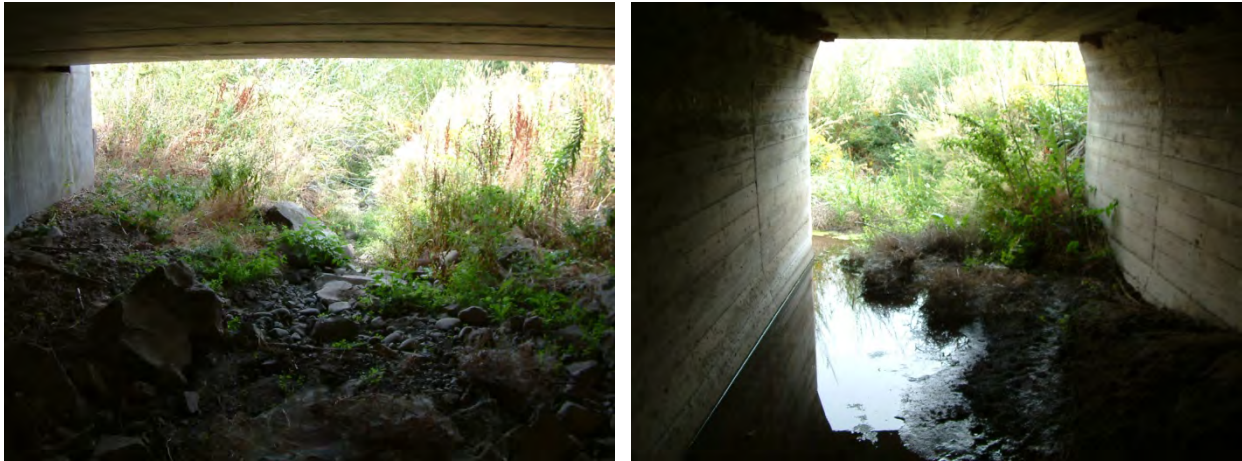
Figure 4.24: Site 22 - Stewart Creek – Culverts under new and old highways

evidence of baffles and weirs in the culvert but a large portion of these was covered by the accumulation of fines. Inside the larger culvert, there was no accumulation of fines and water was flowing normally.
