**ADIEM II END TERMINAL FOR
CONCRETE BARRIER**

Final Report

**Experimental Features
Project #96-01**

Oregon Department of Transportation

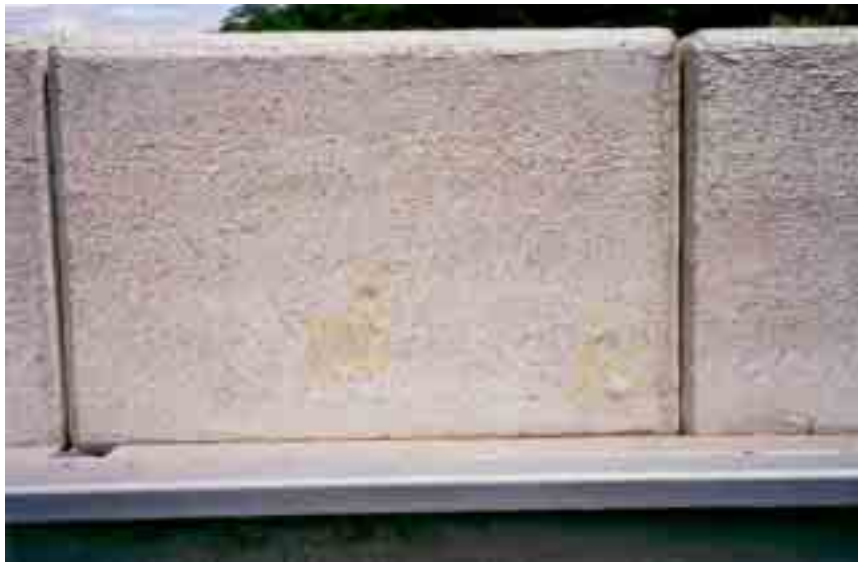
Figure 3.1: Soft Spots on Crushable Block

A second inspection was made of the ADIEM II on May 28, 1998. This inspection consisted of visual observations, photographs and a "touch test" for soft spots. Only one soft spot was visible. This spot, which was reported on the first inspection, had increased in size. Other spots were found by touch. When a moist or soft spot was found, the area was defined by pressing hard with the thumb until the soft area was outlined. All but two of the blocks had at least one soft spot. Block 10, the block closest to the barrier, had the most soft spots with 5.

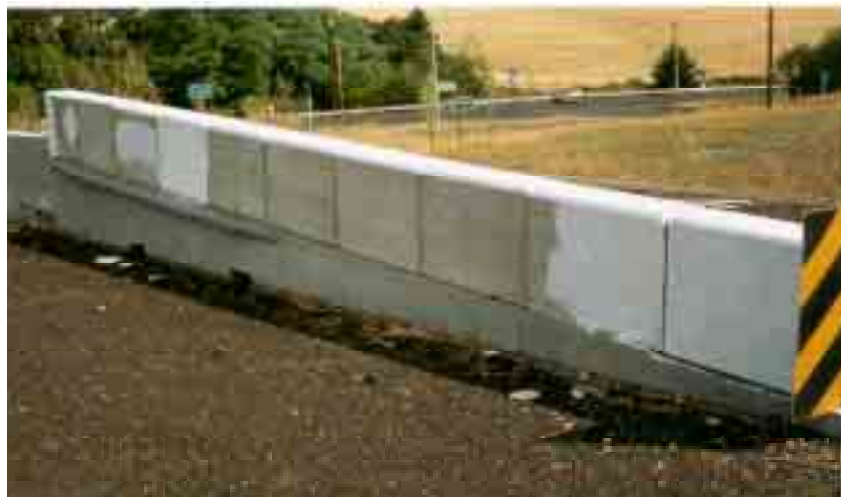
Figure 3.2: The Repair

On September 9, 1998, a SYRO, Inc. representative made repairs on the crushable blocks on both north and southbound lanes. Most of the soft spots were dug out and refilled with a grout made for the ADIEM II system. After a half-hour cure time, the grouted areas were coated with Acrylink, a product from Isothermal Protective Coatings, Inc. used for coating roofs. Other soft areas were not grouted, but covered only with Acrylink. The repairs are described in a field report (see Appendix B). New coating was only applied to the repaired areas because, according to the SYRO, Inc. representative, the remaining coating was considered adequate to protect the module. The resulting appearance (see Figure 3.2) was not acceptable to ODOT, so further repairs were made, as described in the Section 3.4.

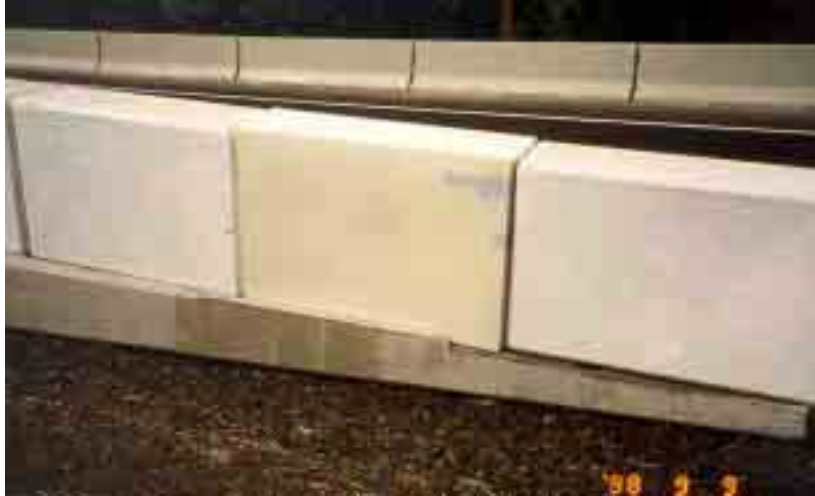
Figure 3.3: Waterproof Cover on Block

A polypropylene plastic corrugated cover, developed by SYRO, Inc. to prevent water intrusion, was installed on one block of the southbound ADIEM. The installation was difficult because there was no clearance between the blocks. A better installation method would require removal of the blocks from the base, attaching the cover, and then re-installing the blocks onto the base. The color of the cover was yellow, which contrasted with the white coating of the other blocks, as seen in Figure 3.3.

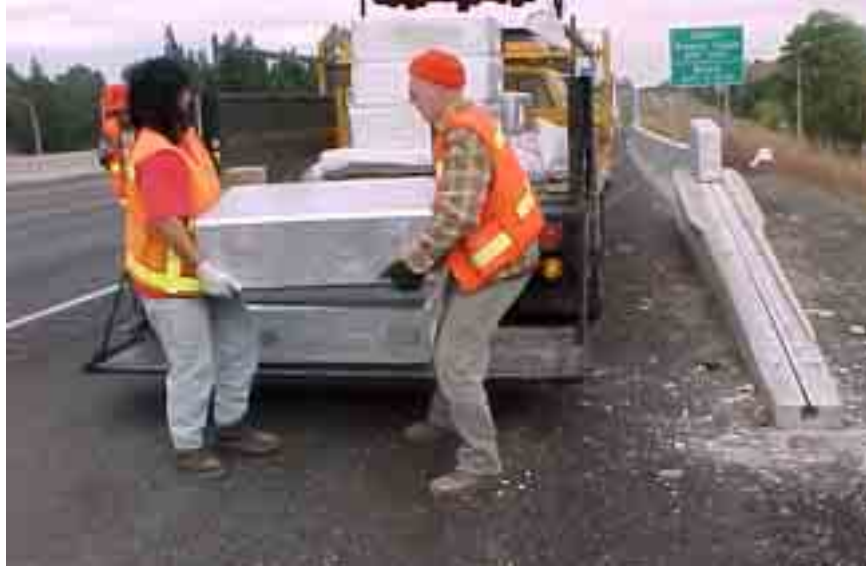
Figure 3.4: Workers Install New Blocks

On October 5, 1999, new crushable concrete modules were installed at the northbound ADIEM II system. A Trinity, Inc. representative was on hand to oversee the removal of the old blocks and replacement with new. Two ODOT maintenance workers completed the task in two hours (see Figure 3.4). As with the initial installation, the blocks had to be loaded, unloaded and installed by hand, without equipment which could damage the blocks or coating. To transport and replace 10 blocks, workers had to lift or move an 81.5 kg weight approximately 60 times, raising concern about the stresses to workers backs. Appendix C contains the detailed report.

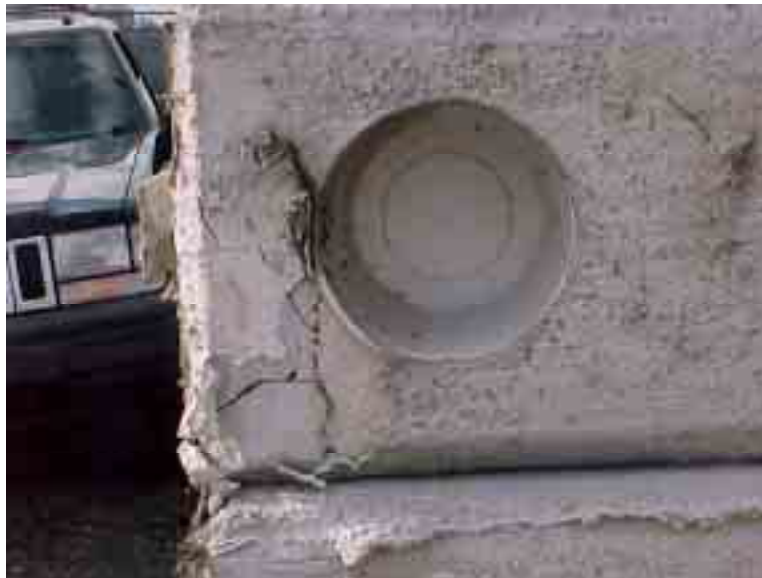
Figure 3.5: Cracks in a Block Removed in 1999.

The concrete bases of two of the blocks were crumbled, and pieces of concrete in the tracks made removal of the blocks difficult. Deep cracks were found on one block when it was removed from the base. These cracks were near one of the plastic inserts in the block (Figure 3.5).

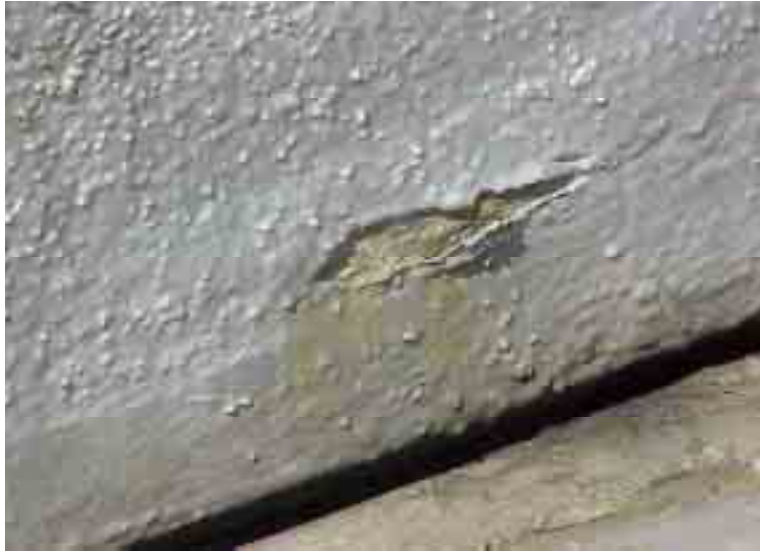
Figure 3.6: Tear in Garna-Thane Weatherproofing on Block

In April of 2000, a brief inspection was made of the ADIEM II system. The southbound modules were showing some bubbling and soft spots. There was a tear in the covering in one of the new modules in the northbound lane (Figure 3.6).

Though the new Garna-Thane covering appears to be less susceptible to weather, the concerns remained about the high level of maintenance required to protect the lightweight concrete.

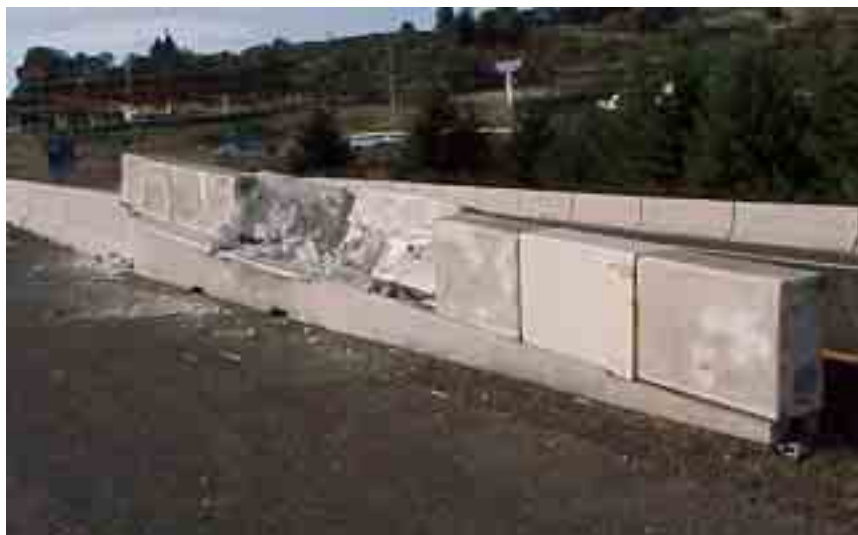
Figure 3.7: Damage from Vehicle Impact.

In October 2000, the southbound ADIEM was hit by a vehicle, with several blocks damaged. The impact, to the 4th, 5th and 6th blocks, also visibly damaged the 7th and 10th blocks (see Figures 3.7 and 3.8). The 10th block, nearest to the concrete barrier, was pushed onto the barrier approximately 0.33 m. Because no responsible party could be determined (the vehicle left the site and did not file an accident report), details about the accident are not available. The system apparently worked as designed, with the blocks absorbing the impact.

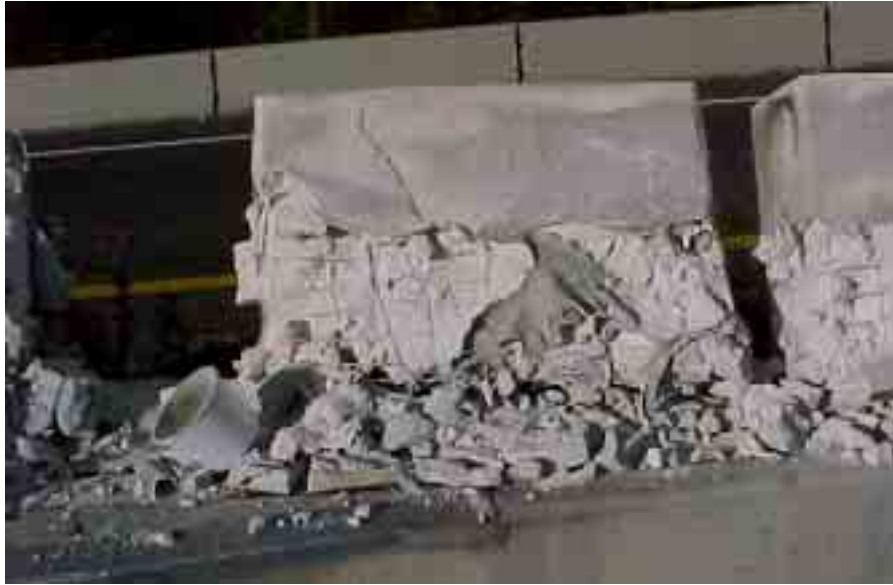
Figure 3.8: Blocks Crushed by Impact

District crews reported that the damaged blocks were difficult to remove, as the reinforcement was twisted. They also said the removal and reinstallation was slowed by debris in the track. The crew replaced the damaged blocks with blocks that had been removed from the northbound ADIEM installation the previous year. The blocks showed signs of deterioration due to moisture. Crews also noted damage to the coating on undamaged blocks that may have been caused by debris thrown by motorists or flung from vehicle tires.

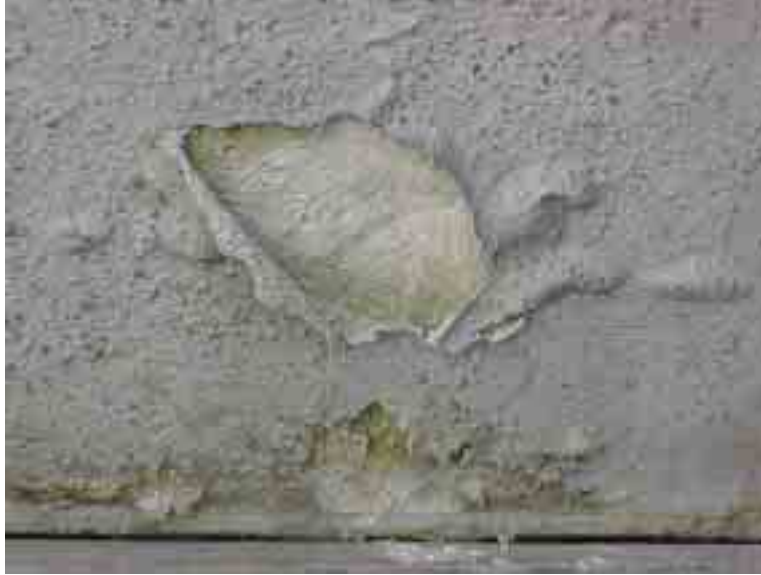
Figure 3.9: Example of Weatherproofing Condition on Southbound Blocks

A final inspection of the ADIEM system, on January 31, 2001, included both the north- and southbound installations. Figure 3.9 shows an example of the severe peeling and bubbling of the coating which was found on several blocks on the southbound system. These blocks were coated with Acrylink. Where exposed, the concrete had soft spots and crumbling areas.

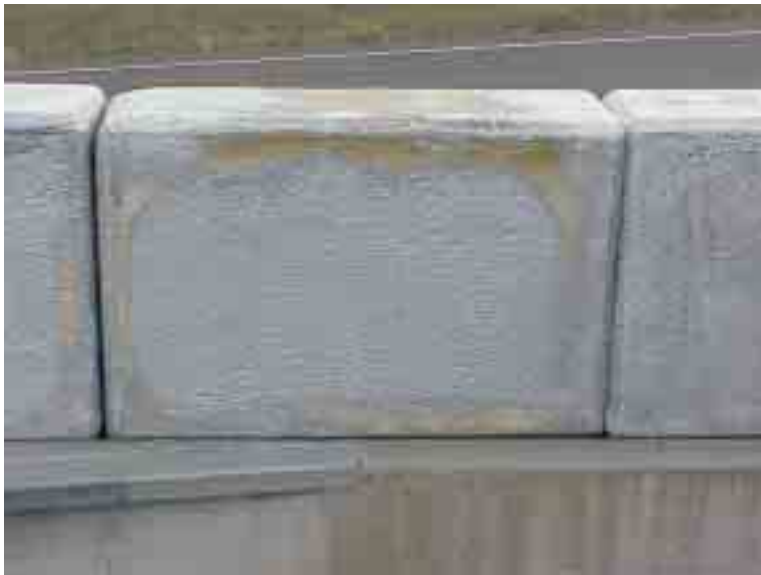
Figure 3.10: Typical Block on Northbound Installation

The blocks on the newer, northbound installation were in much better condition, but were beginning to show slight bubbling and cracking (see Figure 3.10). Because the installation was fairly new, inspectors agreed that the Garna-Thane weatherproofing also appeared inadequate for long term protection of the blocks from moisture intrusion.

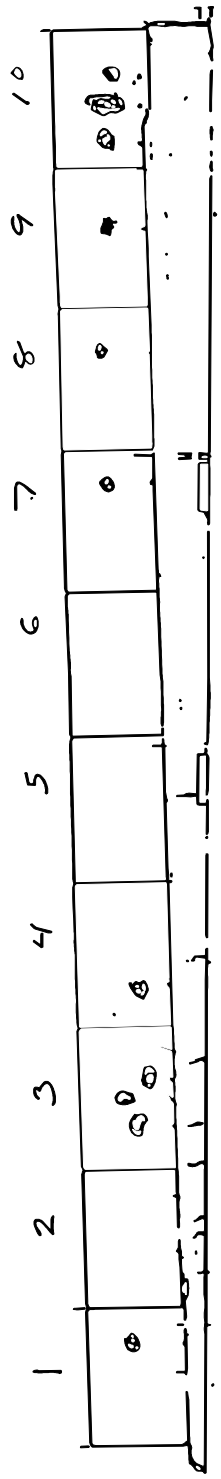
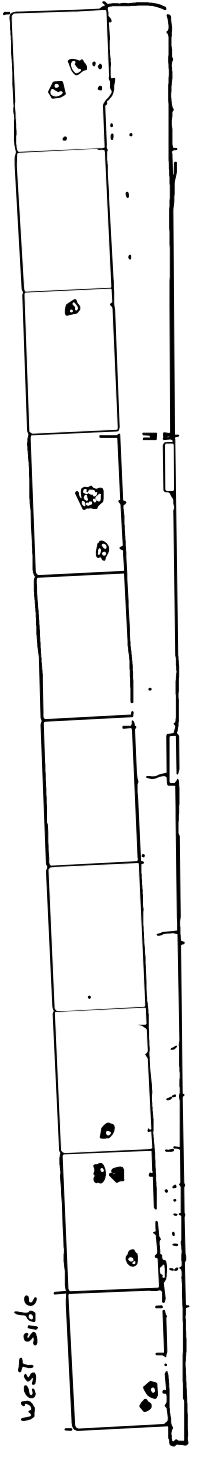
Soft spots noted May 28

Stress cracks in the base

Soft spots on the crushable blocks and stress cracks in the base plotted on the diagram of the ADIEM II

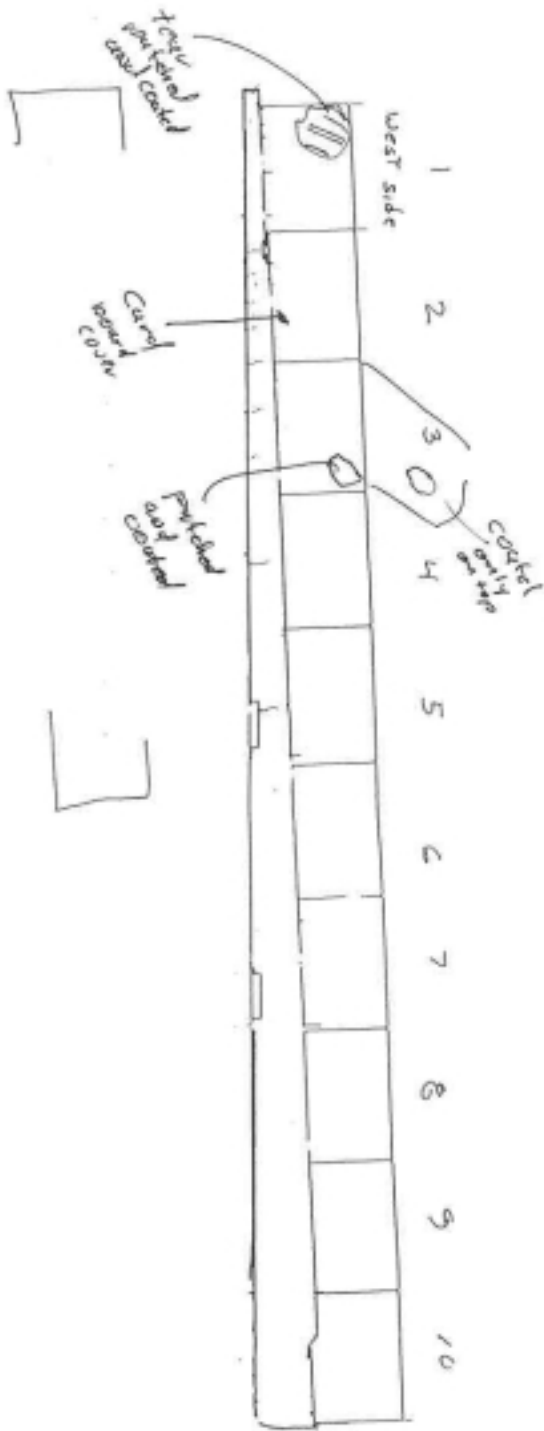
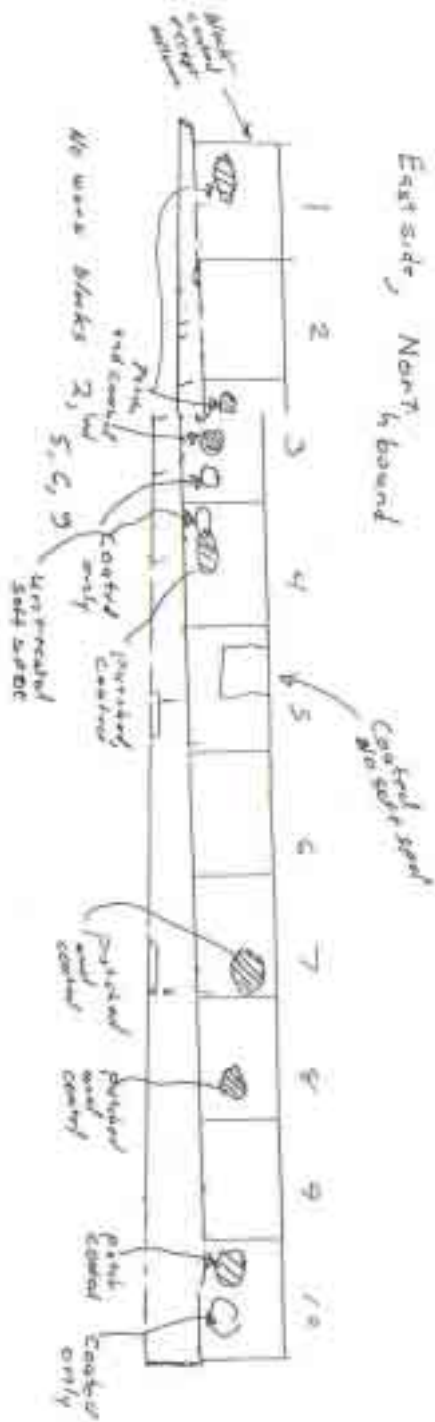
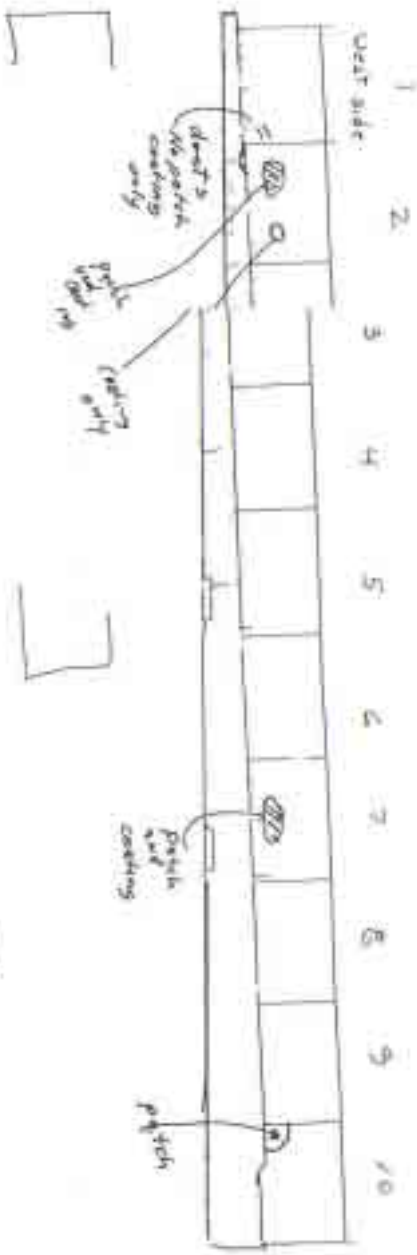
East side, North bound

NO repair blocks 3, 4, 5, 6, 8, 9

repaired areas SEPT 9, 1998

On September 9, 1998 Don Gripne, a consultant for SYRO, made repairs on the crushable blocks at both the northbound and southbound ADIEM II Units on the above mentioned project. Several soft spots were found in the northbound unit in May of 1998. The southbound unit, which was installed in August of 1998, also had a few soft spots and one tear in the coating. SYRO elected to dig out the soft spots and fill the holes with grout and re-coat the grouted surface rather than replace the blocks. (See attached drawings)
