**DURABILITY OF
TRUNCATED DOME WARNINGS
ON EXISTING CURB RAMPS**

Final Report

SPR 304-241

December 2004

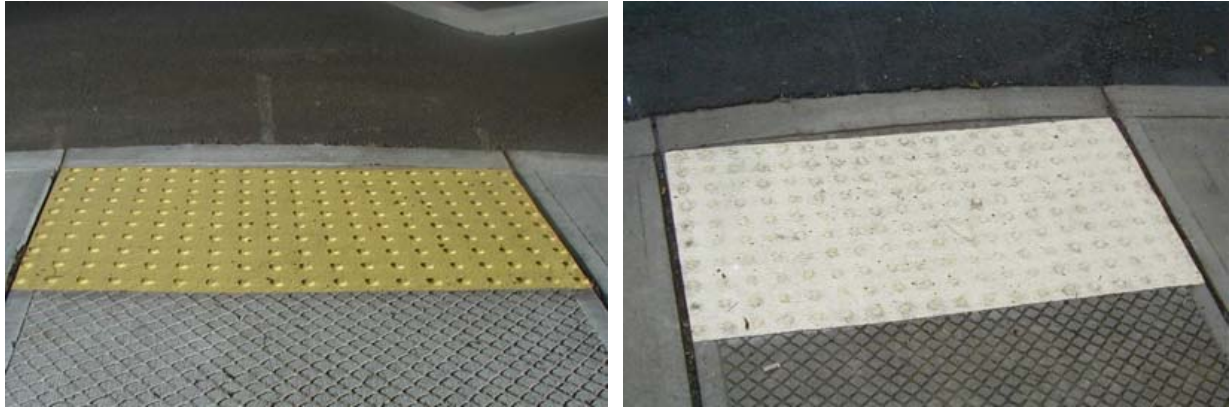
Figure 3.1: Strongwarn Tactile Warning – a) February 2003; b) October 2004

All but the Strongwarn Tactile Warning showed no damage during the two-year period, either to the domes or the surface beneath the domes. The Strongwarn product showed some damage after about 15 months, with parts of three domes broken at the left edge of the warning surface, presumably from a physical impact. (See Figure 3.1 below.)

The Strongwarn Tactile Warning exhibited considerable fading over the two-year period (Figure 3.1). Thus, while the product did not retain its original color, the contrast with adjacent surfaces was increased. This fading of the color, combined with aging of the concrete, actually produced a reversal of the contrast between the detectable warning and the surrounding concrete surface over the two years. When new, the detectable warning was a darker color surrounded by the relatively lighter new concrete; and after two years the detectable warning was a lighter color surrounded by a relatively darker concrete surface.

Product Name	Performance Criteria			Photo
	Adhesion	Damage	Color/contrast	
Strongwarn Tactile Warning	Good	Three domes damaged	Poor; extreme color fading over 2-year period; contrast increased	Figure 3.1
Detectable Warning Mat	Good	None	Good; some staining, but substantially retained original color and contrast	Figure 3.2
Safti-Trax™ Domes	Good	None	Poor; color fading; dirt adhered to much of surface, dulling the color and reducing contrast	Figure 3.3
Safti-Trax Mat™	Good	None	Fair; color fading; dirt adhered to much of surface, dulling the color and reducing contrast	Figure 3.4

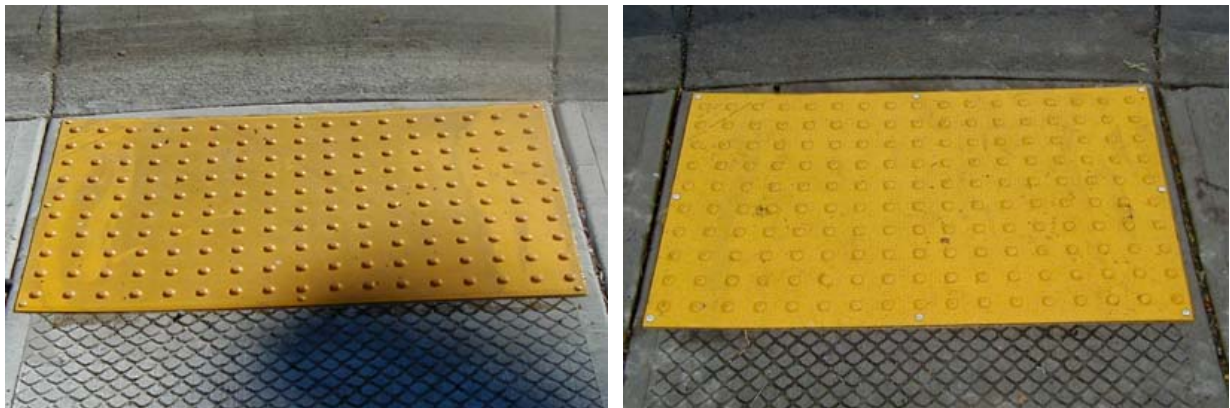
Figure 3.2: Detectable Warning Mat – a) February 2003; b) October 2004

Over the course of the test period the color of the Detectable Warning Mat changed little, although some staining of the mat occurred, and the heads of the anchor pins faded noticeably (Figure 3.2).

- Detectable Warning Mat: The Wisconsin study found that this product showed good durability. There were some problems with staining from dirt in the pores of the material (*Kemp 2003*). This finding is consistent with observations in this report, Section 3.3 (Figure 3.2).

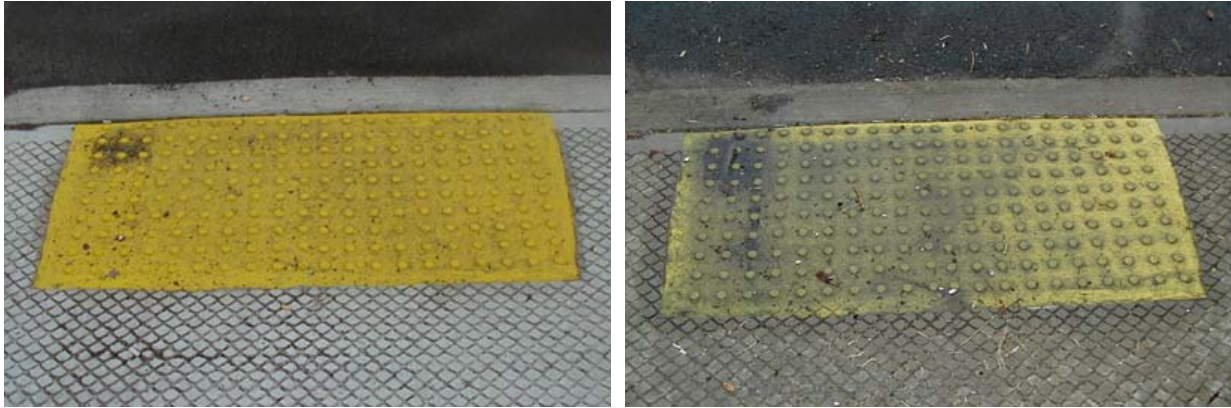
Figure 3.3: Safti-Trax™ Domes – a) February 2003; b) October 2004

Both the Safti-Trax™ Domes and the Safti-Trax Mat™ exhibited fading, and the contrast of the surfaces with the surrounding concrete was degraded over time, due to the accumulation of dirt on the detectable warnings and the darkening of the concrete surface (Figures 3.3 and 3.4). The field inspections determined that a likely reason for the accumulation of dirt was storm water collecting at the base of the ramps and poor drainage.
