**TEN YEAR PERFORMANCE OF  
ASPHALT ADDITIVE TEST  
SECTIONS  
LAVA BUTTE – FREMONT  
HIGHWAY JUNCTION SECTION  
THE DALLES - CALIFORNIA HIGHWAY  
(US#97)  
DESCHUTES COUNTY, OREGON  
FHWA Test and Evaluation Project #3**

September 1998

# TEN YEAR PERFORMANCE OF ASPHALT ADDITIVE TEST SECTIONS

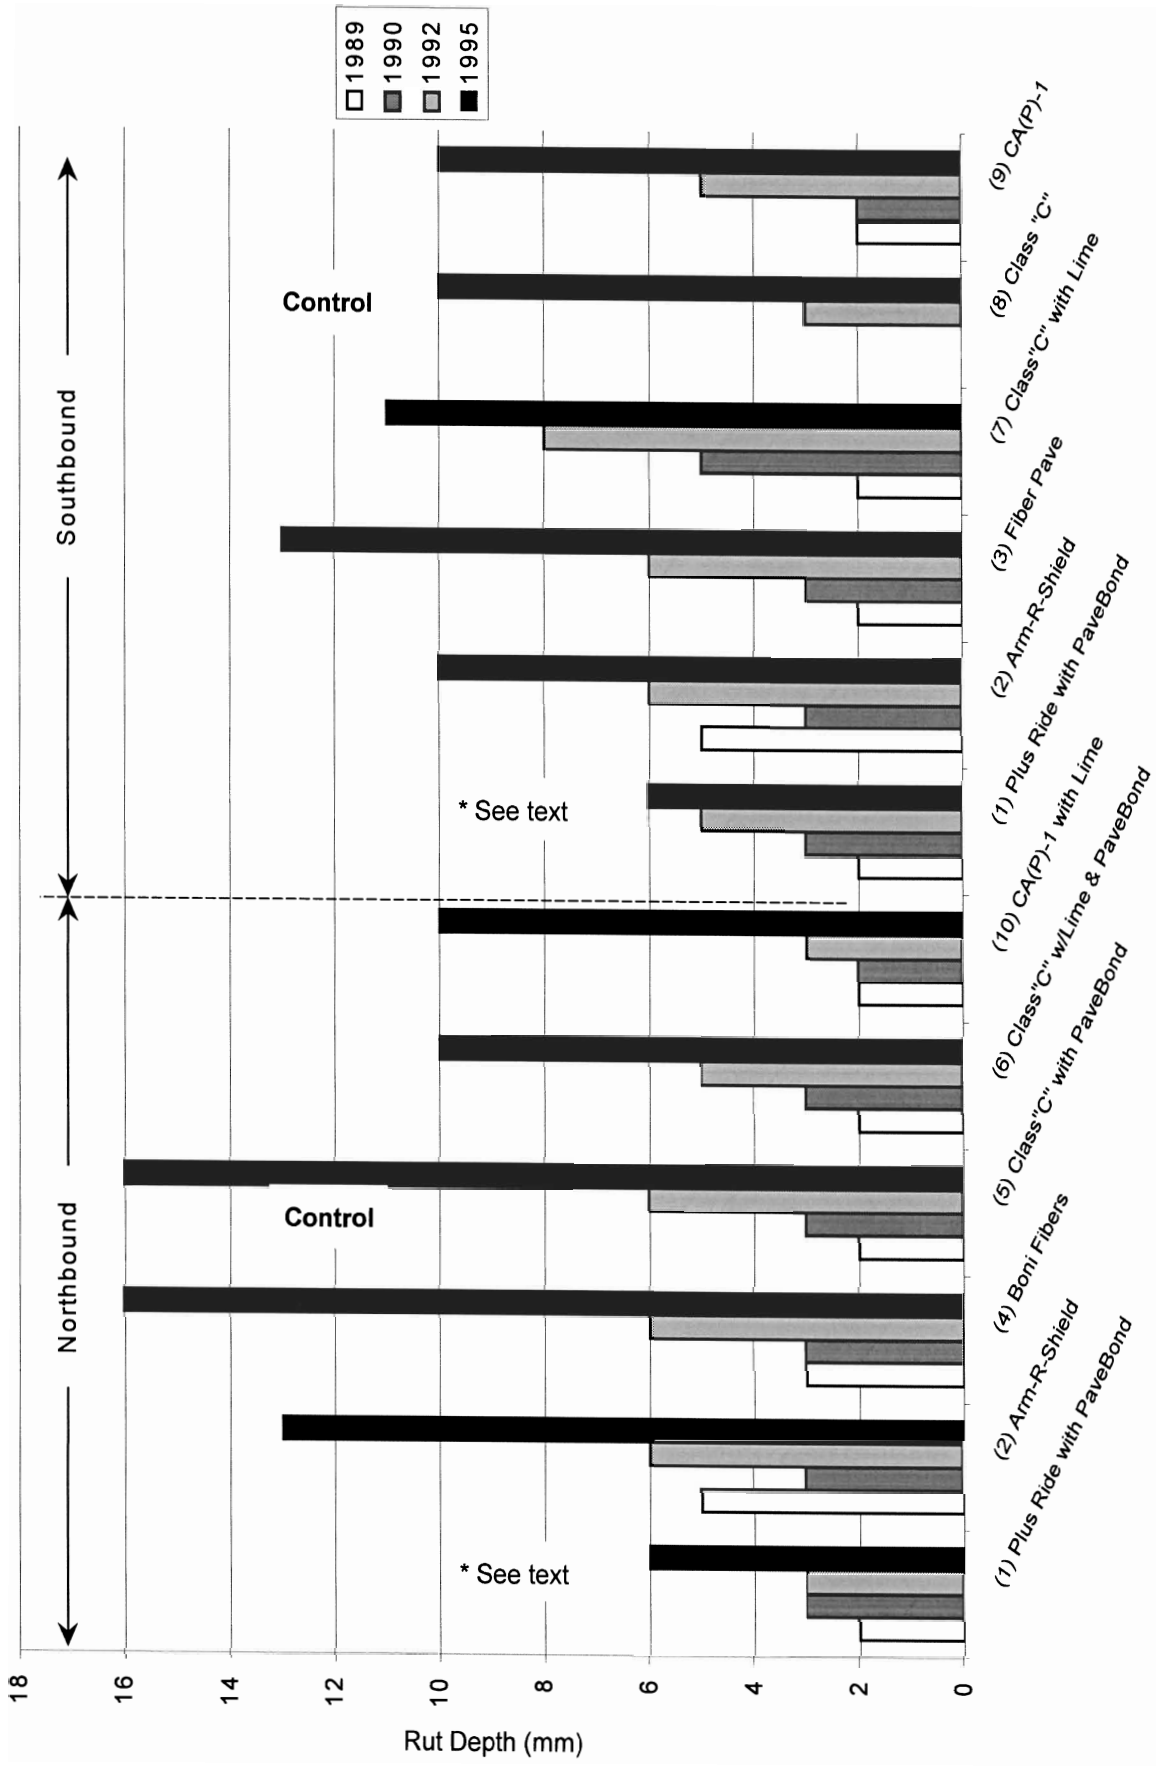
Figure 2.1: Average Rut Depths 1989-1995

The sections had rut depths between 6 to 16 mm.

With the exception of the Plus Ride section, the rutting resistance on all sections was the same as, or slightly better than, the control sections. The Plus Ride rut depth in 1995 was less than the other sections, but this was due to the reduction in traffic caused by the construction of slow moving vehicle lanes in 1990. Since the Plus Ride rut depths were similar to the control sections

in 1989 and 1990, it is assumed that the overall rutting resistance of Plus Ride is similar to the control section (see Figure 2.1).

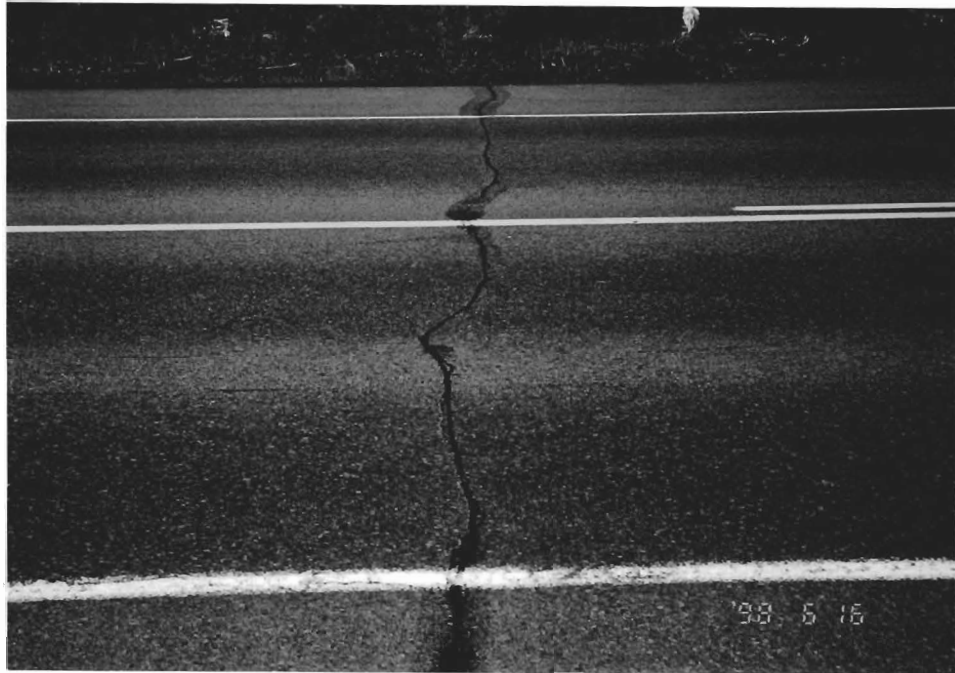
pavement evaluations are performed. Most of the cracks (69%) were of a low severity level (0 to 6 mm), 26% were moderate (6 to 19 mm) and 4% were of high (over 19 mm) severity (*SHRP 1993*). The cracks had little or no spalling around their edges and did not significantly affect the ride of the sections. Examples of routed cracks are shown in Figure 2.2.

Figure 2.2a: Typical Transverse Crack that was Routed and Sealed.  
CA(P)-1 with Lime pavement is in the near lane, and CA(P)-1 pavement is in the far lane.  
Location: MP 161.5 looking west.

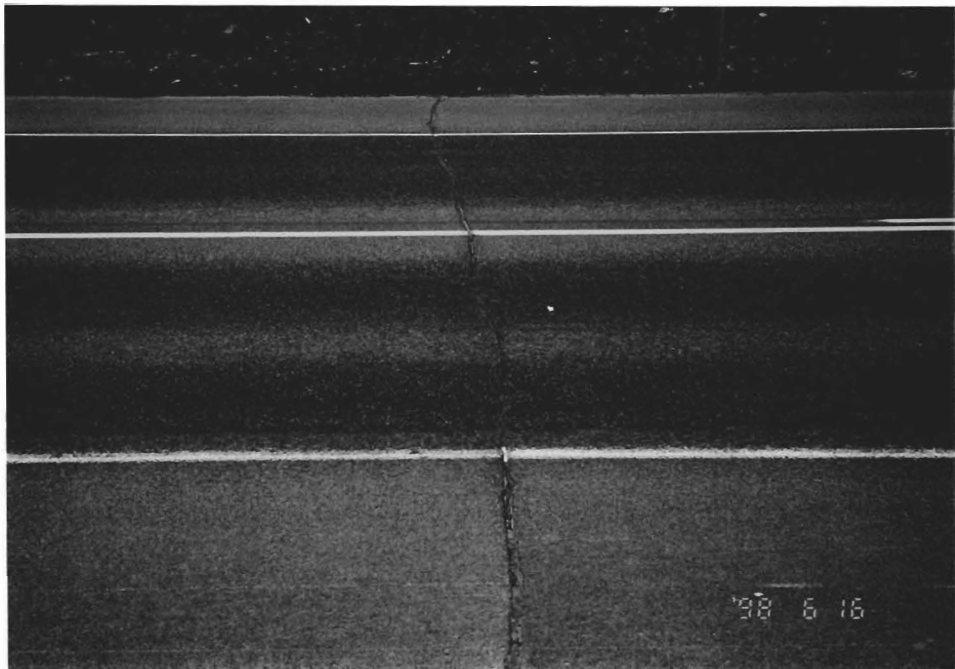
Figure 2.2.b: Typical Transverse Crack that was Routed, but Not Sealed.  
Arm-R-Shield is in the two travel lanes, and Class "C" with PaveBond and Lime is in the shoulder.  
Location: MP 158.6.

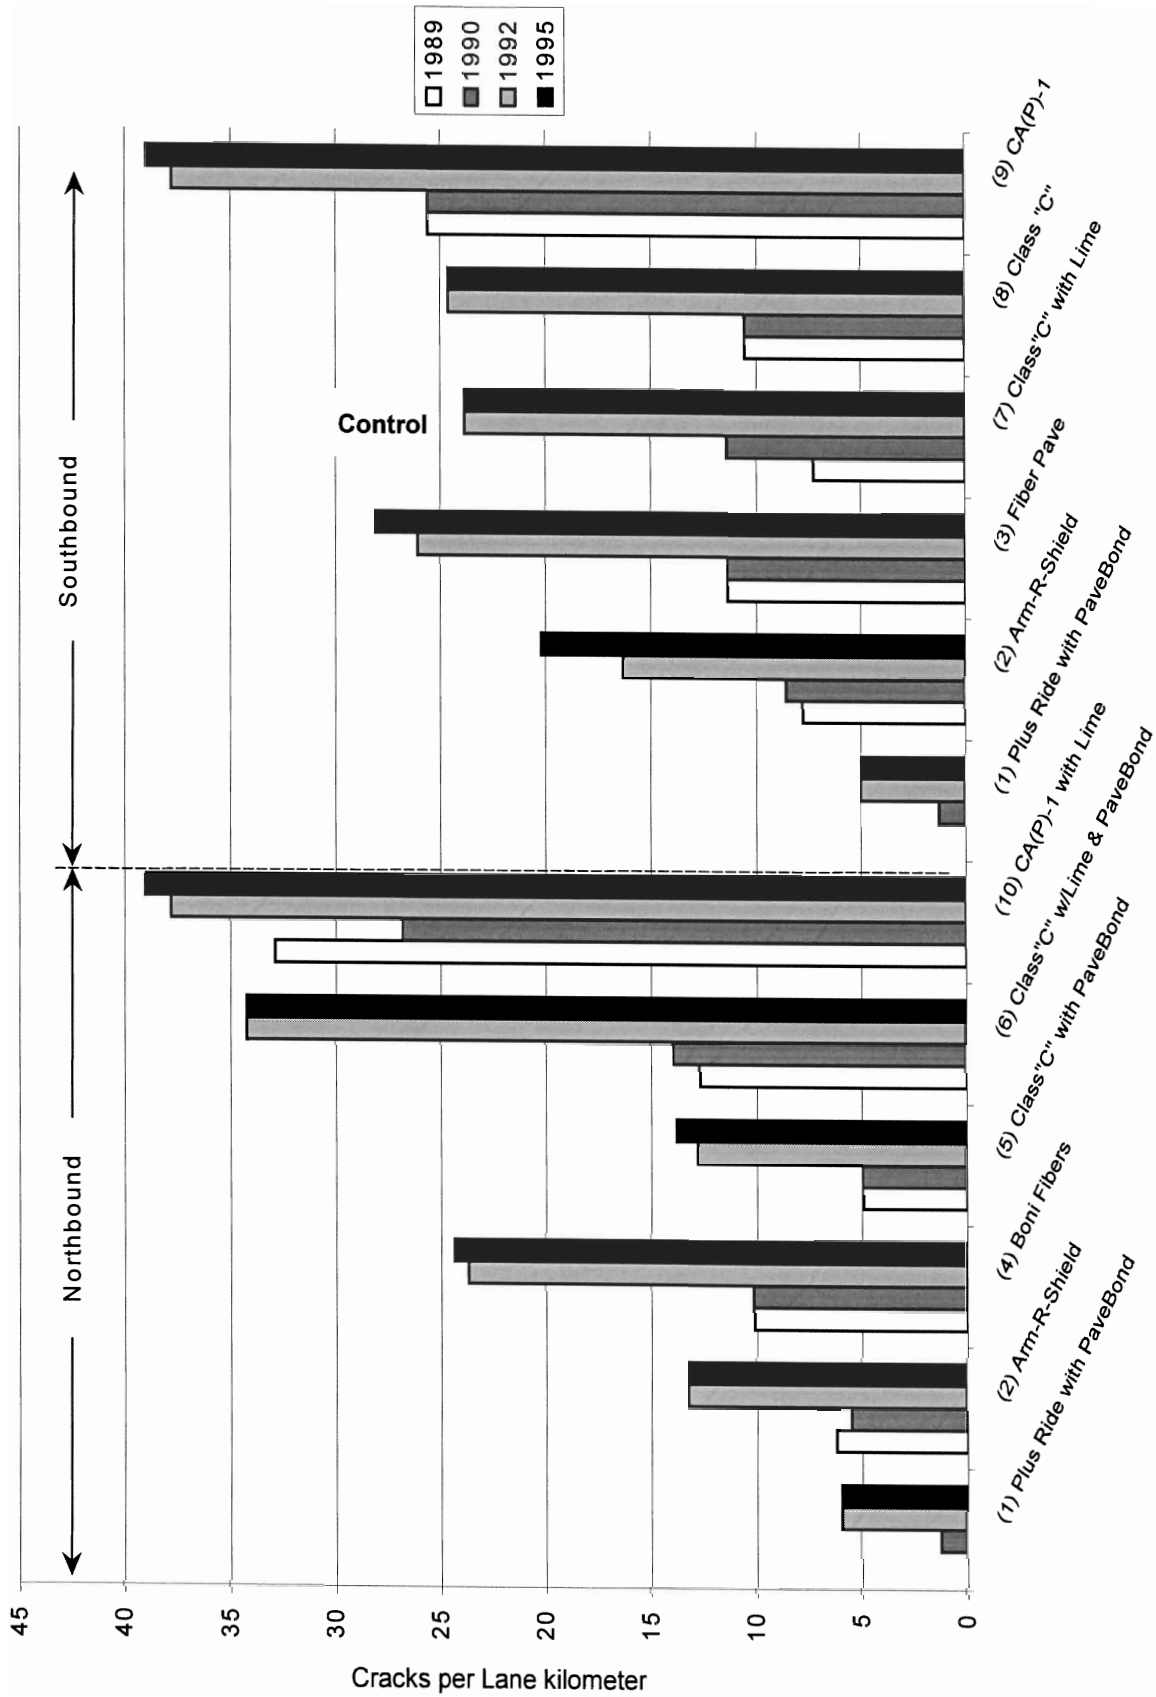
Figure 2.3: Transverse Cracking

The test and control section's transverse crack counts ranged from 5 to 39 cracks per lane kilometer. Consequently, all of the sections had much less transverse cracking than the 93 large transverse cracks per lane kilometer on the road before the overlay.

Plus Ride had the least amount of transverse cracking, followed by Class "C" with Pave Bond and Arm-R-Shield. CA(P)-1 had the most cracking. The low number of cracks in the Plus Ride and Arm-R-Shield sections was expected, as these sections contain rubber which is usually resistant to thermal cracking. The lack of transverse cracking in the Class "C" with Pave Bond mix is puzzling, as this section is alongside the Class "C" with Lime section which has about twice as much transverse cracking. It was initially thought that the Pave Bond improved transverse crack resistance. However, this may not be true. The Class "C" with Pave Bond and Lime section had more transverse cracking than the Class "C" section that is alongside it.

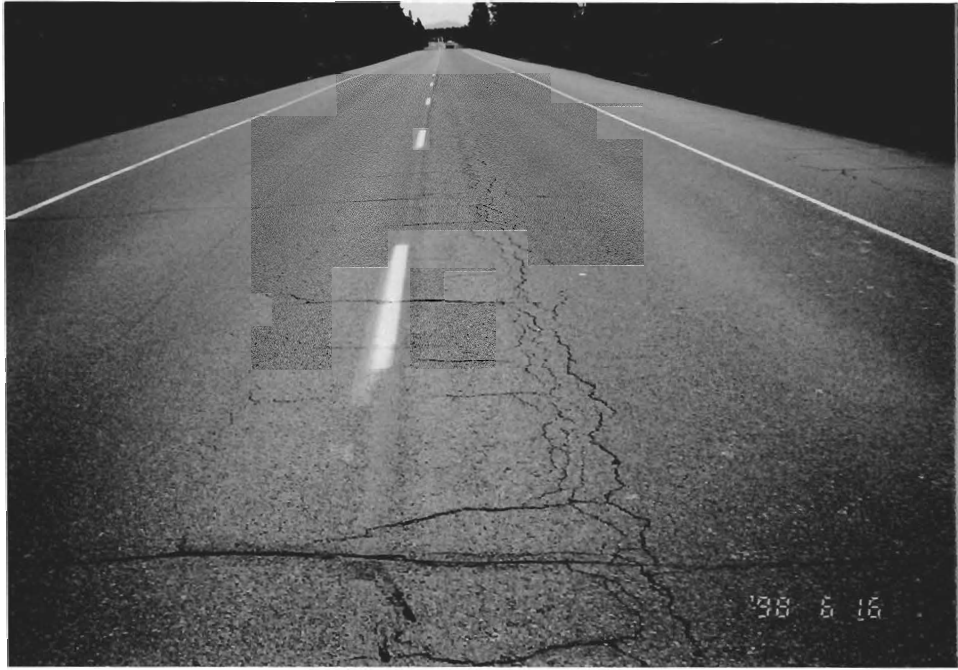
Transverse cracks approximately 0.3 to 0.6 m long were found near the centerline of many sections. An example of this cracking is shown in Figure 2.4. These cracks were counted as block cracking rather than transverse cracks. The remainder of the cracks may be reflective cracks, cracks in the old roadway reflecting up through the overlay. The presence of this block cracking near the centerline is accounted for in Table 2.3. Block cracking on the shoulder is not included in this rating, as many sections paved with experimental mixes have shoulders of conventional mix.

Figure 2.4: Typical Block Cracking and Fatigue Cracking. The Class "C" pavement is on the left, and the Class "C" with Lime and Pave Bond pavement is at the right.  
Location: MP 61.05 looking south.

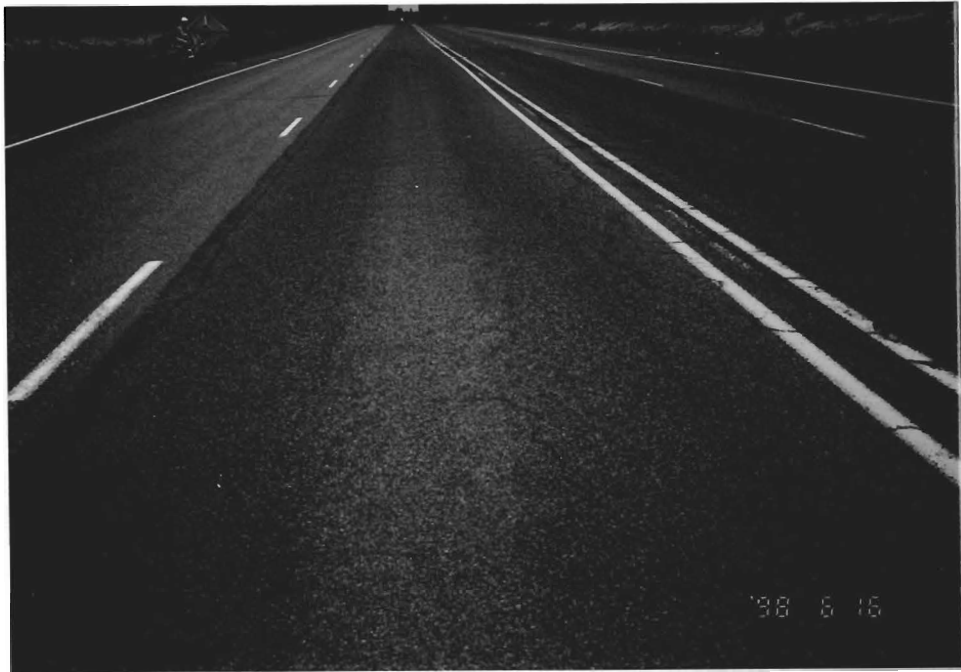
This cracking is often called "wheeltrack" or "alligator" cracking and is associated with repeated traffic loading. The cracks usually begin as a series of short non-connected longitudinal cracks, progressing to a series of interconnected cracks and then developing into an alligator crack pattern comprised of small blocks usually less than 0.1 m<sup>2</sup>. The following forms of cracking, even if they were in the wheelpath, are not included in the rating: transverse thermal cracking, reflective cracking, block cracking, and longitudinal cracking over joints between pavement panels. Typical cracking in the wheel tracks is shown in Figure 2.5.

Figure 2.5: Wheeltrack Cracking on Plus Ride. About 7% of the wheeltracks were raveled. The newly constructed slow-moving-vehicle lanes are on the outside lanes. Location: MP 158.2

All sections, except the Plus Ride, had low severity raveling. The surface texture on the Plus Ride section was considerably rougher than the other sections and is of a moderate severity level. Inspections made in 1989 found the Plus Ride section already in poor condition, which had worsened by 1992. Portions of the section have been patched to correct the problem.

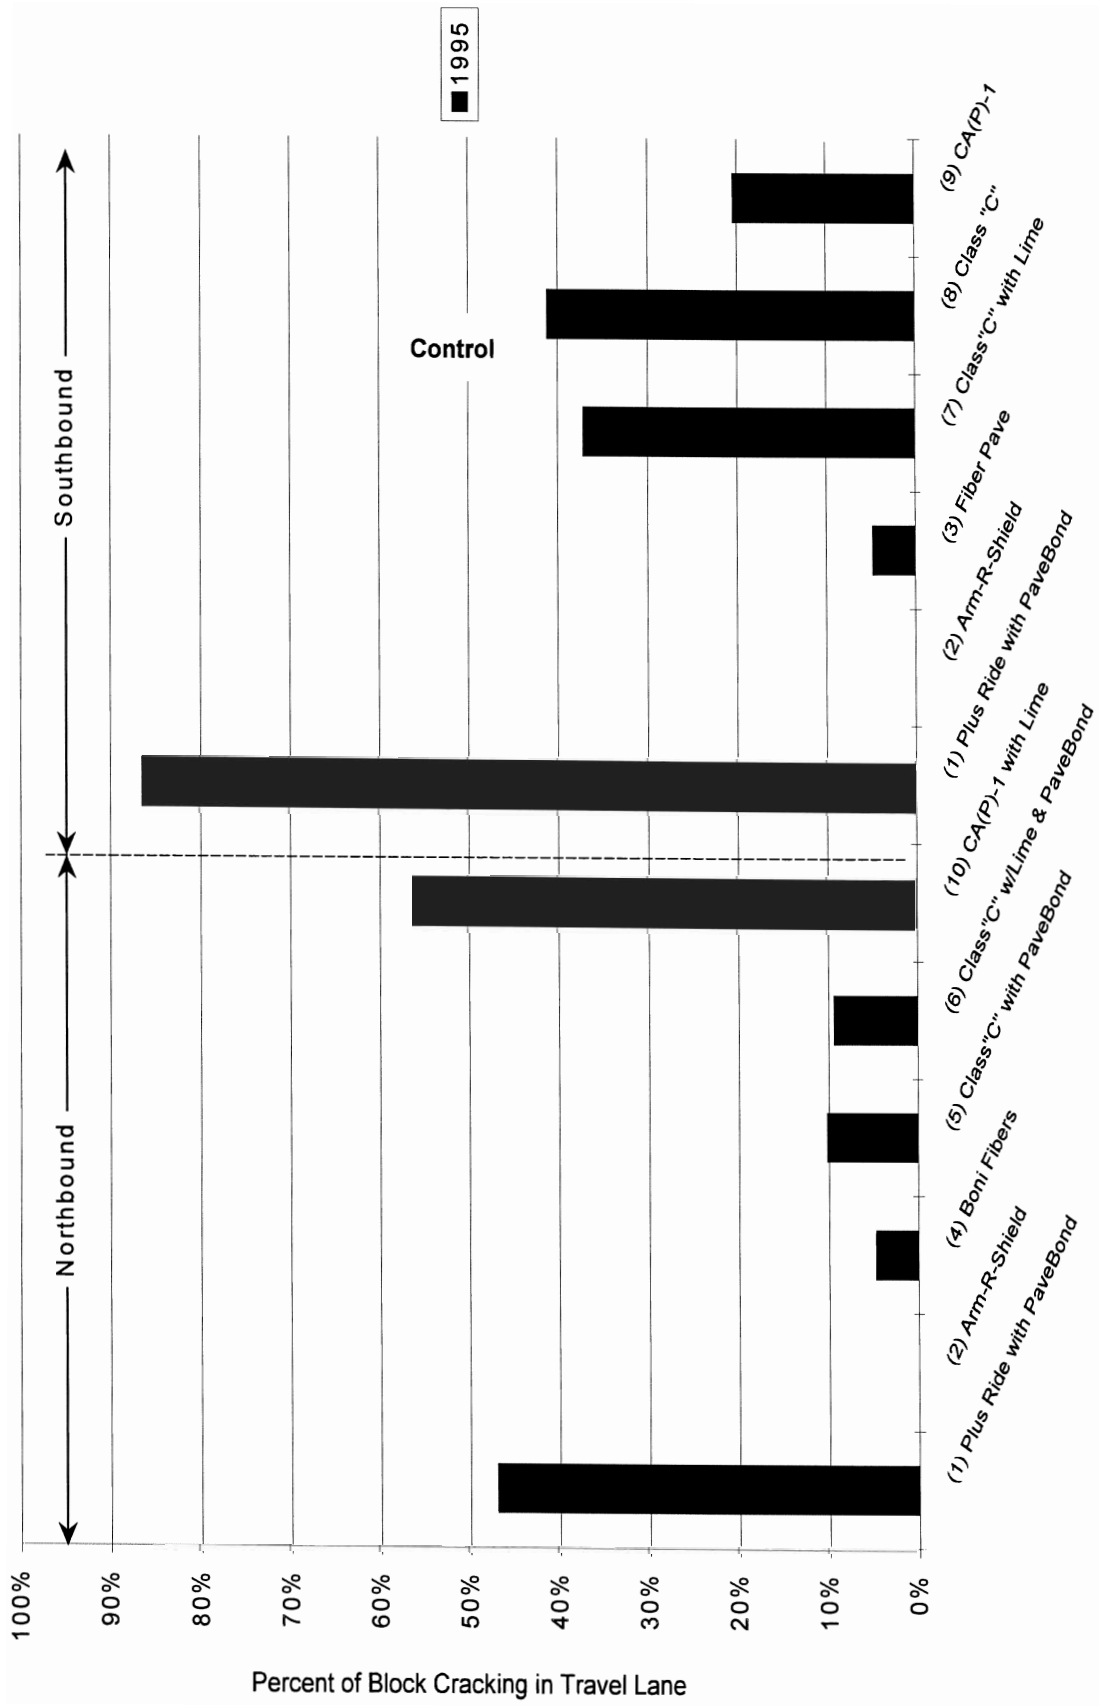
Figure 2.6: Block Cracking

Only the Arm-R-Shield section had no block cracking. All other sections had block cracking of a "low" severity level. (*SHRP 1993*).

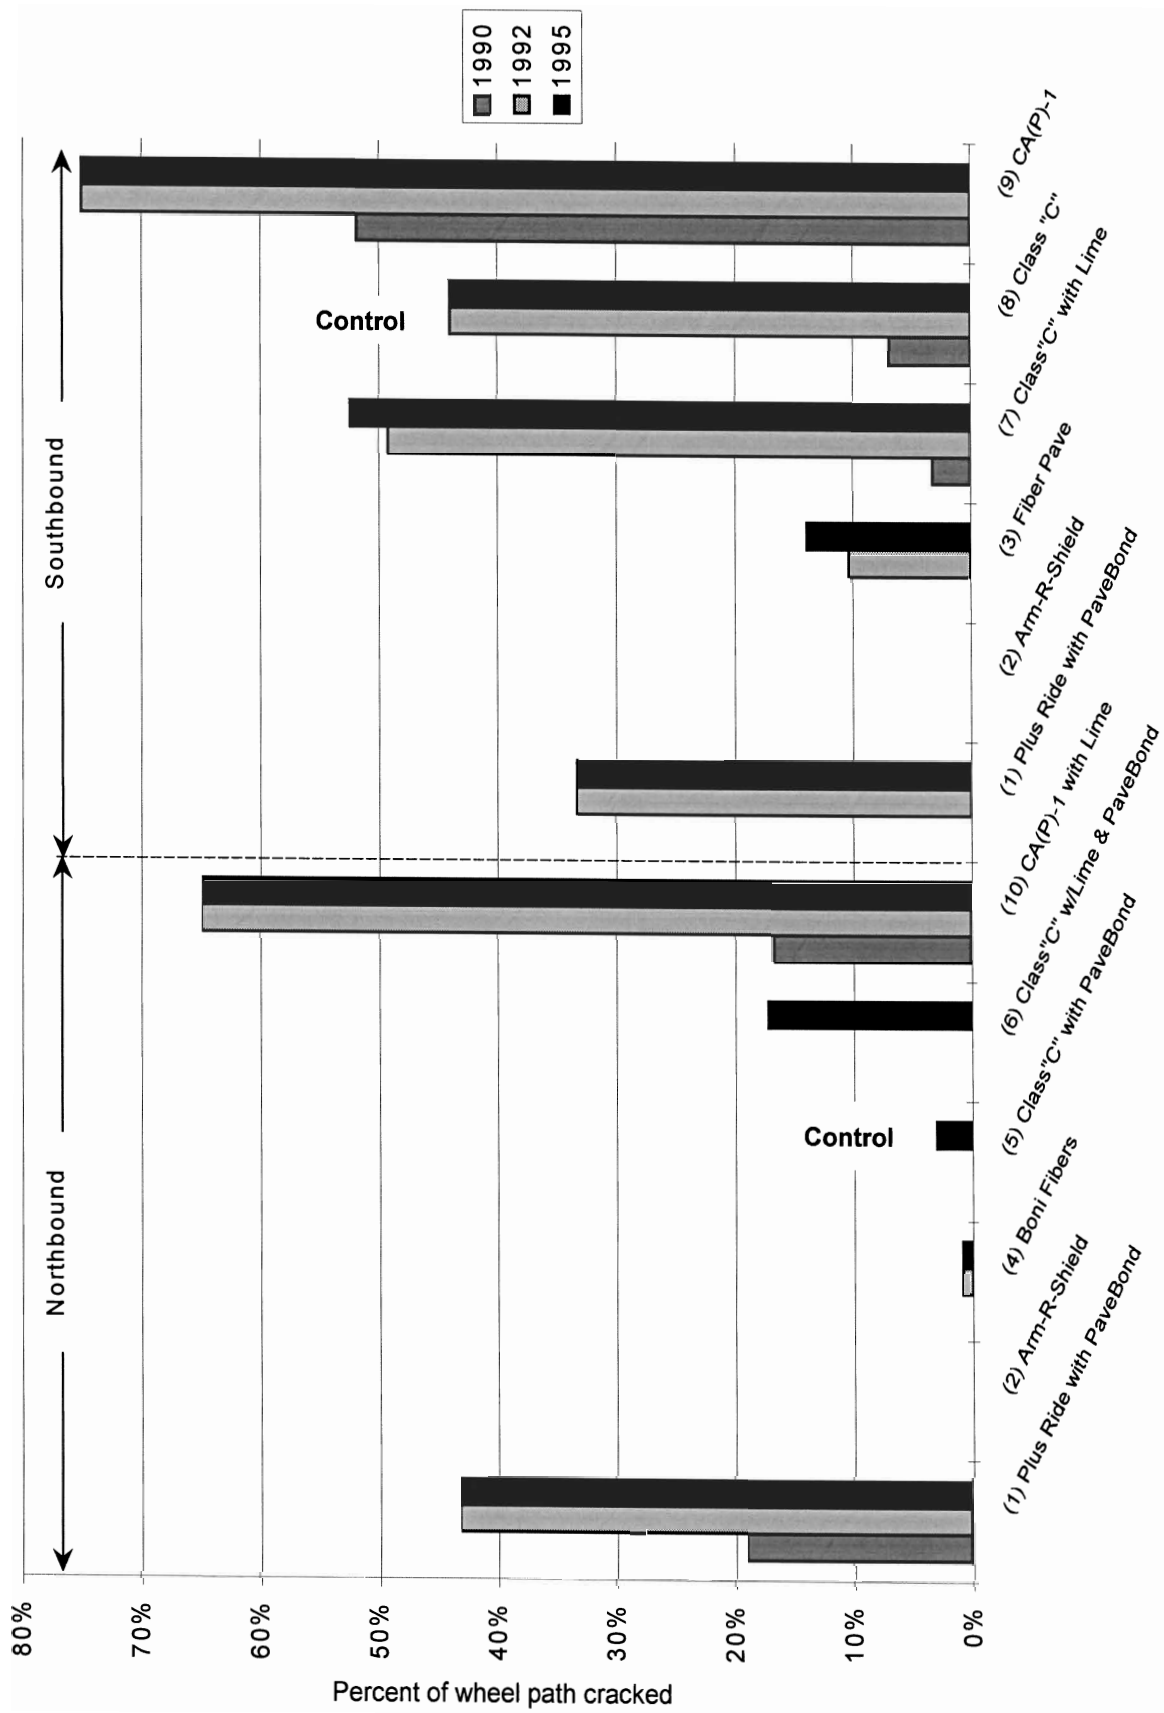
Figure 2.7: Fatigue Cracking

The Arm-R-Shield section had excellent resistance to fatigue cracking. There was no cracking in either the southbound lane with the higher truck traffic, or the northbound lanes with the lower truck traffic. All other sections had some fatigue cracking, though it was of a "low" severity level (*SHRP 1993*).
