**Report No. CDOT-2011-10  
Final Report**

# **INVESTIGATING CRACK SEALANT PERFORMANCE AND CAUSES OF BUMPS IN NEW HOT MIX ASPHALT OVERLAYS OVER CRACK SEALANTS**

**Scott Shuler**

**COLORADO DEPARTMENT OF TRANSPORTATION  
DTD APPLIED RESEARCH AND INNOVATION BRANCH**

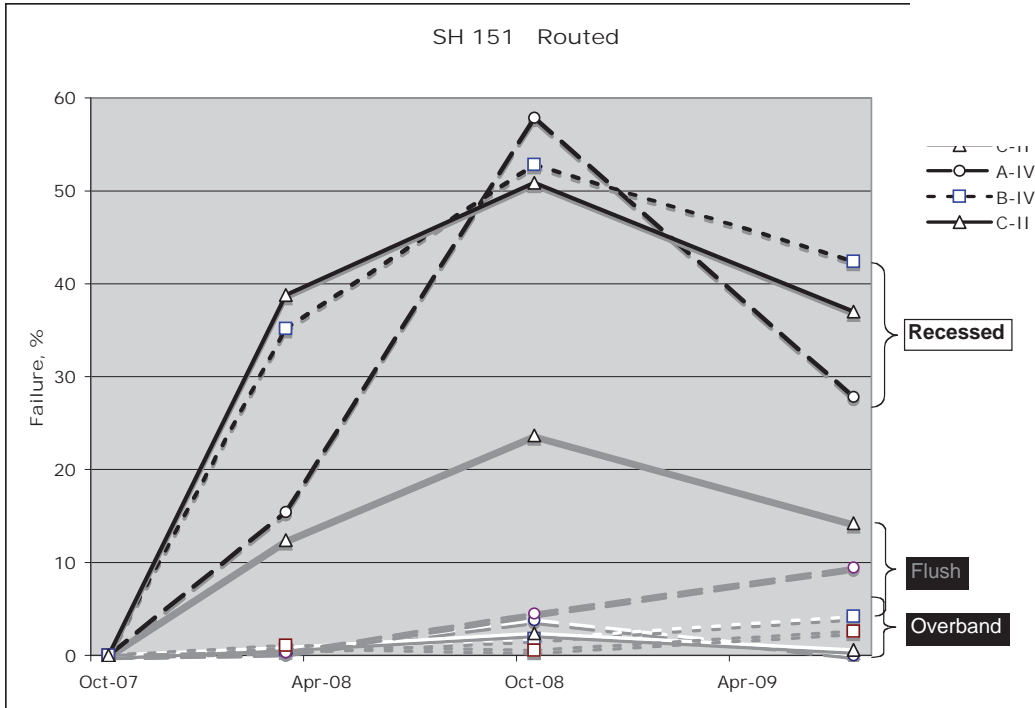
Figure 3. Sealant Performance on S.H. 151-Cracks Prepared by Routing

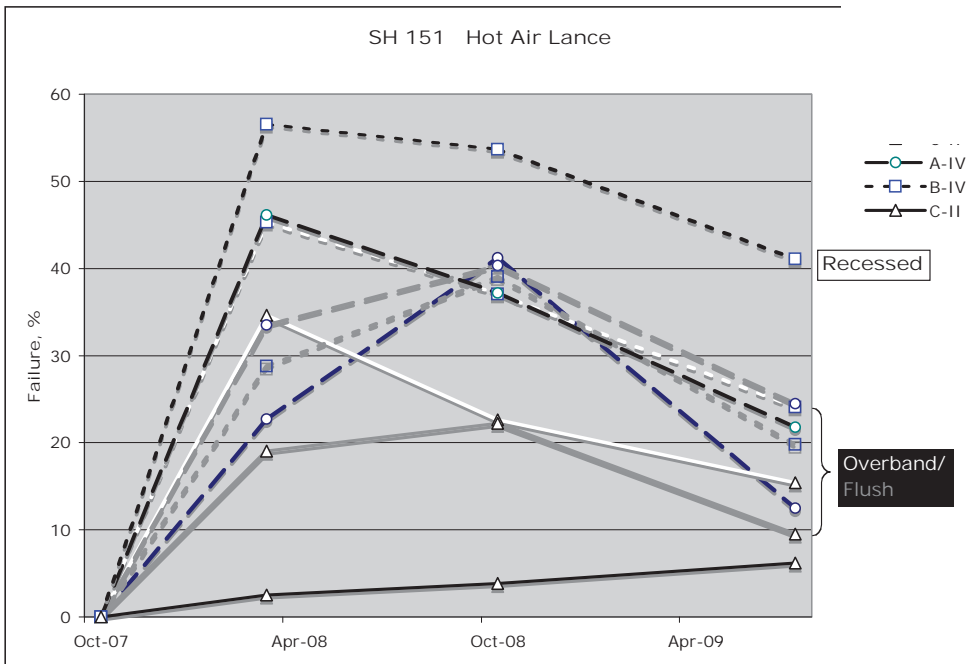
Figure 4. Sealant Performance on S.H. 151-Cracks Prepared by Hot Air Lance

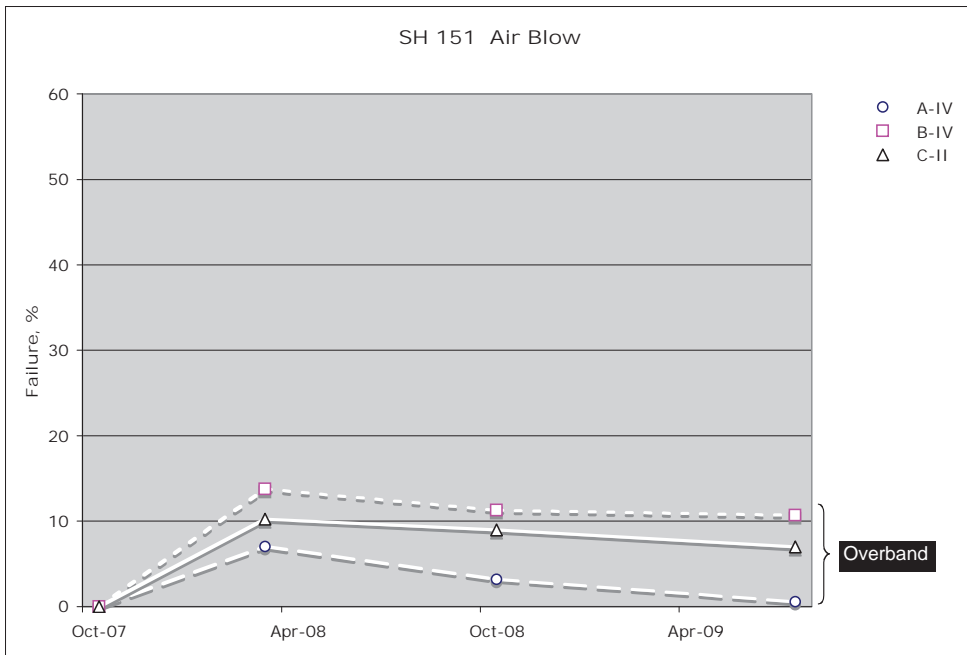
Figure 5. Sealant Performance on S.H. 151-Cracks Prepared by Air Blowing

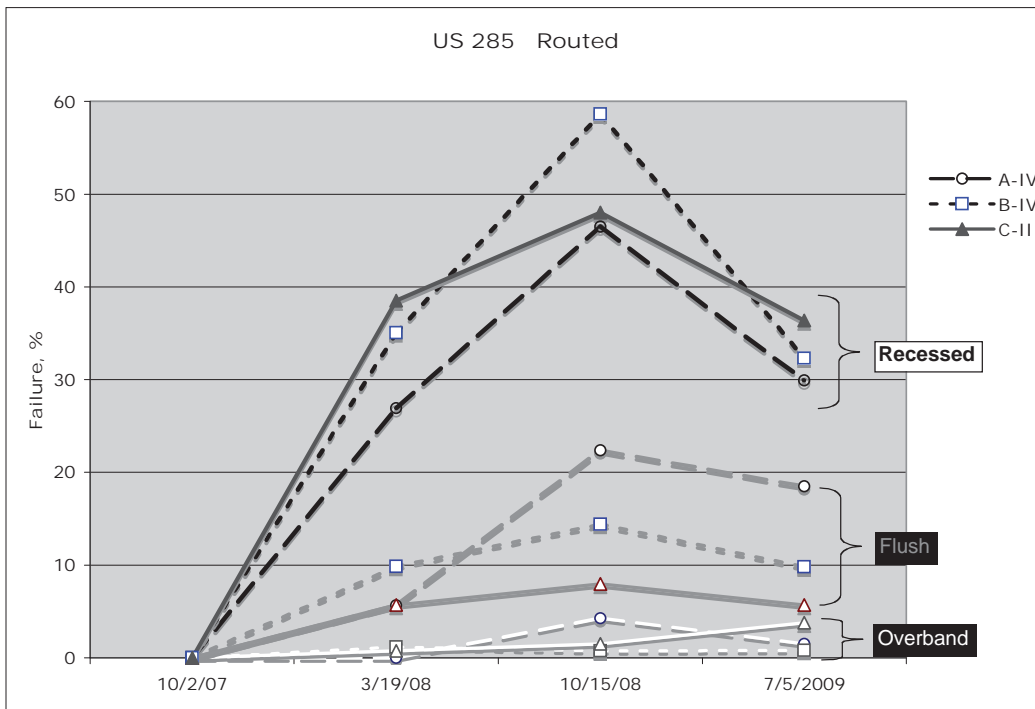
Figure 6. Sealant Performance on US 285-Cracks Prepared by Routing

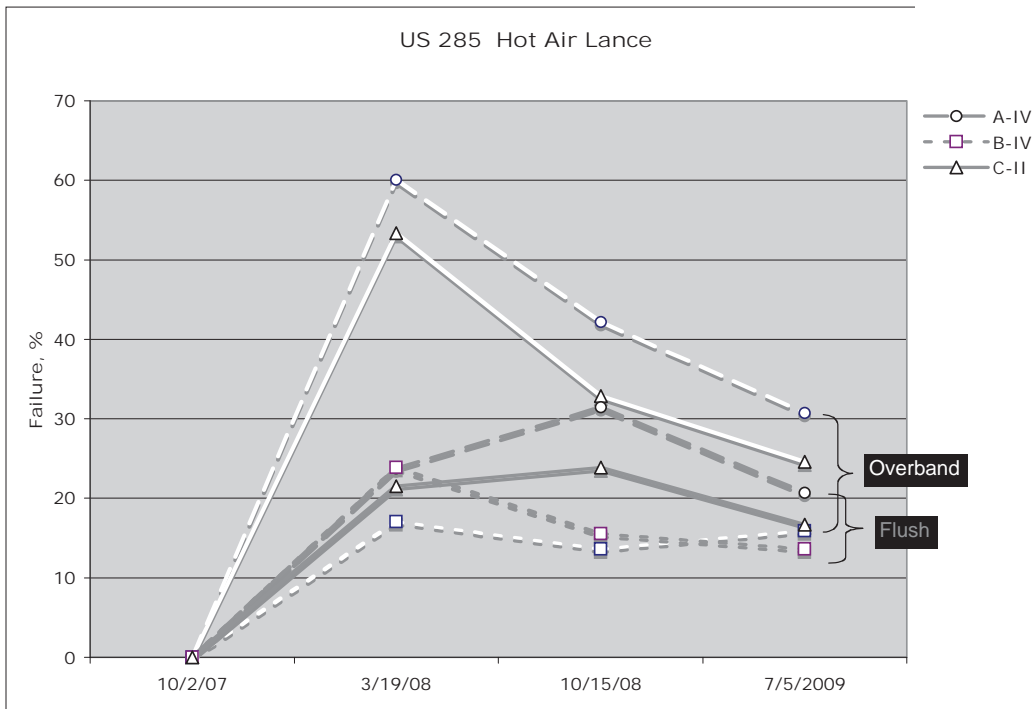
Figure 7. Sealant Performance on US 285-Cracks Prepared by Hot Air Lance

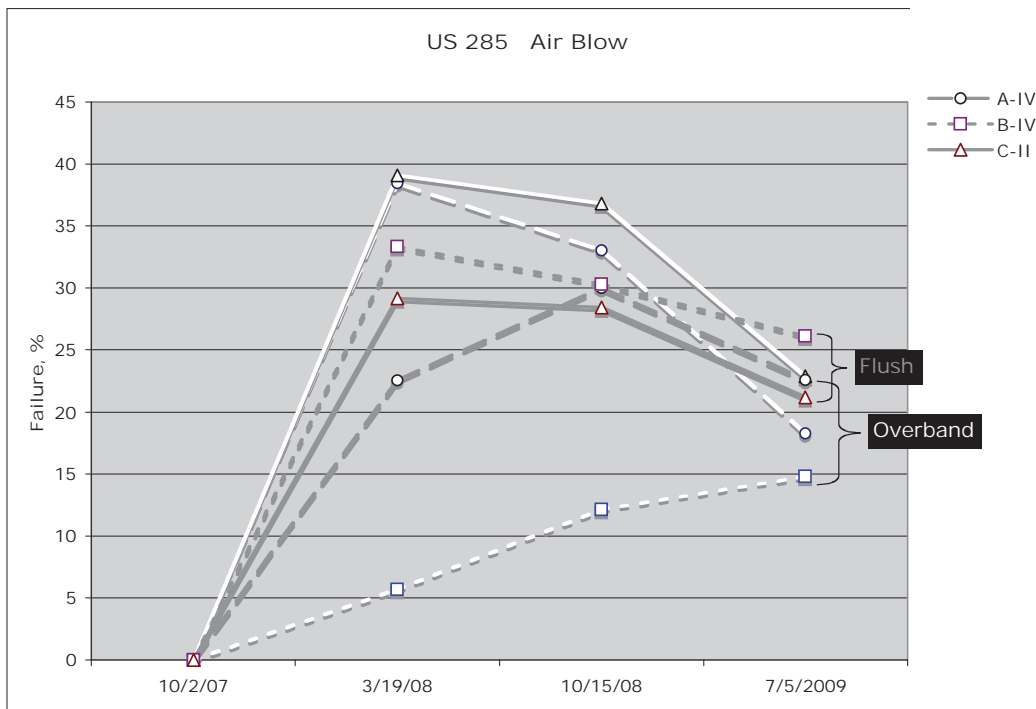
Figure 8. Sealant Performance on US 285-Cracks Prepared by Air Blowing

reaches 15 percent failure for the air blow and overband process on US 285. Supplier C reaches 4 percent failure on US 350 in Figure 10 for a hot air lance and flush application and Supplier A-I has an 11 percent failure rate on US 350 for the air blow and overband application shown on Figure 11.

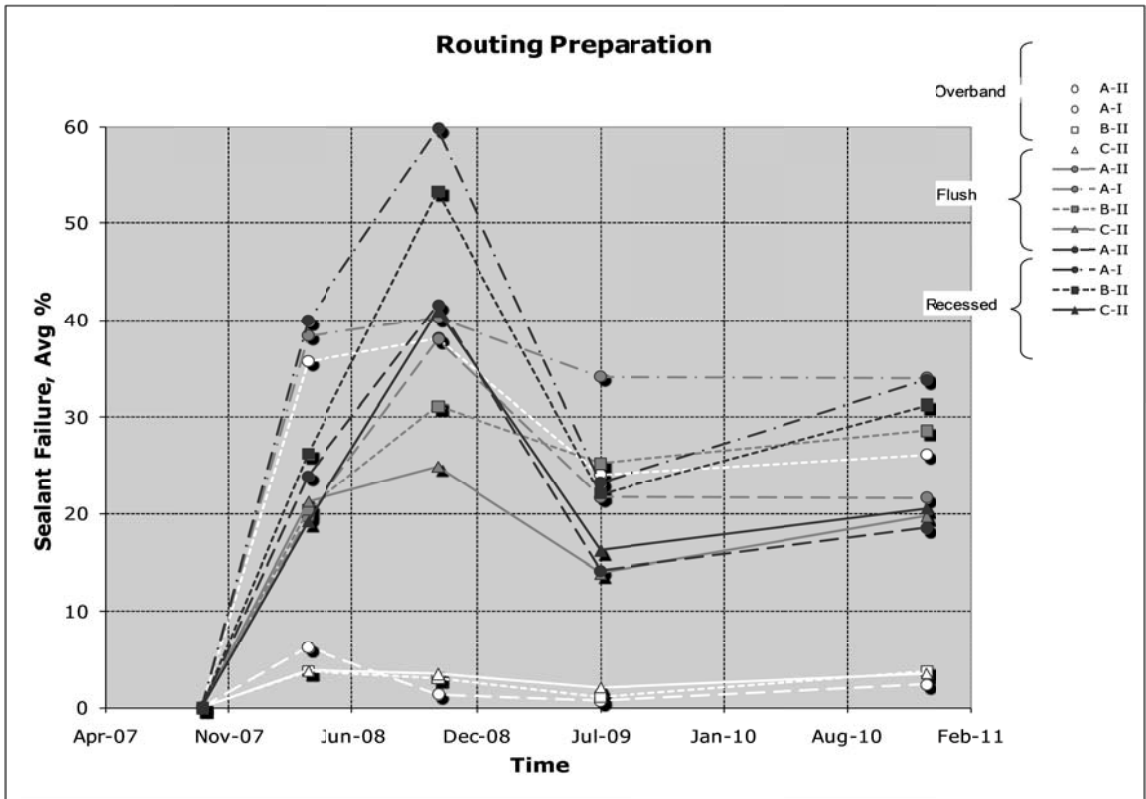
Figure 9. Sealant Performance on US 350-Cracks Prepared by Routing

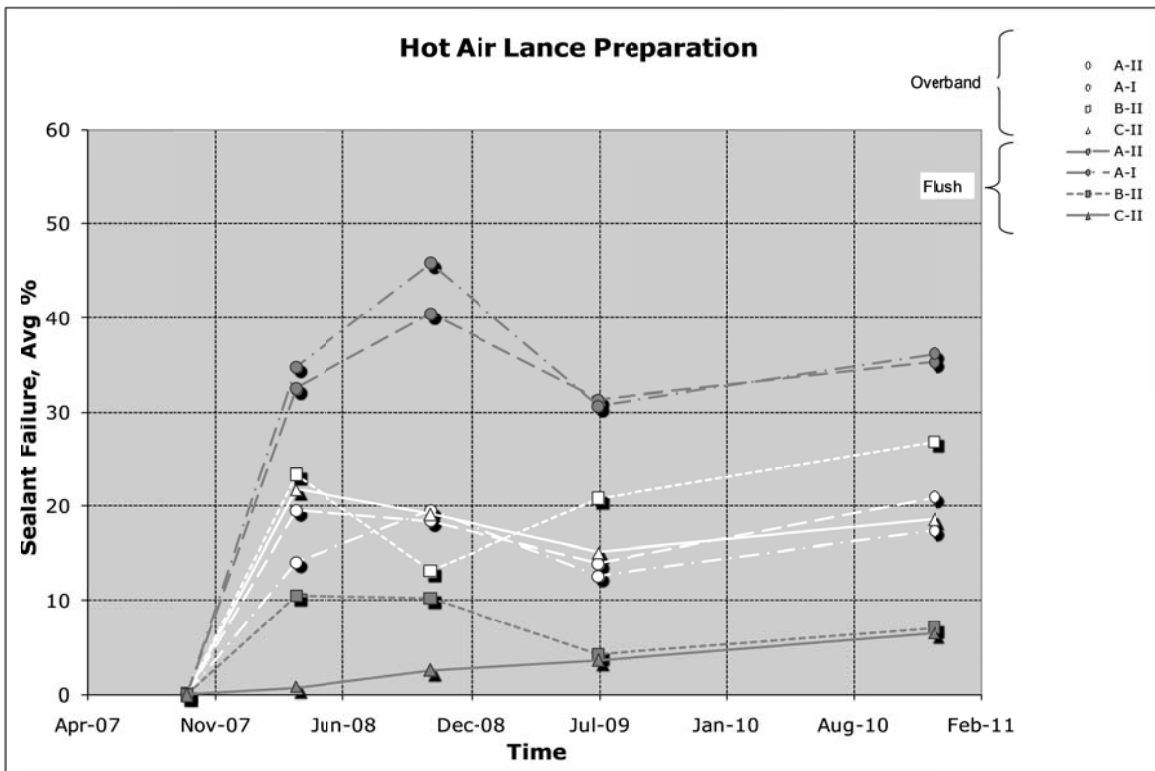
Figure 10. Sealant Performance on US 350-Cracks Prepared by Hot Air Lance

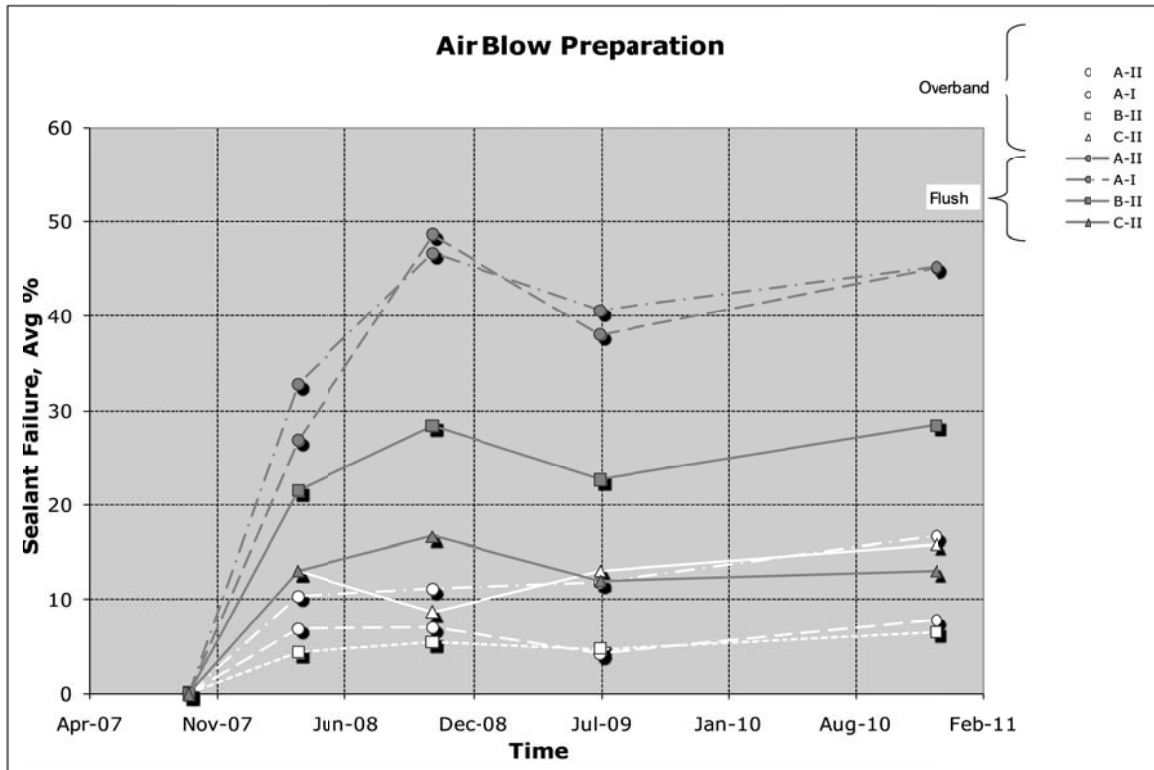
**Figure 11. Sealant Performance on US 350-Cracks Prepared by Air Blowing**

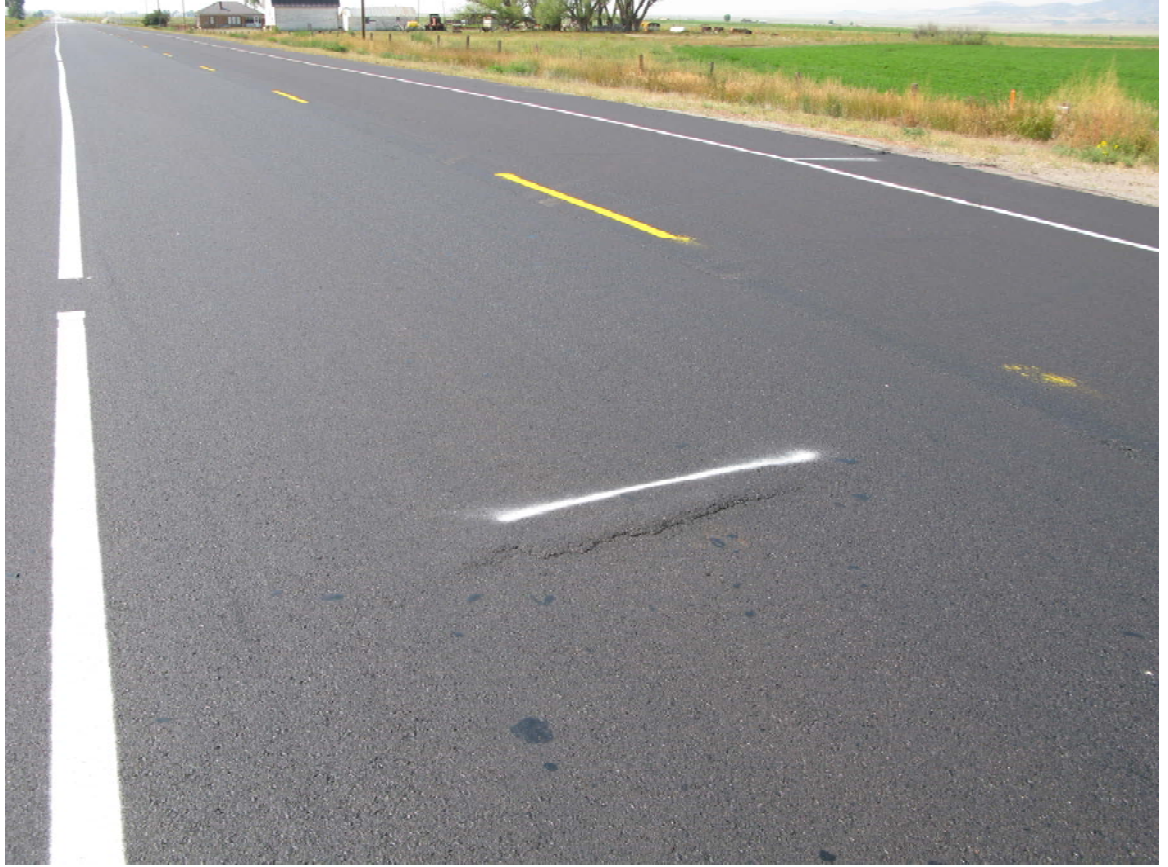
Bumps and transverse cracks began to appear on the project during previous leveling course construction south of the test sections at approximately Station 150+00 as shown in Figure 12. The contractor mitigated further occurrence of this distress

**Figure 12. Bumps and Transverse Cracks at Station 150+00**

by changing from vibratory steel rollers in vibrating mode on breakdown compaction to pneumatic tired rollers. The vibratory steel rollers being used were a Bomag BW190AD and a Caterpillar CB534C. The pneumatic rollers were a Hypac C530AH and a Caterpillar PS150B. However, the material properties of the crack sealant used at Station 150+00 were unknown, therefore, it was not possible to conclude that the bumps and transverse cracks in the leveling course at Station 150+00 were not material related. An experiment was developed to determine if the bumps and cracks could be reproduced within the crack sealant test sections.

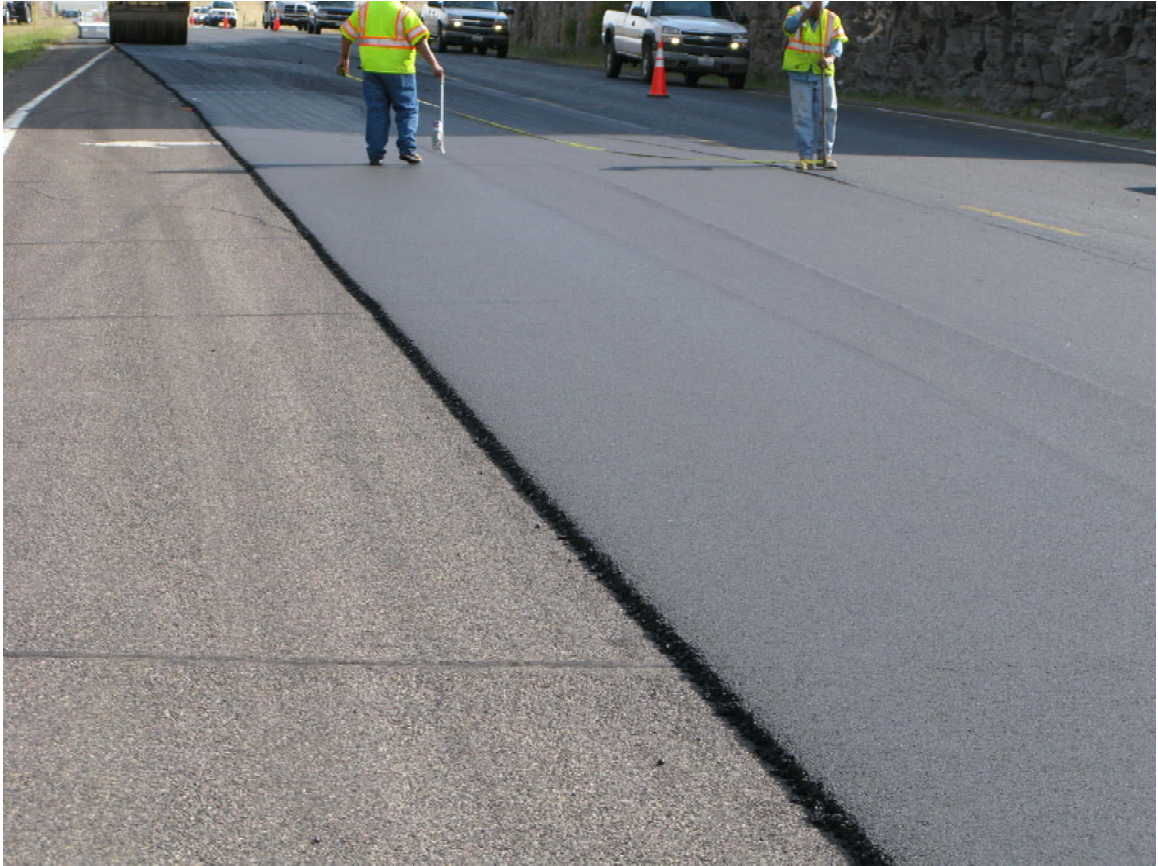
Second and third attempts to create the bumps and transverse cracks were done over cracks 199 to 204 and again at cracks 127 to 132. The results of this experiment are shown in Figures 14 and 15. The severity of the cracks and bumps appeared directly related to the number of passes of the vibrating roller. As cracks began to appear after the first pass of the roller, the contractor was reluctant to continue the experiment with additional roller passes. The severity of the cracks and bump shown over crack 271 was not observed over cracks 199 to 204 or 127 to 131 due to fewer passes of the vibrating rollers.

**Figure 14. Bumps and Transverse Cracks over Cracks 129, 130, and 131 Northbound US 285**
