# Evaluation of Various Hot Mix Asphalt Pavement Thicknesses over Rubblized Concrete Pavement

FINAL REPORT

Evaluation of Various Hot Mix Asphalt Pavement Thicknesses  
over Rubblized Concrete Pavement  
Research Study # WI-93-06a

Report # FEP-07-10

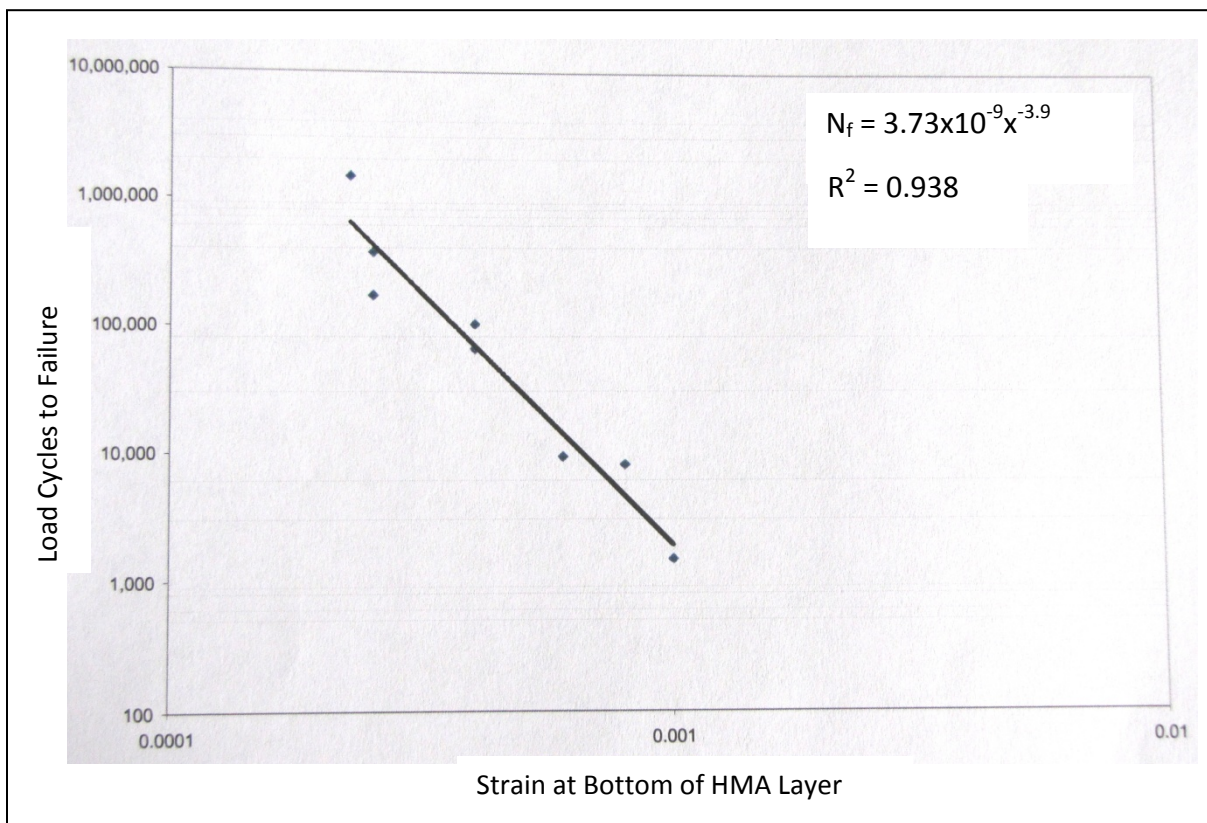
Figure 5. Fatigue curve for lower layer mixture. [12]

Fatigue test results for the lower layer mixture are shown in Figure 5. The curve shows the number of load cycles ( $N_f$ ) the mixture can sustain at a set strain level before failure. In this test, failure was defined as the point where the initial flexural modulus decreased by 50 percent. The material's predictive fatigue equation is also shown in Figure 5; the exponent of 3.9 indicates good fatigue resistance. [12]

The commonly accepted strain endurance limit for HMA pavements is  $70 \times 10^{-6}$  to  $100 \times 10^{-6}$ , below which level no permanent fatigue damage will occur in the pavement. [13, 14] For this pavement's lower layer mixture, the  $100 \times 10^{-6}$  strain level extrapolates to nearly 10 million load cycles to failure (Figure 5). As will be discussed in Section 5.1.2, loads resulting in a strain of  $100 \times 10^{-6}$  are unlikely to occur in any of the test sections, and therefore the pavement is well-protected from fatigue damage.

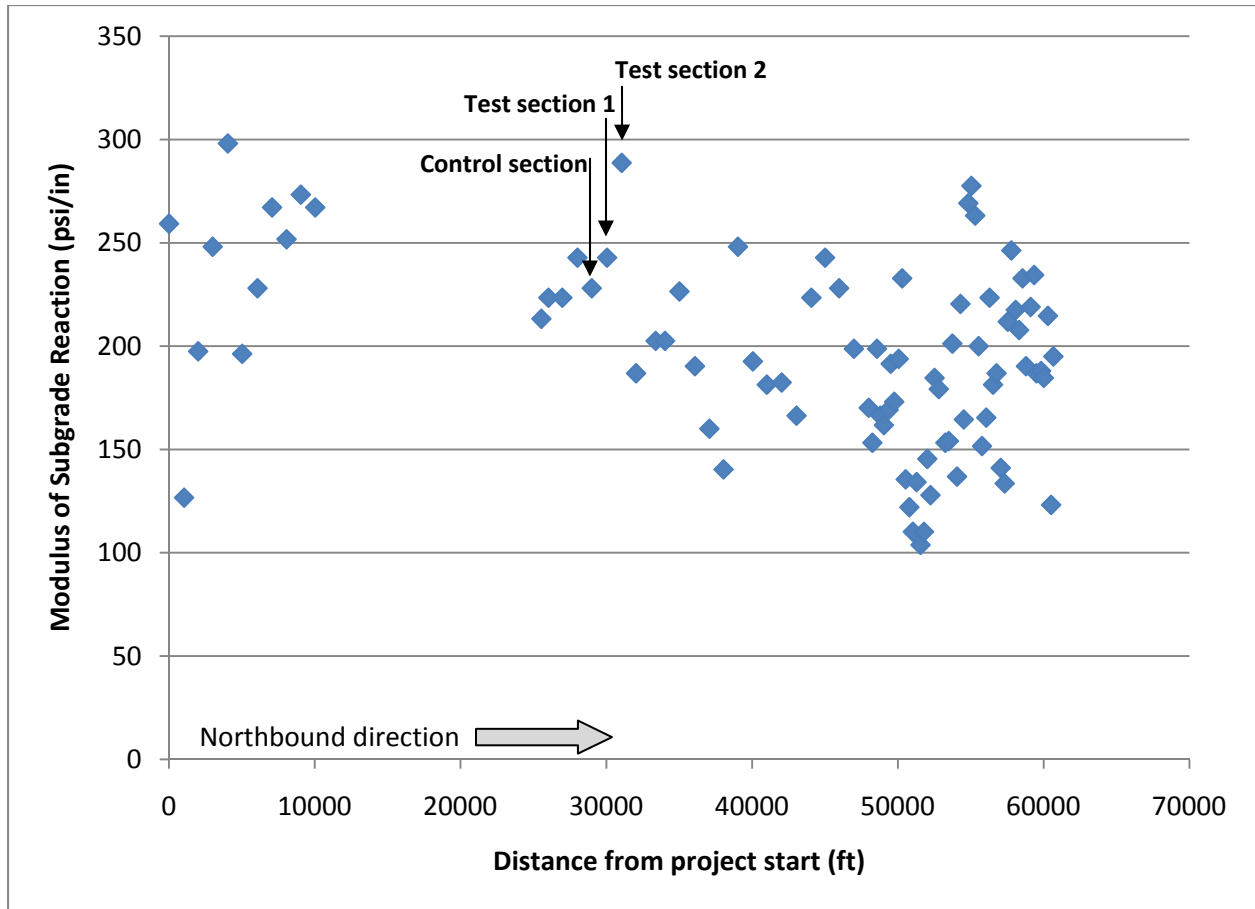
Figure 6. Modulus of subgrade reaction values for rubblization project.

The northern section of the project did have slightly lower modulus of subgrade reaction values, especially between 50,000 and 53,000 ft north of the project start. However, the support in this area was still within an adequate range for rubblizing. The area chosen for the experimental sections had very good slab support, as shown in Figure 6.

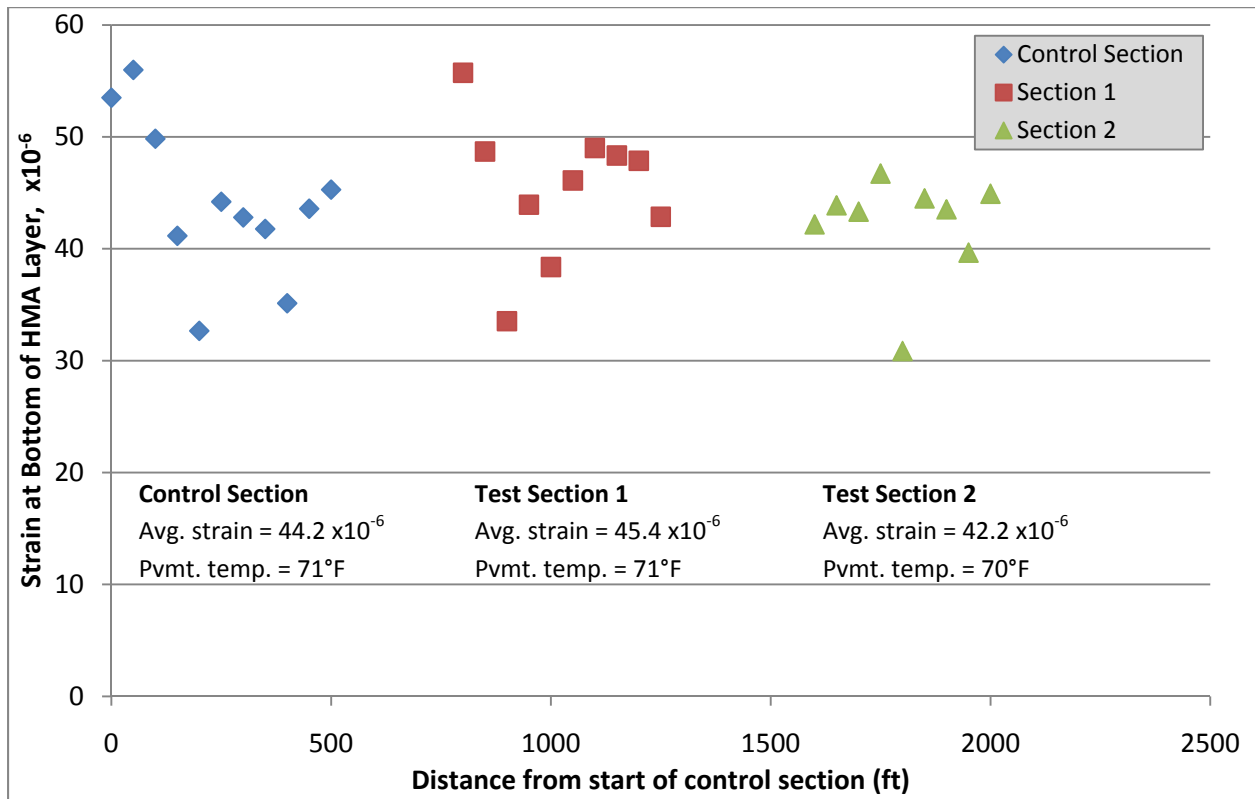
Figure 7. Strain data backcalculated from June 22, 2000 FWD test results, 9.5-kip load.

It is first useful to compare strain data for test sections that were measured by the FWD under equal temperature conditions. Pavement temperatures were approximately equal (within 1°F) among the test and control sections in 2000, 2001 and 2003 (Figures 7, 8, and 10). In these cases, the strain typically decreased with increasing HMA thickness. One exception was that Test Section 1 in 2000 showed a slight increase in average strain compared to the thinner control section (Figure 7). The cause(s) of this anomaly is unknown.

The maximum strain measured in the thinnest (control) section at the 9.5-kip load level was 56 microstrain (Figure 7). This strain level is lower than the 70 to 100 microstrain endurance limit that is commonly associated with a perpetual asphalt pavement. [13, 14] Therefore, while the additional 1.0-in HMA layers resulted in a reduction in strain, the control section provided adequate thickness in terms of protecting the pavement foundation from the cumulative effect of high strain from traffic loadings.

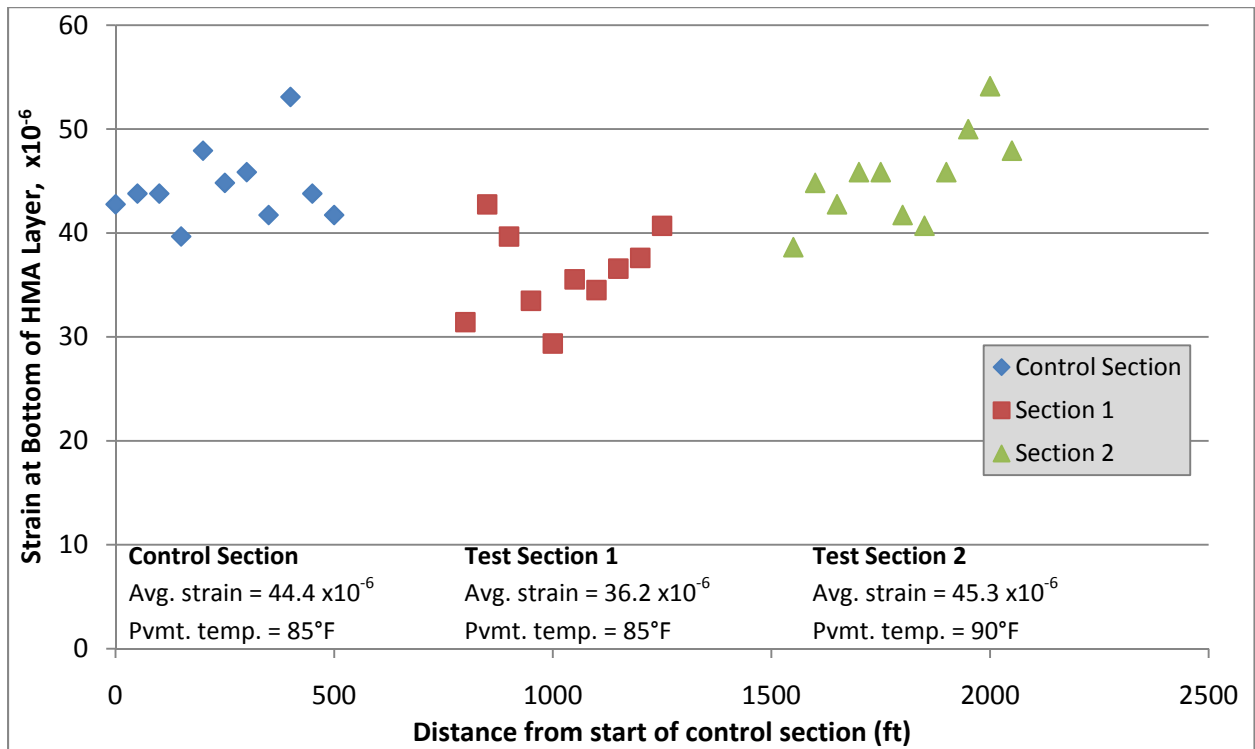
Figure 11. Strain data backcalculated from July 2004 FWD test results, 9.5-kip load.

A second aspect noted in the backcalculated strain data was the effect of pavement temperature on strain level. Considering the 2004 data (Figure 11), the pavement temperature increased from 85°F when the control section was tested to 90°F when test section 2 was tested. As a result, the test section 2 pavement had approximately the same strain level as the control section, despite being about two inches thicker.

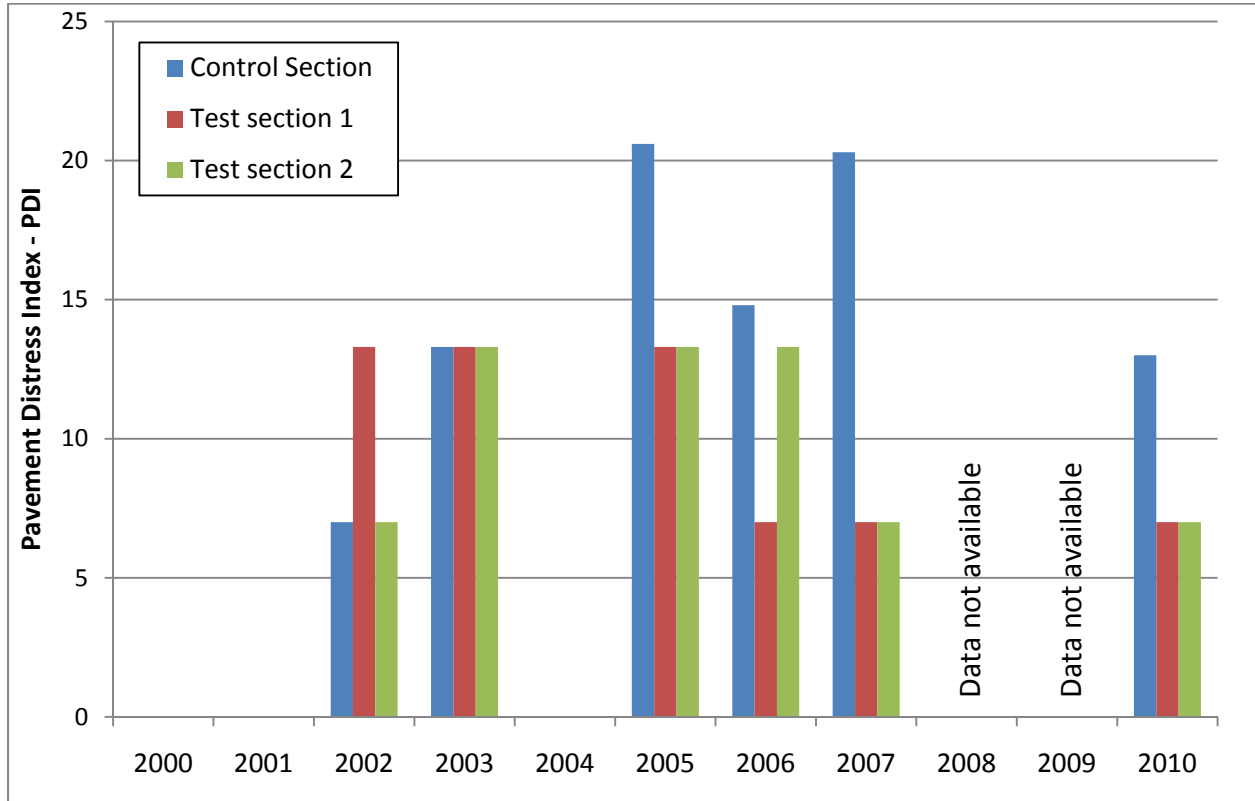
Figure 12. Pavement distress index survey results.

The WisDOT PDI value is a measure of distress in a pavement section, with a value of zero indicating no distresses present and a value of 100 indicating a severely deteriorated pavement. For reference, the PDI of the JRCP in the area of the test and control sections was 71 prior to the rubblization project. PDI data collected for the test and control sections showed no definitive change in PDI over time (Figure 12). In general, the PDI of the two test sections were approximately equal, and the thinner pavement section (control) had a slightly higher PDI. A PDI of zero was measured in all pavement sections in 2000, 2001 and 2004. Slight variation in PDI from year to year is not uncommon due to differences in the surveyor's interpretation of distresses. The relatively low values (PDI of 20 or less) indicated that the rubblized pavement system performed well during the first eleven years in service, regardless of HMA thickness.

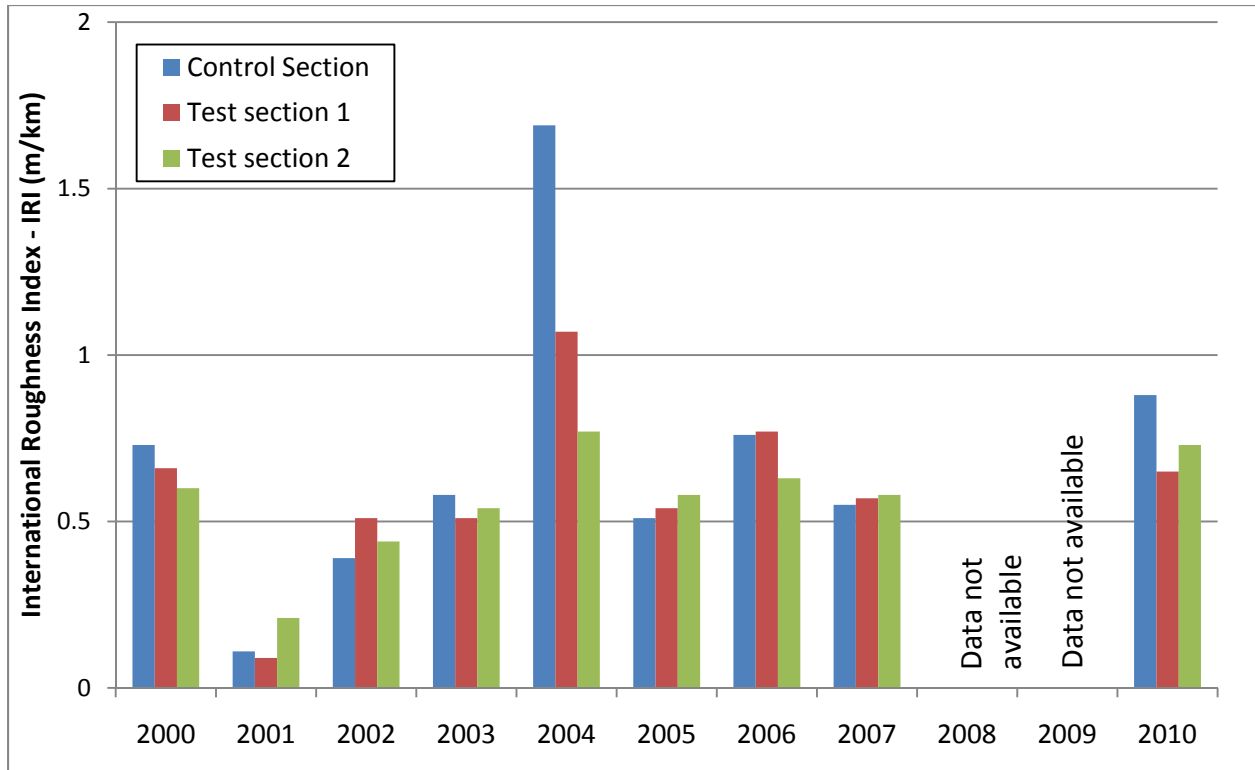
Figure 13. International roughness index survey results.

The IRI value is a measure of pavement ride quality; IRI increases with roughness. For reference, the IRI of the JRCP in the area of the test and control sections was 1.63 m/km prior to the rubblize and overlay project. As expected, there was a slight increasing trend overall in IRI over time (Figure 13). The test and control sections performed at approximately equal levels in most years. In 2010, however, the roughness in the control section was greater than in the thicker test sections. The IRI data indicated excellent performance over eleven years, with values typically less than 1.0 m/km. The data from 2004 was anomalous; the higher measured values could be due to equipment calibration or tracking of the automated survey vehicle. It is puzzling to note that the high 2004 IRI values correlated with PDI values of zero in the same year (Figure 12).

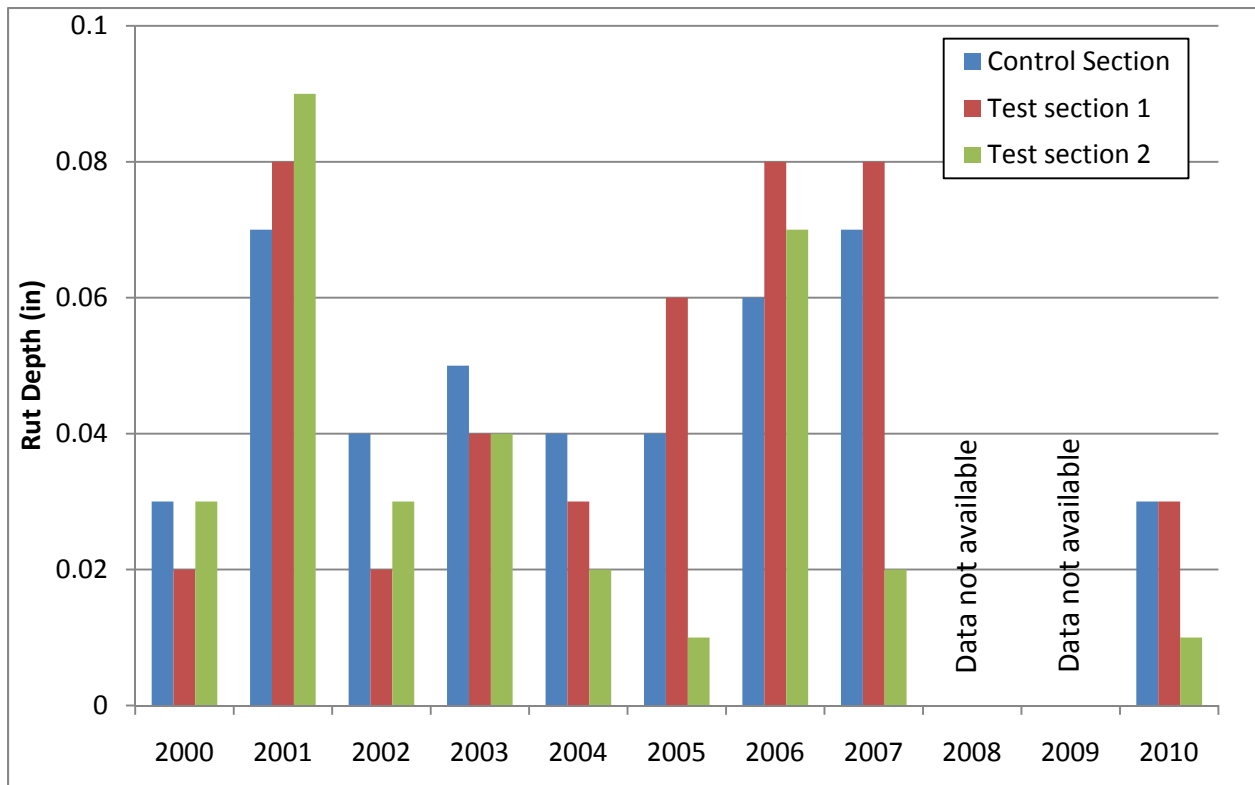
Figure 14. Rut depth survey results.

The measured rut depth data indicates excellent deformation resistance of the pavement layers to truck loads. Rut depth measurements in the test and control sections were less than one tenth of an inch for all 11 years of monitoring (Figure 14). There was no major difference in performance among the sections. As discussed in Section 5.1.2, the measured pavement strain was low in all pavement sections. Low strain at the bottom of the HMA pavement layer typically results in low permanent deformation (rutting), which was confirmed with this survey data.

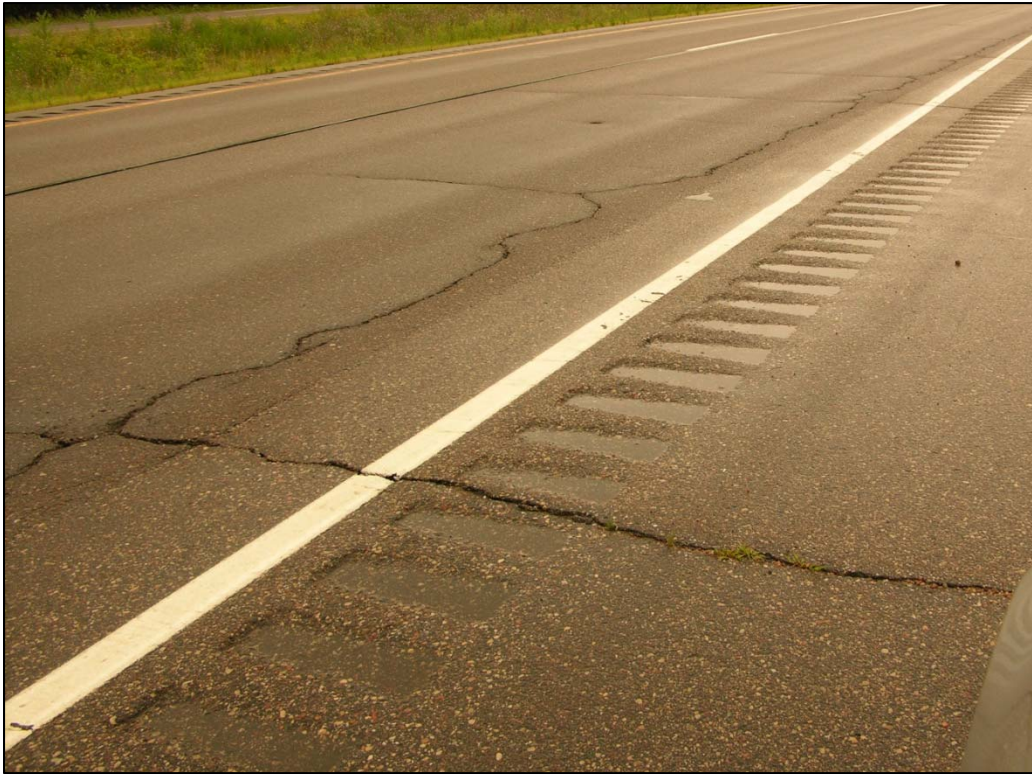
Figure 15. Control section cracking, July 2010.

In the control section, approximately ten transverse cracks were noted. Most of these cracks originated at the paving joint between the right edge of the control section and the left edge of the tapered entrance ramp from CTH HH. It was therefore difficult to determine whether the cracks were due to normal pavement deterioration or if they were caused by paving irregularities in the area of the ramp. In the pavement immediately south of the control section, prior to the ramp, numerous one-foot transverse cracks were noted that originated from the right edge of pavement. In this area, a few transverse cracks extended the entire width of the driving and passing lanes. None of the cracks had been sealed at that time. It is possible that these transverse cracks had reflected through the HMA pavement layer at the locations of former PCC pavement joints. This would indicate that PCC slabs were not broken into small enough pieces during the rubblization process.

In the control section, a 200-ft longitudinal crack was noted at the right edge of the driving lane, adjacent to the tapered entrance ramp from CTH HH (Figure 15). The width of this crack was greater than ½-inch, making it a severity level 2 crack according to the WisDOT Pavement Distress Manual. Ten transverse cracks were present that extended from the longitudinal crack half-way into the driving lane. Similar cracking was noted in the pavement just south of the control section. No cracking was noted in the passing lane of the control section.
