SERB GUARDRAIL
SOUTH ASHLAND INTERCHANGE CALIFORNIA
STATE LINE SECTION PACIFIC HIGHWAY
(INTERSTATE 5) JACKSON COUNTY, OREGON

Final Report

Oregon Experimental Features
Project Number or 88-02

February 1997

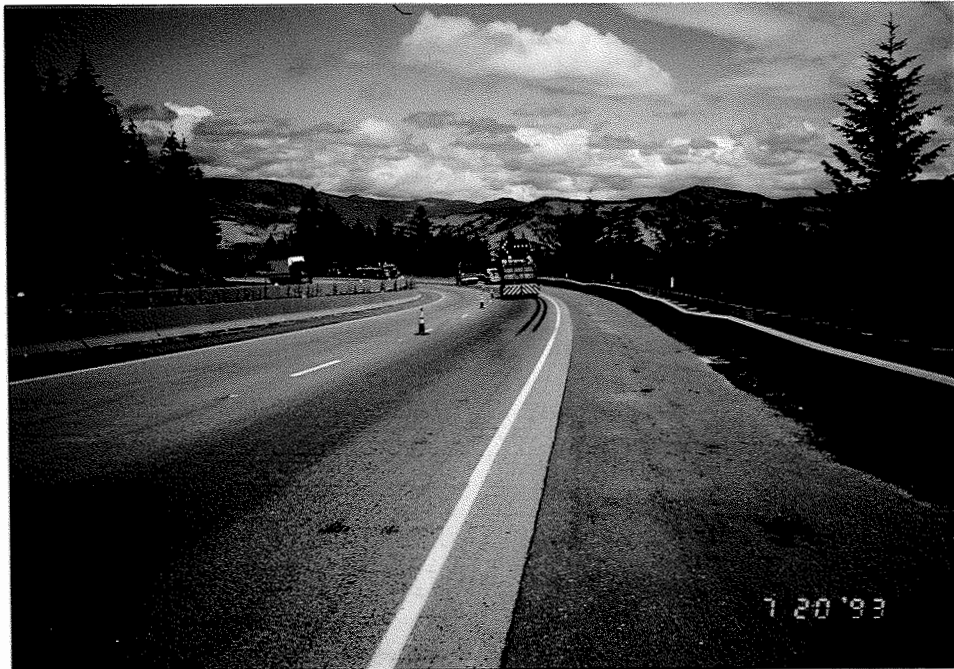
Most of the reported accidents were confined to a section at milepost six. This is a curve to the left with super elevation and on a grade. (See Figure 5.1) Collisions in this area were typically multi-vehicle and involved ice or snow on the road surface. There were as many reported collisions with the median barrier on the left as there were collisions with the guardrail on the right.

Figure 5.1 Many accidents are reported at milepost six.
Also note lane closure for SERB removal.

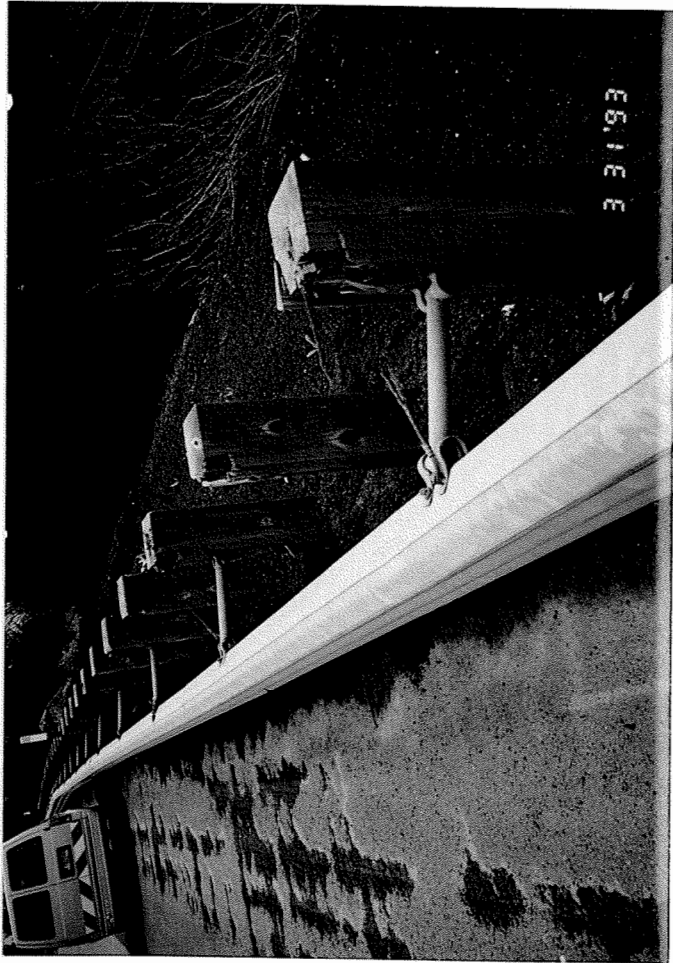
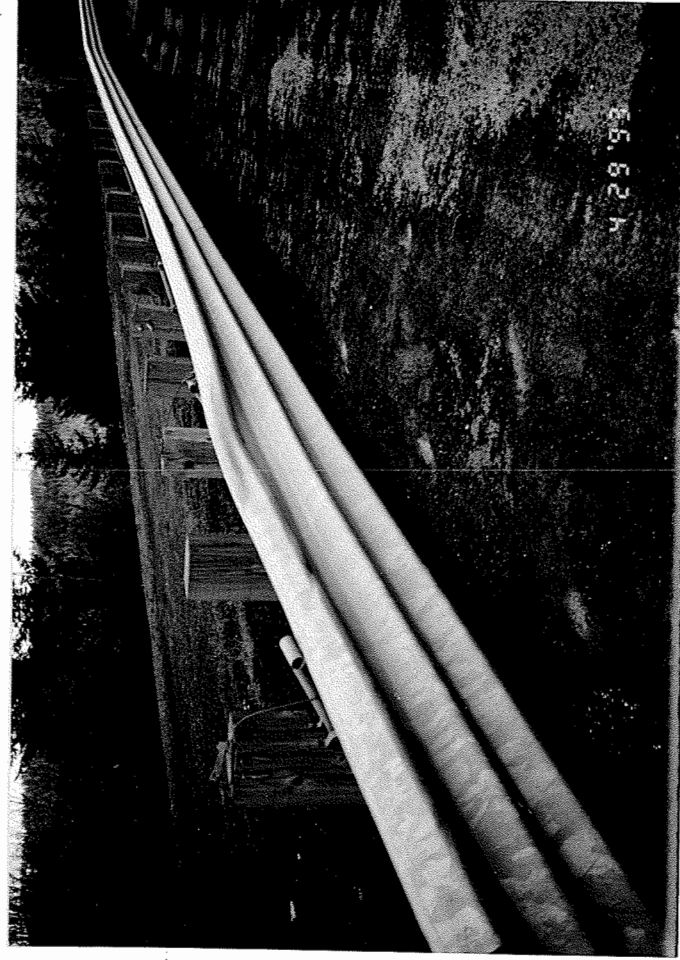
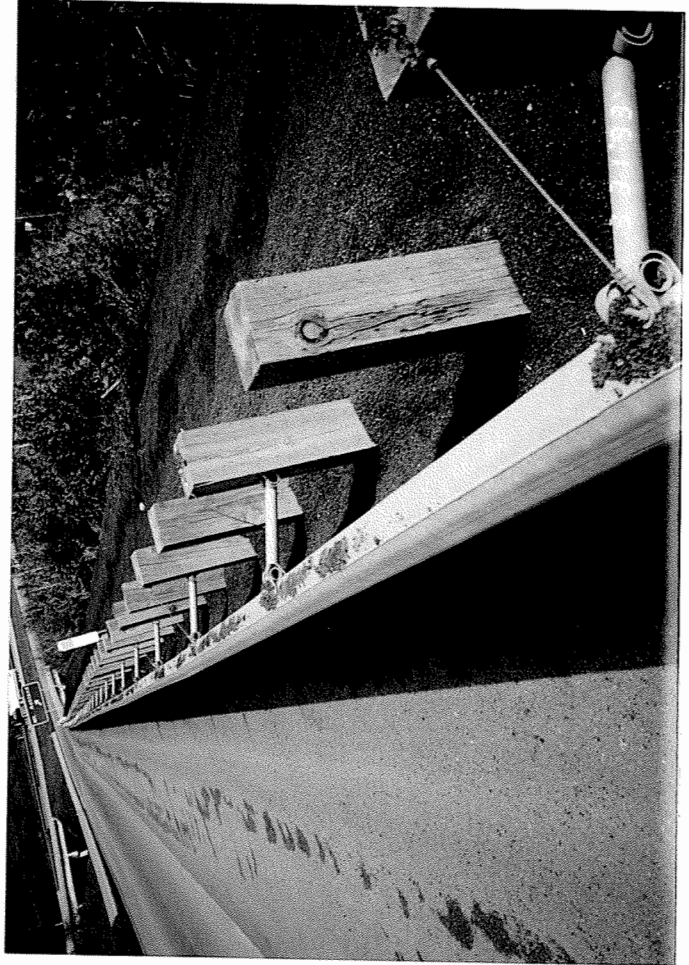
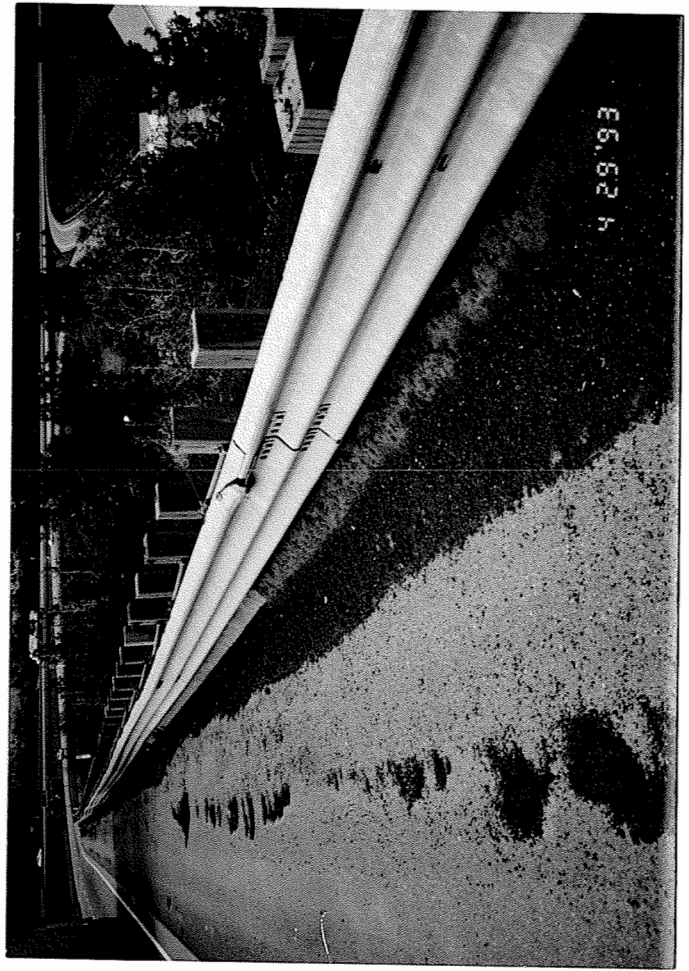
Figure 5.2

Major damage to the SERB Guardrail was done by an out of control tractor-trailer truck in early 1993. This accident was not reported to the DMV but details were deduced from skid marks and damage to the SERB installation. Several posts were split and 2 cables were broken. One section of the three-beam was bent severely. One of the support arms came loose when the arm connecting bolts were sheared by the impact. (See Figures 5.2 and 5.3).

Top right - Dent from impact.
Bottom right - Snow plow gauge.

Top left - Top of posts damaged
Bottom left - Broken cable; cable cutting into post

The broken arm allowed the thrie-beam to rest on the asphalt shoulder. The height of the top of the rail was only 23 inches at this section. The recommended minimum is 28 inches to prevent vaulting on a vehicle impact.

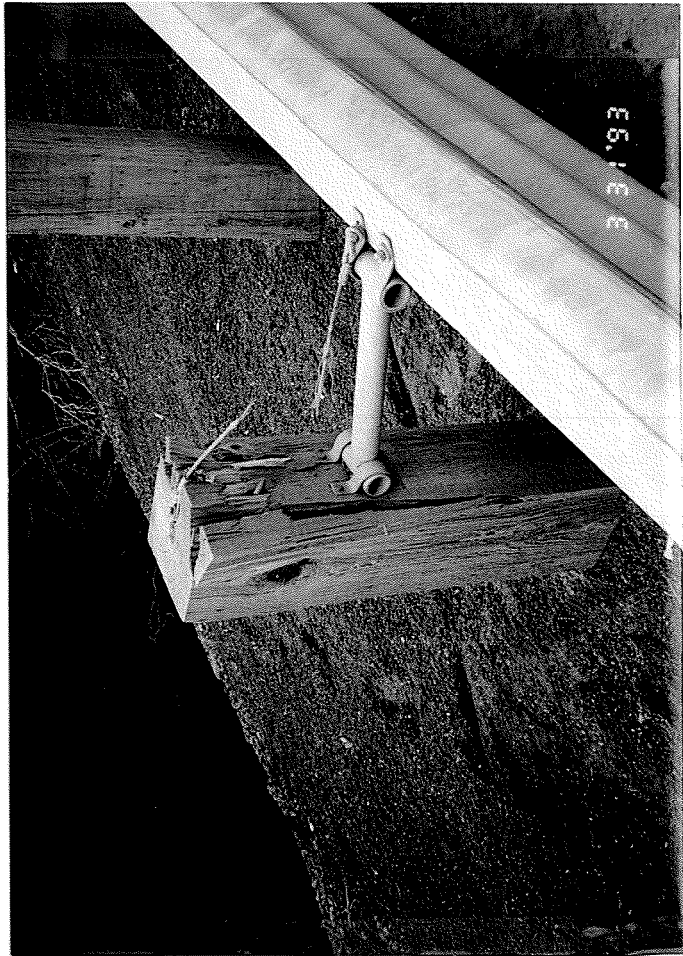
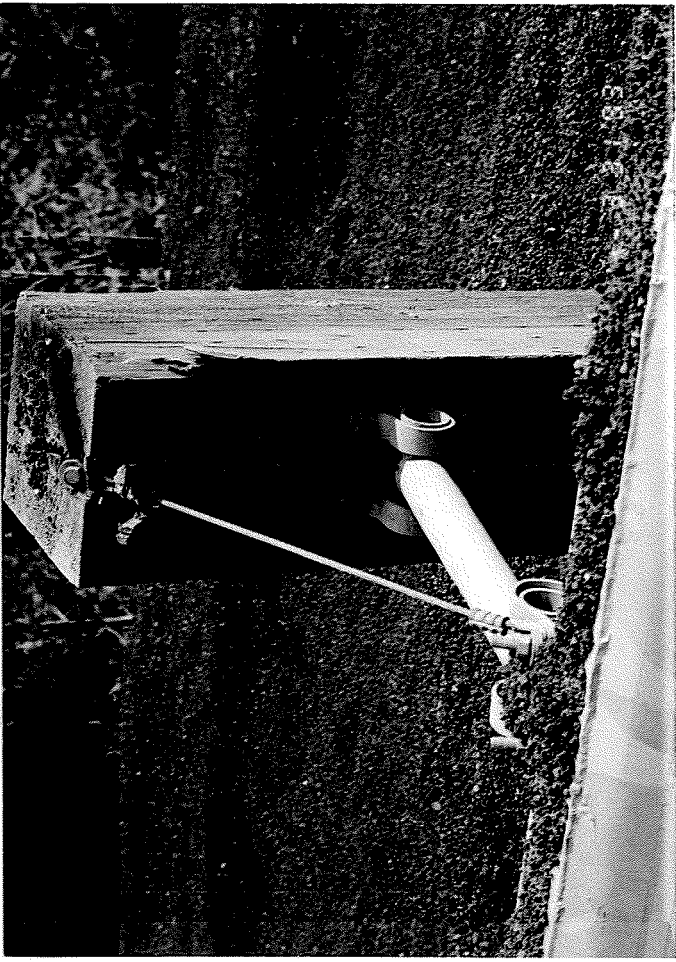
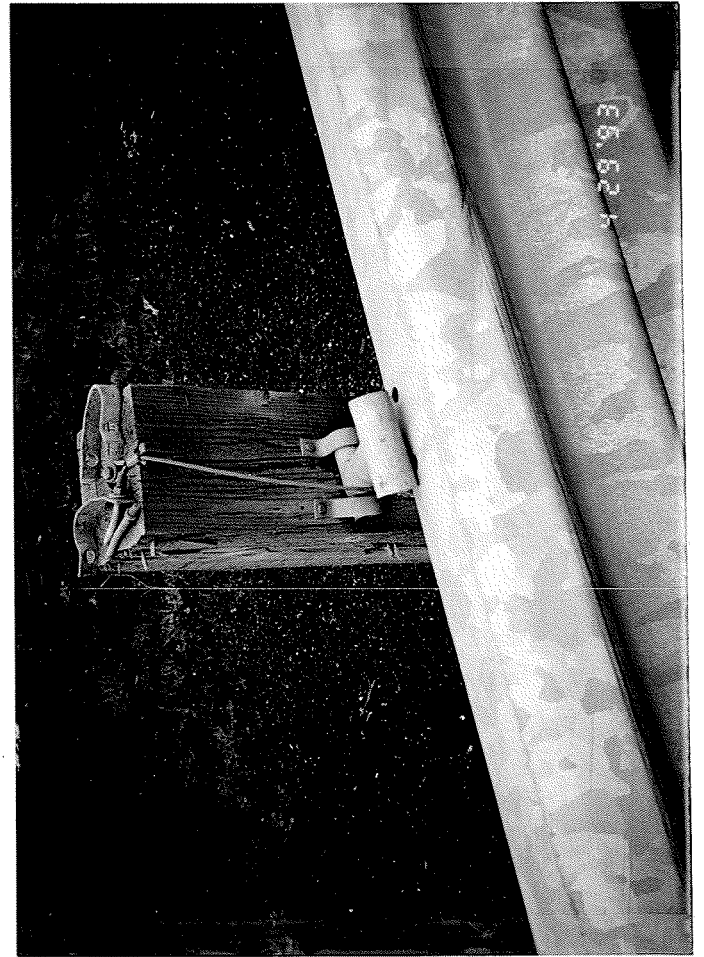
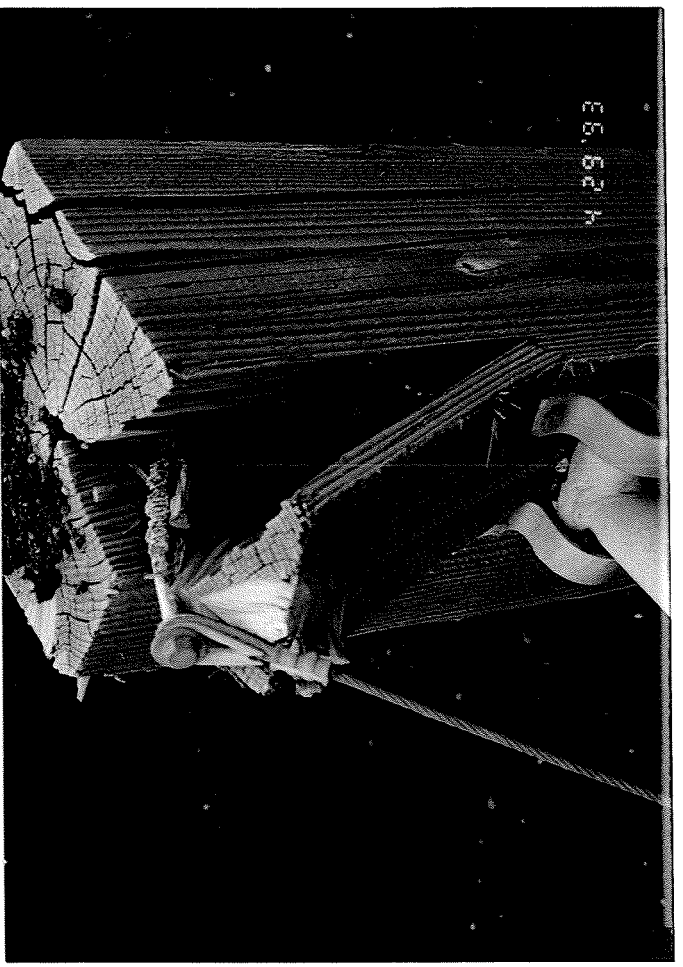
Figure 5.3 Typical damage to SERB Components
 Top right - Post splayed by cable, lag bolt pulled to side.
 Top left - Post split and cable broke by impact
 Bottom left - Sheared not clamp bolts sheared from pivot arm
 Bottom right - Post split - lag bolt pulled to side and bent Not corded threads.

The main cause of the sag was found to be movement of the lag bolts in the post. Some bolts were partially pulled out the from post top and leaned toward the rail top. In other cases the posts split, allowing the bolt to move toward the rail top. A few bolts were sheared off at the post top.

Snow plow operators observed that the action of snowplowing caused the SERB to activate. After the plow passed, the SERB would return to its rest position very abruptly. This jarring is believed to be the cause for the lag bolt shift in the post (See Figure 5.3).

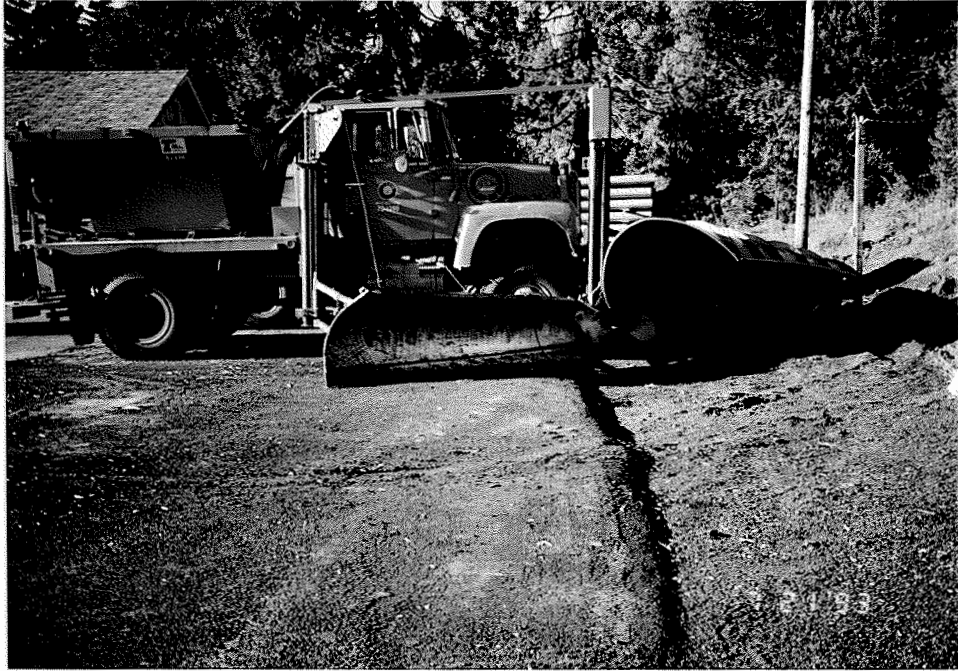
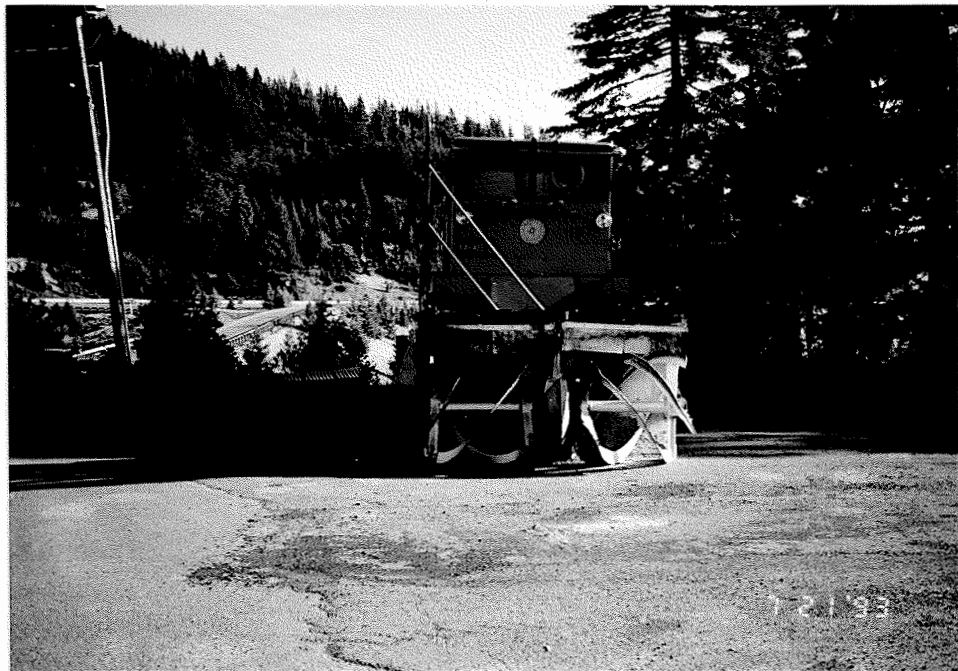
Figure 5.4 Snow removal equipment used on Syskiyou grade.
Truck mounted snowplow(top). Snow blower (bottom).

Much of the sagging problem was caused by snow plow operations. Snow plows impact on standard guardrails is only minor. Since this section receives several snow storms each year, it is important to keep the roadway plowed. Keeping the plows from hitting the SERB was not practical.(Figs. 5.4)

ODOT maintenance forces decided to remove the SERB installation rather than experiment with repair methods. Standard repair methods had not been established and were believed to be costly(see section 4.2).

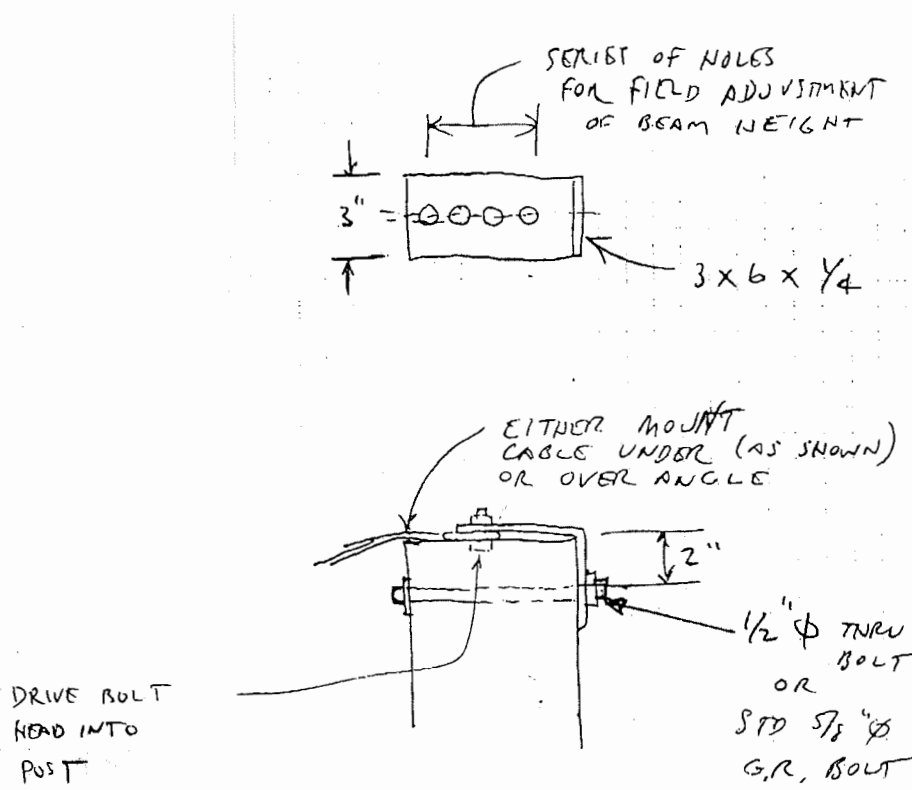
Figure 5.5 Drawing of suggested improvement for cable mounting.

The damaged section of the SERB which was resting on the shoulder needed quick repair. Also, many sections of sagging rail needed to be raised. Several solutions were suggested. One was to jack the rail up and attach the cables by placing the lag bolts on the back of the post. Another was to place a steel plate on the post top to prevent the cable from cutting into the post. The damaged rail could be cut with a torch and a new section welded into place (See Figure 5.5).

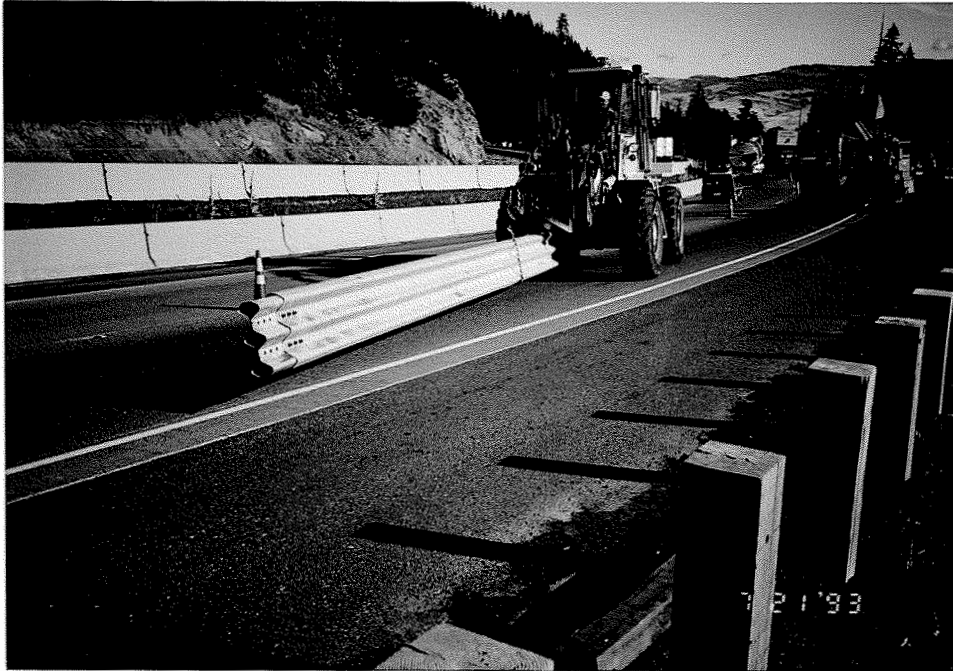
Figure 5.6 A special attachment for the front end loader was rented to move SERB sections.

The entire installation was removed in July of 1993. Removal called for one lane of traffic to be closed, in order for the equipment to maneuver. The rails were unbolted at the splice plates and removed by a front end loader. A special hydraulic lift attachment for the front end loader had to be rented for this job. The operator lifted the SERB sections by balancing the beam as a counter lever. A chain connected near the hoisted end secured the section. This was a slow process and required a great deal of skill by the loader operator.(See Figure 5.6) This same method was used to load the SERB onto a trailer.
