**ASPHALT CONCRETE  
PATCHING MATERIAL  
EVALUATION**

**Interim Report**

**SR 548**

**June 2001**

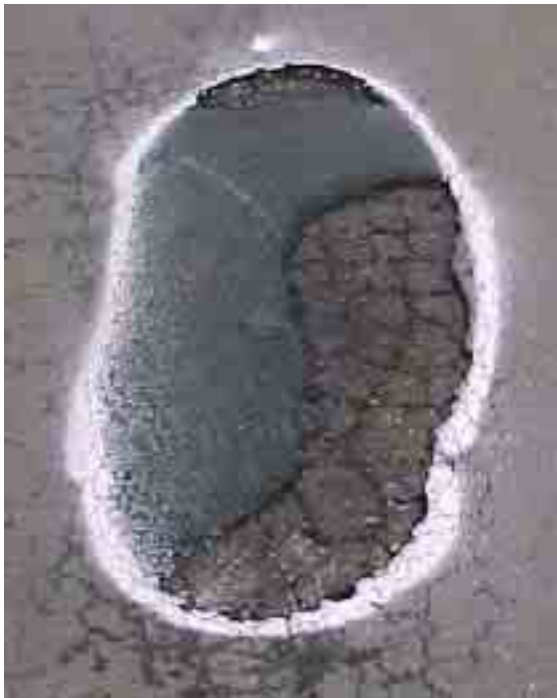
Figure 4.9: Albany mix partial failure

- One of the Albany mix potholes was a partial failure (Figure 4.9), which could have been caused by not rolling over the whole 457-mm (18-in) wide patch. This partial failure changed little over five months of monitoring. The other Albany mix patch was a complete failure (Figure 4.10).
- The Instant Road Repair patch failure resulted from the center portion wearing away (Figure 4.11).
- The King Patch product was a complete failure in less than a week.

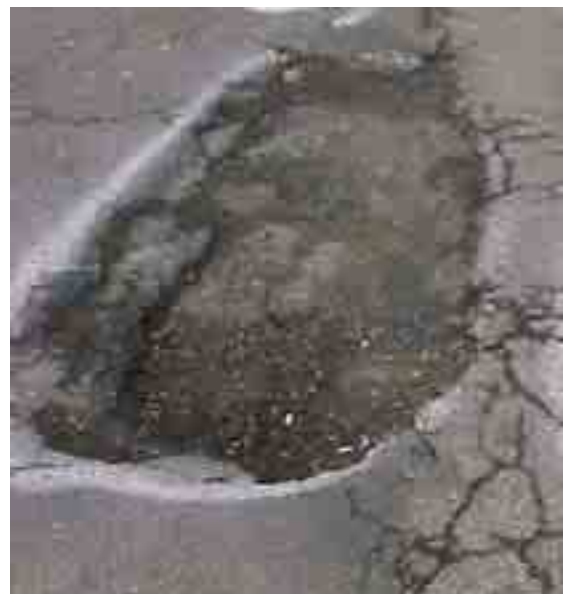
Figure 4.10: Albany Mix complete failure

Of the ten natural potholes patched on Century Drive in wet weather, four had failed when inspected a week later – two Albany Maintenance Yard stockpile material patches, an Instant Road Repair patch, and the King Patch:
