**BASE ISOLATION BEARINGS  
(Dynamic Isolation Systems, Inc.)**

**Construction Report**

**OR-EF-91-02**

Steve Starkey, P.E.  
Senior Structural Design Engineer  
Bridge Design Section  
Oregon Department of Transportation

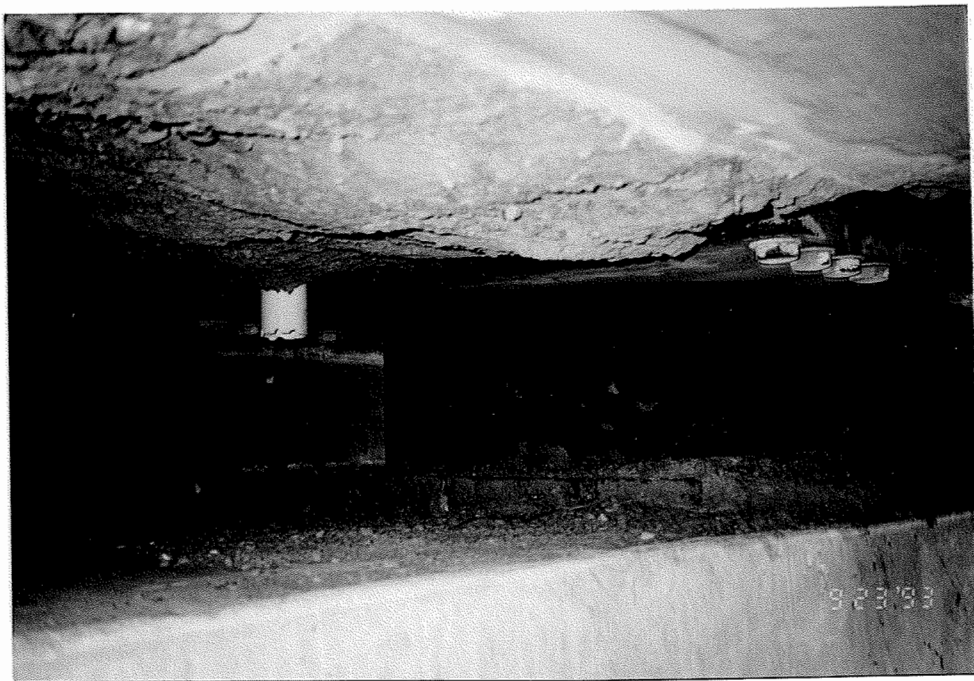
Figure 4.2 The circular bearing at bent 7 of BR.# 9669A is also inclined to vertical, and has a slight bulge.

- Bent 7: Right bearing shows slightly more bulging in upper portion. Offset about 1" as described for bent 6. No other defects noted.
- Bent 8: Offset about 2" (top toward bent 7). No defects noted.

All bearings should have continued serviceability monitoring. Special attention should be given to the right bearings of bents 2, 6 and 7 to verify the detected flaws are not serious.
