## Asphalt Cement Chip Seals – How Have They Done?

### Inspections in 2001

## March 2002 Inspection

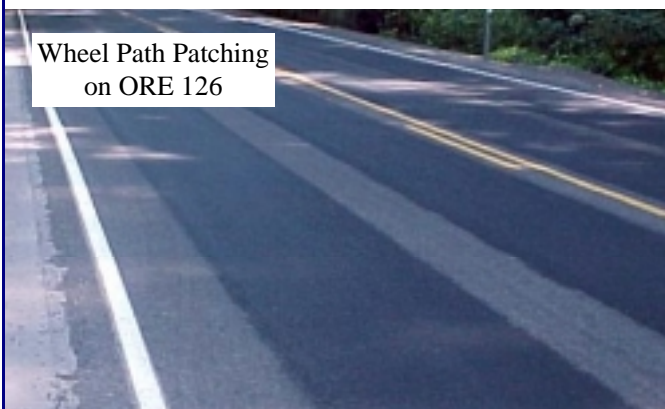
The second ORE 126 project beginning at MP 26 had 90% chip retention for most of the project. Bleeding was higher on the western part of the project from MP 26 to 28.5. The eastern section, from MP 29 to 31.2 had many wheel path patches. Most of the chip loss occurred in the curves.

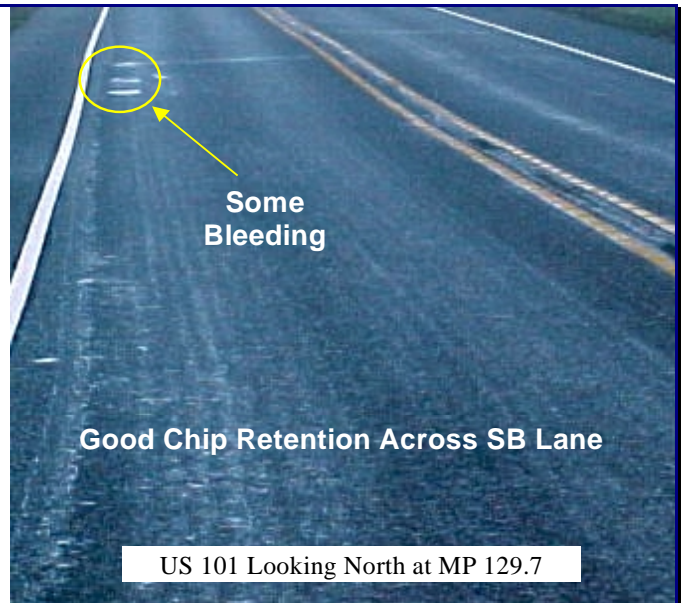
On the US 101 chip seal, bleeding was minimal. Chip retention was also very good through most of the 1.2-mile chip seal section, except for some isolated spots under canopy shade and in the curve sections.

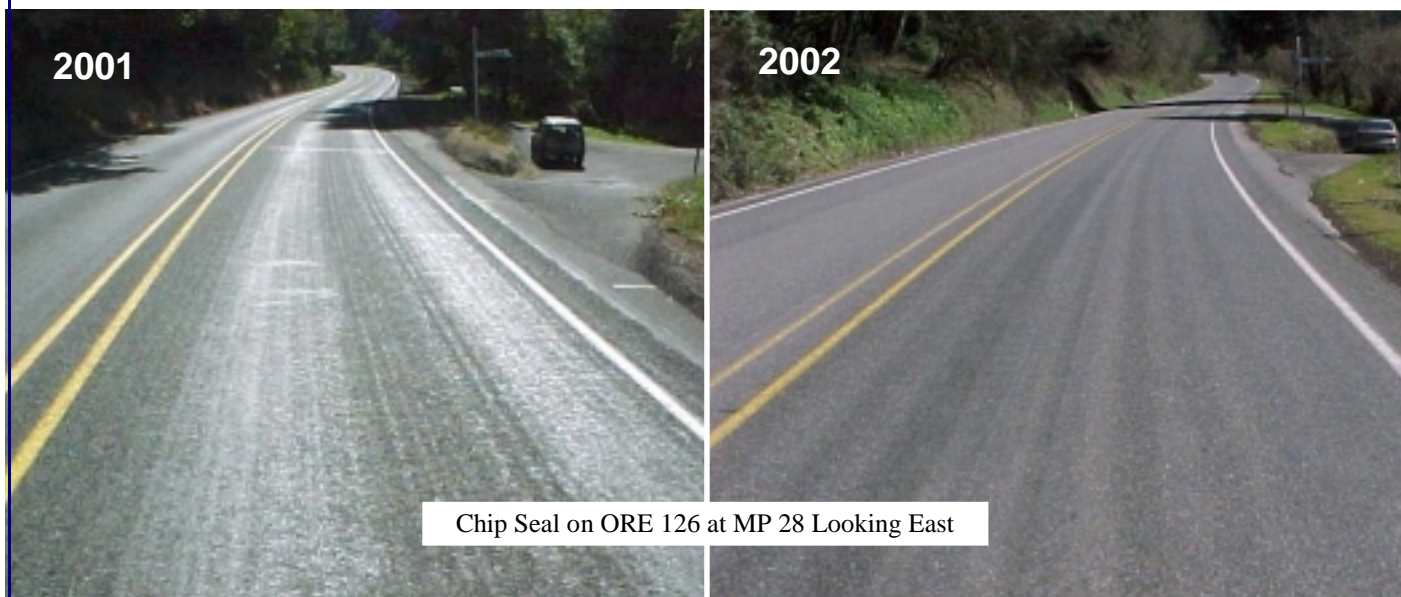
The skid numbers increased from September 2001 to March 2002. The increase can be attributed to a reduction in the amount of bleeding at the pavement surface. Loss of the excess binder at the surface, coupled with good chip retention, has resulted in an increase in skid resistance. The results of skid testing, with the mean skid number value for each section, are provided in the table below:

This March, a follow-up inspection found chip loss about the same, but bleeding was much less visible. In the pictures below, the left picture shows excess asphalt in the wheel path on ORE 126 in September 2001. The right image is the same location in March 2002; it shows significantly less bleeding.
