## Investigating Moisture Damage to Pavement

**Oregon Department of Transportation**  
**Research Section**  
**200 Hawthorne Ave. SE, Suite B-240**  
**Salem, OR 97301-5192**  
**Telephone: 503-986-2700**  
**FAX: 503-986-2844**

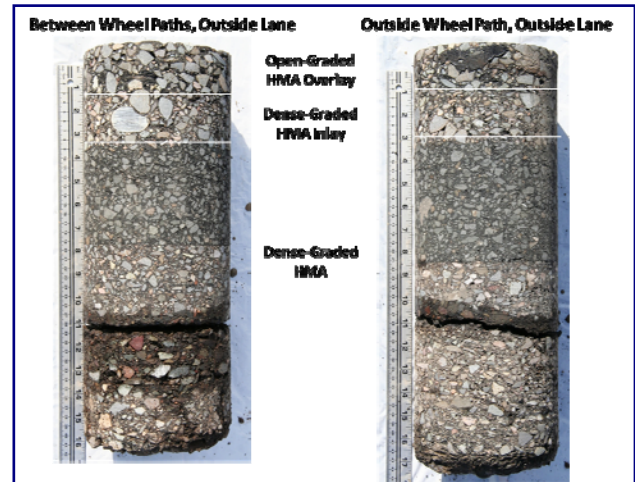
For each project, field investigations were conducted, ODOT maintenance personnel were interviewed, and records were reviewed. Where possible, core samples were collected and historic records of pre-rehabilitation cores were examined. Thickness, layer identification, and the condition of each core (Figure 1) were evaluated and were noted in a core log. Laboratory testing of the cores included permeability and volumetric tests, as well as bulk specific gravity tests.

Figure 1: A Comparison of Adjacent Core Samples

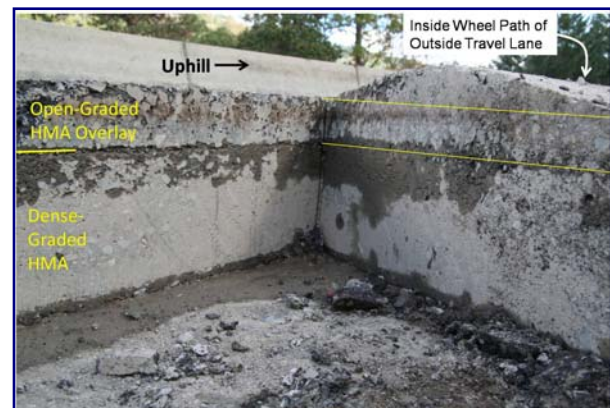
In addition, in three of the project areas, trenches were excavated. The trenches measured approximately 2-foot wide, extended across the entire width of the outside travel lane, and were excavated to full pavement depth, through all layers. Visual assessments were made of exposed pavement layers in trench profiles (Figure 2).

Figure 2: One of the Trenches Excavated for the Investigation

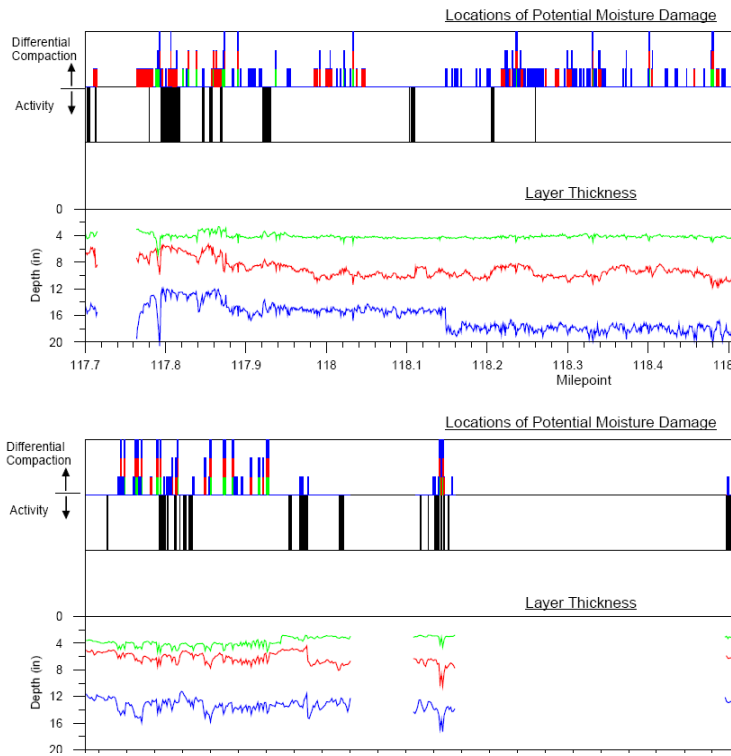
Ground penetrating radar (GPR) surveys of the project sites were also made to evaluate this testing technique. The survey results from an investigation site are shown below in Figure 3.

Figure 3: Ground Penetrating Radar Results Showing the Locations of Potential Moisture Damage
