MODIFIED ROCKFALL CATCH FENCE  
MAYFLOWER CREEK - DETROIT DAM

Experimental Feature  
Final Report

OR 84-01

MAYFLOWER CREEK - DETROIT DAM  
NORTH SANTIAM HIGHWAY #162  
MARION COUNTY  
EXPERIMENTAL PROJECT NO. 84-01  
AUGUST 8, 1988

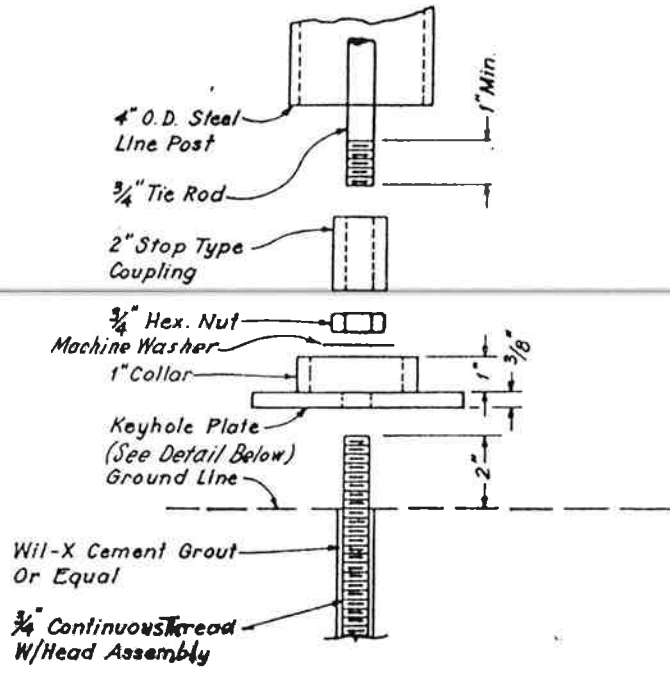
EXPLODED VIEW DETAIL 'E'

The rock bolt fence post assembly is shown on Figure 4. The construction sequence was as follows. First, a hole was drilled into the rock and a continuously threaded rock bolt, 3/4 inches in diameter by 24 inches long, was grouted in place. Next a key hole plate and hex nut were put on the rock bolt. The rock surface had been preleveled for the plate. The nut and plate were set so one inch of the rock bolt extended above the hex nut. A two-inch stop type coupling was added and above this a 3/4-inch steel tie rod was installed. Extra tie rod length was included to accommodate slope variations. A four-inch O.D. steel fence post (minimum length six feet) slid over the tie rod. Longer fence posts were used where needed to maintain a level top fence line. The tie rod was cut so that one inch extended above the fence post. To the top of the tie rod a 1/4-inch steel plate and a one-inch eye bolt with a 3/4-inch tap was installed and used to tighten the fence post in place.

There were a few construction concerns with this feature. The first was due to the contractor and his fabricator misinterpreting the plans. They understood the plans to call for the key hole plate to be welded to the bottom of the fence posts. This made tightening the hex nut and the stop type coupling impossible. This error was corrected in the field by cutting the plates off the posts and regalvanizing the steel. The attached expanded assembly sequence drawing (Figure 5) which is now included in the plans has corrected this type of problem from occurring on recent projects.

Finally, although attention was given to properly tightening the threaded eye bolt on top of the post, the fence posts had a tendency to slip along the key hole plate. Movement occurred when the fence support cable running from post to post was tightened to the prescribed amount. This caused no appreciable construction problems. However, on recent projects, this slippage has been eliminated by adding a one-inch high sleeve to the key hole plate. This addition is also shown on Figure 5. The short sleeve does not hinder tightening the hex nut or the stop type coupling, but helps to strengthen the system.

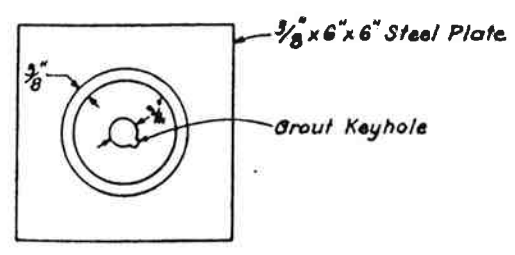
KEYHOLE PLATE

Secondly, the contractor had difficulty developing level surfaces for the key hole plates in the rock. The rock tended to spall off along lines roughly parallel to the slope. This problem may have been avoided if a little more care and effort had been taken. In some cases the contractor had to develop level surfaces with grout. This proved to be an effective solution.
