CONDITION MONITORING OF CONTINUOUSLY
REINFORCED CONCRETE PAVEMENT

HP&R #5264
Final Report

Oregon Department of Transportation
Highway Division
Research Unit

March 1991

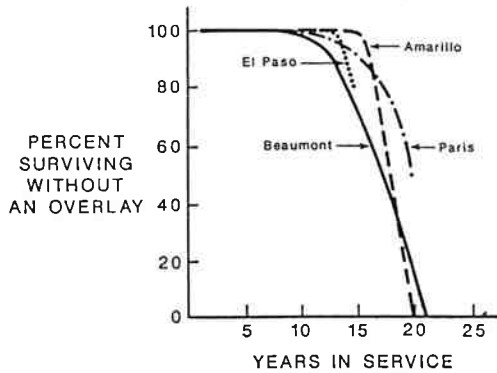
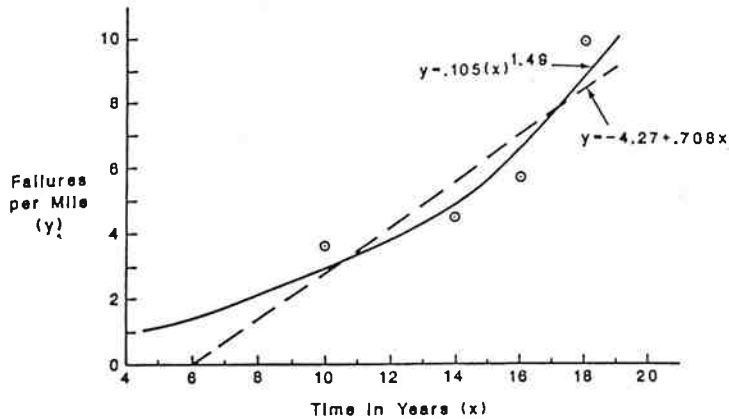
The graphs at the left, were extracted from the third Texas study. Both show trends which support the average time to failure of about twenty years. They also indicate that failure, once it begins, grows rapidly.

It is possible that Oregon's highways will have a longer average time to rehabilitation but that failure will increase rapidly. One interesting conclusion of the Texas study was that rainfall and design parameters had more effect on failures than traffic loadings. The Illinois study, discussed next, used only axle loads and design parameters to predict failures.
