**INVESTIGATING PREMATURE  
PAVEMENT FAILURE DUE TO  
MOISTURE**

**FINAL REPORT**

**SPR 632**

Oregon Department of Transportation

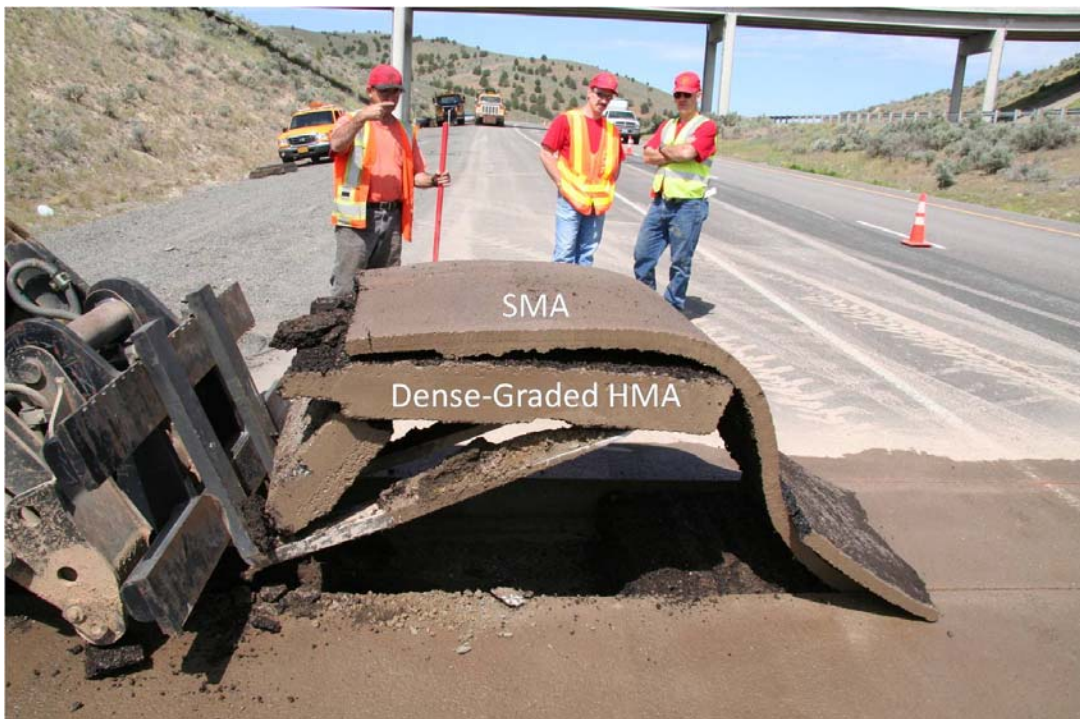
Figure 3.4: SMA Wearing Course Delaminating from Underlying HMA Course.

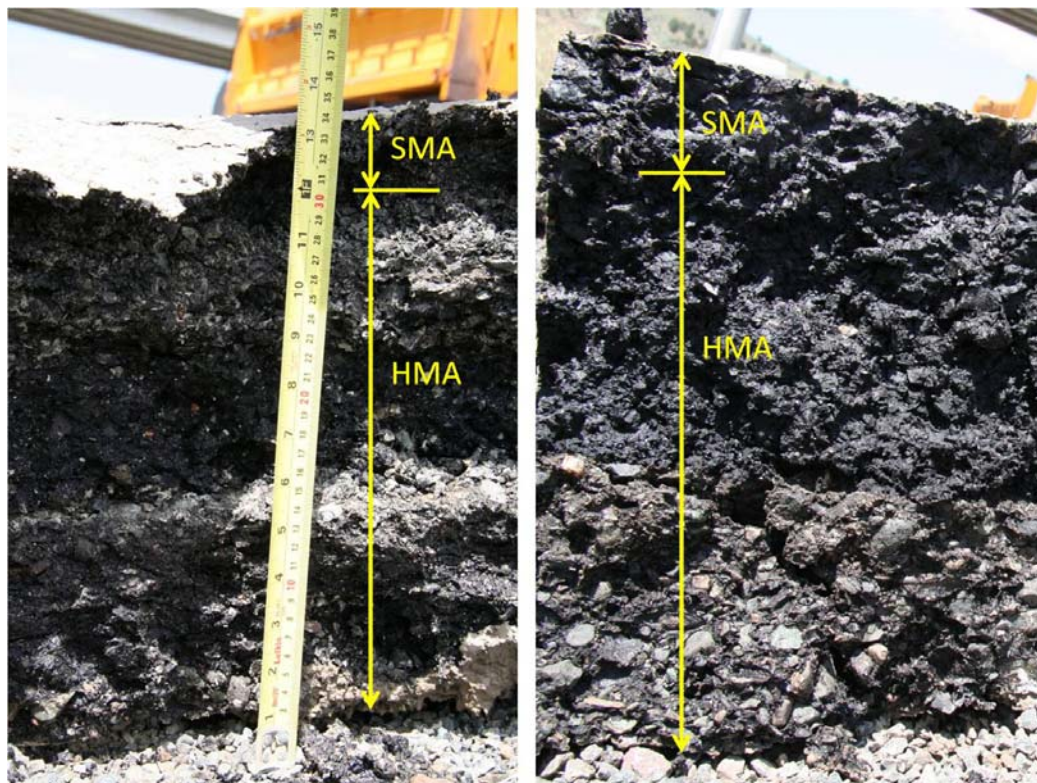
Figure 3.8: View of Stripping in the Bound Layers at MP 323.5.

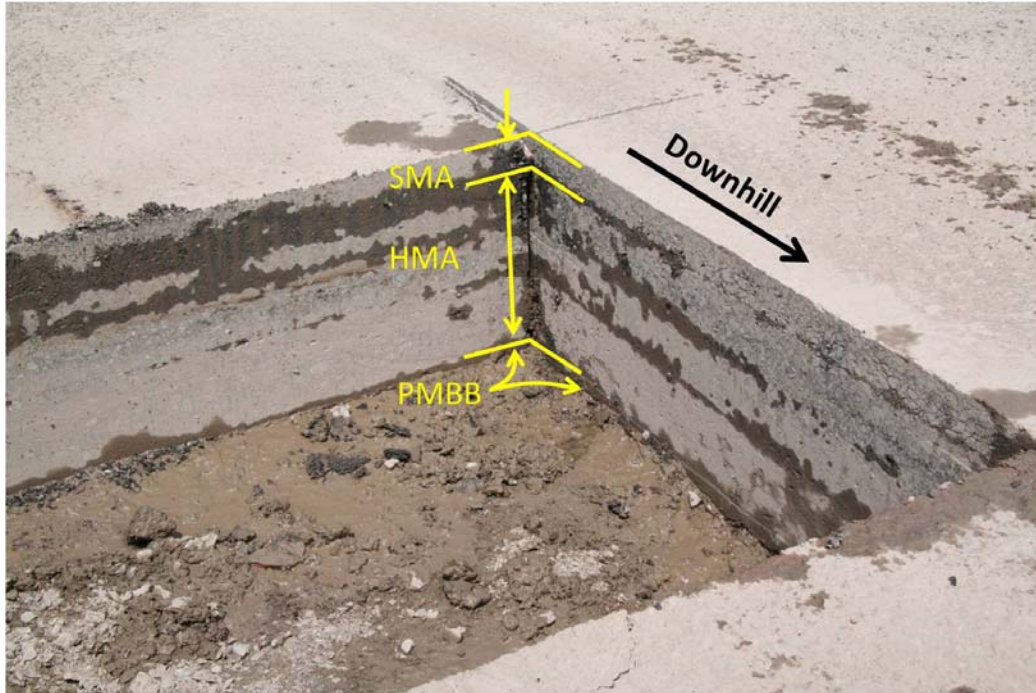
Figure 3.9: Uphill and End Faces of Trench at MP 323.5 Approximately Two Hours after Excavation.

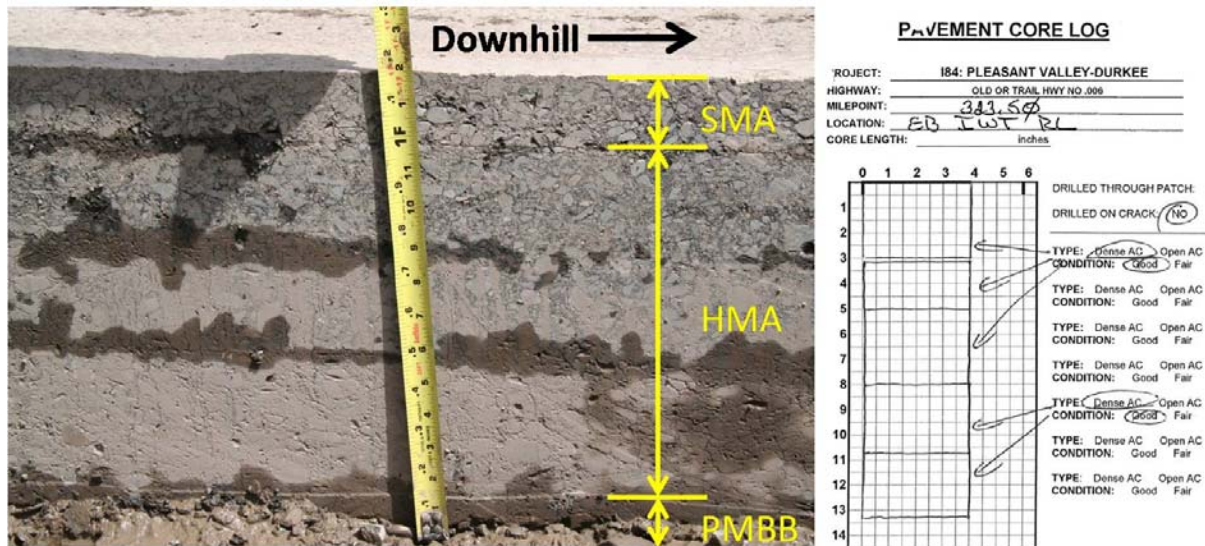
depths of water seepage within the HMA layers correspond with the layer interfaces identified in the pavement core log (Figure 3.10) at depths of five and eight inches.

Figure 3.10: End Face of Trench at MP 323.5 Approximately Two Hours after Excavation.

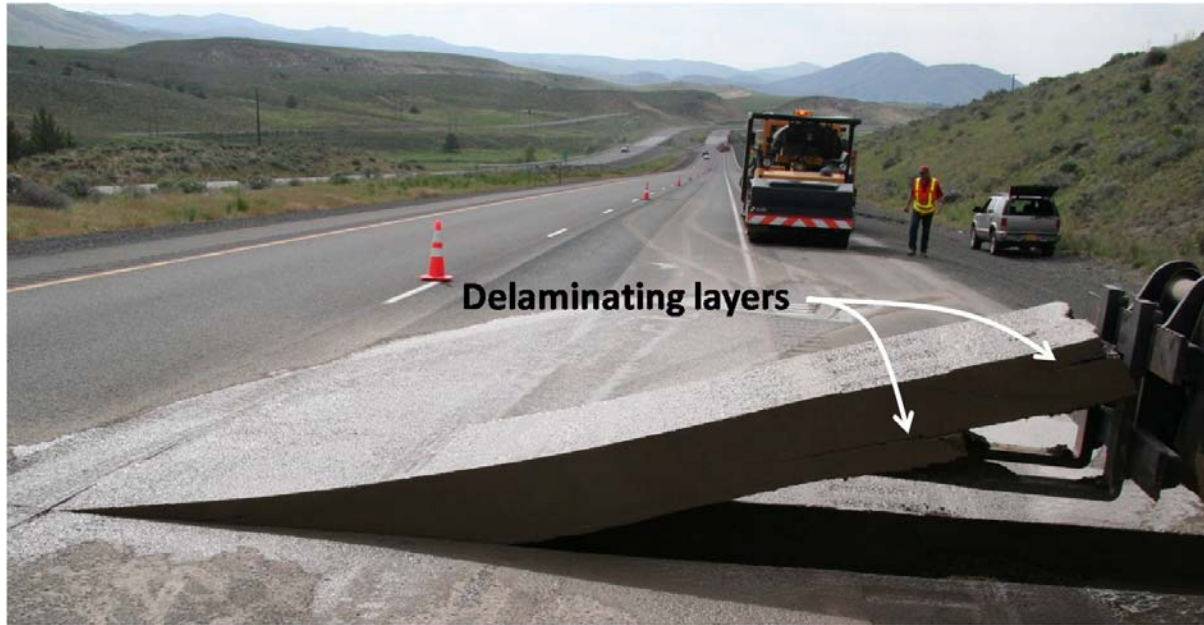
Figure 3.11: Pavement Layers Delaminating During Removal.

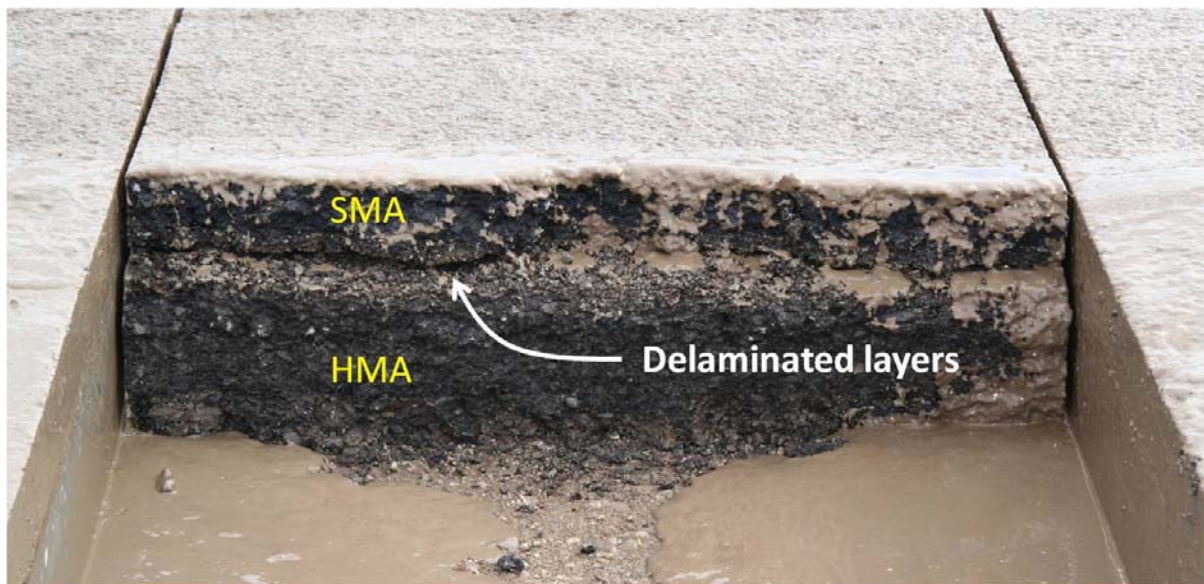
Figure 3.12: SMA Wearing Course Delaminated from HMA Layers.

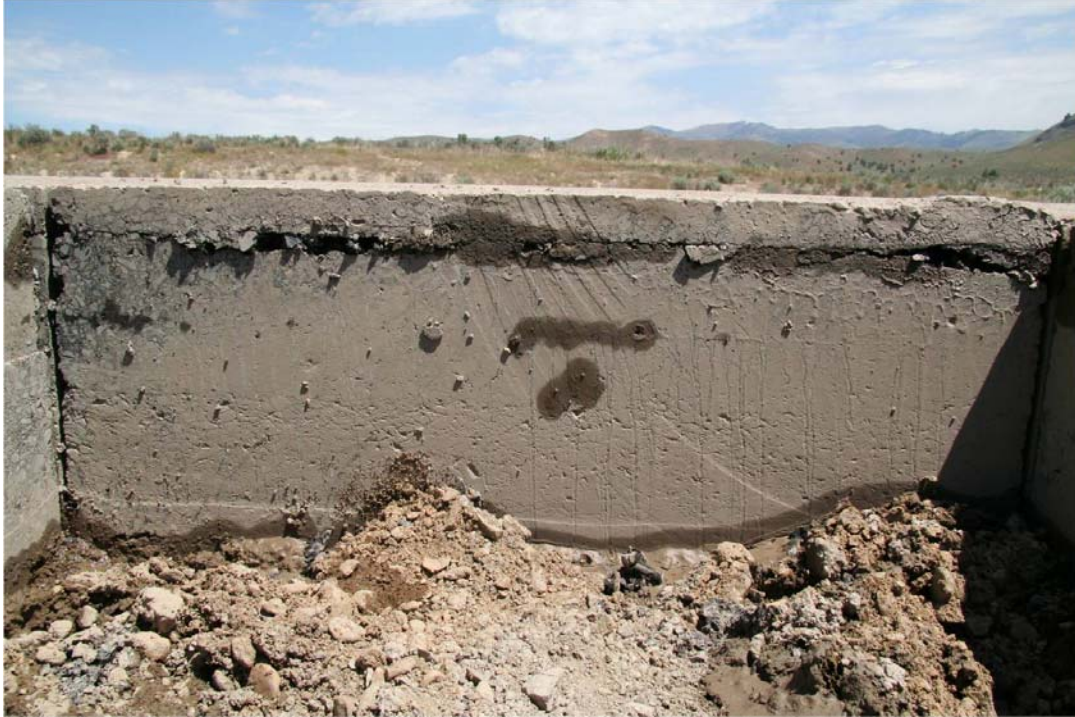
Figure 3.13: Wearing Course Delaminated from the HMA Course at the End of the Slab.

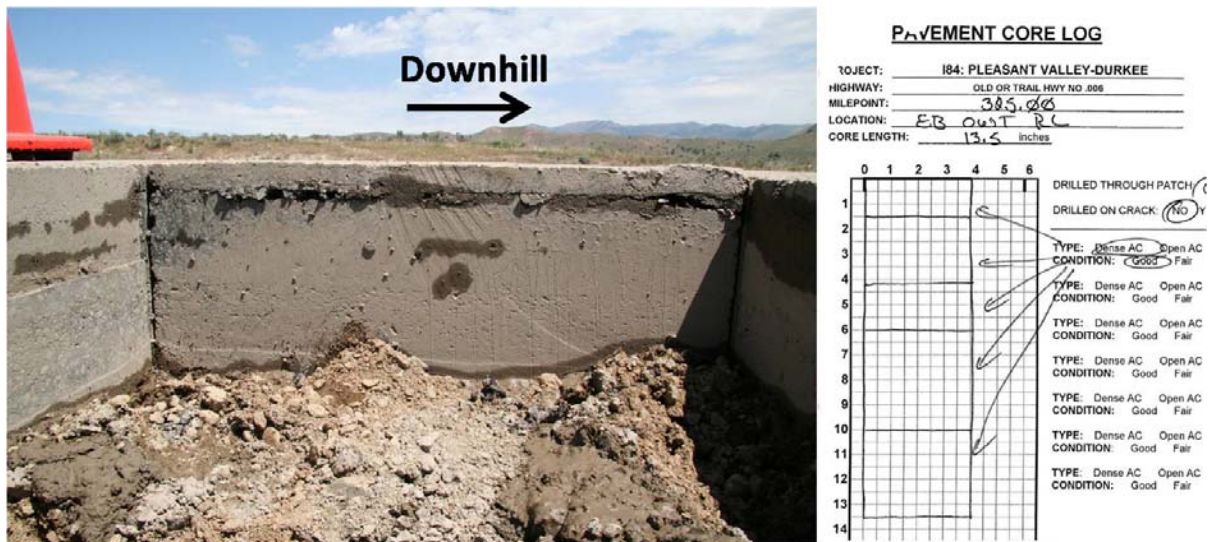
- The photo in Figure 3.19, also taken over two hours after the trench had been opened, indicates water seepage at the delaminated layers as well as through the upper portion of the HMA layers. Note that the depths of water seepage within the HMA layers correspond with the layer interfaces identified in the pavement core log at depths of four and six inches. Note also the wet patch near the top of the downhill face of the trench, which indicates water seeping out of the SMA/HMA interface.

Figure 3.19: End Face of Trench at MP 324.9 Approximately Two Hours After Excavation.

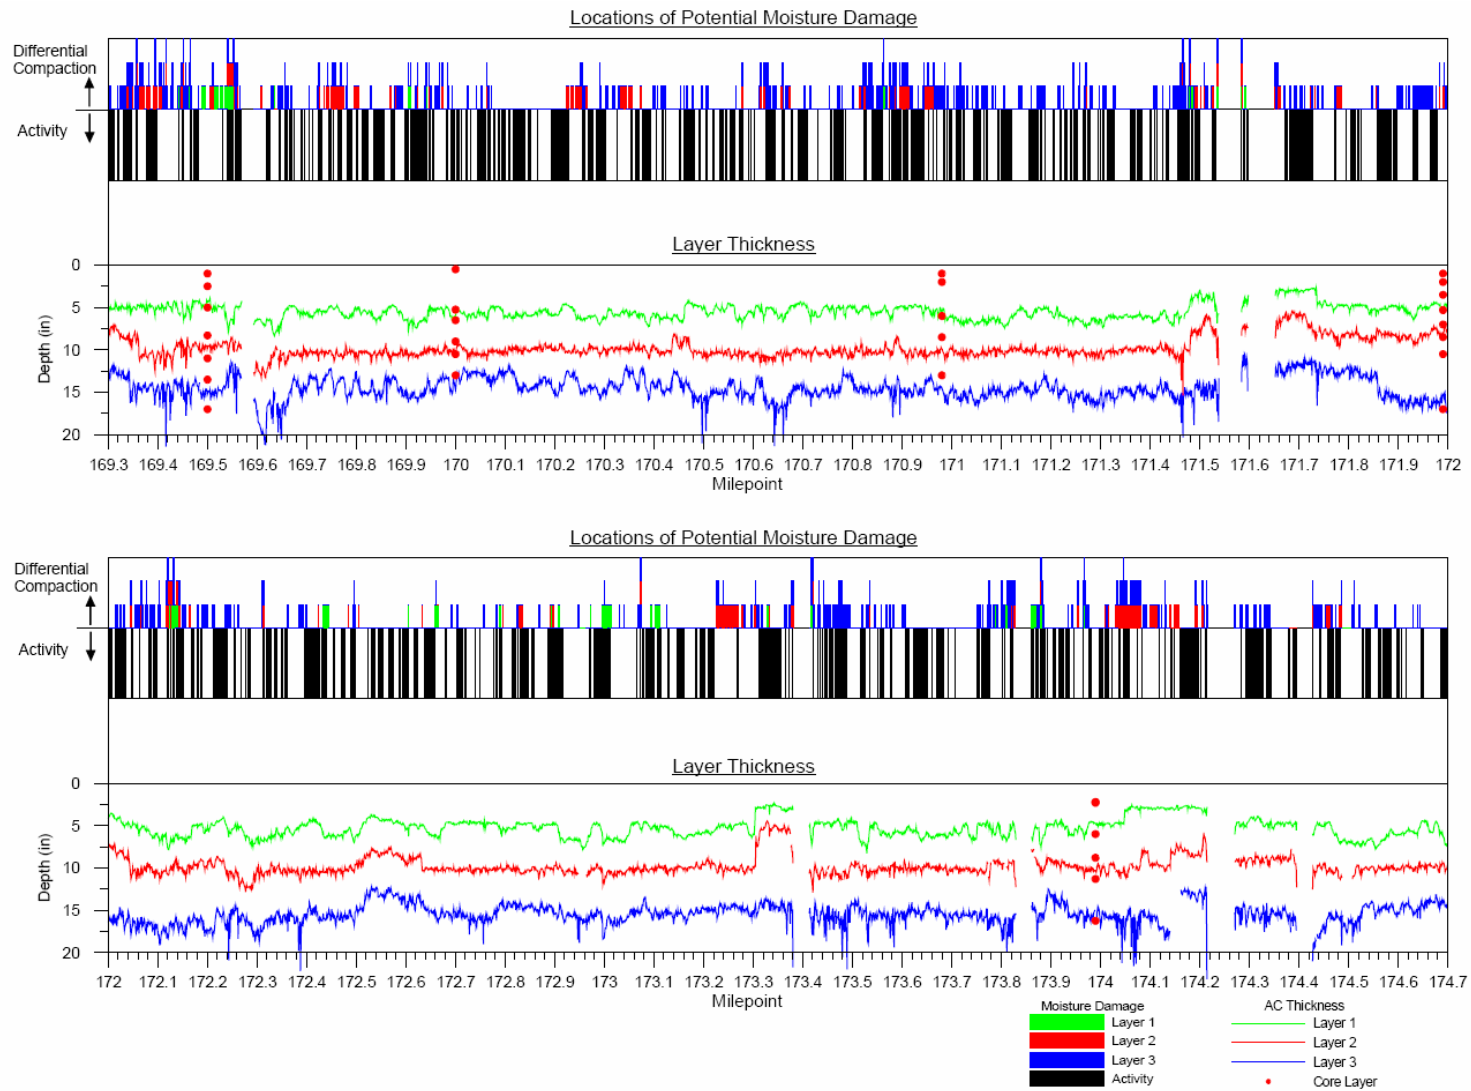
Figure 3.21: Locations of Potential Moisture Damage for the Cottage Grove – Martin Creek Project, Southbound Lanes.

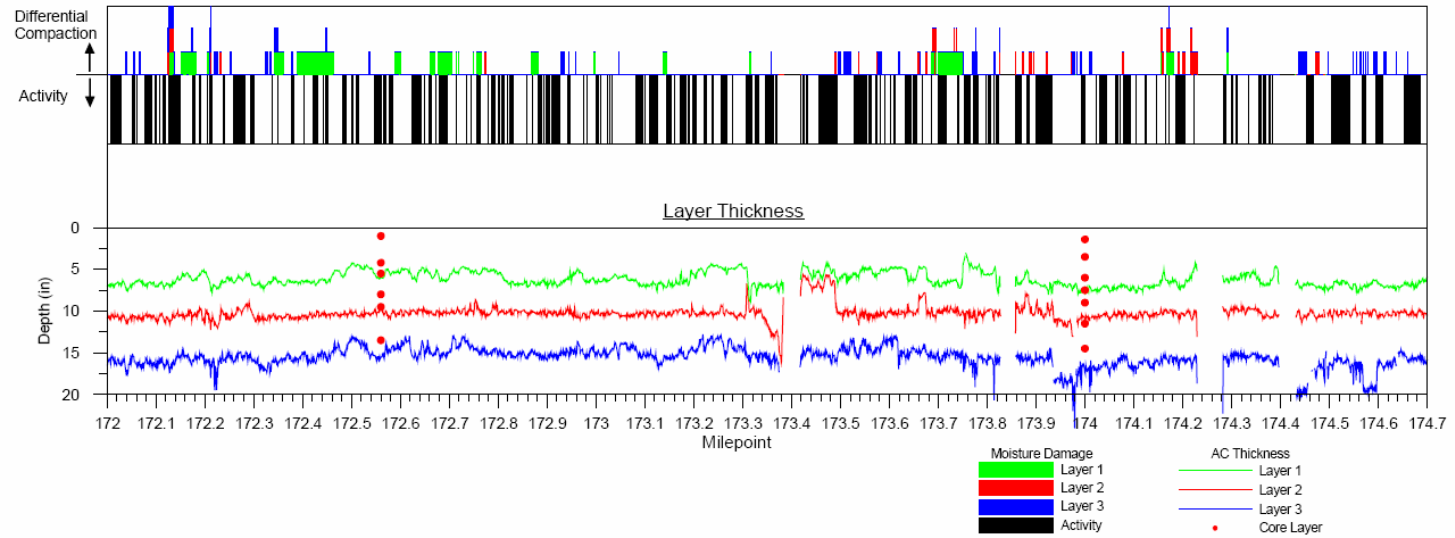
Figure 3.22: Locations of Potential Moisture Damage for the Cottage Grove – Martin Creek Project, Northbound Lanes.

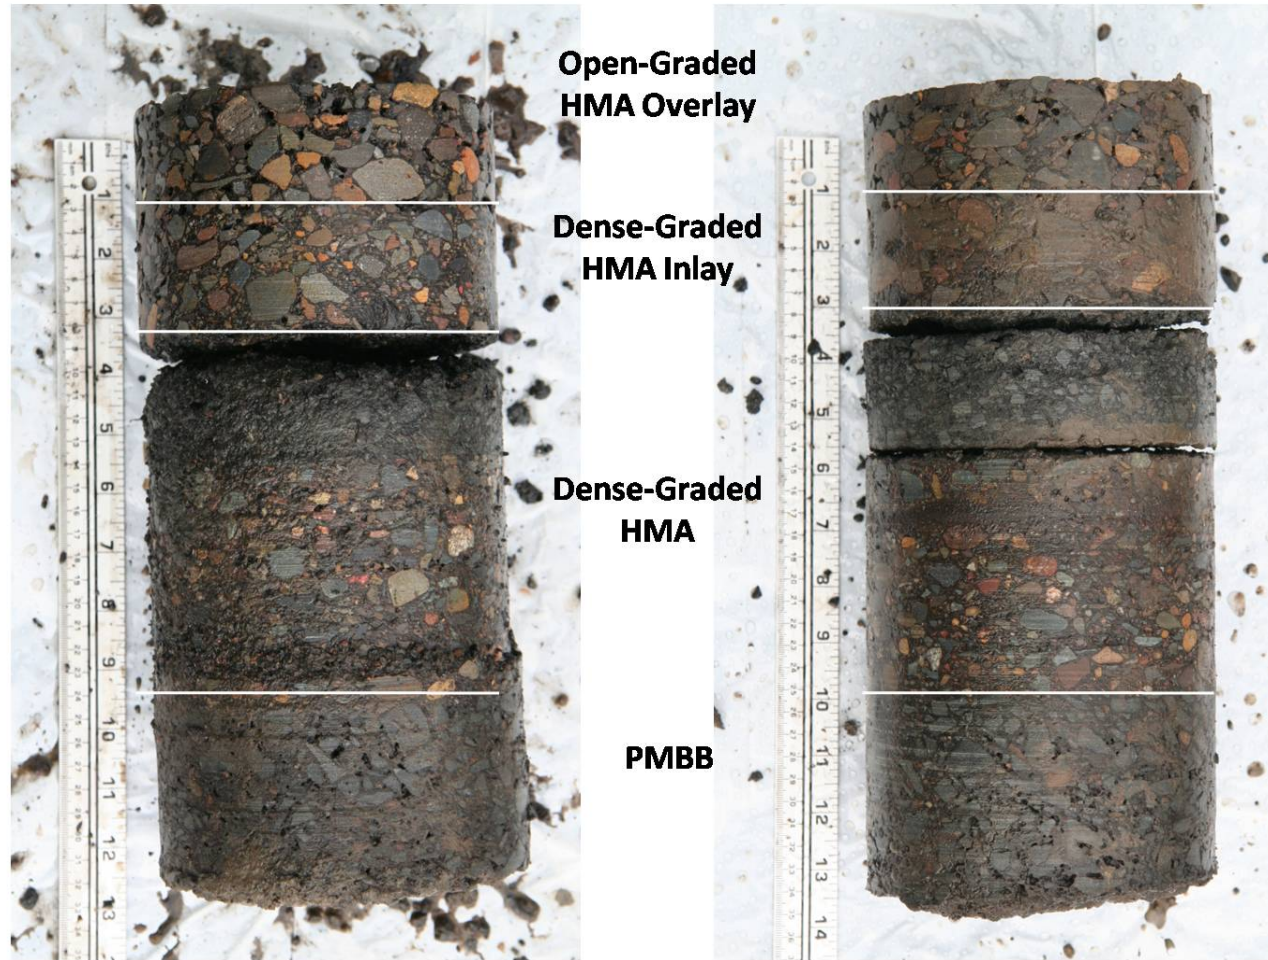
Figure 3.25 shows that the core obtained from the outside wheel track broke at both interfaces of the C-Mix layer. It also appears that stripping had occurred in the C-Mix and underlying B-Mix layers as evidenced by the core obtained from between the wheel tracks.

Figure 3.25: Adjacent, Broken Cores Obtained from MP 157.20 of the Anlauf – Elkhead Road Project.

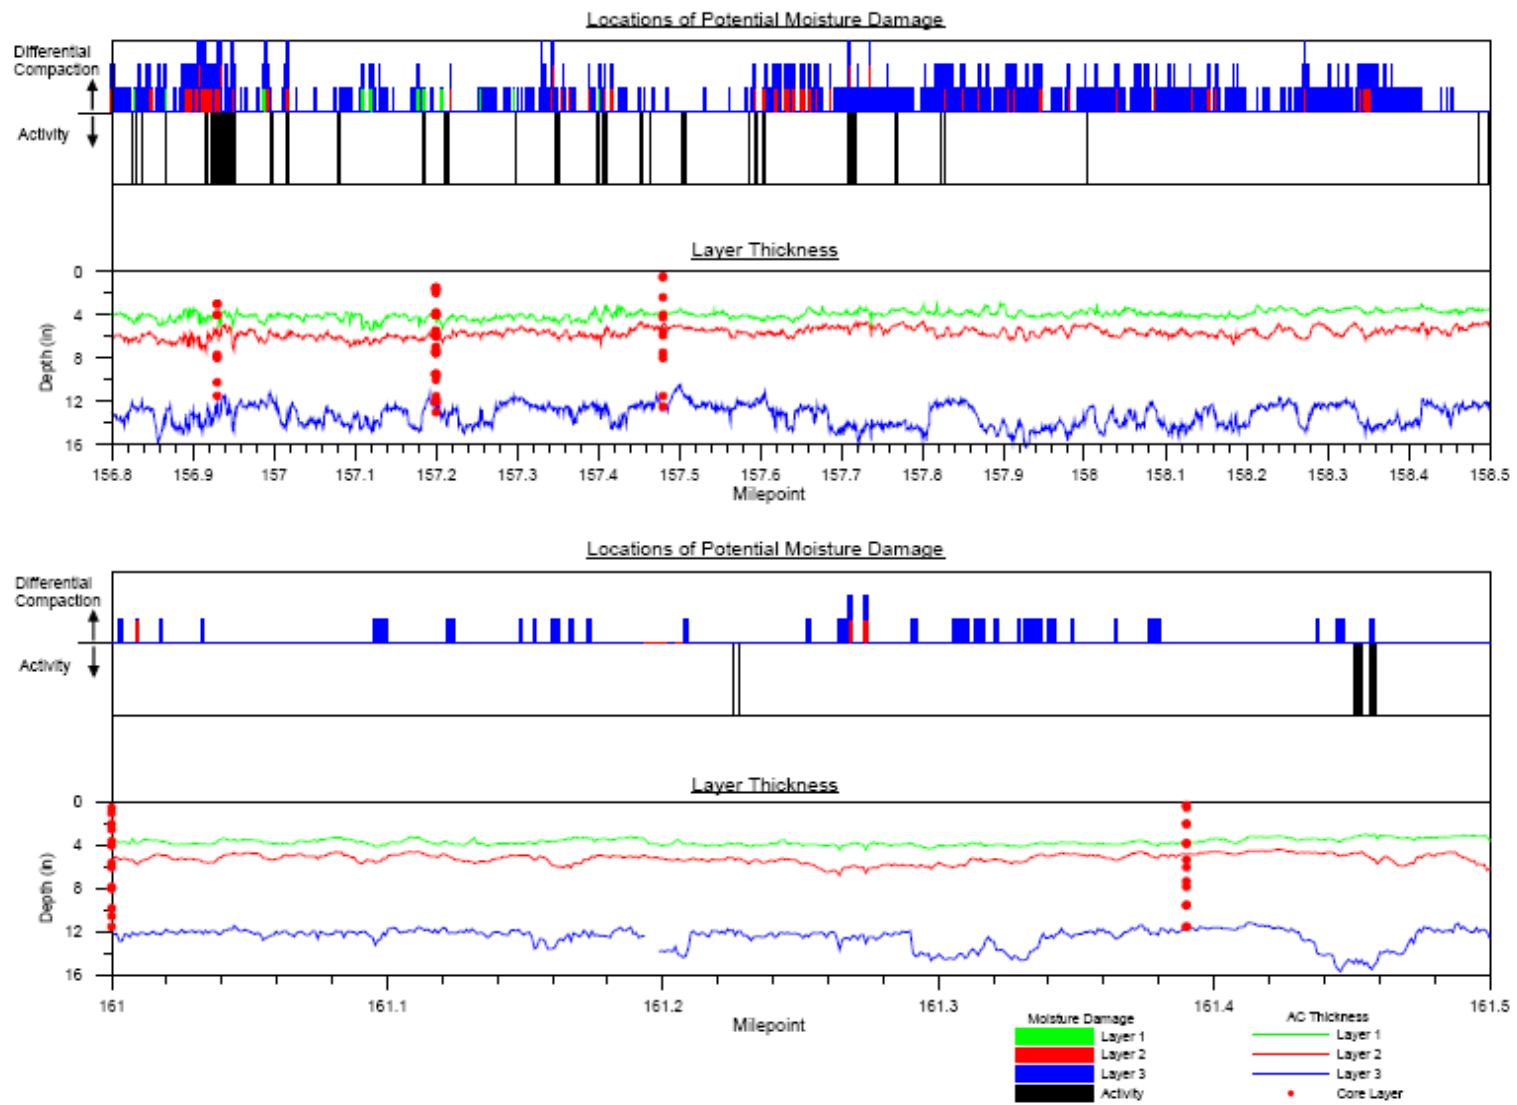
Figures 3.26 and 3.27, taken from the subcontractors report (Appendix K), show locations of potential moisture damage and layer thickness, based on analyses of the GPR data, in the southbound and northbound directions, respectively.

Figure 3.26: Locations of Potential Moisture Damage for the Anlauf – Elkhead Road Project, Southbound Lanes.

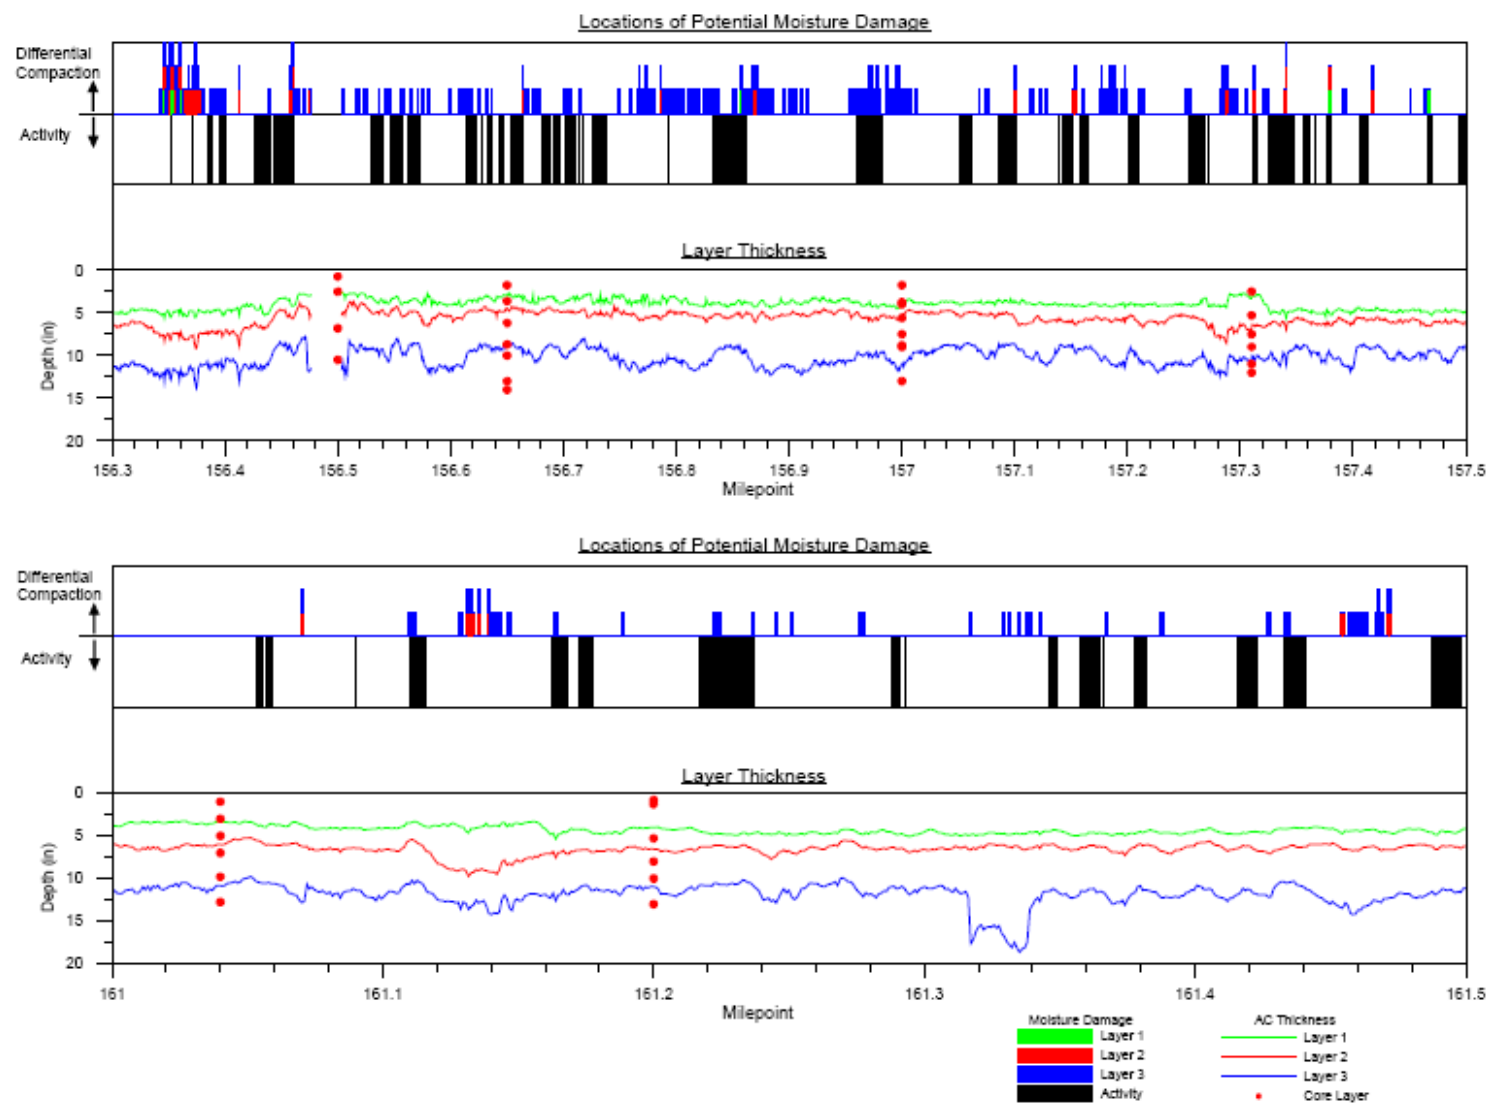
Figure 3.27: Locations of Potential Moisture Damage for the Anlauf – Elkhead Road Project, Northbound Lane

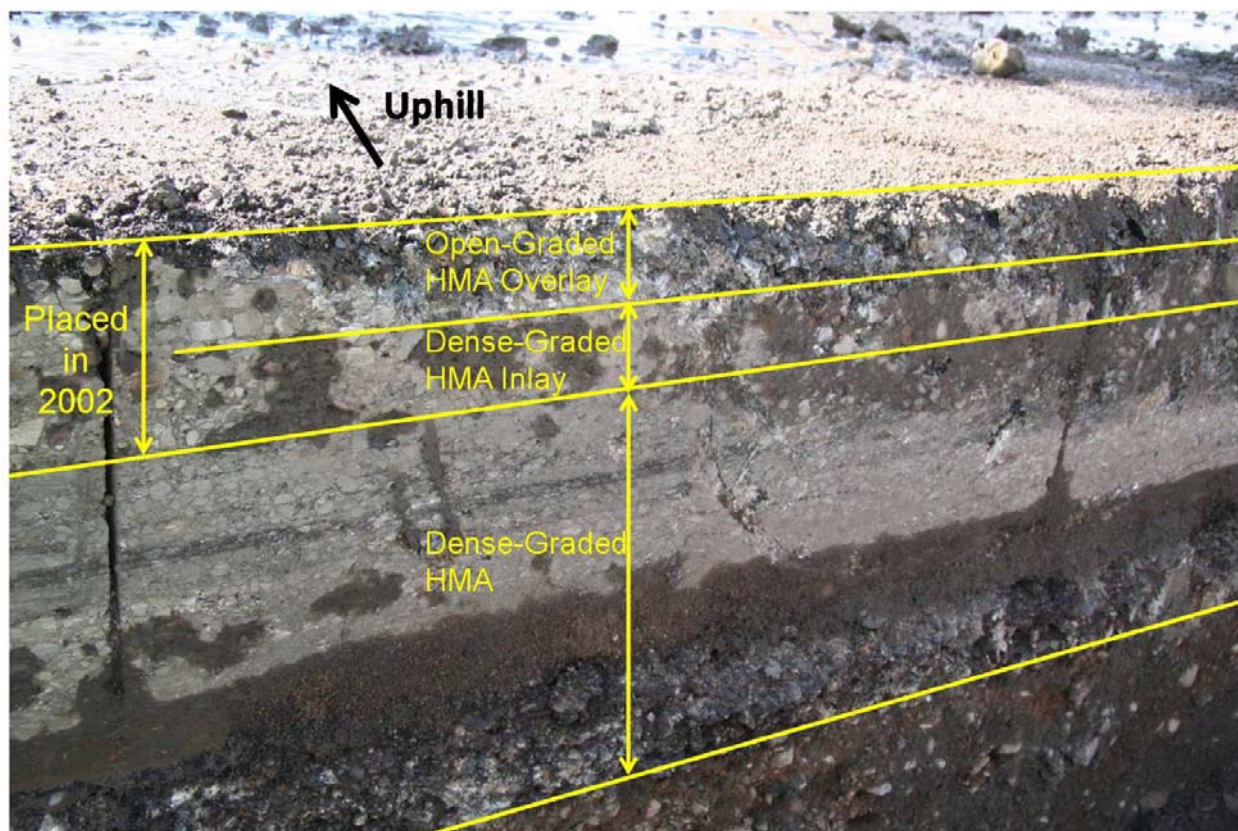
One trench was excavated from the outside, southbound travel lane on a gradual uphill gradient at MP 118.5 in an area with only minimal rutting. Figure 3.29 shows a photo of the uphill trench wall indicating that water was still wetting the trench wall approximately 1½ hours after excavation along portions of most of the bound layers, and the lowest approximately 6 inches (150 mm) appeared almost completely wet. Stripping was also observed in the lowest approximately 4 inches (100 mm) of the bound layers.

Figure 3.29: Garden Valley – Roberts Creek Trench Wall Approximately 1½ Hours after Excavation.

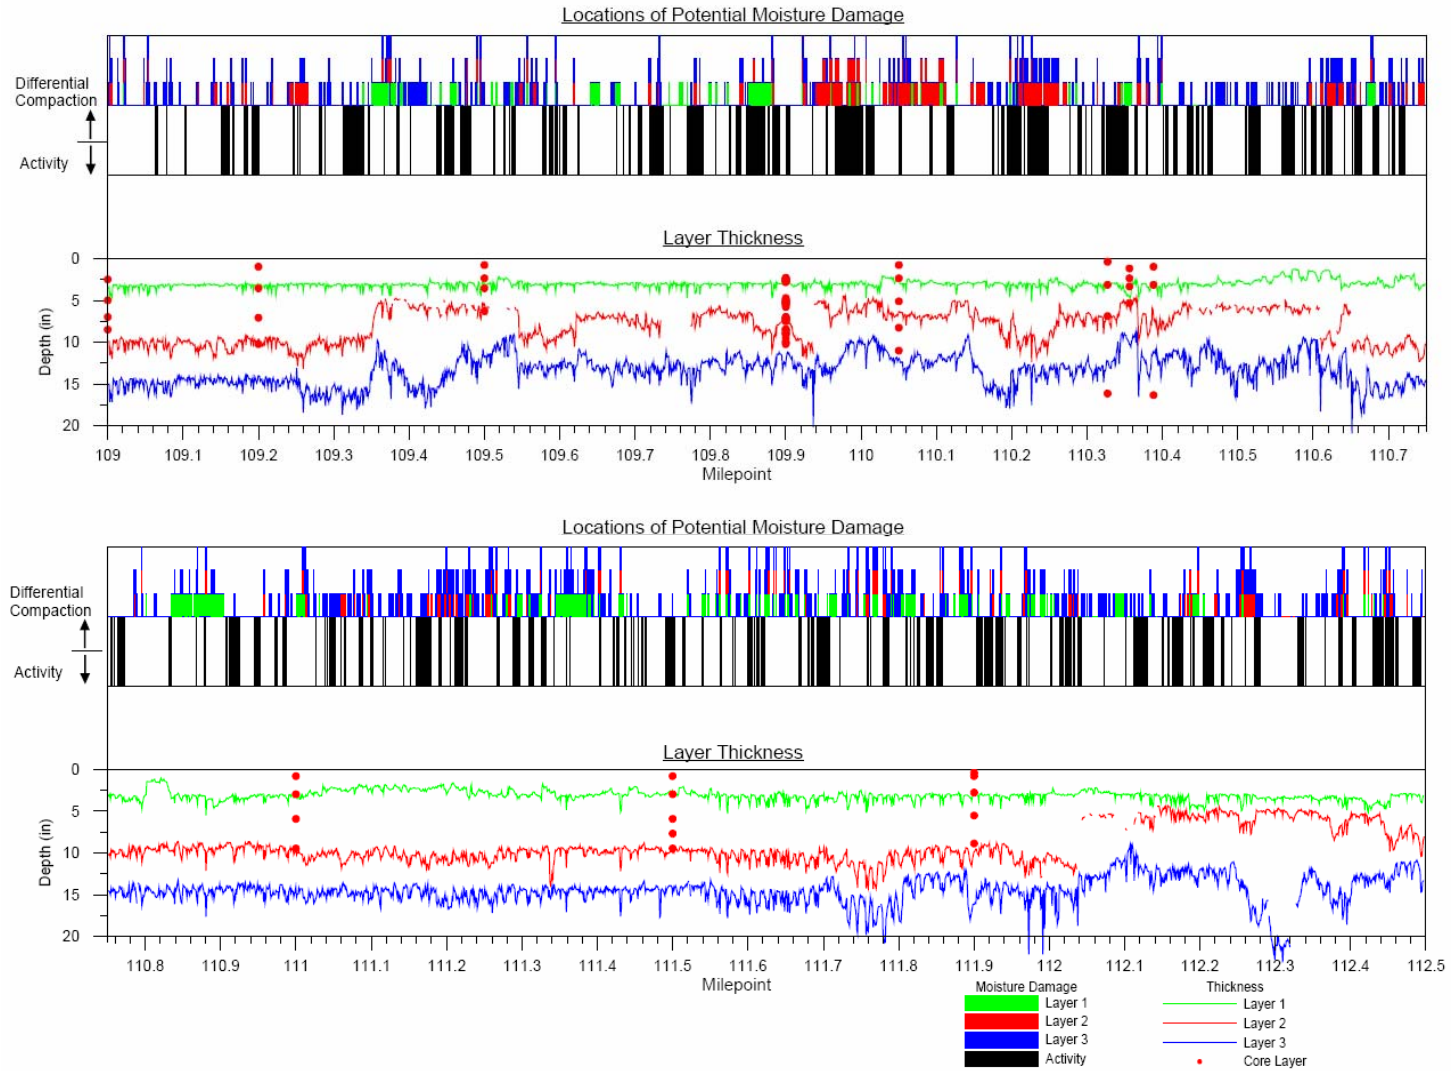
For the Vets Bridge – Myrtle Creek project, data were collected between mile points 109.00 and 112.50 in both directions. Figures 3.35 and 3.36, taken from the subcontractors report (Appendix K), show locations of potential moisture damage and layer thickness, based on analyses of the GPR data, in the southbound and northbound directions, respectively.

Figure 3.35: Locations of Potential Moisture Damage for the Vets Bridge – Myrtle Creek Project, Southbound Lanes.

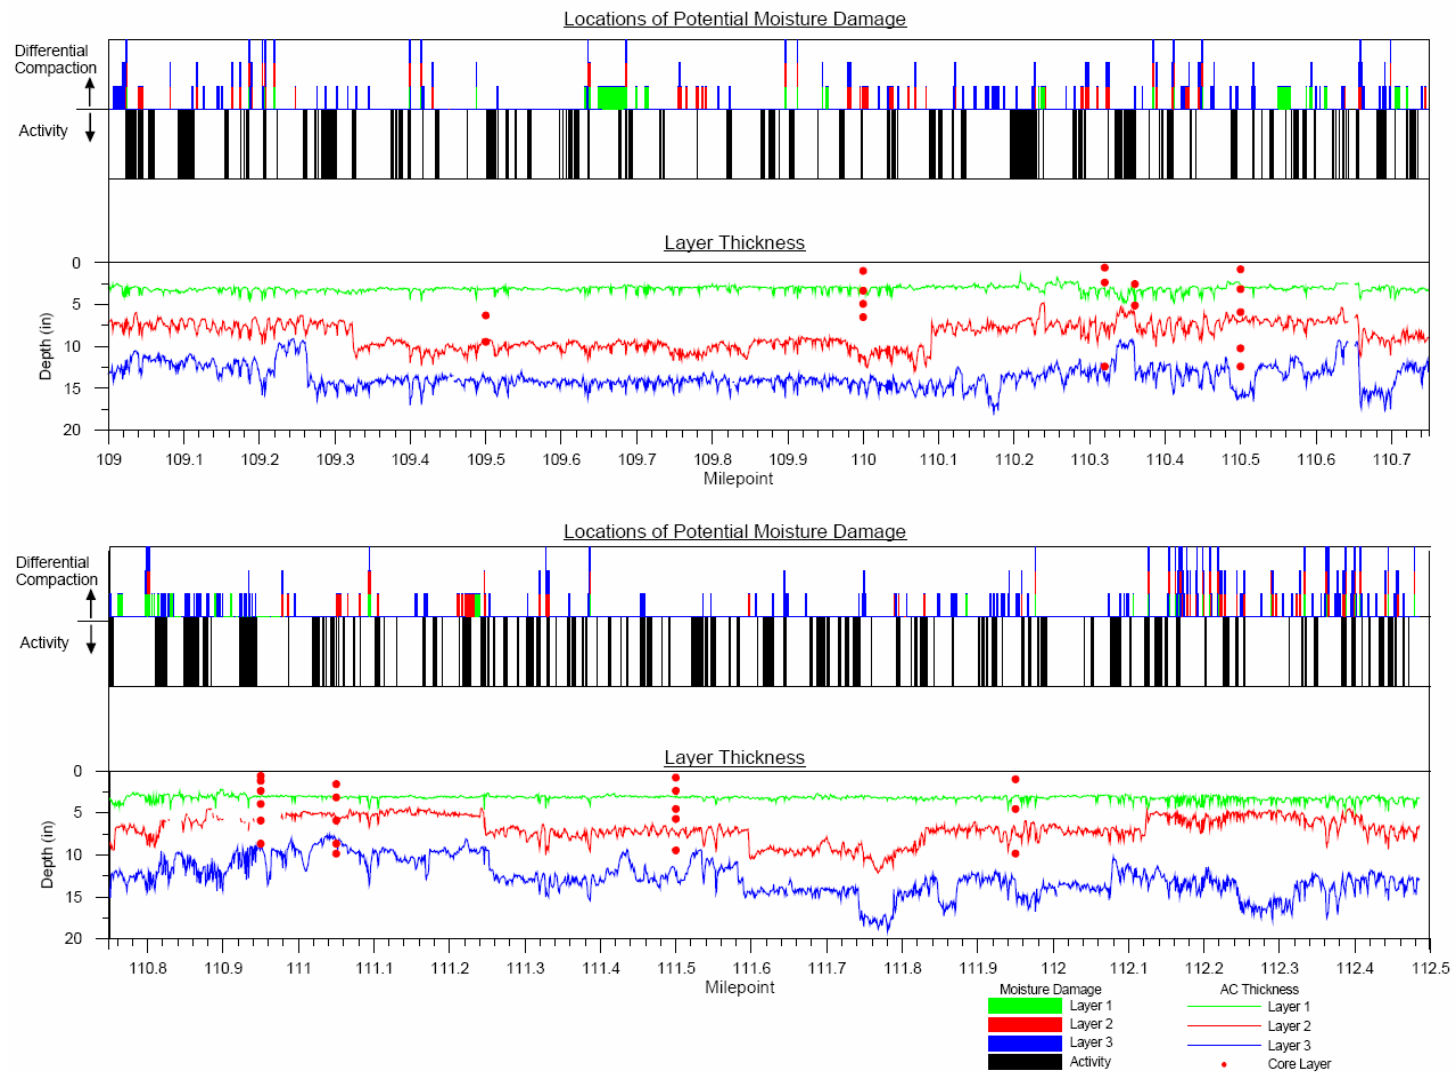
Figure 3.36: Locations of Potential Moisture Damage for the Vets Bridge – Myrtle Creek Project, Northbound Lanes.
