**INVESTIGATING PREMATURE PAVEMENT
FAILURE DUE TO MOISTURE**

FINAL REPORT

SPR 632

July 2009

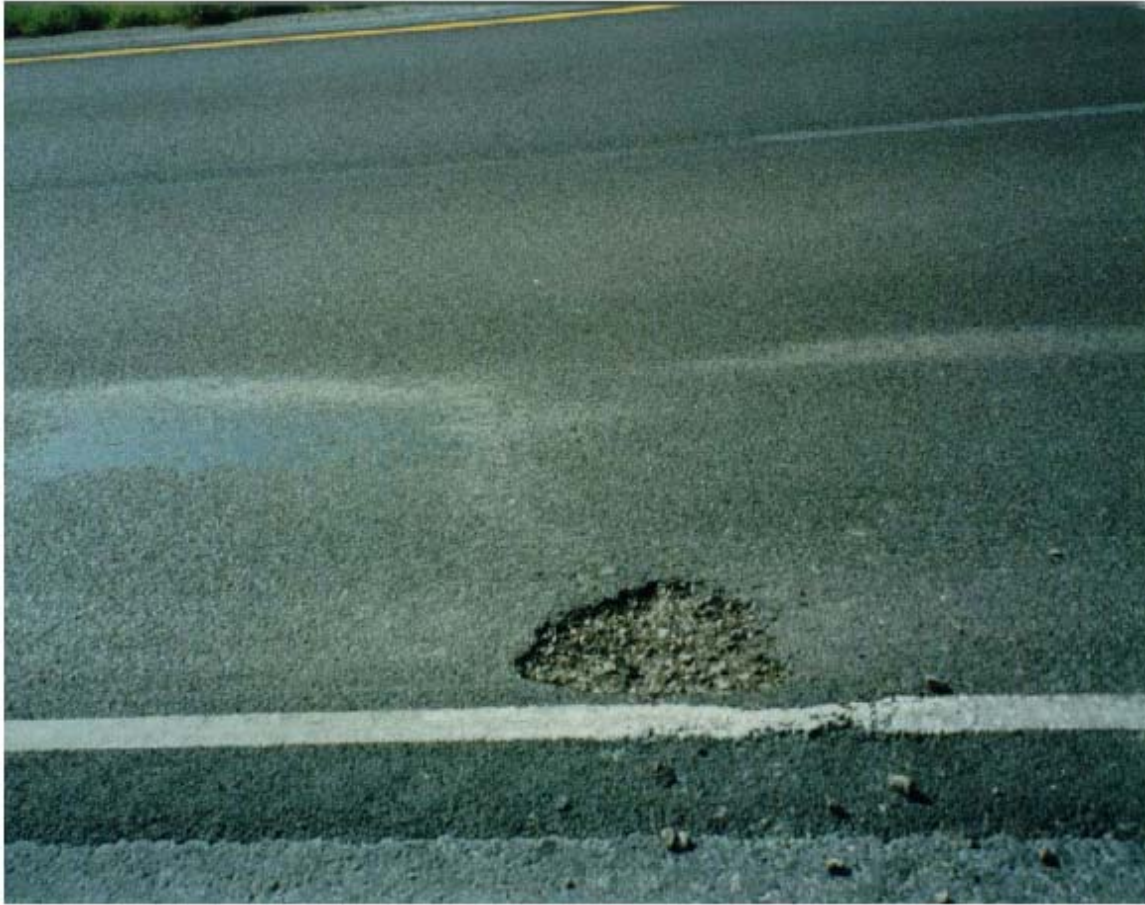
Figure A-3.1: Three Stages of Stripping: White Stains, Flushing, and Pothole (After *Kandhal 2001*)

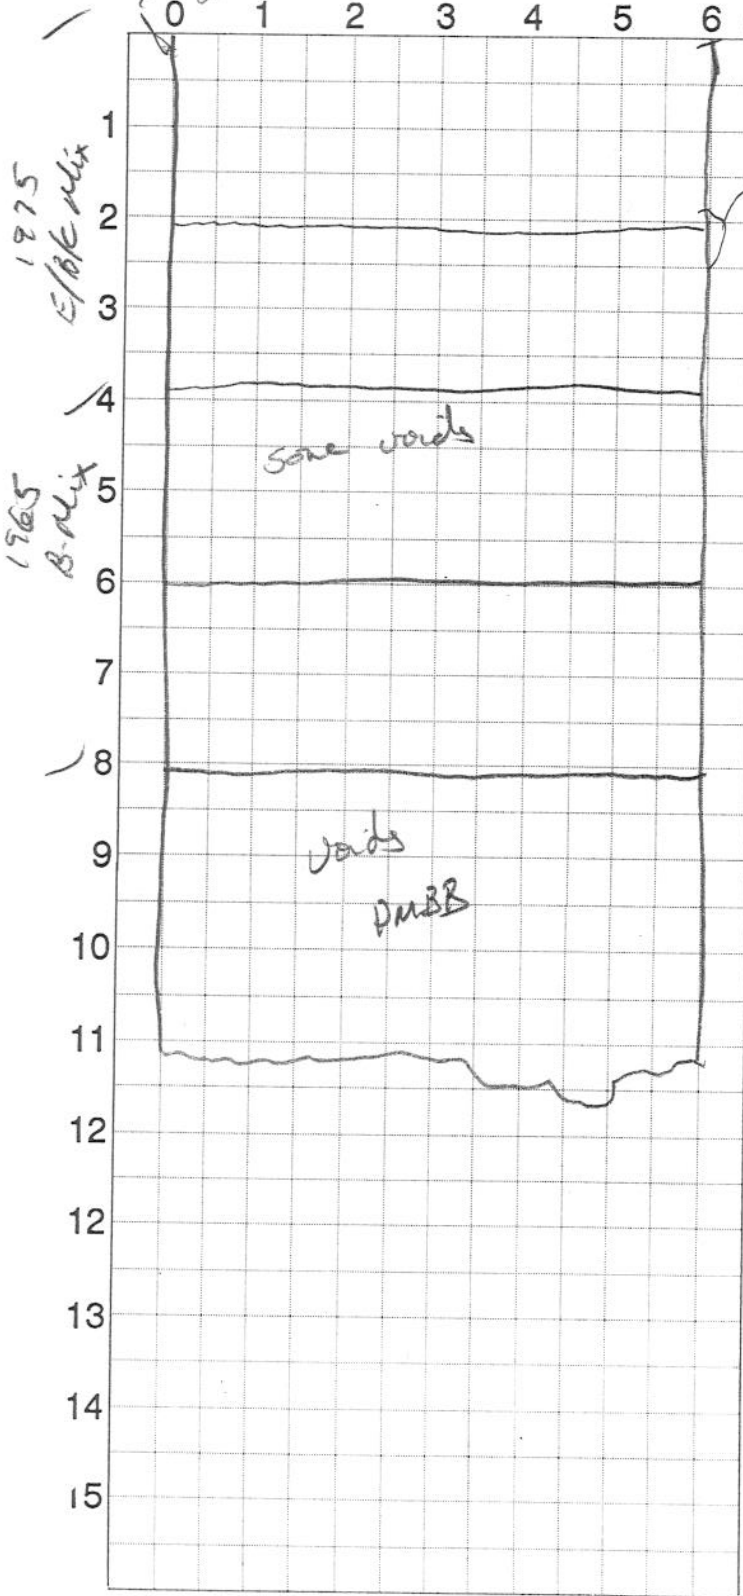
TYPE:	Dense AC	Open AC	Patch	Stripping	PCC	CTB	Other
CONDITION:	<u>Good</u>	Fair	Poor				
MAX. AGG.:	1/4	3/8	<u>1/2</u>	5/8	3/4	1	1+
<i>free MC on side of core</i>							
TYPE:	Dense AC	Open AC	Patch	Stripping	PCC	CTB	Other
CONDITION:	<u>Good</u>	Fair	Poor				
MAX. AGG.:	1/4	3/8	<u>1/2</u>	5/8	3/4	1	1+
TYPE:	Dense AC	Open AC	Patch	Stripping	PCC	CTB	Other
CONDITION:	Good	Fair	Poor				
MAX. AGG.:	1/4	3/8	1/2	5/8	<u>3/4</u>	1	1+
TYPE:	Dense AC	Open AC	Patch	Stripping	PCC	CTB	Other
CONDITION:	<u>Good</u>	Fair	Poor				
MAX. AGG.:	1/4	3/8	1/2	5/8	3/4	1	1+
TYPE:	Dense AC	Open AC	Patch	Stripping	PCC	CTB	Other
CONDITION:	<u>Good</u>	Fair	Poor				
MAX. AGG.:	1/4	3/8	1/2	5/8	3/4	<u>1</u>	1+

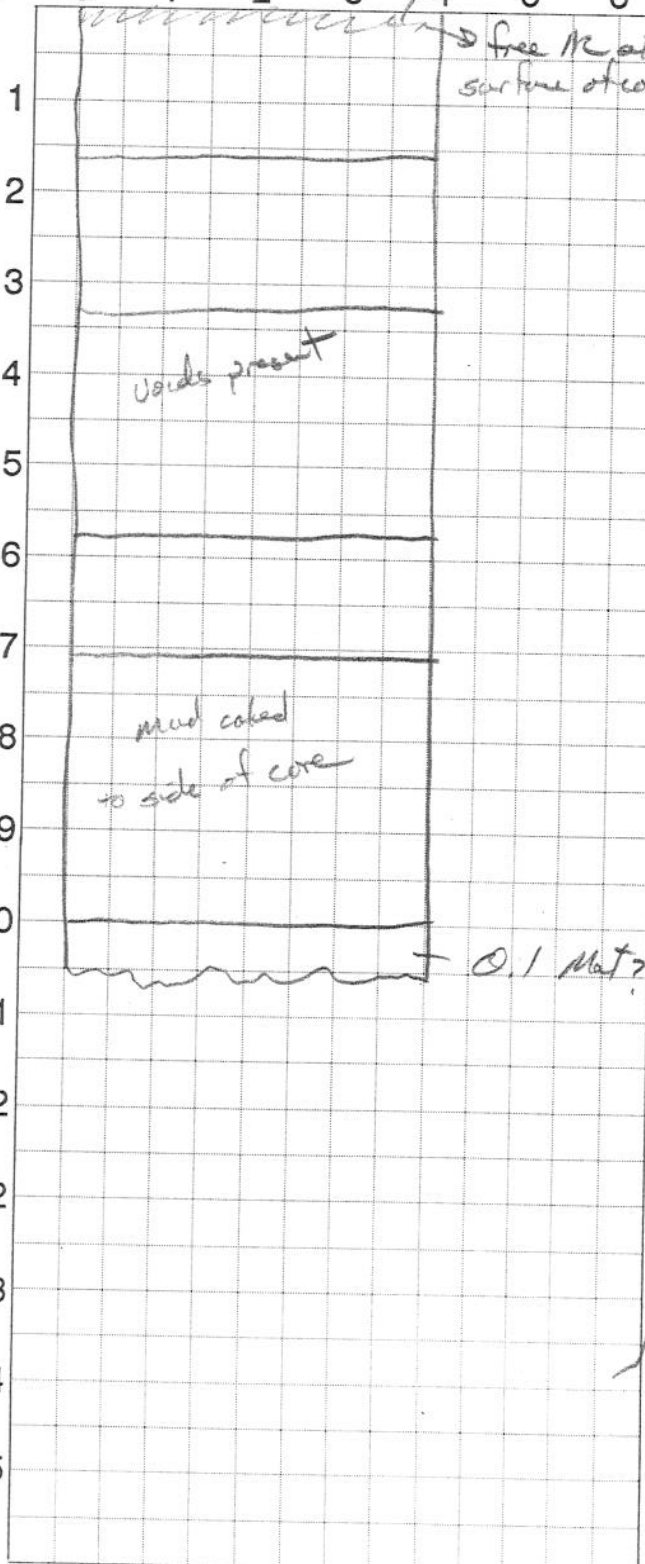
could not distinguish E-Mix
