MICROSILICA MODIFIED CONCRETE FOR BRIDGE DECK OVERLAYS

Second-Year Interim Report

FHWA Experimental Features
OR 89-03A, OR 89-03B, and 89-03C

October 1994

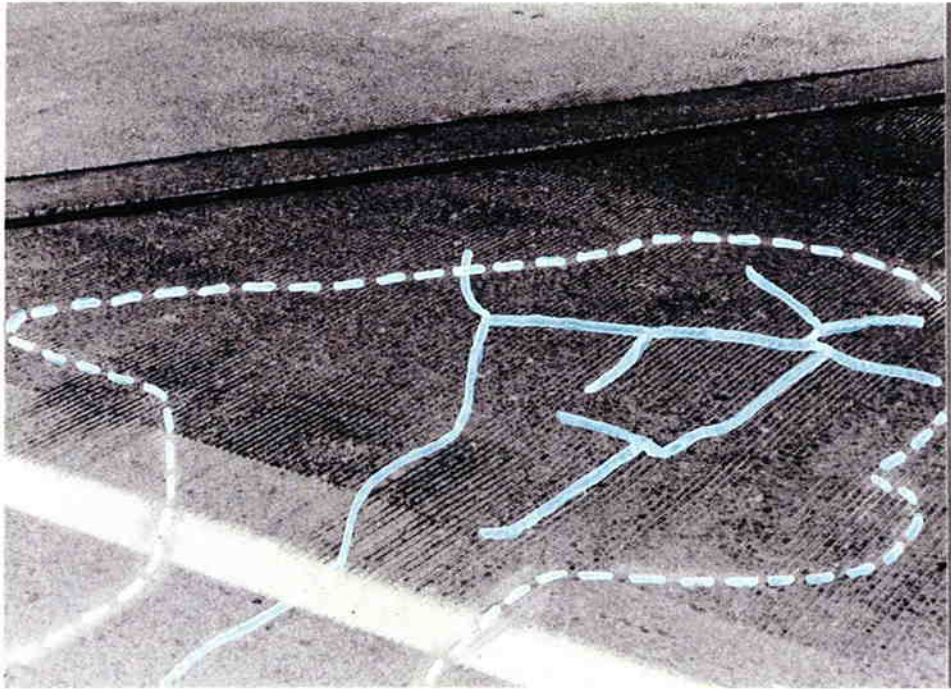
Many of the areas which were cracked in 1992 were also cracked in 1990. However, in 1990, there were not as many cracks. Figure 3.1a shows a typical crack pattern. This photo was taken in 1990 on the Colestin Road Overcrossing Bridge. Cracks were present, but they had not interconnected into an alligator pattern. Figure 3.1b shows the same cracked area in 1992. The cracks had interconnected to form an alligator pattern. This was typical of many cracked areas on these overlays.

a) Cracking and Delamination on the South End of the Overlay in September 1990. In These Enhanced Photographs, Cracks are Marked by Solid White Lines, and the Edges of Delamination are Marked by Dashed White Lines.

1.25 percent to an average of 3.75 percent. Figure 3.1 shows a typical large delamination in 1990, and again in 1992. As shown in the photographs, delamination increased in size during the two-year period.

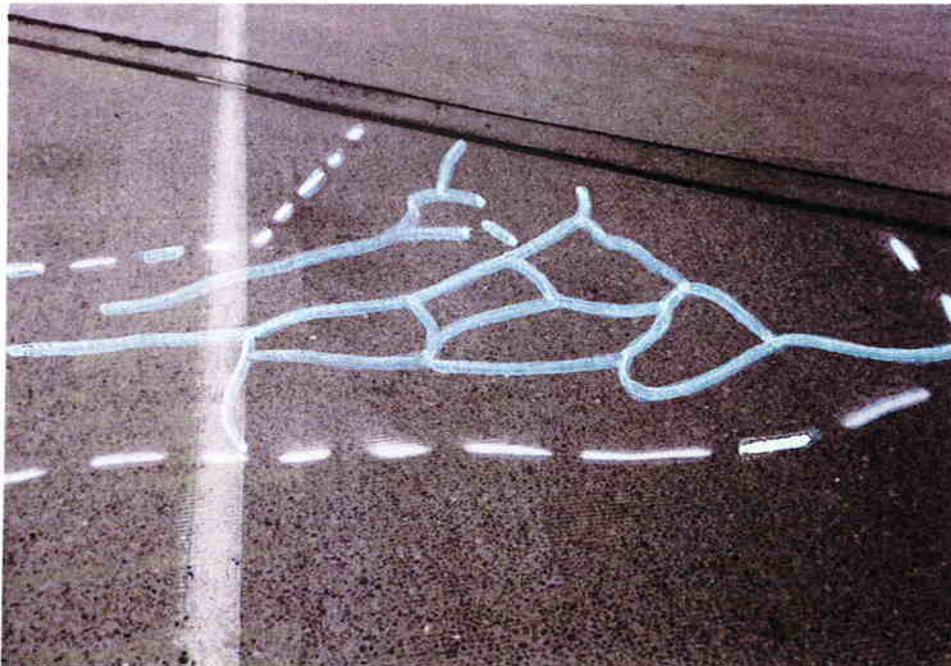
b) The Delaminated Area Shown in Figure 3.1a During June 1992. The Cracking and Delamination had Increased.

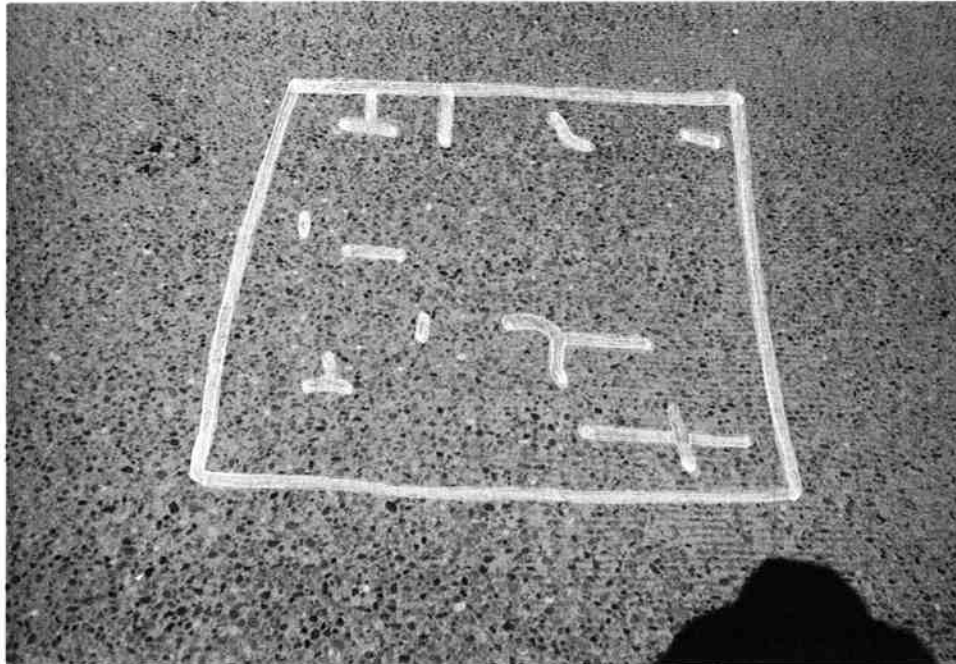
Between 1990 and 1991, the amount of cracking increased from approximately 3.4 to 3.9 lineal feet per square yard of deck surface. These cracks were very fine and their edges were not spalled. A typical square yard of the overlay in 1991 is shown in Figure 3.2.

Figure 3.2: A Typical Square Yard of the Meacham Overcrossing Bridge Overlay. In This Enhanced Photograph the Square Denotes the Boundaries of the Square Yard, and the Lines Within the Square Denote Cracks.
