**MICROSILICA MODIFIED CONCRETE  
FOR BRIDGE DECK OVERLAYS**

**First-Year Interim Report**

**FHWA Experimental Features  
OR 89-03A, OR 89-03B, and OR 89-03C**

**November 1991**

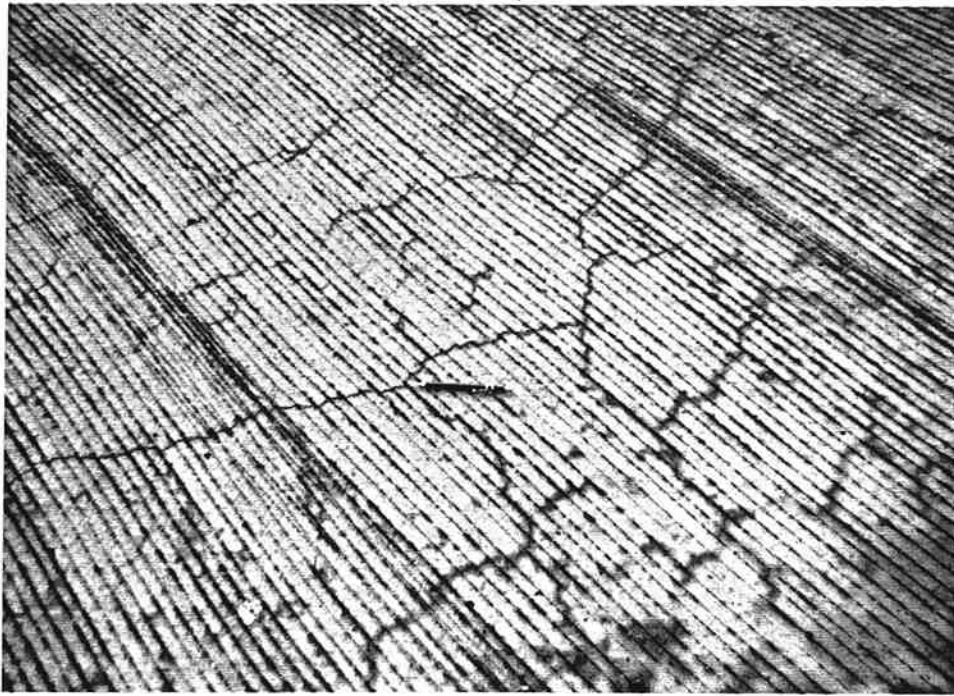
There was cracking on all of the seven overlays. In most cases, the cracks were random and hairline; and if they were sufficiently developed, they connected into a map pattern. Four overlays had alligatored sections. Figure 3.1a shows the crack severity and pattern typical of the map cracked areas. The cracking was most severe on pours that had construction difficulties, and pours over the deeper sections of the overlays, as seen in Figure 3.1b [1].

- (a) Hairline cracking of the MC overlay on the Grand Avenue Ramp Bridge. The pavement surrounding the cracks is moist, and consequently darker, than the rest of the surface.

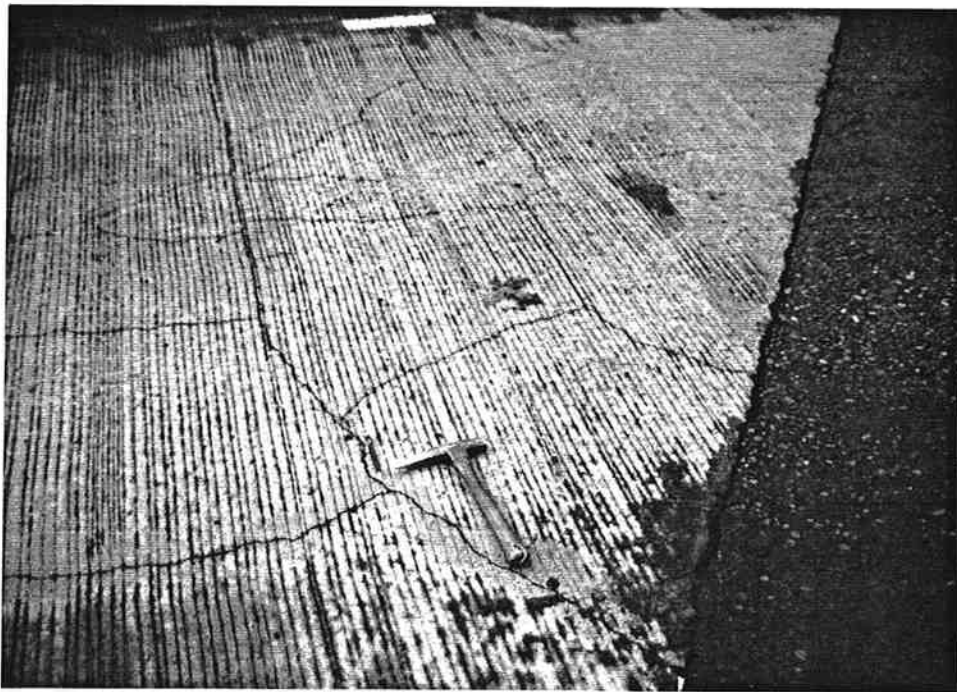
- (b) Wider cracking on the deeper section (5 to 7 inches) of the MC overlay on the Holladay Street Ramp Bridge. The remainder of the overlay was about 2-inches thick.

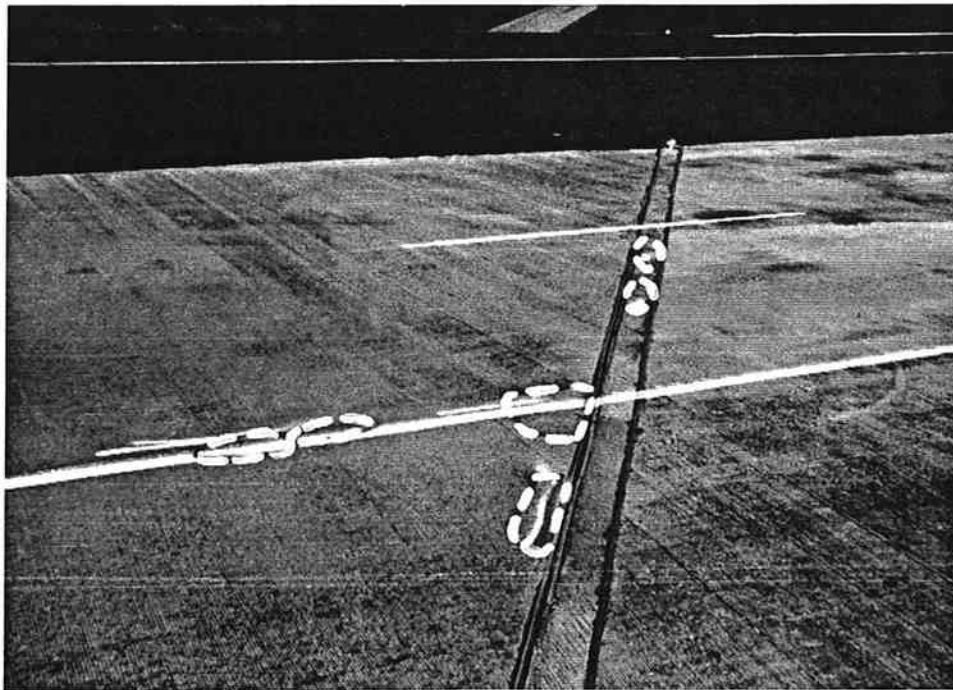
Of the seven overlays, five had some delamination. However, this distress was not extensive, as the worst deck had delaminations under 2.5% of its surface. In almost all cases, the delaminations were small and they were scattered throughout the deck. On three of the overlays, delaminations were detected adjacent to either construction or expansion joints, as shown in Figure 3.2a.

- (a) Delaminations on the Southbound Colestin Road Overcrossing Bridge. In this enhanced photo, the edges of the delaminations are marked by a dashed white line. Delaminations under the fog line are adjacent to a joint between two pours. The other delaminations are adjacent to an expansion joint.

Date of Inspection or Repair	Comments
August and September, '89	<u>Poured.</u>
September, '89	<u>No cracking or delaminations</u> were found when the deck was uncovered after the cure.
September, '90	<p><u>Several cracks</u> 20 to 30 feet long were found in Pour 1, the climbing lane, near the leading edge of the bridge.</p> <p><u>Scattered cracks</u> up to 12 feet long were found throughout the rest of Pour 1 and Pour 2. <u>Cracking</u> was found on the strip of MC between the expansion joints and the poured filler on both ends of bridge.</p> <p><u>.7% of the surface was delaminated.</u> Most delaminations were on the right edge of Pour 2 where it abutted Pour 1 [Figure 3.2a].</p>

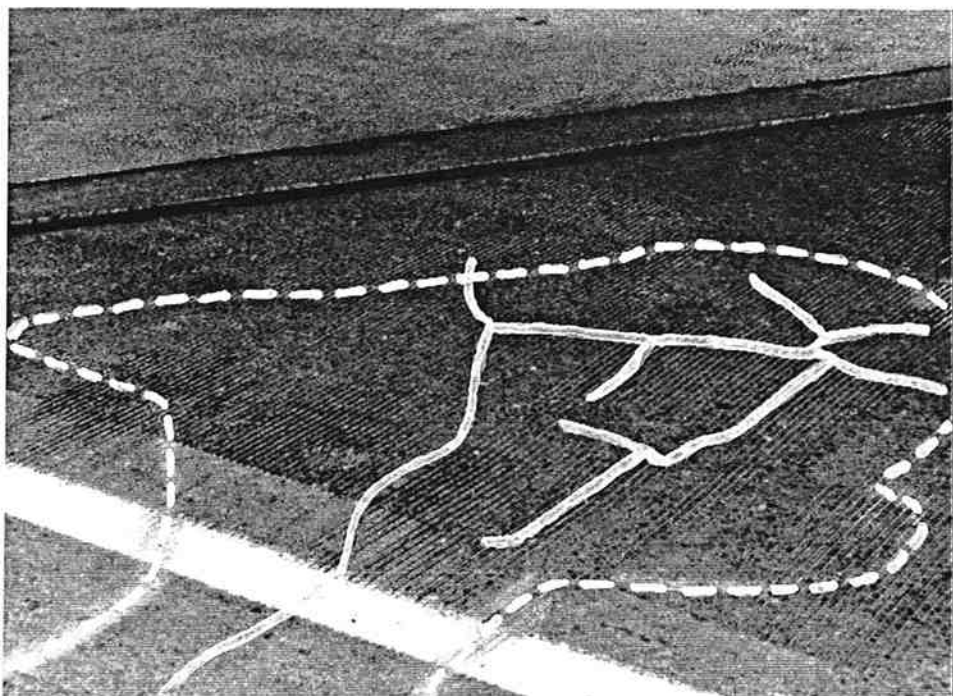
Most of the time, the overlay above the delamination was uncracked. However, there were two notable exceptions. On the south end of the Northbound Colestin Road Overcrossing Bridge, the overlay over a 25 square foot delamination was severely map cracked, as shown in Figure 3.2b. On the south end of the Southbound Neil Creek Road Overcrossing Bridge, less severe map cracking was noted over a smaller delamination. In both cases, there were no loose pieces in the cracked overlay.

- (b) Delamination and cracking on the south end of the Northbound Colestin Road Overcrossing Bridge. In this enhanced photograph, the edge of the delamination is marked by a dashed white line, and the cracks are marked by a solid white line.
