LONG TERM DECK DETERIORATION

Experimental Feature
Final Report

OR 82-02 through OR 82-08

LONG TERM DECK DETERIORATION
EXPERIMENTAL FEATURE PROJECTS OR 82-02 THROUGH 82-08

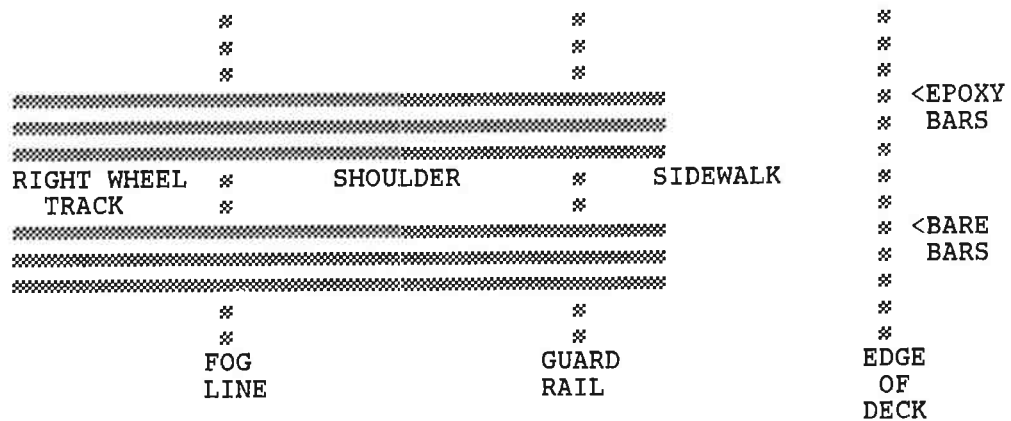
FIGURE 1
TOP VIEW OF THE TEST BAR LAYOUT WITH
RESPECT TO THE DECK

Two sets of six, #5 x 20 ft. transverse test bars were placed in the deck for testing. Three bars in each set were in the top and bottom mat respectively. One set of bars were epoxy coated and the other set were bare. Leads from the bars were terminated in junction boxes on the side of the structure. Lead wires numbered 1 and 2 were from the top and bottom mat of epoxy coated bars respectively. Lead wires numbered 3 and 4 were similar for the un-coated test bars.

The table indicates that the resistance between wire 1 and 2 is 300 ohms. Wire 2 (bottom mat of epoxy bars) is electrically isolated since the resistance increases from it to 1, 3 and 4, reflects the resistance of the concrete with distance. The zeros indicate that the top mat of epoxy bar is electrically continuous with the bare test bars.
