APPENDIX

**LIQUEFACTION DAMAGE TO BRIDGES
AND APPROACH EMBANKMENTS:
CATALOG OF SELECTED CASE HISTORIES**

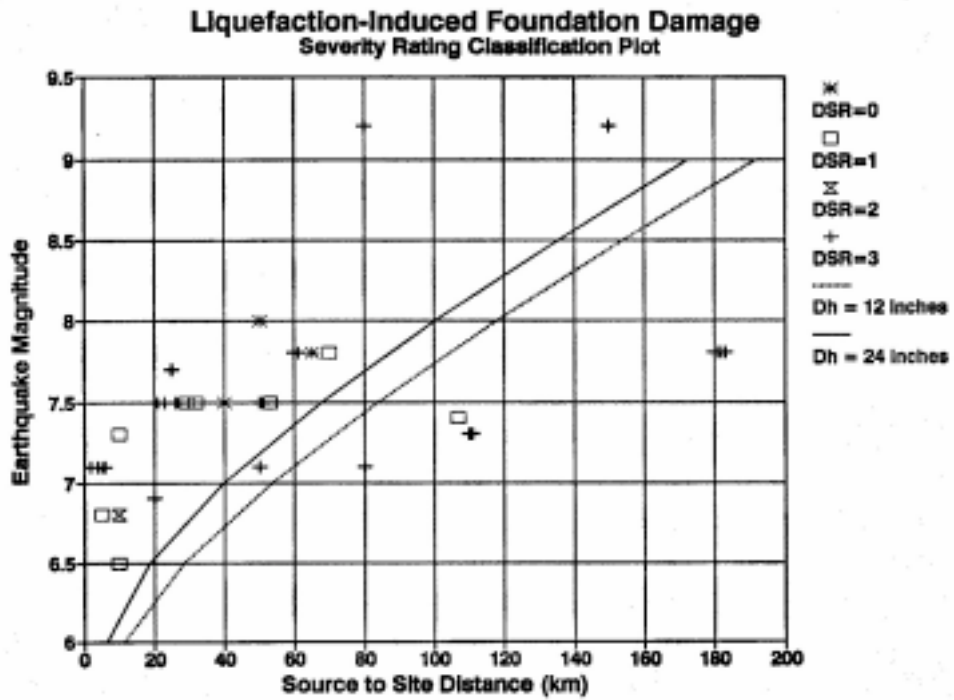
Figure A.1: Bridge damage as a function of earthquake magnitude and source-to-site distance.

The Damage Severity Indexes for selected bridges have been plotted as a function of earthquake magnitude and the distance from the earthquake source to the bridge site (Figure A.1). This general plot accounts, in an approximate manner, for the intensity of ground shaking and the duration of the motions. The bridge catalog includes an array of structures of various age, design and construction, therefore the relationship demonstrated in this figure provides only a very general view of bridge performance.

The two curves superimposed on Figure A.1 represent lateral spread displacements (D_h) of 305 mm (12 in) and 610 mm (24 in), computed using the empirical relationship of Bartlett and Youd introduced in Chapter 4. On the basis of the data obtained in this study it appears that the curve for lateral spread displacements of 0.3 m (1 ft) can be used as an approximate source-to-site boundary of damage/no damage in preliminary, system-wide screening evaluations of liquefaction hazards to bridges. It should be noted that several case studies demonstrated extensive bridge

damage at source-to-site distances greater than that indicated for 0.3 m (1 ft) displacement. This could be due to several factors (e.g., uncertainty in the Bartlett and Youd procedure, unique site effects, poorly designed or constructed bridges). Variables such as these must be evaluated in site-specific hazard analyses.
