# INJECTED POLYURETHANE SLAB JACKING

**Final Report**

**SPR 306-261**

# June 2002

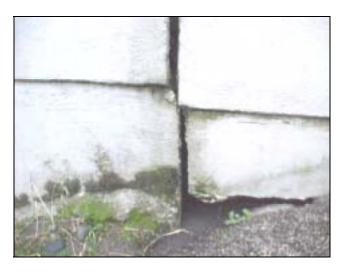
Water in the subgrade under a roadway can cause sections of the roadway to settle. The water suspends soil particles that are subsequently pumped out when traffic drives over the concrete slab, causing a void to develop. This mechanism was probably responsible for the settling at the end panel of the southbound I-205 Glenn Jackson Bridge and the adjacent slab of the exit ramp, as shown in Figure 1.1. A leak in a 305 mm (12 in) drainpipe at the site was the source of water. The extent of the settling is shown in Figure 1.2.

Figure 1.2: Side view of joint between the end panel and the adjacent slab before slab jacking

As part of a maintenance project on the Bridge, the leaking drainpipe was repaired and the slabs were raised to a smoother profile. Injected polyurethane was used to raise the slabs to the desired profile using The URETEK Method, a technique relatively new in Oregon.

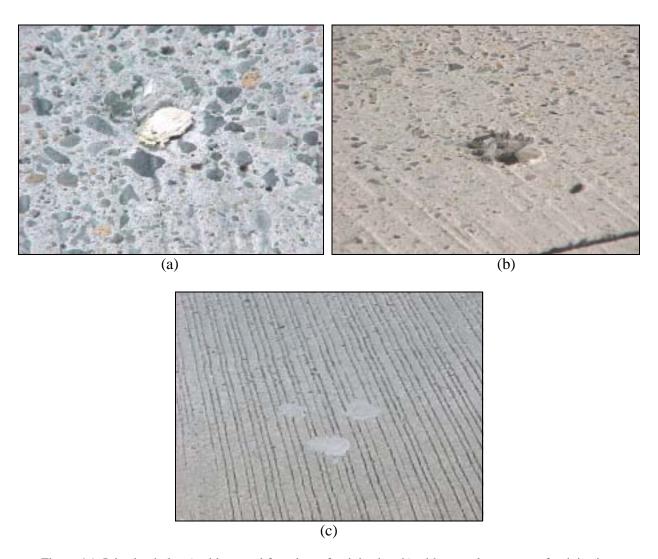
Figure 4.1a shows a hole after injection and 4 days of traffic exposure. Like many of the other injection points, the polyurethane was exposed, indicating that the grout seal either had not been applied or had popped off. Holes that were not sealed showed signs of raveling after being exposed to traffic for two years, as shown in Figure 4.1b. Holes that were properly sealed with grout showed no signs of damage after two years, as shown in Figure 4.1c.

Figure 4.1: Injection holes a) with no seal four days after injection; b) with no seal two years after injection; and c) with grout seal two years after injection.

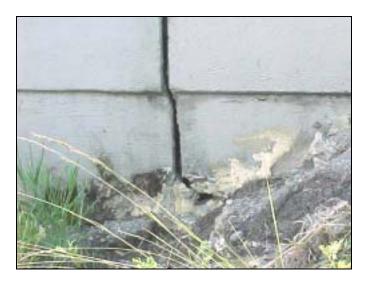
The aligning effect of the injection project is visually illustrated in Figure 4.2, which is a photograph of the same location as Figure 1.2 after polyurethane injection.

Figure 4.2: Side view of joint between the end panel and the adjacent slab after slab jacking

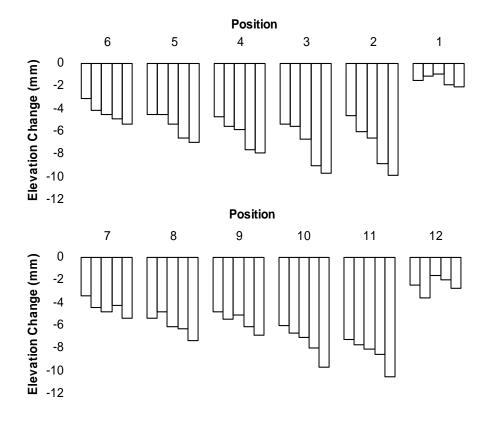
Figure 4.3: Comparison of elevation data from Table 4.1. Positions aligned vertically in the figure are opposite each other on the roadway (see Figure 2.1).

The roadway settled at all twelve positions with a maximum decrease in elevation of 10.5 mm (0.413 in). The majority of the settling occurred within the first three months after injection with one position sinking 7.2 mm during that period. The settling was still continuing two years after injection. The reason for the settling was not investigated, and it was not known whether the settling would continue.

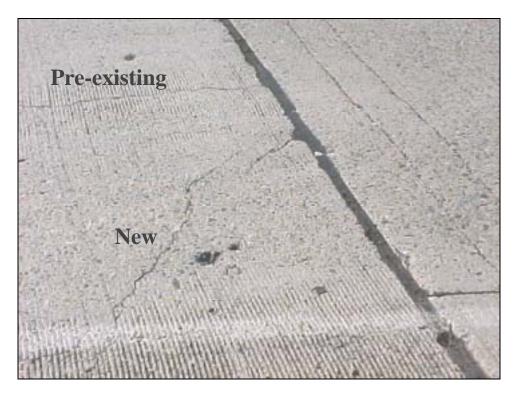
The joint between the roadway slab and the end-panel, which had the largest elevation discontinuity before injection, experienced the largest amount of settling. Both sides of the joint (positions 2 and 11 vs. 3 and 10) settled by nearly the same amount; therefore, the ride over the joint was not affected by the settling. However, the difference in elevation between the ends of the end-panel (Positions 1 and 12 vs. 2 and 11) increased over two years. This change in elevation may have been responsible for new cracks that appeared in the end-panel. Figure 4.4 shows a pre-existing crack and a crack that either opened up or was created since the first survey four days after injection.

Figure 4.4: Cracks in the end-panel near Position 2

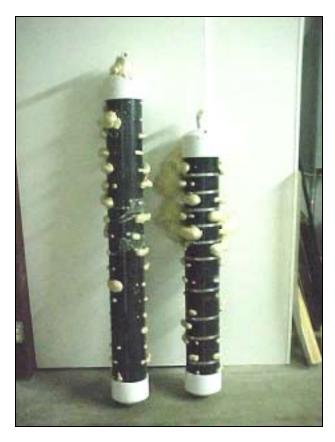
Figure 4.5 and Tables 4.2 and 4.3 show the results of the hole penetration trials. To be considered penetrated, a hole had to be completely filled. The polyurethane penetrated through all holes 6.4 mm (0.25 in) in diameter and larger. None of the 1.6 mm (0.062 in) holes was filled. Based on these results, it was expected that with injection holes drilled every 1.2 m (4 ft), the foam should have penetrated all openings (based on the smallest dimension) as small as 6.4 mm (0.25 in). Openings with a minimum dimension of 3.0 mm (0.12 in) should have been penetrated up to 0.62 m (2 ft) from the injection point. It was thought that actual field injection probably resulted in greater penetration due to higher pressures from the constraining weight of the slab.

Figure 4.5: Penetration tubes after injection

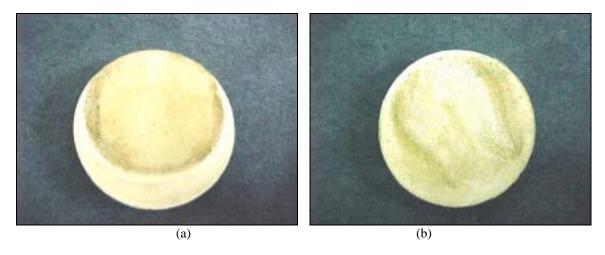
Two distinct regions were visible in all the samples cut from the tubes, as shown in Figure 4.6. One section was relatively dense and extended around much of the circumference. The second region occupied the interior of the samples and was less dense than the first region. The samples cut from Tube 1 had a greater volume of the relatively dense section, which resulted in the higher measured density values reported in Table 4.4.

Figure 4.6: Samples cut from (a) Tube 1 and (b) Tube 2
