**GEOTEXTILE FABRICS UNDER AN
ASPHALT CONCRETE OVERLAY TO
RETARD REFLECTIVE CRACKING**

INTERIM REPORT

**Experimental Features Project
No. OR 91-03**

**East 39th Avenue - East 47th Avenue Section
East Burnside Street
City of Portland**

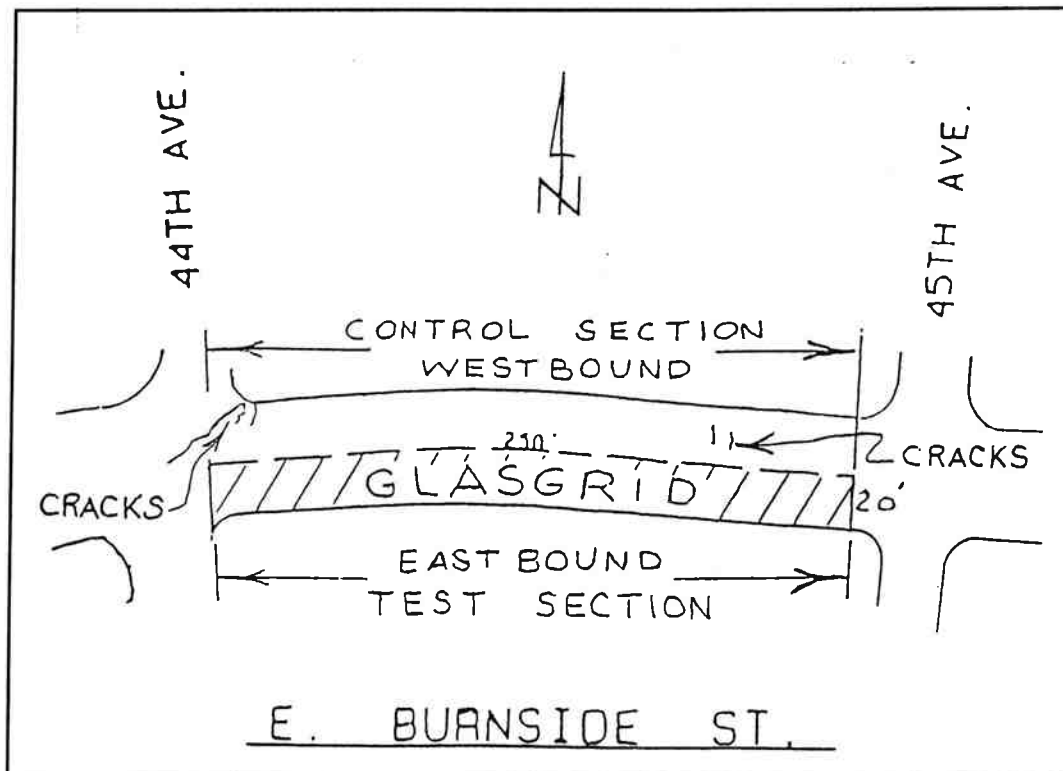
Figure 4.1: Cracks in the Asphalt Concrete Overlay

On January 28, 1994, I met with Randy Countryman, at East 44th Avenue and East Burnside Street. A visual inspection of East Burnside was conducted. The test sections and control sections were observed. The pavement where the Polyguard was applied was in good condition with no noticeable cracks existing in either the test or control sections. In the Glasgrid pavement reinforcement control section, as shown in Figure 4.1, only two small cracks were observed on the north side (westbound lane) of Burnside Street, approximately 31 meters (100 ft.) west of 45th Avenue (see Figure B.1 (a), Appendix B). No evidence of cracking was observed in the test section (eastbound lane). Pavement cracking was also observed on Burnside Street (westbound lane) just west of the Glasgrid pavement control section at the intersection of 44th Avenue (see Figure B.1 (b), Appendix B), as shown in Figure 4.1.

- 1) The existence of these small cracks appearing in the control section and nonexistence of cracks in the pavement reinforcement control section correlates with an inspection done by Eric Brooks and Randy Countryman in June 1993. These small cracks were documented at this time and apparently have not become any larger in size.

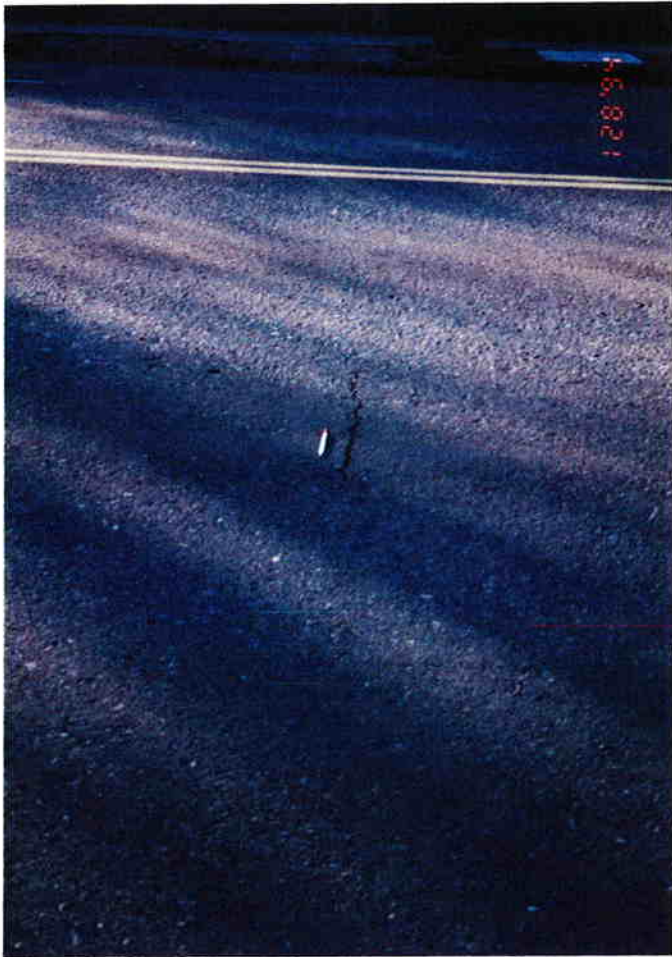
(a) Cracks in the AC Overlay in the Pavement Reinforcement (Glasgrid) Control Section

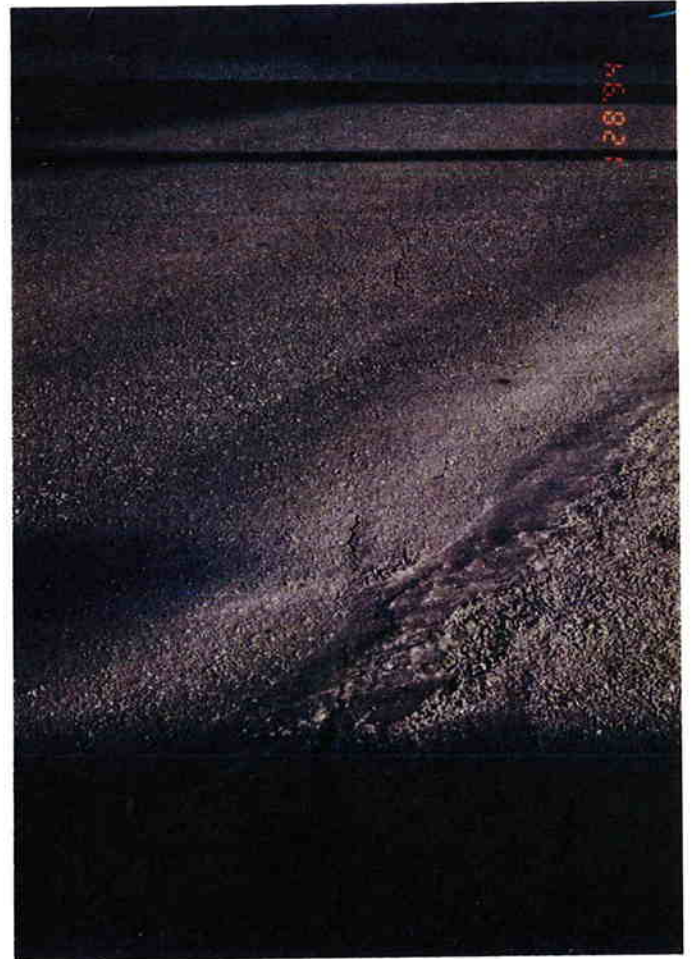
- 2) Randy Countryman commented on the cracking observed at the intersection of Burnside Street and 44th Avenue. He said this cracking is probably due to a drainpipe under the asphalt concrete overlay which had been installed prior to construction. This pipe connects an inlet from the northeast corner of 44th Avenue to a manhole located in the center of the intersection. This is an area where matching the grades at the intersection was critical. Other cracking that is occurring at this intersection is from roots of a tree that is located near the curb at the northeast corner of 44th Avenue and E. Burnside Street.

(b) Cracks in the AC Overlay at the Intersection of East Burnside Street and East 44th Avenue
