**GEOTEXTILE FABRICS UNDER AN
ASPHALT CONCRETE OVERLAY TO
RETARD REFLECTIVE CRACKING**

FINAL REPORT

East 39th Avenue – East 47th Avenue Section
East Burnside Street, Portland

Experimental Features Project OR 91-03

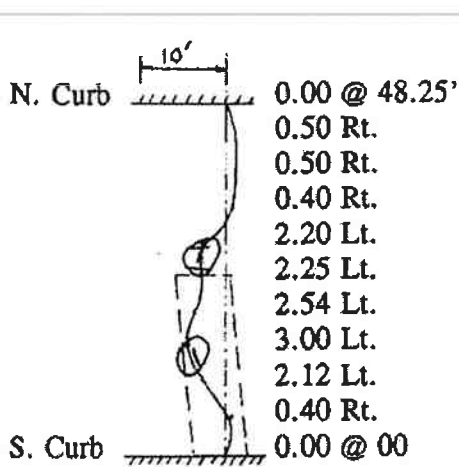
Crack #1, Fabric 1
 E. of N.E. Meikle Pl.
 Single layer of 5-foot wide
 Glasgrid

The four test cracks were also observed. Only very minor reflective cracking was found. Crack #3 was in the best condition with zero linear meters of cracking. Crack #4 had the most reflective cracking, but the location was not conclusive. A curb replacement and widening job after the overlay destroyed one of the reference nails, thus the exact location of the existing crack is not certain. The Polyguard at test crack #4 was not overlapped. Overlap of the Polyguard on the other cracks may have improved the performance of the geotextile.

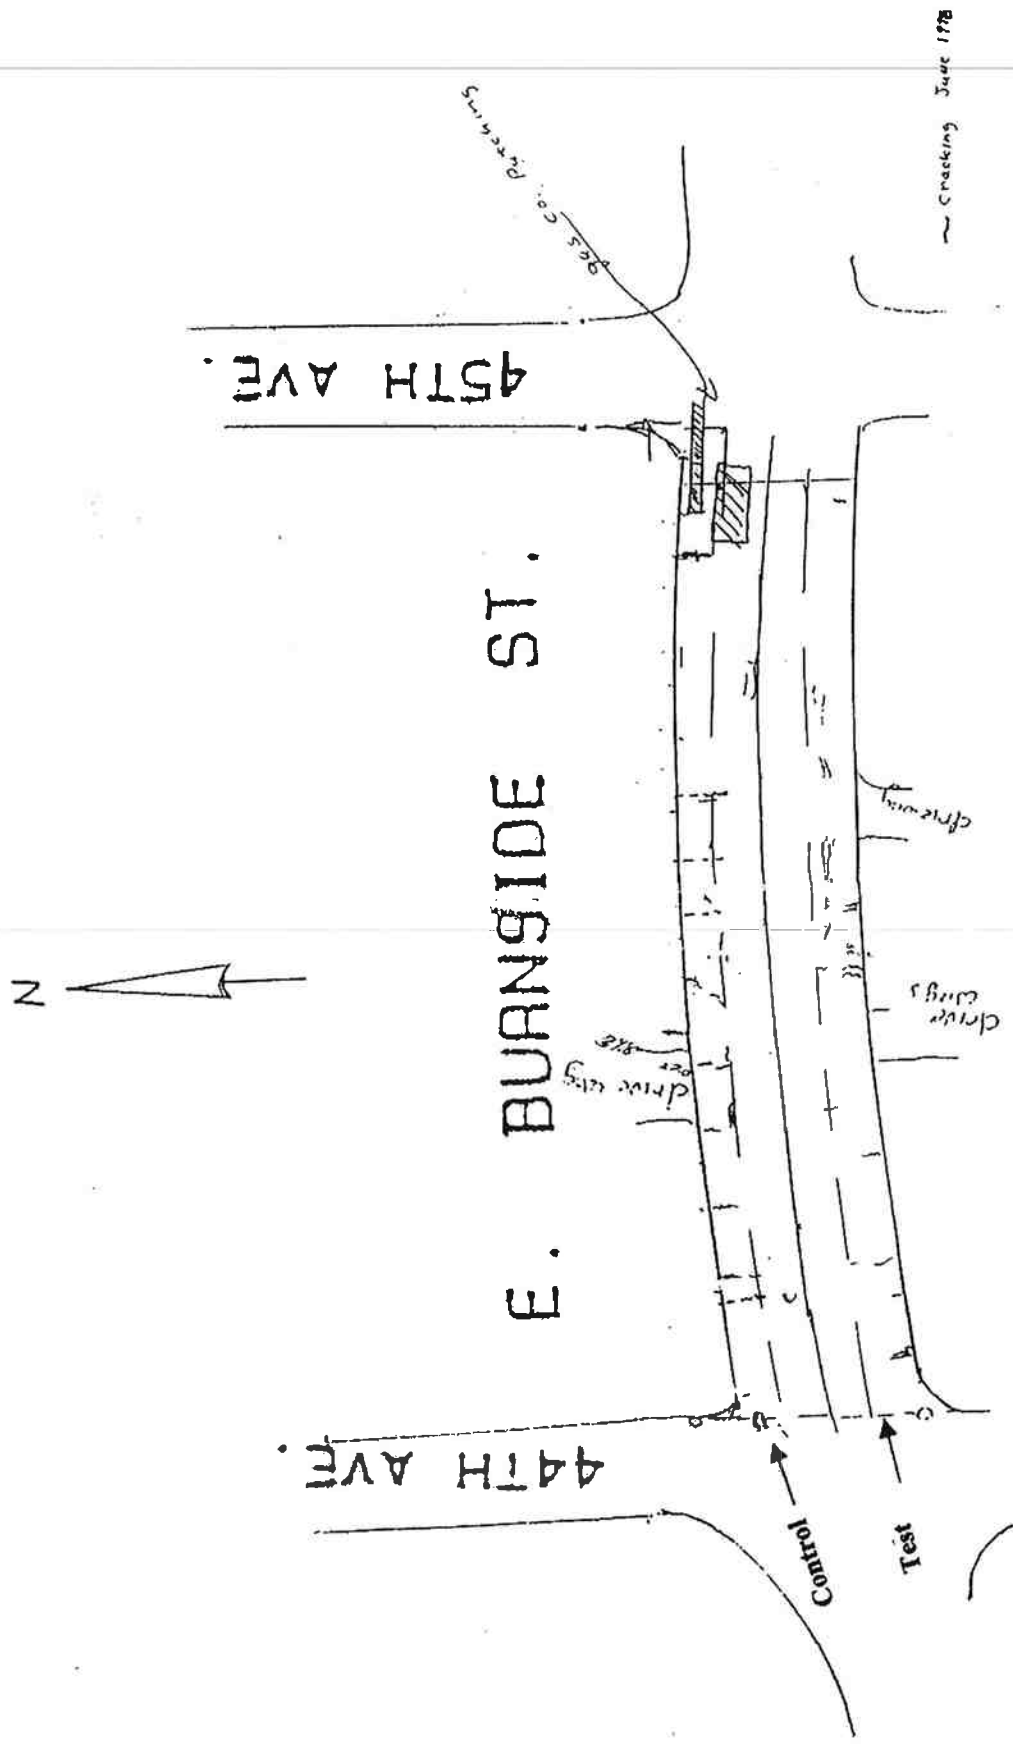
Figure 5.1: Crack Map of Test and Control Sections

The project was evaluated once each year from 1992 to 1998. For the first few years in the reinforced section, only a few cracks were found. In 1996, more and larger cracks started to grow. Longitudinal cracks found in this area were visible on the original pavement after the grinding was completed. The cracks are starting to reflect through the overlay in the test section. However, the total cracking today in either the test or control sections is much less than the original reflective cracks shown in the pre-construction videotape. Figure 5.1 is a sketch of the 1998 noted cracking in the reinforced section and Figures 5.2 and 5.3 include photographs of the test and control sections. Note from the crack map (Figure 5.1) that the control section has slightly more cracking than the test section. Rutting was found to be less than 6 mm.

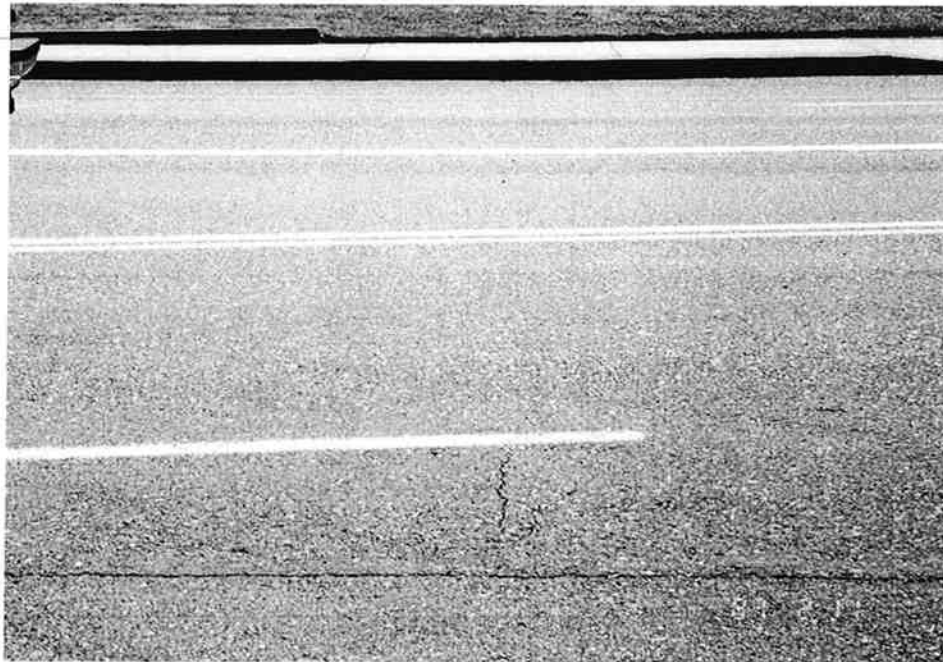
Figure 5.2: Typical View of the Test Section

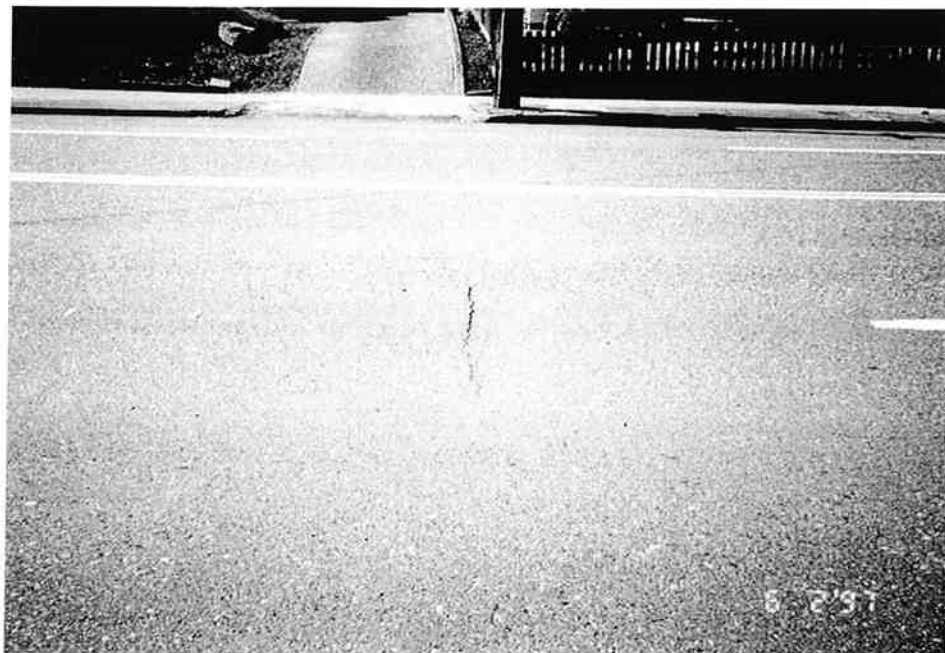
Figure 5.3: Typical Cracking in the Control Section

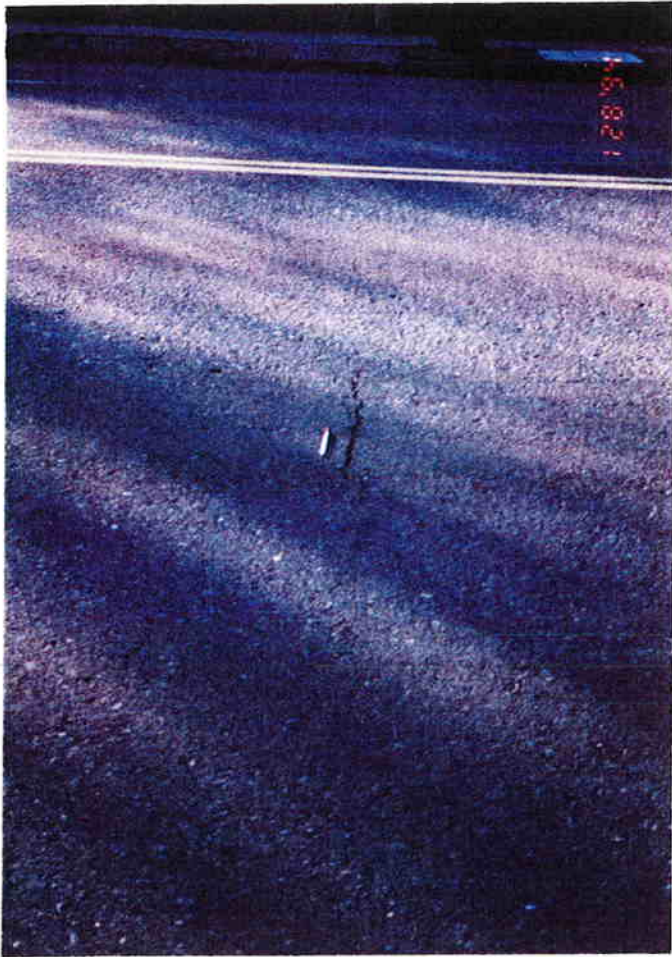
(a) Cracks in the AC Overlay in the Pavement Reinforcement (Glasgrid) Control Section

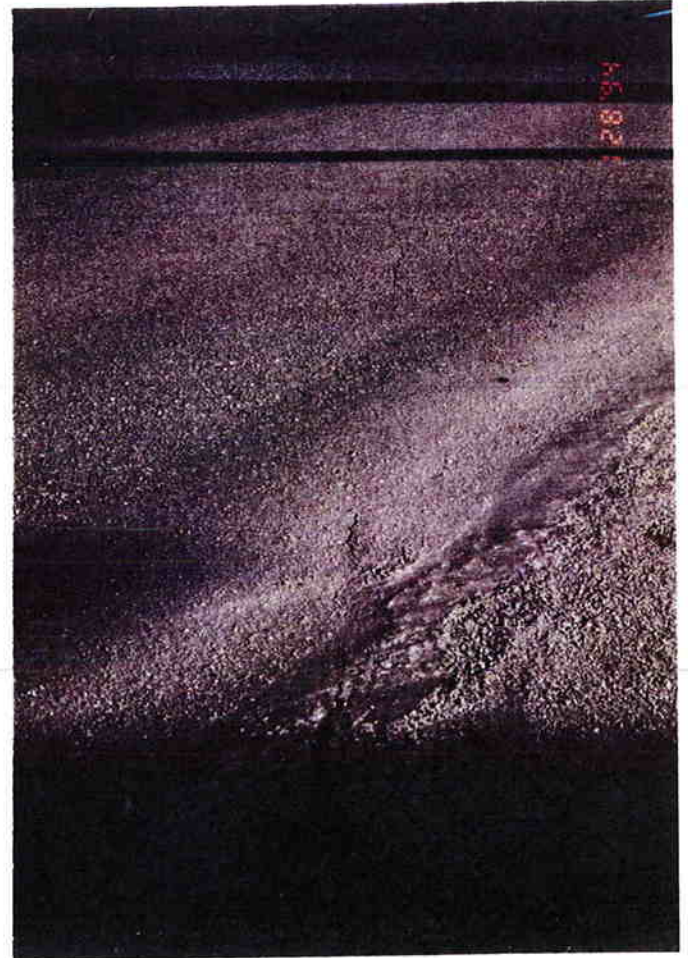
(b) Cracks in the AC Overlay at the Intersection of East Burnside Street and East 44th Avenue
