FOLLOW UP OF INJECTED POLYURETHANE SLAB JACKING

Keely Heintz
Apprenticeships in Science and Engineering Intern

Oregon Department of Transportation
Research Unit
200 Hawthorne SE, Suite B-240
Salem, Oregon 97301-5192

August 2003

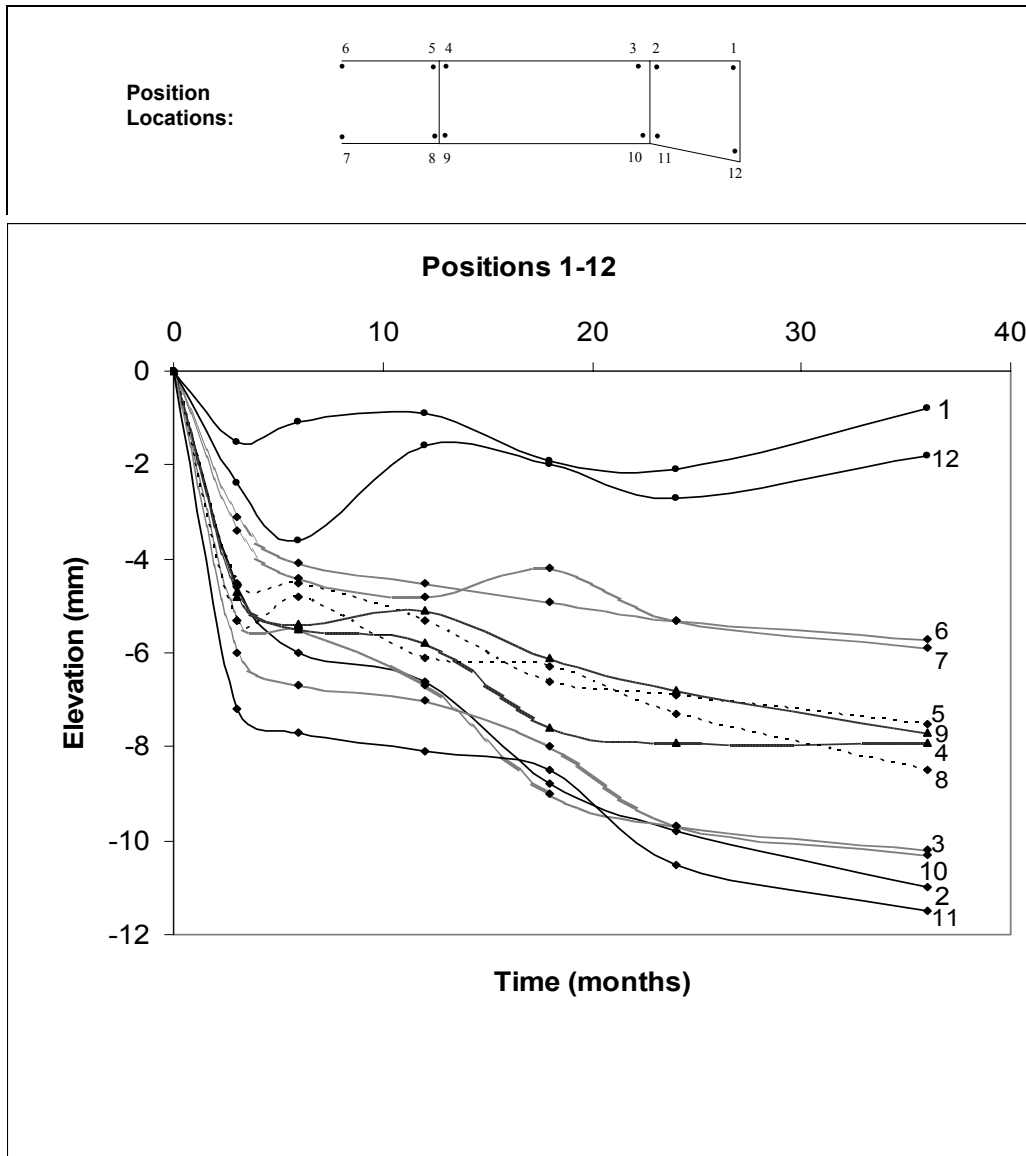
After three years, ten of the twelve positions show continued settling. The rate of settling (change in elevation of the slab) has decreased but has not stopped altogether. The results are shown in Table 3.1 and Figure 3.1.

Figure 3.1: All twelve positions graphed by change in elevation (mm) over time (months)

The twelve curves in Figure 3.1 showed a natural separation into four groups: 1 and 12; 2, 3, 10, and 11; 4, 5, 8, and 9; and 6 and 7. The positions within these groups happen to be within relatively close proximity to each other on the roadway.

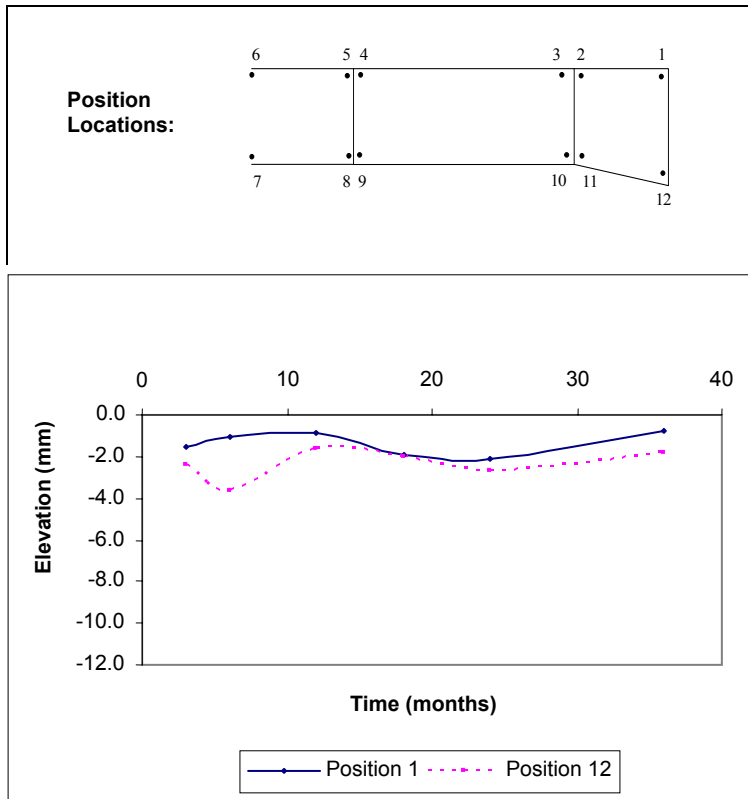
Graphs of the four position groupings showing elevation change over time relative to the first survey are shown in Figures 3.2 - 3.5. Positions 1 and 12 fluctuate over time, but they have an approximate slope of zero. The remaining ten positions all show settling.

Figure 3.2: Elevation change over time of Positions 1 and 12

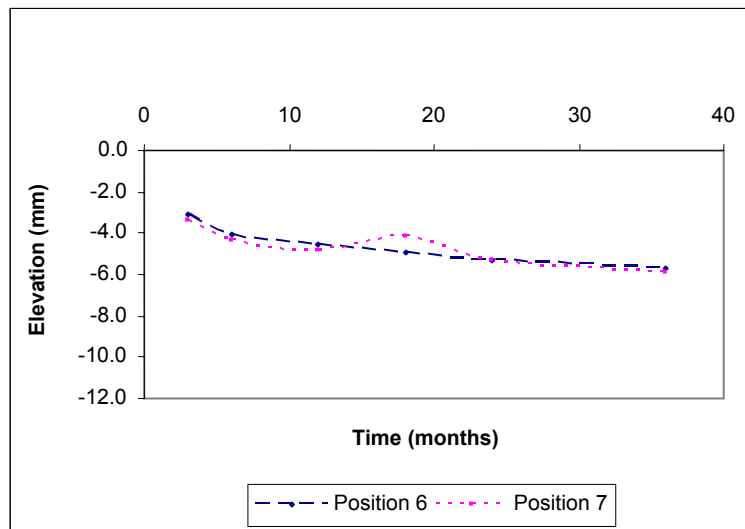
Figure 3.3: Elevation change over time of Positions 6 and 7

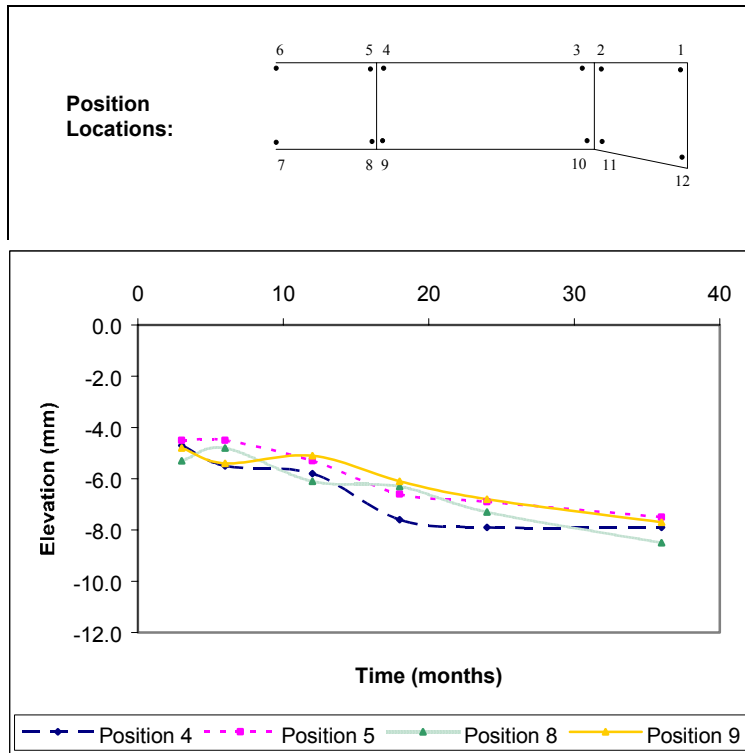
Figure 3.4: Elevation change over time of Positions 4, 5, 8, and 9

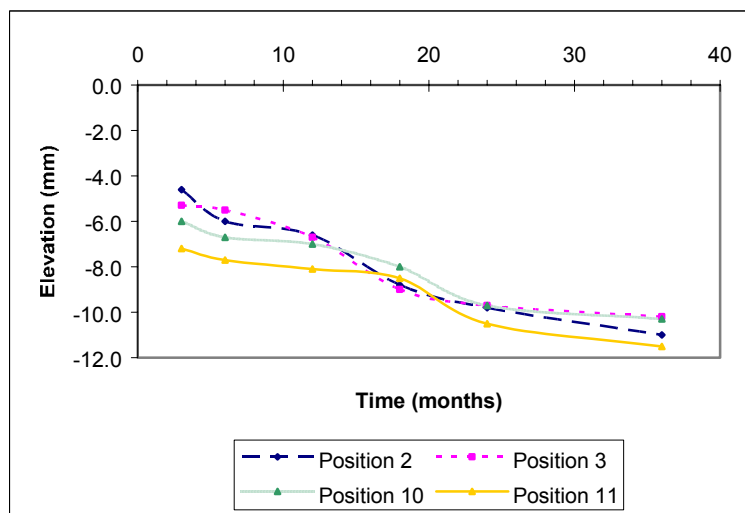
Figure 3.5: Elevation change over time of Positions 2, 3, 10, and 11

Positions 4, 5, 8, and 9, and Positions 2, 3, 10, and 11. The group of Positions 2, 3, 10, and 11 had the largest settling rate over the past three years with an average rate of elevation loss of 1.9 millimeters per year.

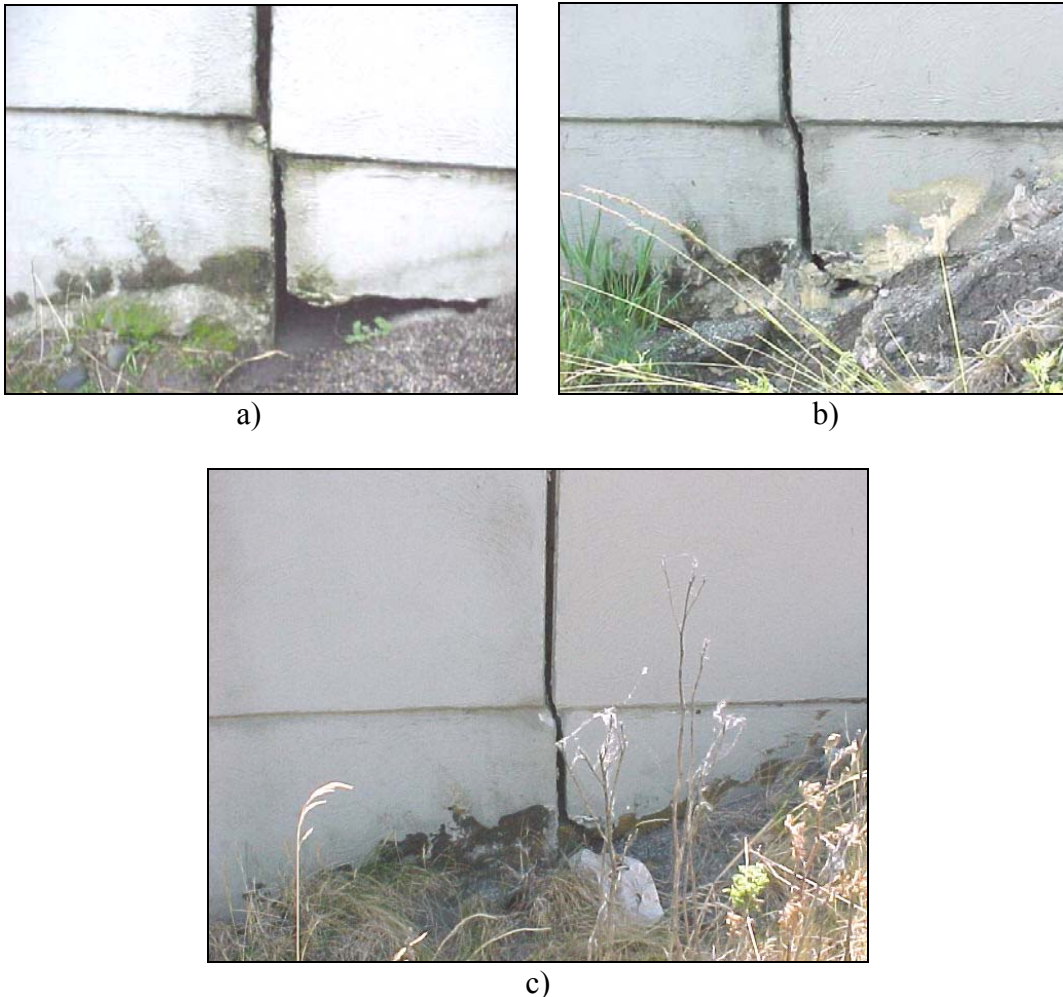
Because this slab jacking site has only been tested for three years, it is hard to make any conclusions about whether or not injected polyurethane has been a good solution to the original problem. The settling of the position groupings ranged from 0 to 1.9 mm/yr. However, to the naked eye, this site has not changed since slab jacking was done, as shown in Figure 4.1.

Figure 4.1: Side view of joint between bridge end panel and the adjacent slab (between Positions 2 and 3):
a) before slab jacking; b) four days after slab jacking; c) three years after slab jacking
