PERFORMANCE OF ULTRA-THIN WHITETOPPING (UTW) IN OKLAHOMA

FINAL REPORT ~ FHWA-OK-10-05
ODOT SP&R ITEM NUMBER 2222

DECEMBER 2010

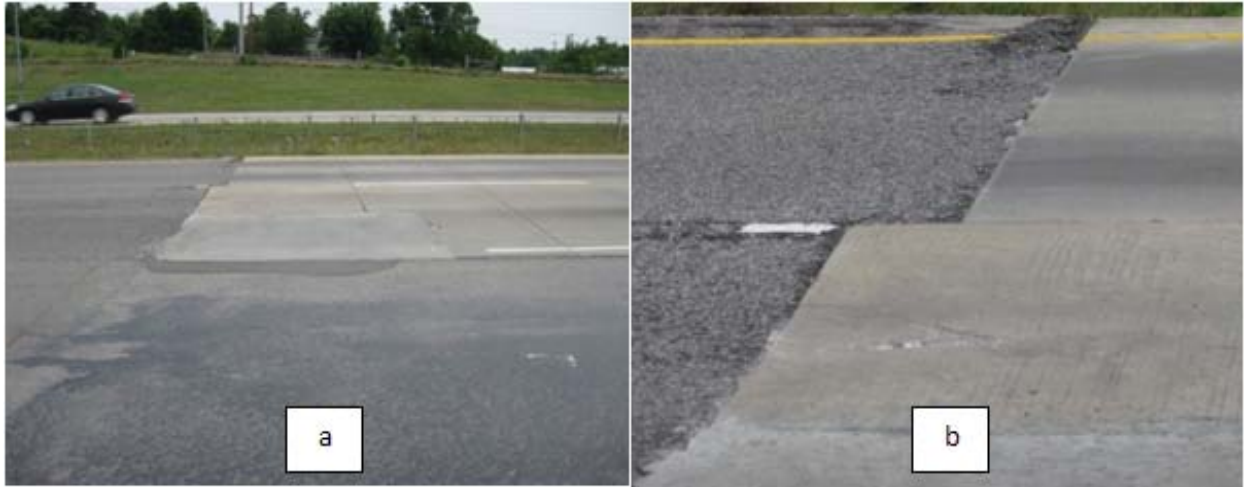
The overall condition of this overlay looked very good. However, there were some problems observed. The initial panels had been replaced with a new concrete panel (Fig. 2.10 a). A definite elevation difference was seen between the asphalt pavement and the approach thin white-topping panel at the beginning of the project. The elevation difference was very significant, with some cracking observed in the approach panels even after the replacement (Fig. 2.10 b). Some heavy polishing was seen in both driving and passing lanes of the overlay, stretching to over 30 panels in length. Longitudinal cracking was also seen, but it was insignificant as it was just at a couple of places over the overlay and also spanned only for two panels. At about 0.7 miles after the start of the overlay (at exit for US 270 west on the highway), two punch outs were seen, as shown in Fig. 2.11. Some corner cracking was also observed where the approach ramp meets the overlay after this exit. None of the problems stated above were extensive, but they should be monitored for future deterioration. The end of the overlay looked good without any sign of distress, as shown in Fig. 2.12, as it ends in a concrete bridge. Also, drainage of this overlay looked quite good and satisfactory.

Figure 2.10 - Initial panel replacement at the start of overlay as seen in photo a, and in photo b we see how there is an elevation difference between the leaving asphalt panel and approaching concrete panel.

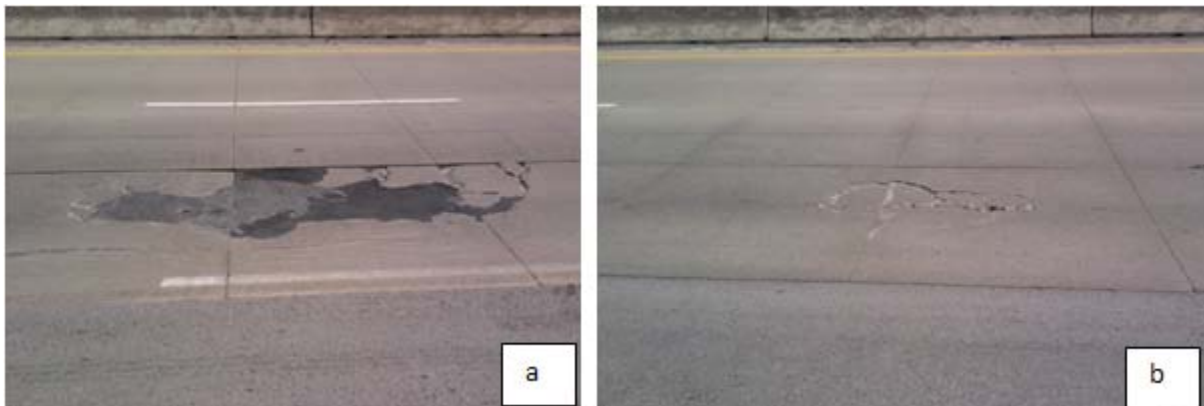
Figure 2.11 - Punch outs at the exit for US 270 west. These two punch (photos a and b) outs are about ten panels apart from each other.

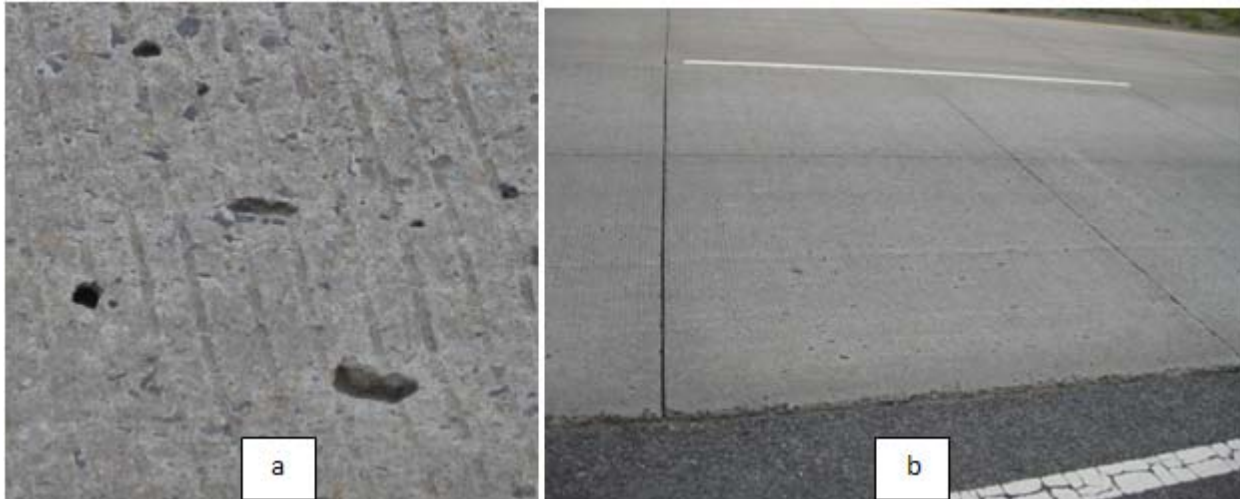
Some pop outs were seen about 0.5 miles from the south end of the overlay. About 24 panels showed pop outs with approximately 20 per panel, as shown in Fig. 2.14. This is likely caused by an unsound aggregate being used in these panels. The overlay ended in a jointed concrete pavement. Significant scaling and faulting were observed where the overlay ends. However, repairs have been done for both panels, as shown in Fig. 2.15.

Figure 2.14 - Photo a showing pop outs (about 20 pop outs/panel) of larger aggregates (on about 24 panels) at about 0.5 miles from the south end of the overlay. Photo b is just the closer view of photo a.

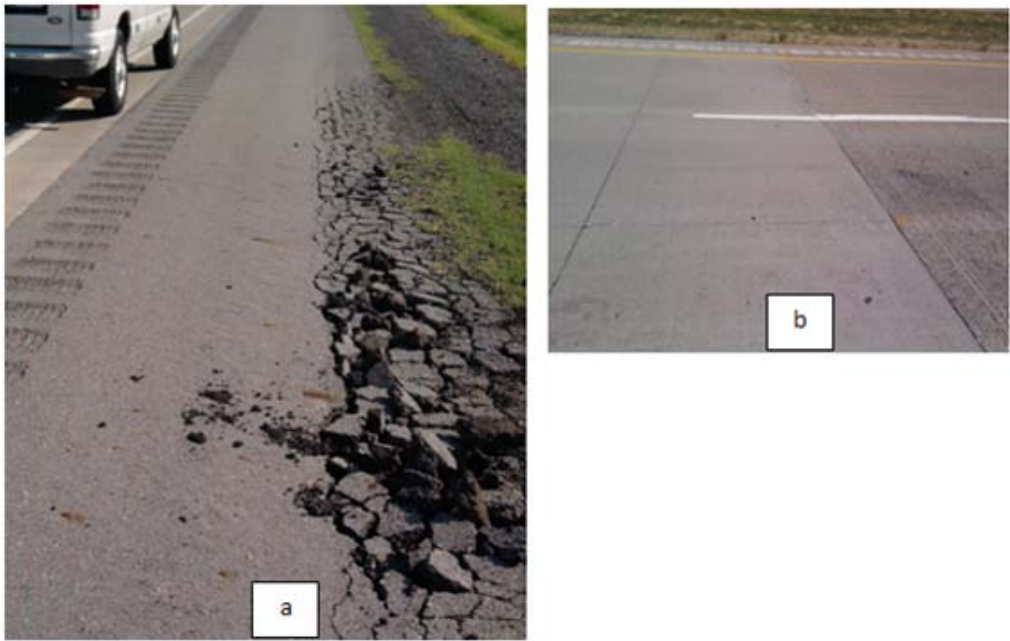
Figure 2.23 – Photo a shows the deterioration of the asphalt shoulders. Photo b shows the interface of the overlay with a CRCP pavement. The end of the overlay was in excellent condition.

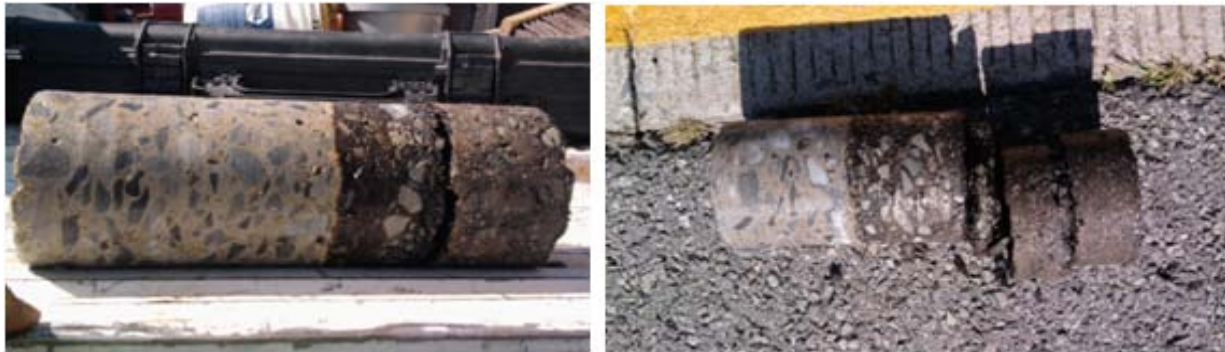
Fig. 2.26 shows the cores extracted from Oldest McAlester Whitetopping. The thickness of asphalt was found to be, at minimum, 9" and was on an average 11". This is likely one contributing factor into the positive performance of the overlay. Four cores were taken at the locations 1 and 5 from the driving lane and 3 and 7 from the passing lane as described in Table 2.9.

Figure 2.26 - Cores extracted on the oldest McAlester Overlay.

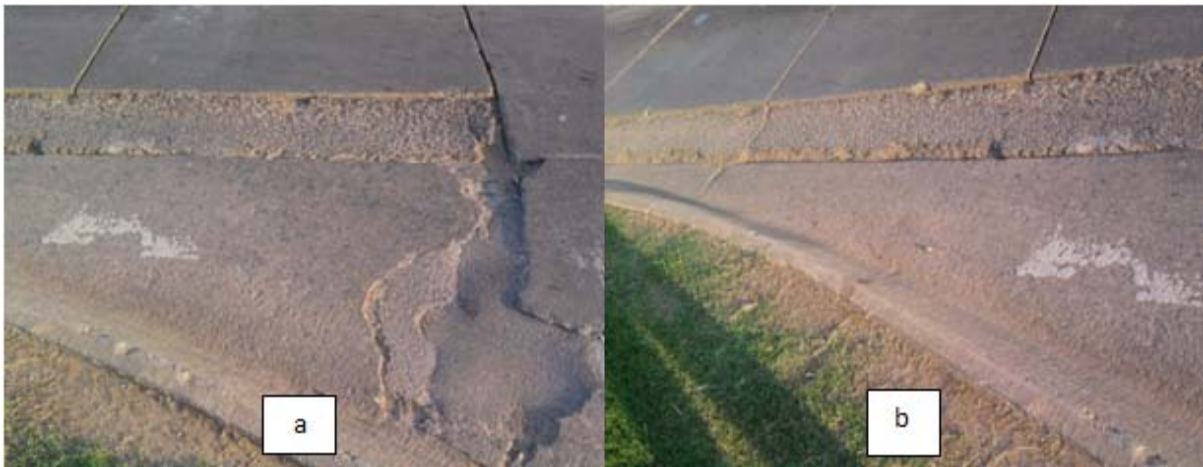
Figure 2.42 - Photos a and b showing faulting as overlay turns from west SH – 51 to north US – 177.
