DETECTION OF STRIPPING IN HOT MIX ASPHALT

Final Report

March 11, 2005

**Office of Materials and Research
Georgia Department of Transportation
Forest Park, GA 30297-2599**

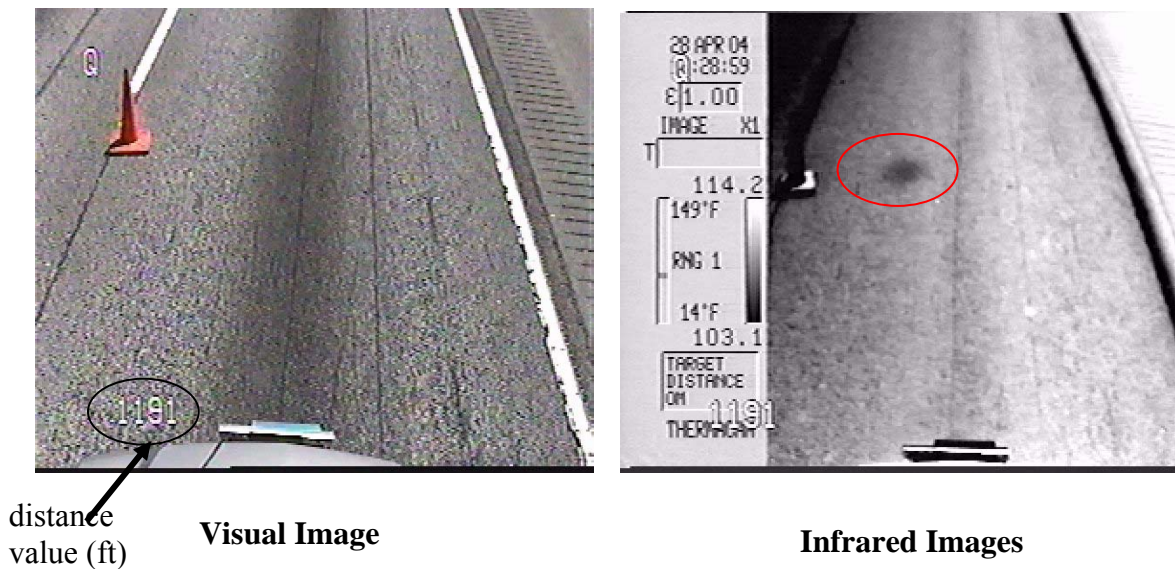
Figure 3-7 shows a pair of images collected at 1191 feet from MP 46. The visual image is on the left, and the infrared image at the same location is on the right. The IR image includes a data bar on the left, which shows the temperature range setting of the camera (103.1°F to 114.2 °F), and the data, the time, and the assumed surface emissivity. Note that there is a cool spot on the IR image which does not correspond to any observable surface feature in the video image. This observation indicates that the cool spot is related to subsurface moisture or some other effect that would lower the surface temperature. The IR anomalies were generally localized, and were not as widespread as expected. None of the locations coincided with core locations, and therefore no correlation between these anomalies and the evidence of moisture damage was found.

Figure 3-7. Visual and infrared camera images (potential stripping area highlighted in red).

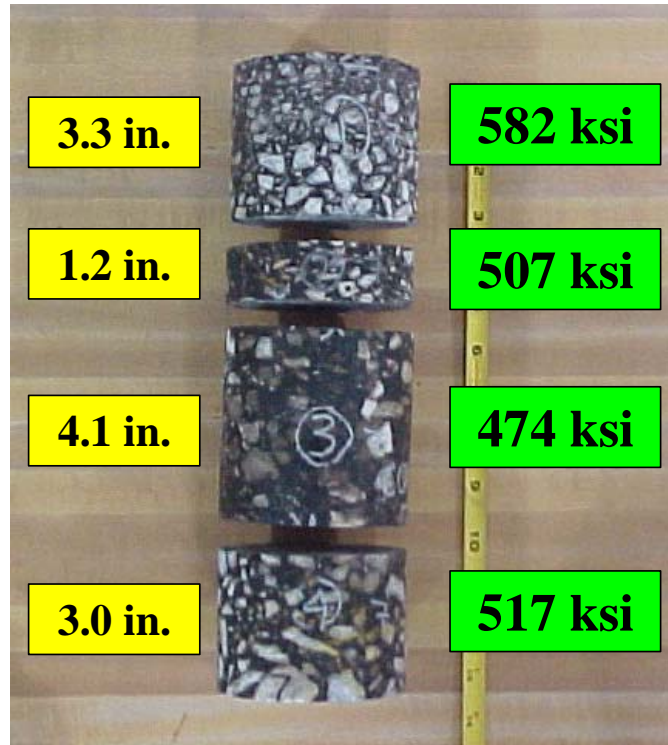
In general, either deterioration due to stripping has occurred or the quality of the material below a depth of 4 to 6 inches is lower than the desirable values anticipated at the site.

Figure 3-11. Variation in modulus of with depth for deteriorated I-20 core

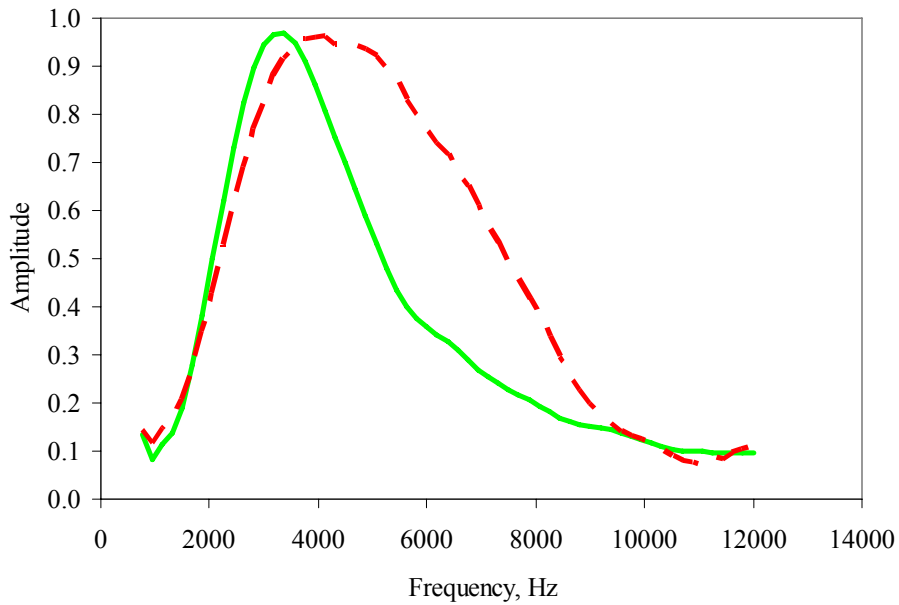
The impact echo amplitude spectra obtained from the intact and deteriorated points are shown in Figure 3-14. The two spectra have similar peak frequencies. This is a unique situation at this site which infrequently occurs. For the intact core, the thickness is about 16 inches. For such a thickness, the return frequency is about 3 kHz. For the deteriorated condition, where the flexural mode of vibration is prevalent, the frequency is about 3.5 kHz. As such, the peak frequency of the impact echo is not a suitable parameter for locating severely deteriorated areas at this site. As shown in Figure 3-15, these spectra can be converted to thickness. In the case of the intact location, as shown in Figure 3-15a, the measured thickness is close to the thickness of the composite HMA layer. The differences lie in the method with which the velocity of the core was estimated. However, for the deteriorated area, the thickness is neither related to the thickness of the HMA layer nor the location of deterioration. Even though the peak frequencies are similar, the shapes of the amplitude spectra are rather different.

Figure 3-14. Impact echo amplitude spectra from intact and deteriorated locations

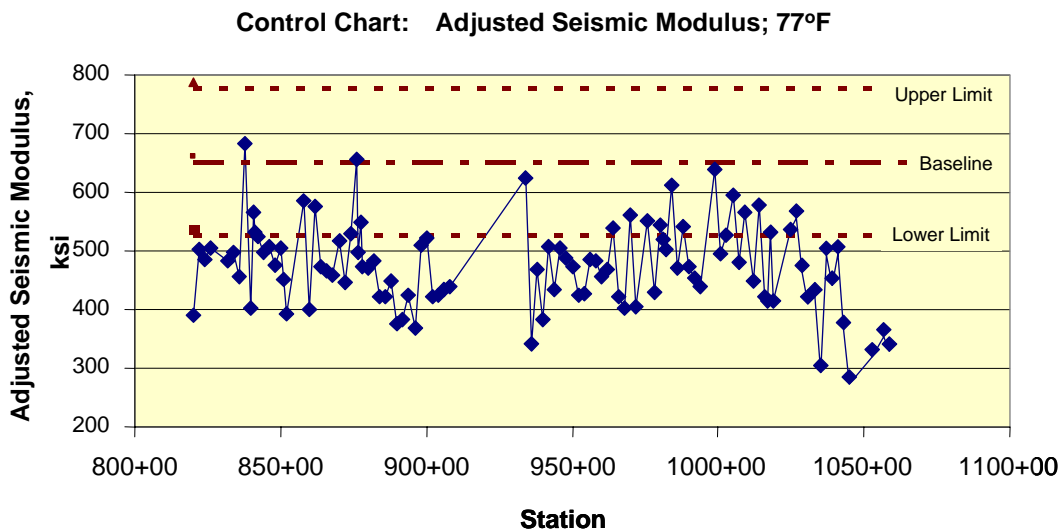
As shown in Figure 3-33, most of the seismic modulus values are significantly less than the values that would be expected for an intact, good quality HMA at a depth of 4 to about 10 inches. Thus, the test results from the seismic testing indicate that the HMA has moisture damage or some other form of damage.

Figure 3-33. Adjusted I-20 HMA seismic modulus as compared to the range of expected modulus values

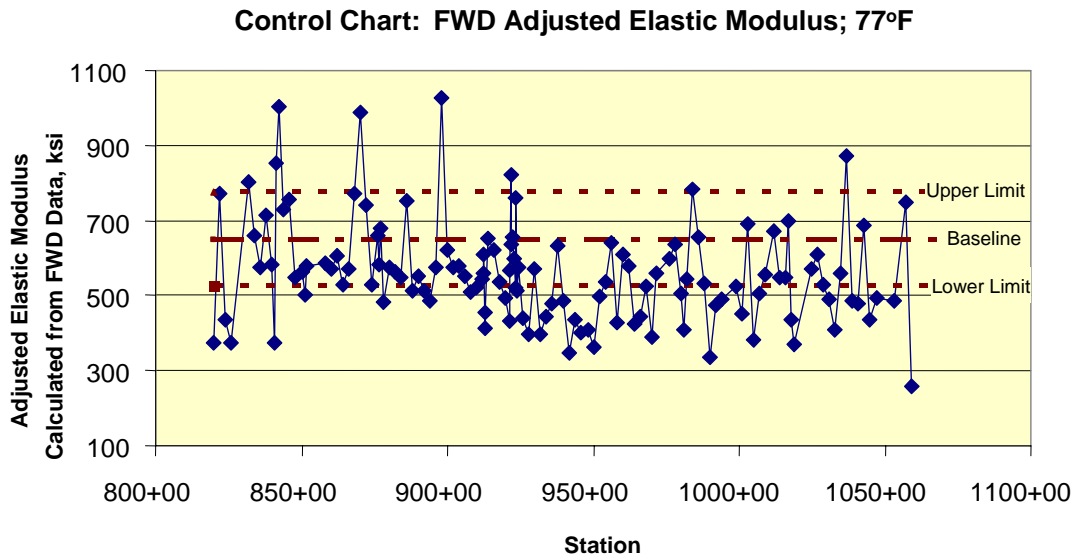
Figure 3-34 shows the longitudinal profile of the elastic modulus calculated from the FWD deflection basin data. Like the seismic modulus data, these data have been adjusted to a standard temperature of 77°F. As shown, most of the modulus values were found to be between the expected low and high baseline values for the HMA binder layer. These data suggest that moisture damage is not as extensive, as suggested by the seismic data. However, the variation in HMA layer thickness can significantly affect these values.

Figure 3-34. I-20 HMA elastic modulus calculated from FWD data as compared to the range of expected modulus values

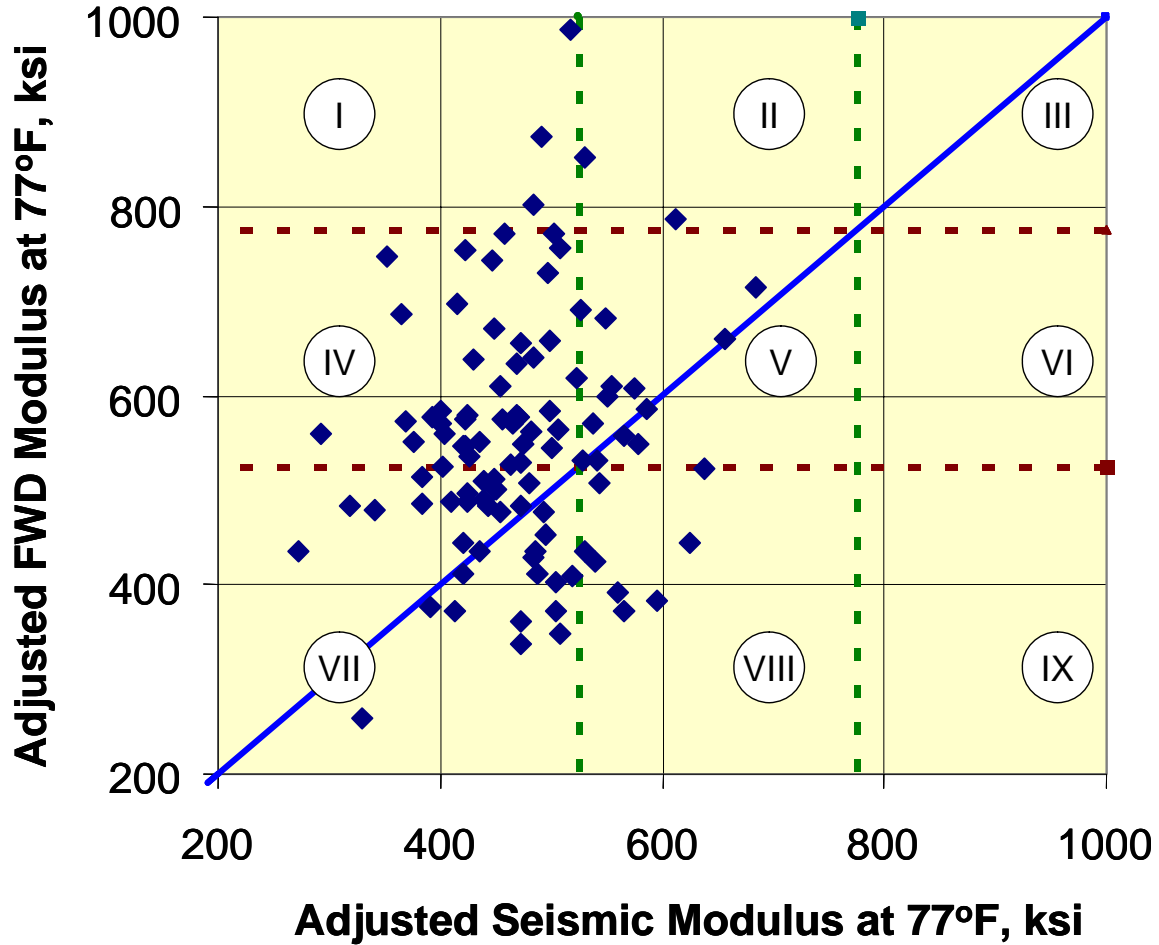
More importantly, no definite relationship was found between the two data sets. Thus, the FWD and seismic test results would indicate different findings. The FWD results suggest that moisture damage may not be severe and confined to specific areas, while the seismic results suggest that moisture damage is more extensive and occurs in most of the areas tested. As such, the hypothesis that modulus values from the deflection basin and seismic data will result in similar values when adjustments for temperature and loading frequency are properly taken into account was not found to be supported by the field test results.

Figure 3-35. Comparison of the HMA modulus values estimated from the FWD and seismic testing

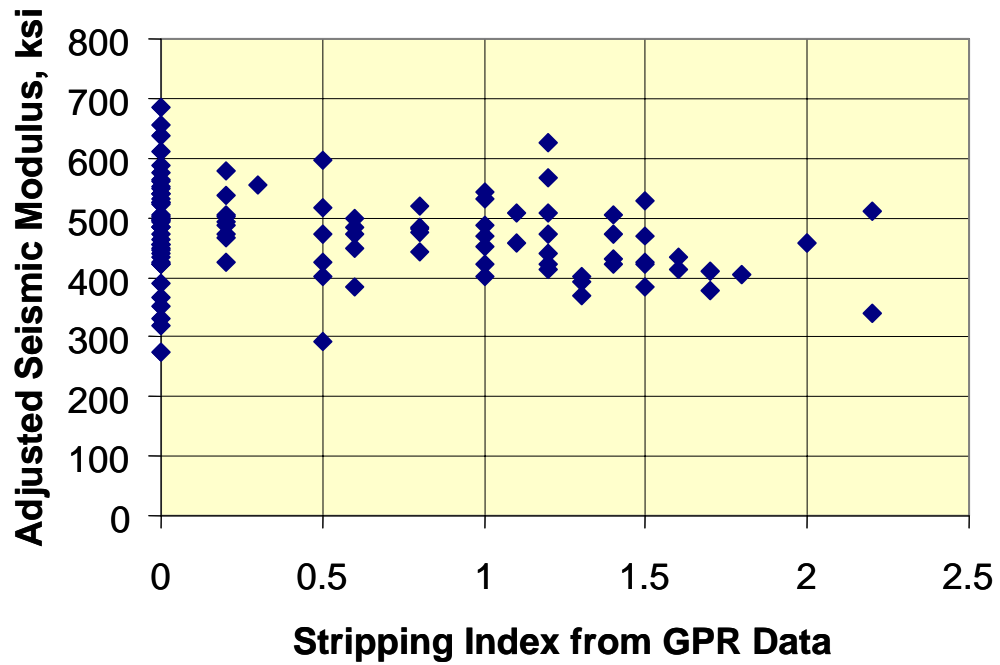
Figures 3-36 and 3-37 show the relationship between the GPR stripping indices determined from the GPR data and the adjusted seismic and elastic modulus values. As shown, there appears to be no relationship between the different data sets.

Figure 3-36. Comparison of GPR SI with adjusted seismic modulus for I-20 Lane 3

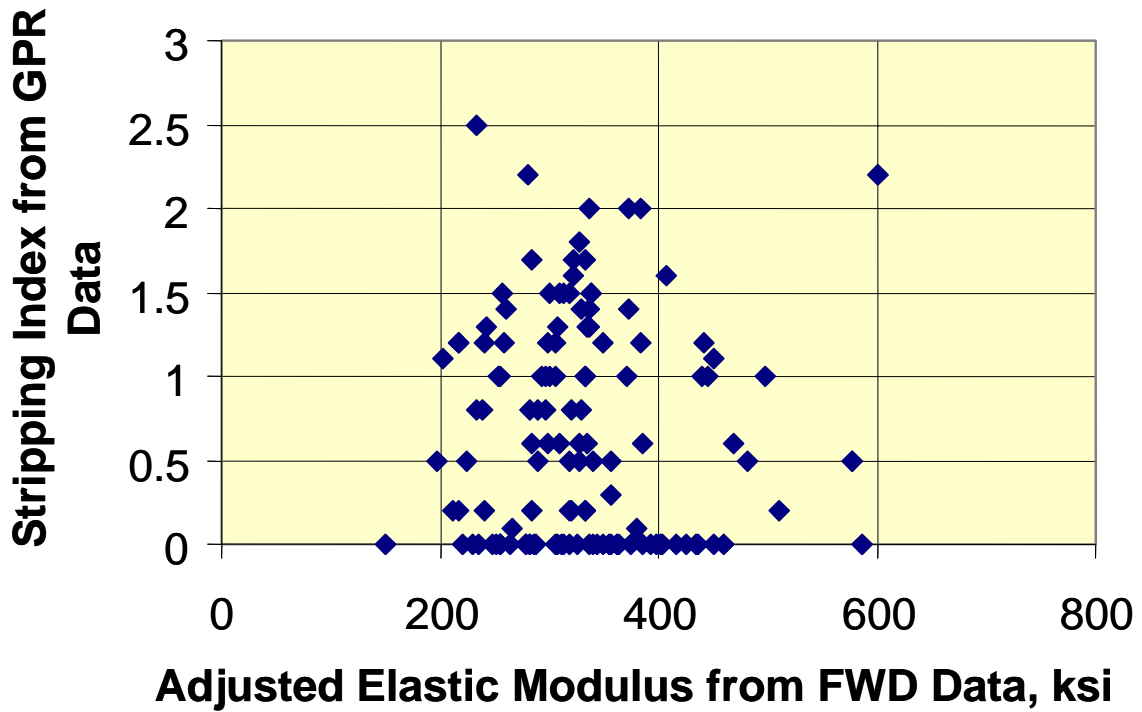
Figure 3-37. Comparison of GPR SI with FWD elastic modulus for I-20 Lane 3

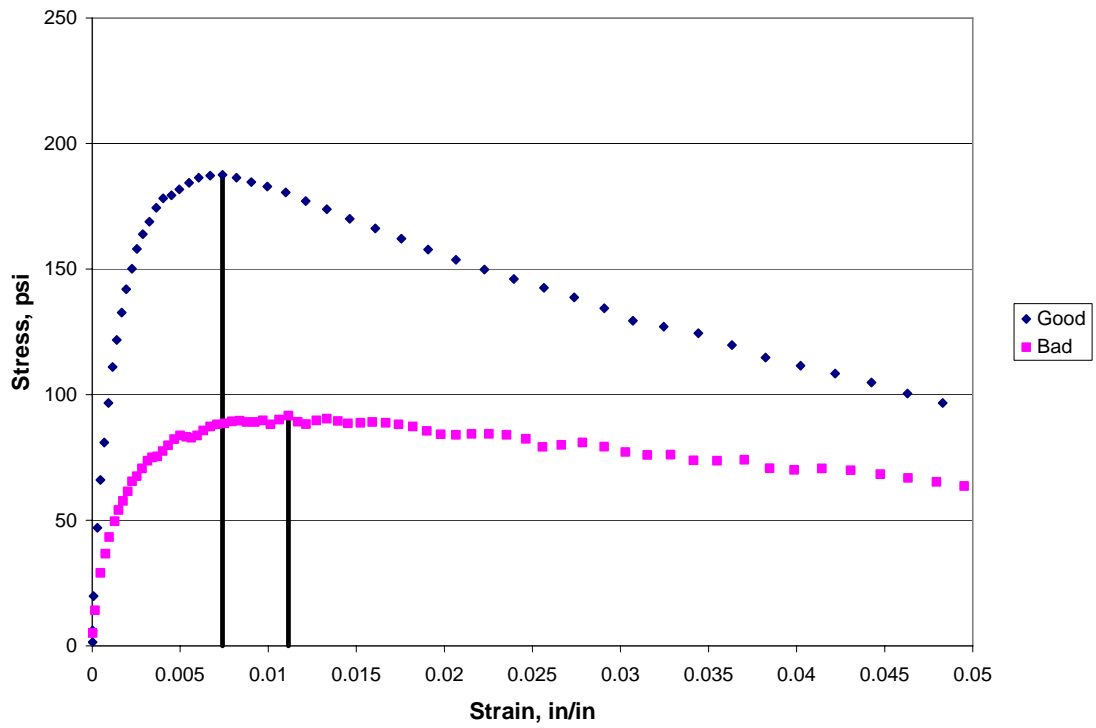
I-20 Core 5

It is difficult to compare the seismic modulus determined from the field tests to those dynamic modulus values measured in the laboratory using the indirect tensile test, since there were only two cores that were taken from the area with the seismic test results. Cores 5 and 8 were taken from the area where the seismic tests were conducted. The other cores were taken either from a different lane or in a different area. The seismic test results in the area represented by cores 5 and 8 suggest little to no moisture damage. The test results from the binder layer of core 8 plot above the standard line and suggest little moisture damage, while the test results from core 5 suggest significant moisture damage.
