Final Report for Research Project

**LONG-TERM MAINTENANCE MONITORING  
DEMONSTRATION ON A MOVABLE BRIDGE**

September 2011

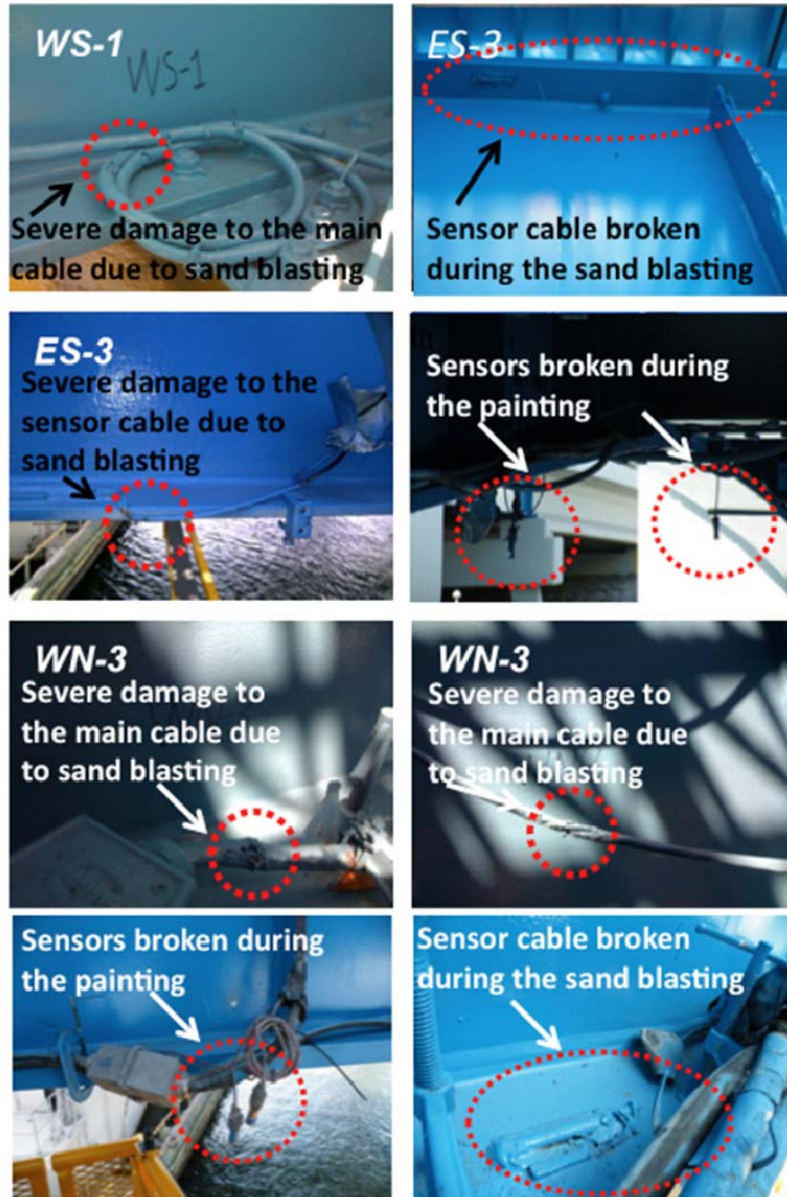
- Operations at the bridge and environmental issues: The maintenance operations, work at the machinery room, loss of power (tripping at the outlets due to rain, or simply disconnected power cords also caused damage in some sensors, which have been replaced accordingly. This system halt caused some missing data from the electrical and mechanical components. The sand blasting and painting operation caused significant damage to the sensors and cabling of the monitoring system. Repairs and/or replacement of these components were attempted during the several field visits conducted during the extension project (details about these field visits are presented in the monthly reports). Some pictures showing damage to the monitoring system due to the sand blasting and painting are presented in the following (Figure 7).

Figure 7: Sample pictures showing the severe damage to the monitoring components at different locations (WS: West-South, ES: East-South, WN: West-North)

structural sensors were repaired/replaced with the help of snooper truck whereas in the sixth trip the mechanical room sensors were repaired/replaced. After these actions, 75% of all channels are working properly, 16% of the channels have connections to the system but the sensors are malfunctioning, however, additional snooper truck and MOT was not available after Field Visit 3 to fix these sensors. The rest of the channels, which corresponds to 9% are showing no reading due to disconnection. This requires additional debugging and possible changing damaged sensor cables (also sensors) and/or main cables.

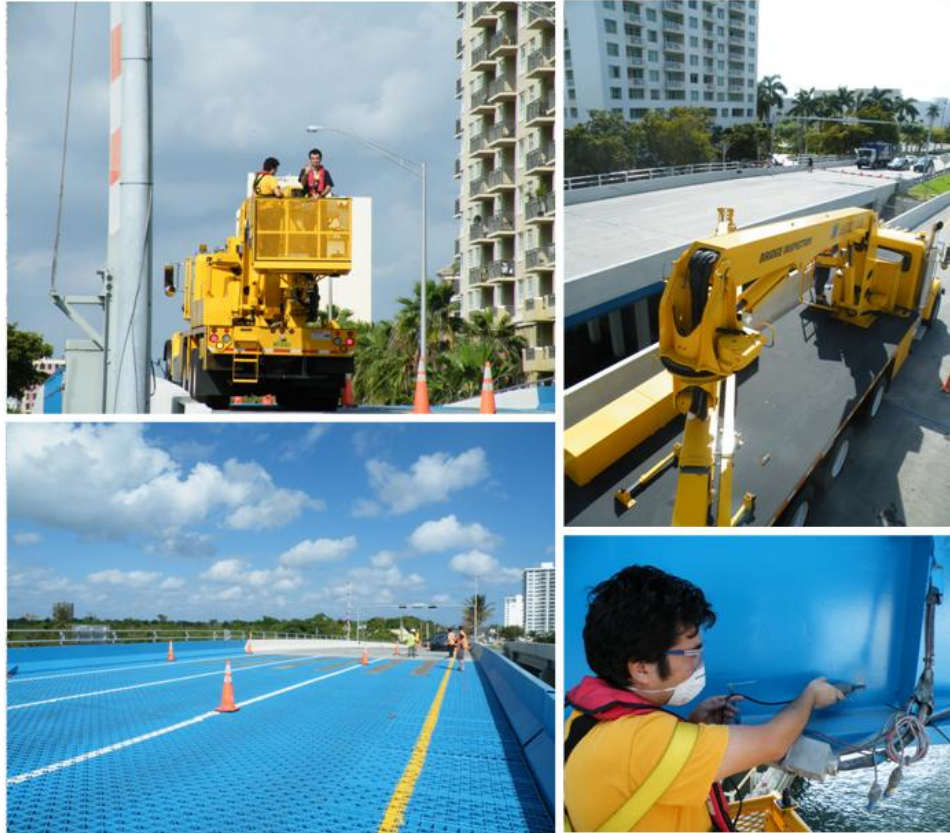
Figure 8: Sample pictures from the field work conducted during 3/8/2011-3/11/2011

3. Field Visit 3 (March 8-11, 2011): The main objectives of this field visit were to investigate the condition of the monitoring system at the structural elements which could not be checked without the help of a snooper truck and to repair/replace the damaged components during the scheduled time. Three days of MOT provided during this visit.

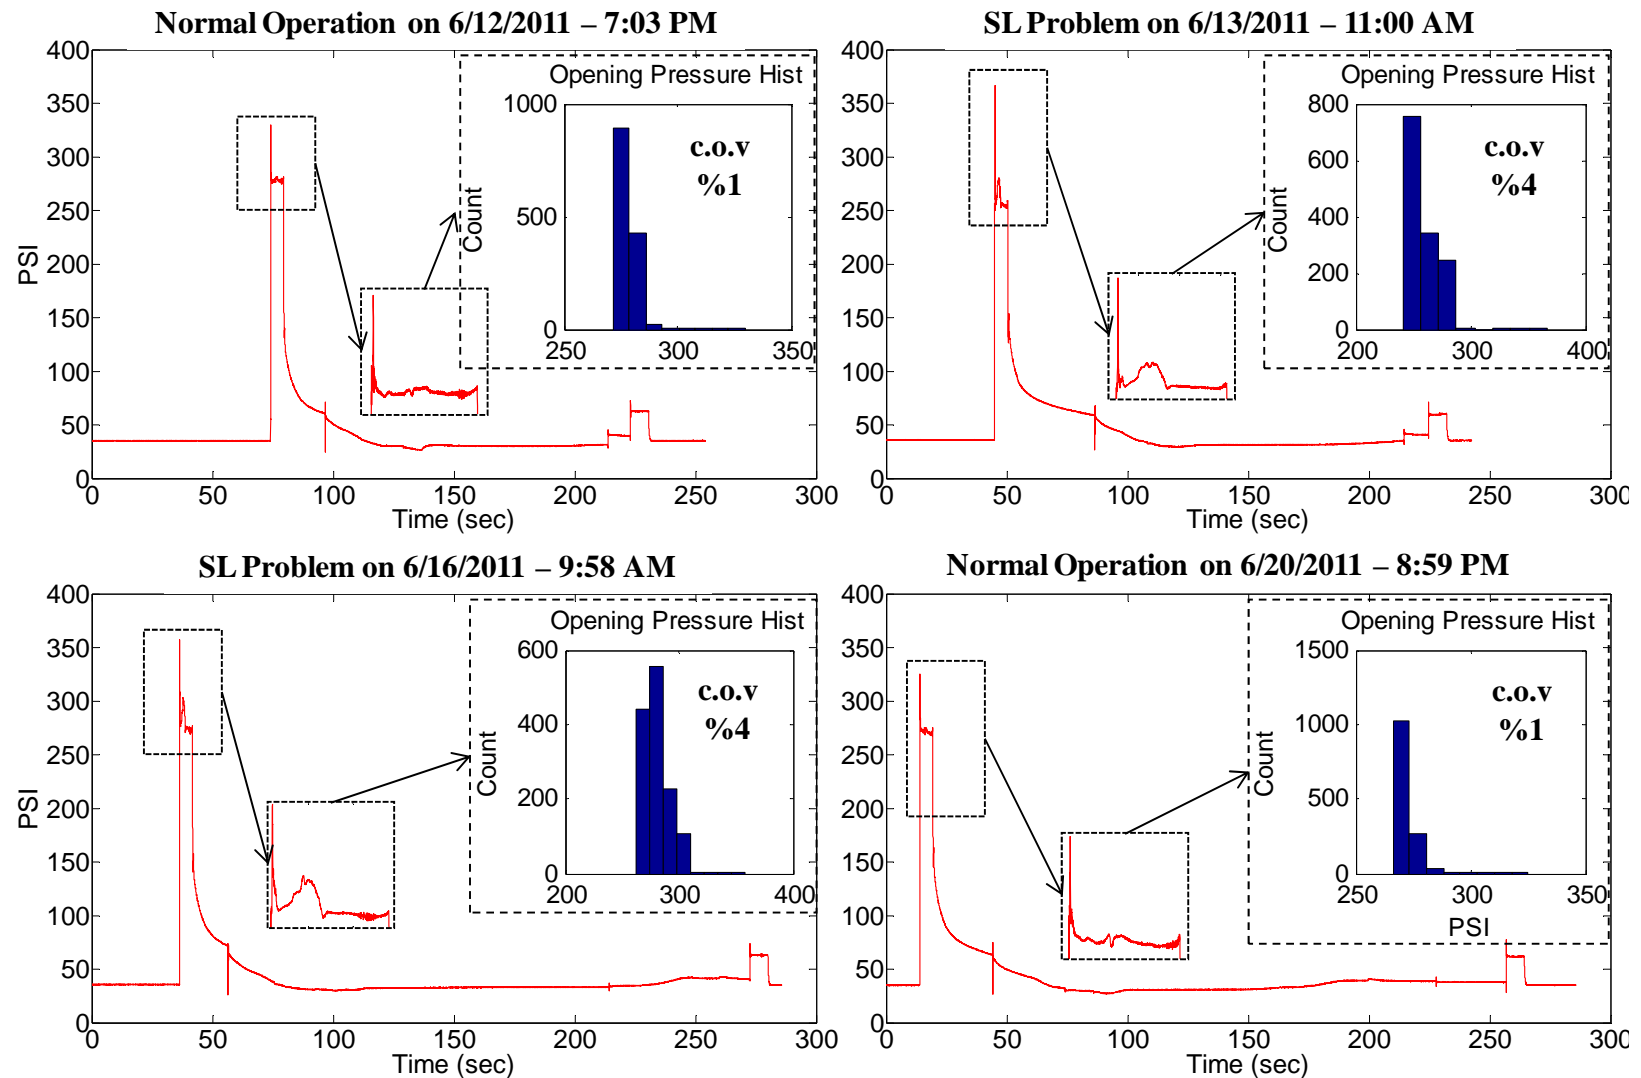
levels corroborate with the changes observed at the span lock pressure gages, these are also affected by the traffic on the bridge.

Figure 44: Behavior change of the pressure gauge data

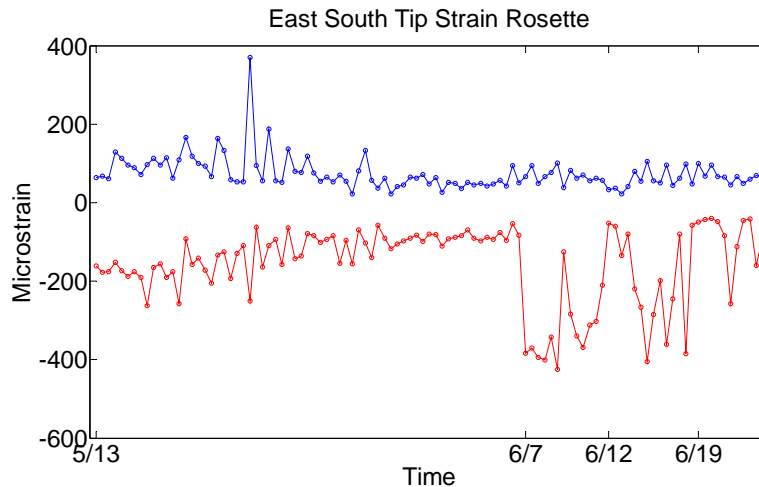
The strain gage at the top of the receiver is evaluated. In Figure 46, daily mean of 30-Max and mean of 30-Min readings for East South tip strain rosette are presented. In east south tip strain rosette (change starts at 6/7/2011 5:10 PM). This comes back to normal to around 6/19/2011.

Figure 46: East South tip strain rosette data trend

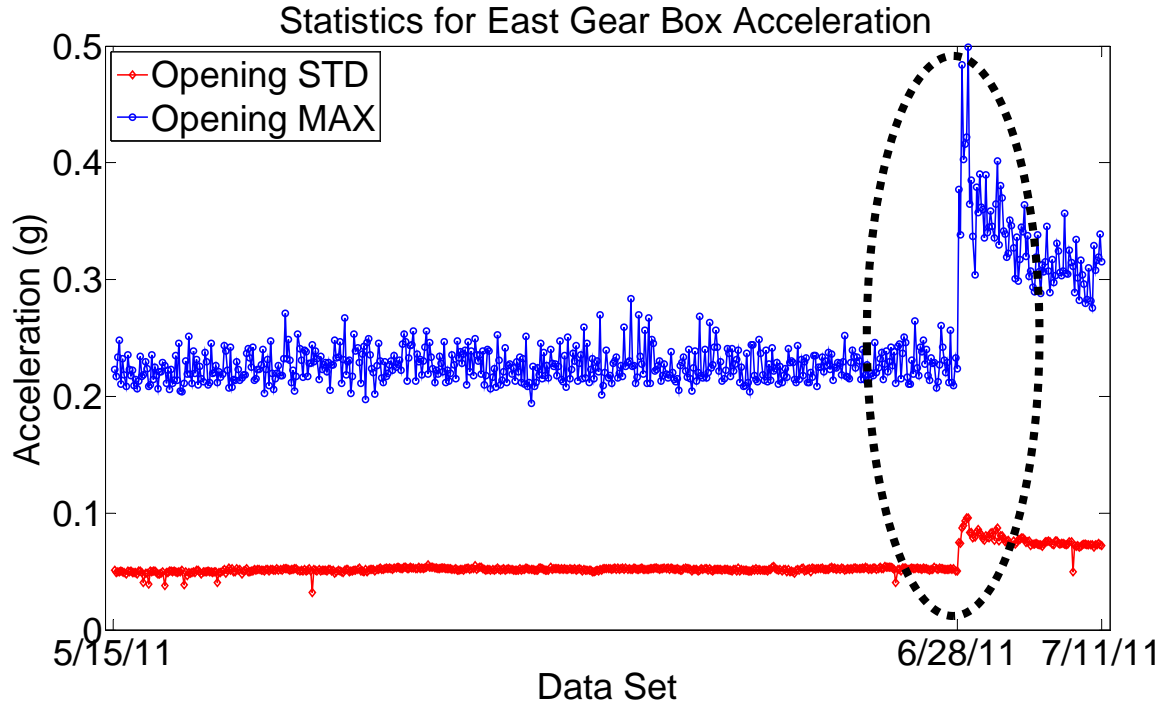
determine if the gearbox condition is satisfactory. While tracking the statistical properties of the gearbox accelerations, a significant increase in the vibration levels is seen on 6/28/2011 which is shown in Figure 48. Before this date, the maximum vibration levels are slightly higher than 0.2 g whereas the vibration levels increased to 0.3-0.5 g after 6/28/2011. The change in the standard deviation characteristics is also shown in Figure 48.

Figure 48: Gearbox acceleration statistical trend

The second case study is the gearbox shaft seal replacement on 6/28/11. In this case study, the effect of maintenance is evaluated with the help of monitoring data. Before this maintenance, the baseline acceleration level on gearbox was around  $\pm 0.2g$  but after the replacement of the shaft seal on gearbox, the acceleration level is increased to  $\pm 0.3g$ . Excessive vibrations are one of the main problems for machinery components, and the effectiveness of the maintenance was demonstrated with the help of the monitoring system.

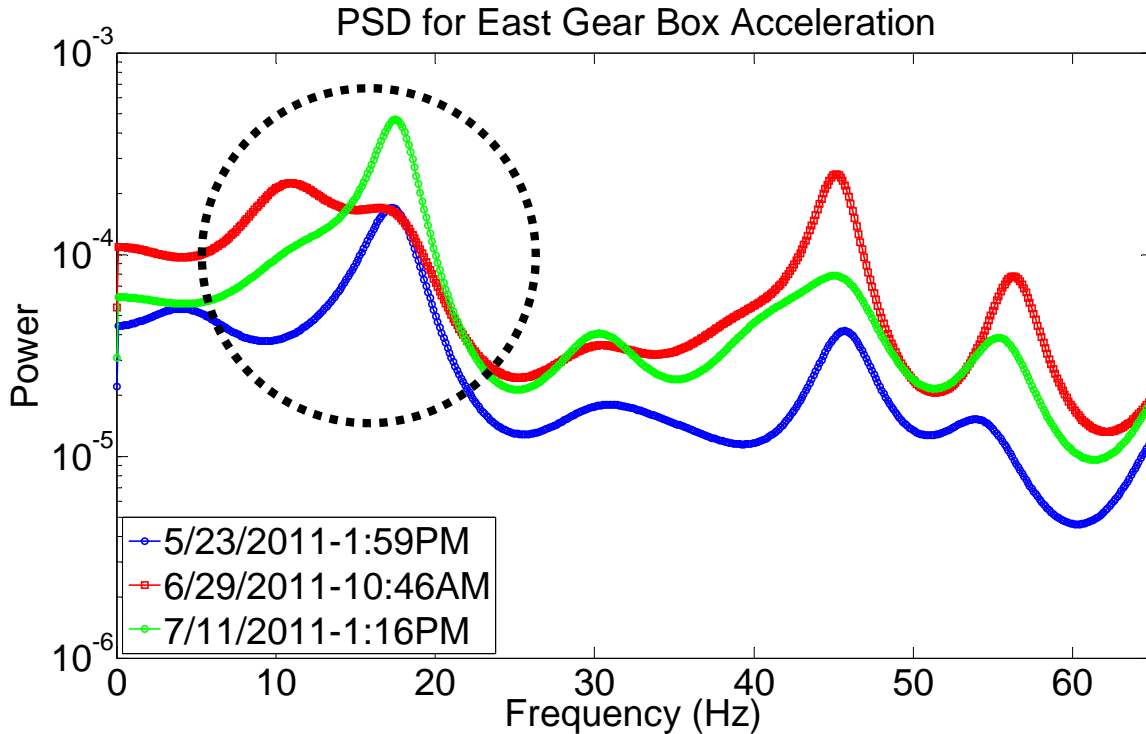
After this observation, authors investigated the frequency domain results of some data sets from 5/23/2011, 6/29/2011 and 7/11/2011 to see the change in vibration characteristics. In Figure 49, a change in dynamic response of the east gearbox is observed especially around 10-20 Hz bandwidth. The change starts on 6/28/2011 and this effect can be observed from the power spectral density plots. By 7/11/2011, the change is getting back to its “normal” condition. The peaks observed around 10 Hz of the gearbox might be attributed mostly to its own dynamic characteristics (mass, stiffness, damping, connection to the concrete etc.).

Figure 49: Gearbox acceleration frequency domain analysis of three different data sets
