Evaluation of Transverse Joint Forming Methods for PCC Pavement

Final Report
January 2006

Sponsored by
the Iowa Highway Research Board (IHRB Project TR-532)

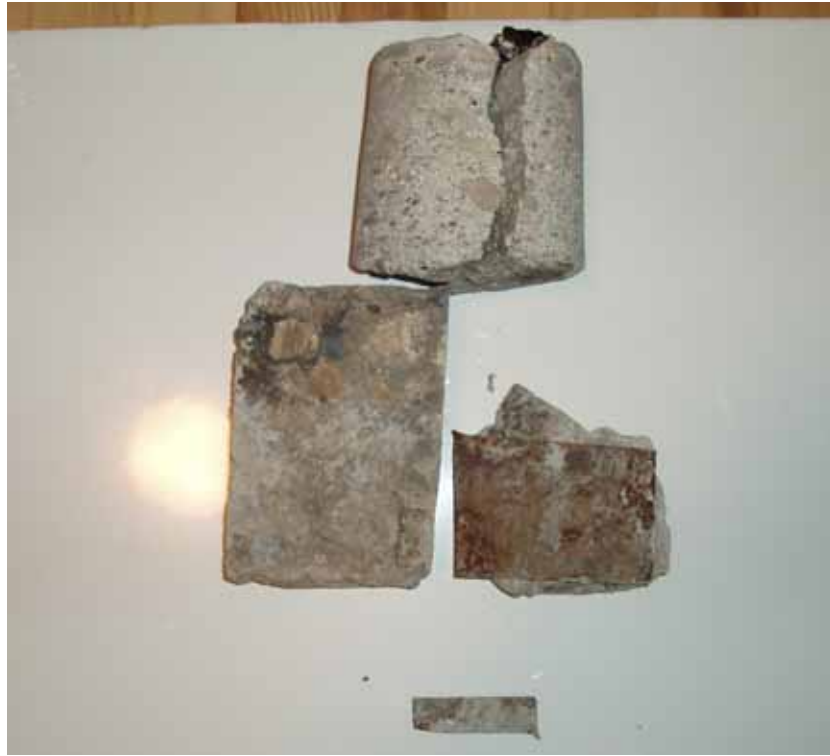
Figure A1. Core 1

Inspiration for the present research arose from two sources. The first source is two cores taken from a former state highway in north-central Iowa. The two cores of transverse cracks, taken at random locations in a 16-km (10-mile)-long project, yielded vertical steel materials at the bottom of the slab. These cores are shown in Figures A1–A3 in Appendix A. The cracks had migrated from the top of the steel strip to the pavement surface. The steel material was 76–89 mm (3 to 3.5 inches) in height and 3.2 mm (1/8 inch) in thickness. The crack formation and the randomness of the cores taken would indicate that the metal extends across the width of the slab. The surface cracks were very straight in alignment across the slab and had not spalled over time. The concrete in Figures A1 and A2 is approximately 24.1 cm (9.5 inches) in depth, and the core in Figure A3 is 27.9 cm (11 inches) in depth.

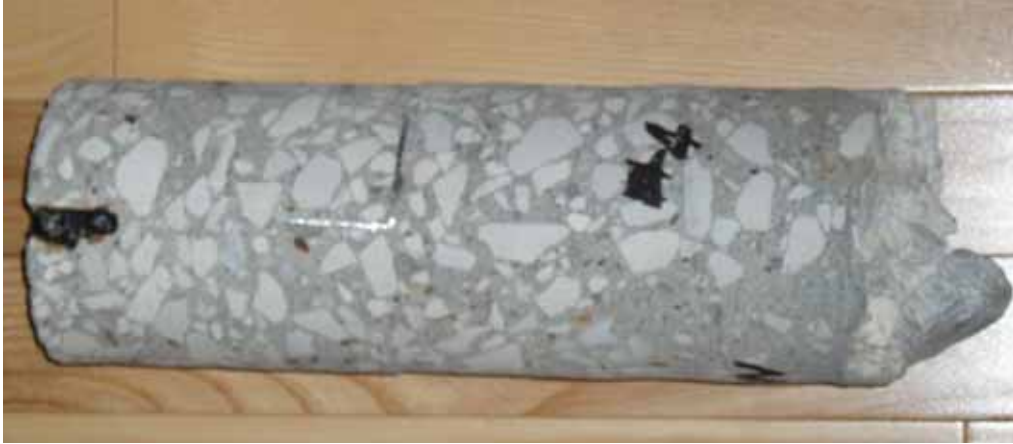
Figure G4. Test section 4 core

The cores indicate two specific details that may be of interest in the future. First, in section four the joint former is above the dowels and, as indicated in the photos, contains a crack that extends between the top of the metal and bottom of the sawed joint. The crack is highlighted by the center black ink mark in Figures G5 and G6 in Appendix G. It is not possible to tell which way this crack initiated, but the crack is of interest to the research.

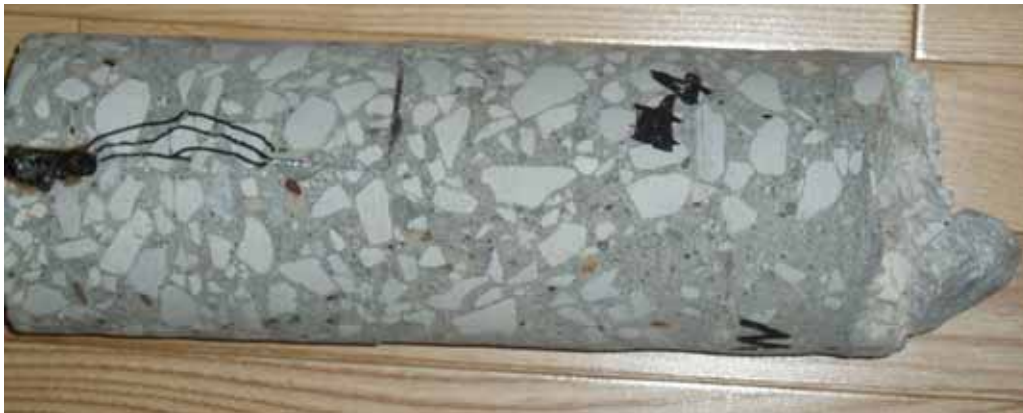
Figure G5. Crack in test section 4 core

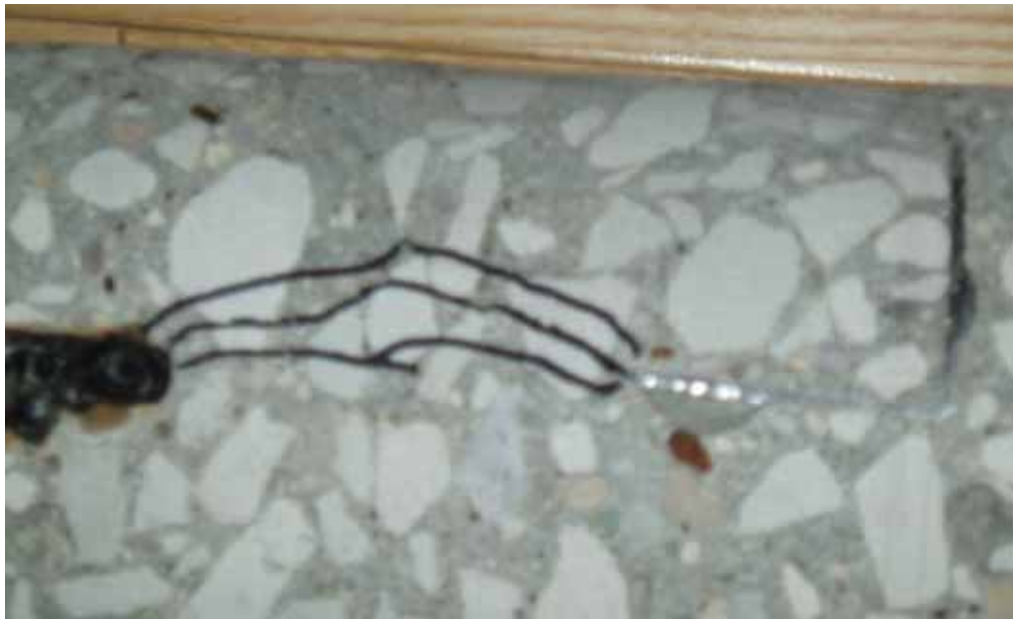
Figure G6. Close-up of crack in test section 4 core
