# Structural Evaluation of LIC-310-0396 and FAY-35-17-6.82 Box Beams with Advanced Strand Deterioration

September, 2011

# **Structural Evaluation of LIC-310-0396 and FAY-35-17-6.82 Box Beams with Advanced Strand Deterioration**

## **Draft Final Report – Phase II**

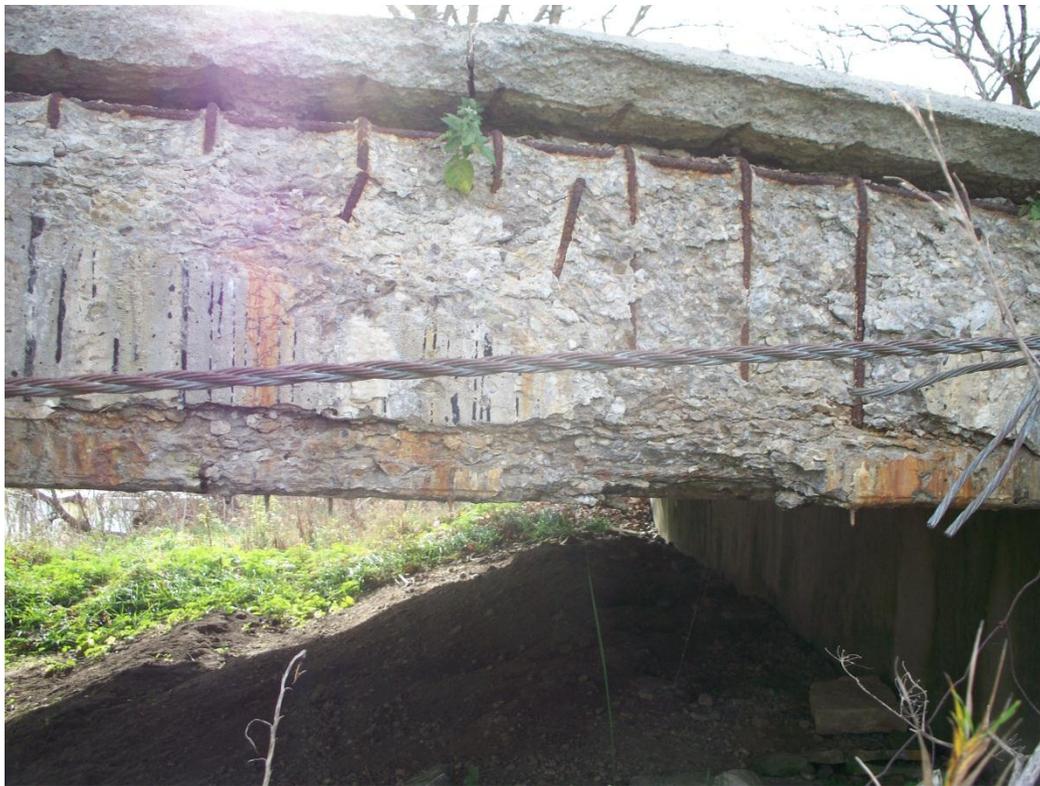
**Figure 5: Exterior North Beam (Beam 9) - West Span**

For the FAY 35- 17-6.80 bridge used in this research, the outside beams were in very poor condition. The top flange separated from the lower portion of the beam for the north outside beam (Beam 9) of the west span (see Figure 5). The south outside beam (Beam 1) of the west span was in similar condition (see Figure 6). The stirrups were exposed for these outside beams of the west span. The top flange had been patched by the County some years prior to testing, but this was not completely successful. Beam 1 of the center span had some degradation of the top flange concrete (see figure 7) but was in relatively good condition. The north beam (Beam 9) of the center span was comparable to Beam 1 of the center span (see Figure 8). The south beam (Beam 1) of the east span had some separation of the top flange near the abutment (see Figure 9). The exterior beam on the north side of the east span also had separation of the top flange and strands exposed (see Figures 10 and 11).

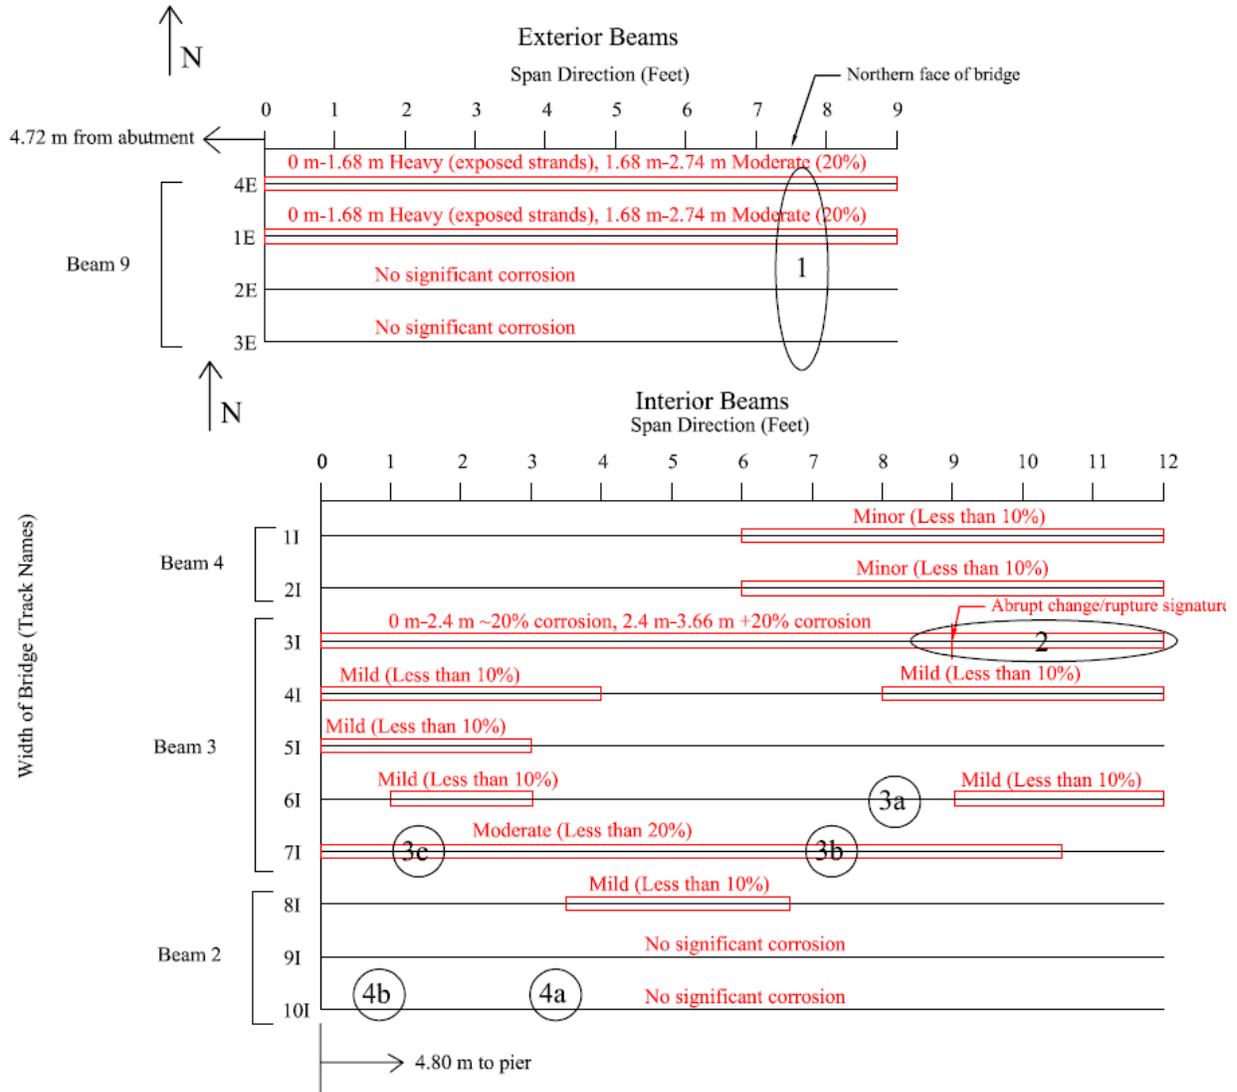
**Figure 46: Track Layout / MFL Corrosion Map**

— = Corrosion Location (Corrosion Severity Details Above Track)

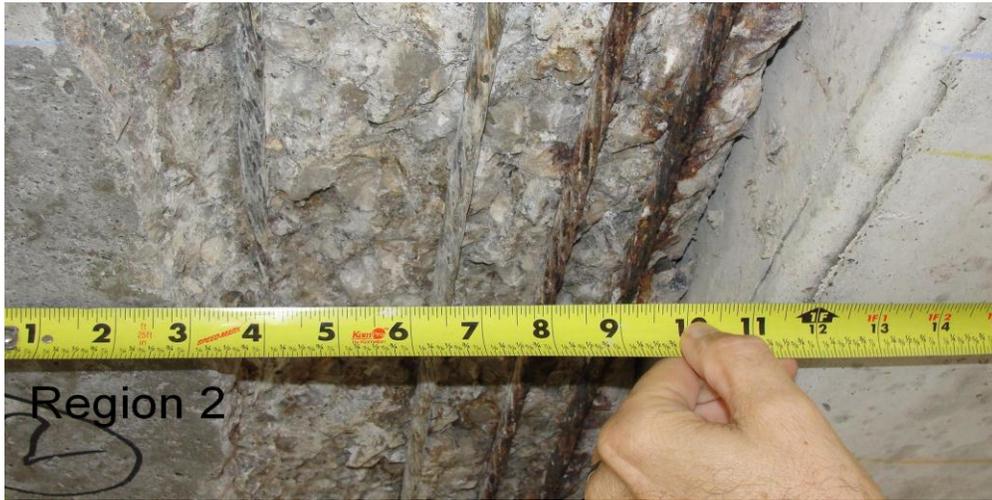
**Figure 51: Area 2 of Beam 3 Exposed**

progressively lighter as the tape measure numbers decrease. The magnetic testing was accurate in this region, except that a full break in strands as depicted in the MFL scan was not found.

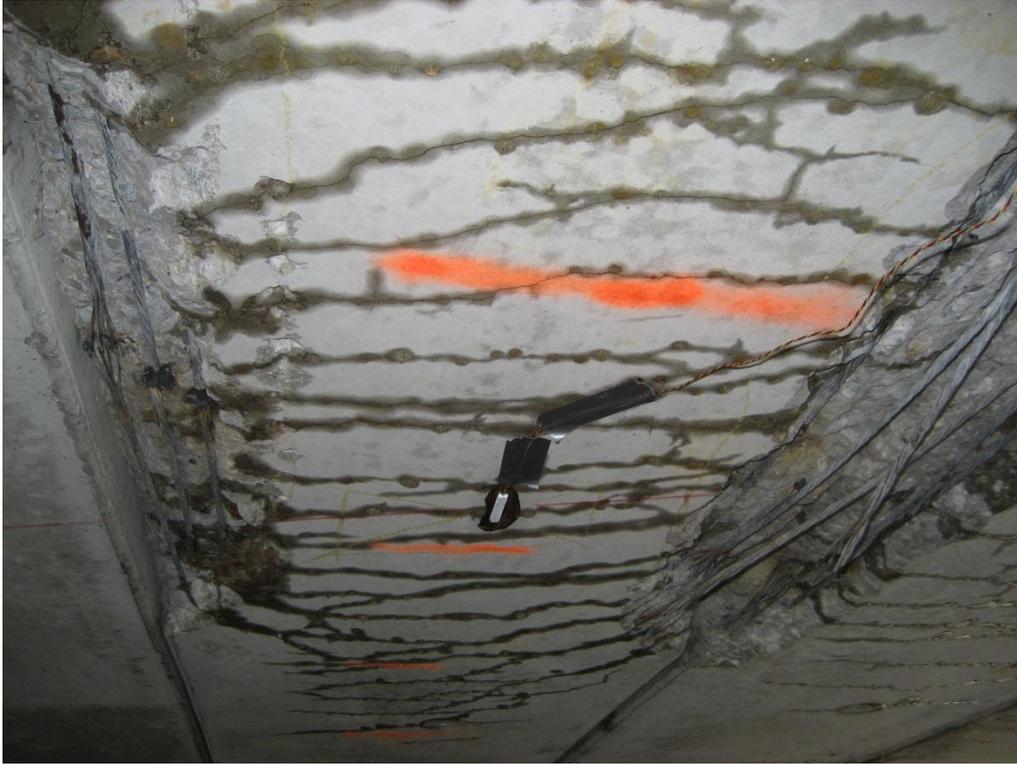
During ultimate loading of the East span, flexural cracking was initiated in the beams and then resulted in water leaking from the cracks indicating the voids of the boxes contained water. This water was significant judging from the duration of leakage (see Figure 67). The bridge failed by crushing of the top flange concrete mainly in the outer beams (Beams 1 and 9). Additional load was no longer able to be supported by the bridge and testing was terminated in order to assure damage to the loading system did not occur. Figure 68 shows the top flange of Beam 1 crushing significantly. Figure 69 shows the flexural cracking and concrete crushing failure of Beam 1. Figure 70 shows the crushing of the top flange of Beam 9 and the buckling of the compression reinforcement. Figure 71 shows the flexural cracking and spalling of Beam 9.

**Figure 67: Flexural Cracking and Void Water Leakage**

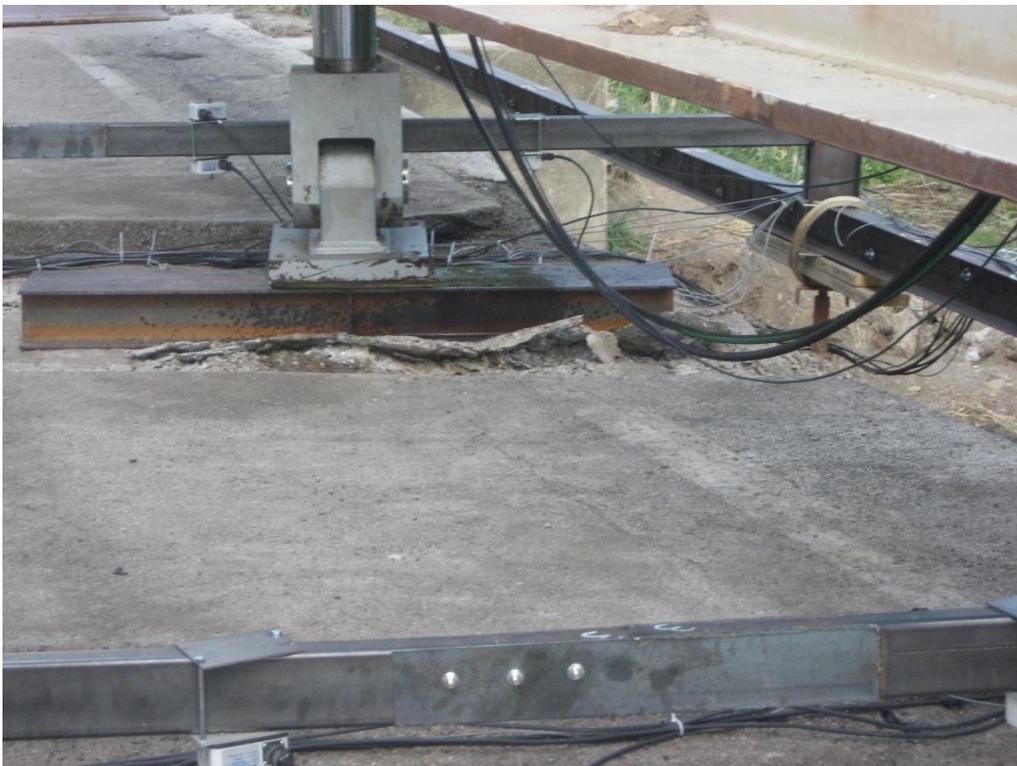
**Figure 68: Concrete Crushing in Beam 1**

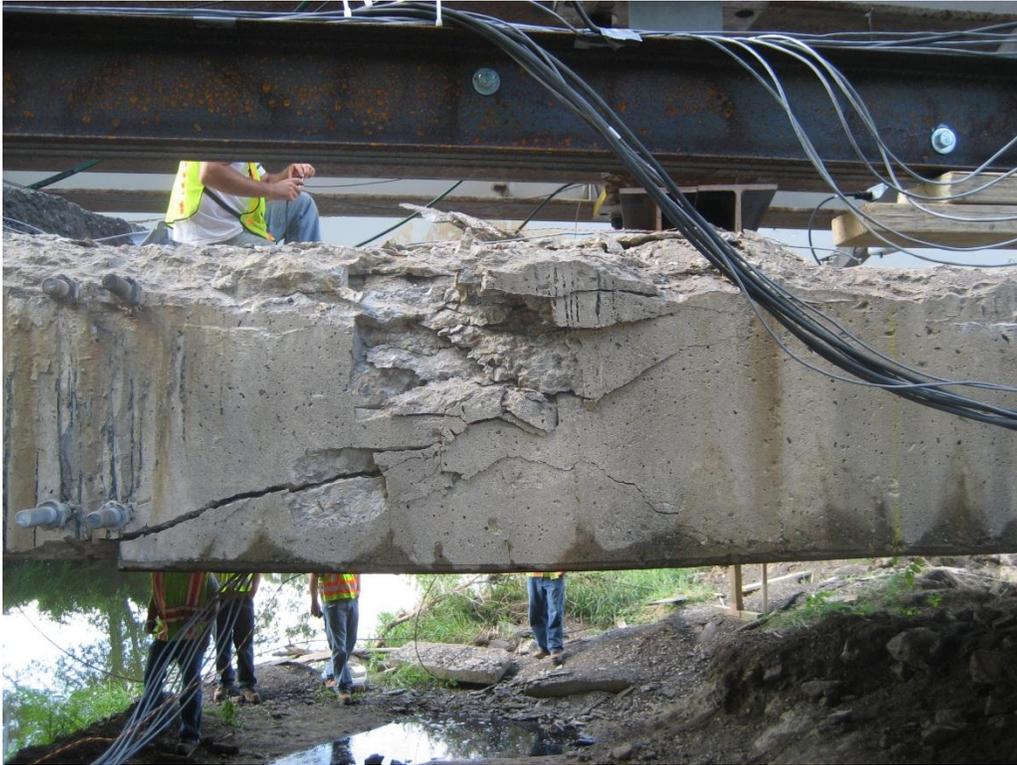
**Figure 69: Flexural Cracking and Concrete Crushing in Beam 1**

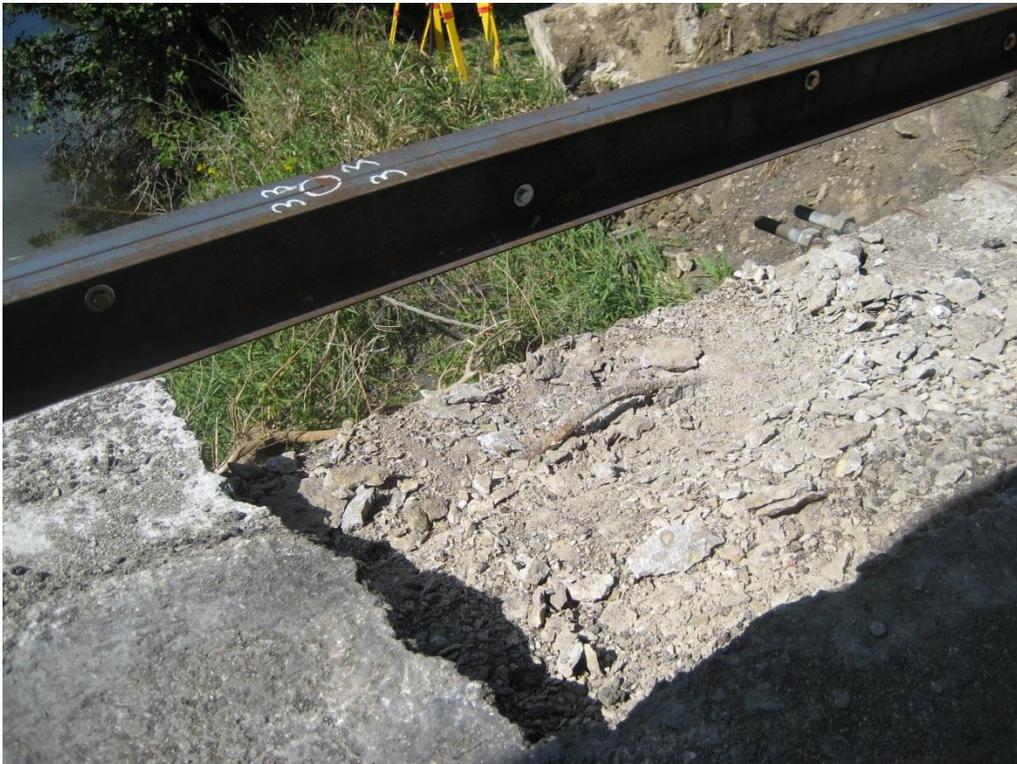
**Figure 70: Concrete Crushing and Buckling of Compression Reinforcement in Beam 9**

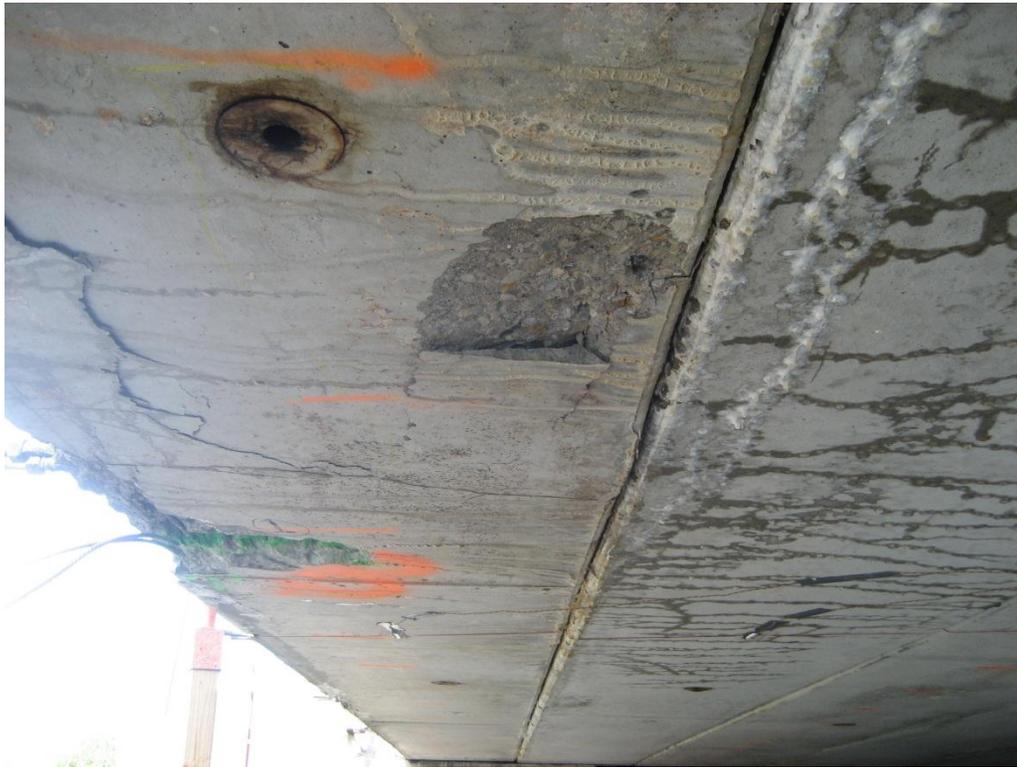
**Figure 71: Flexural Cracking and Spalling of Concrete in Beam 9**

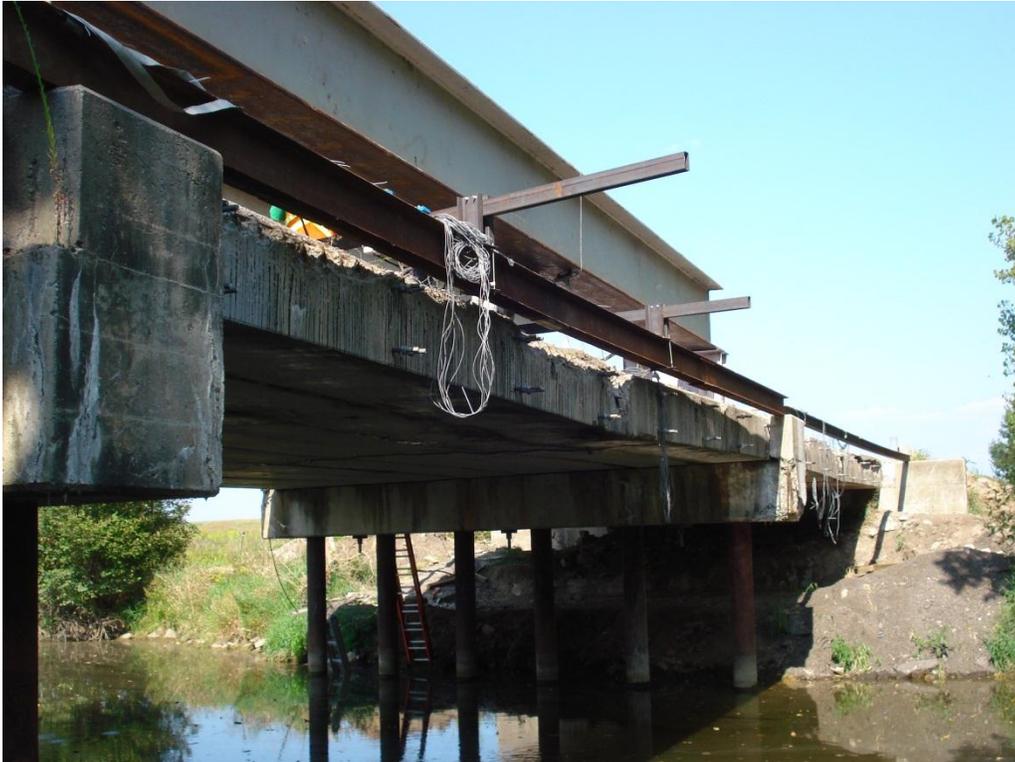
**Figure 87: Beam 1 Failure**

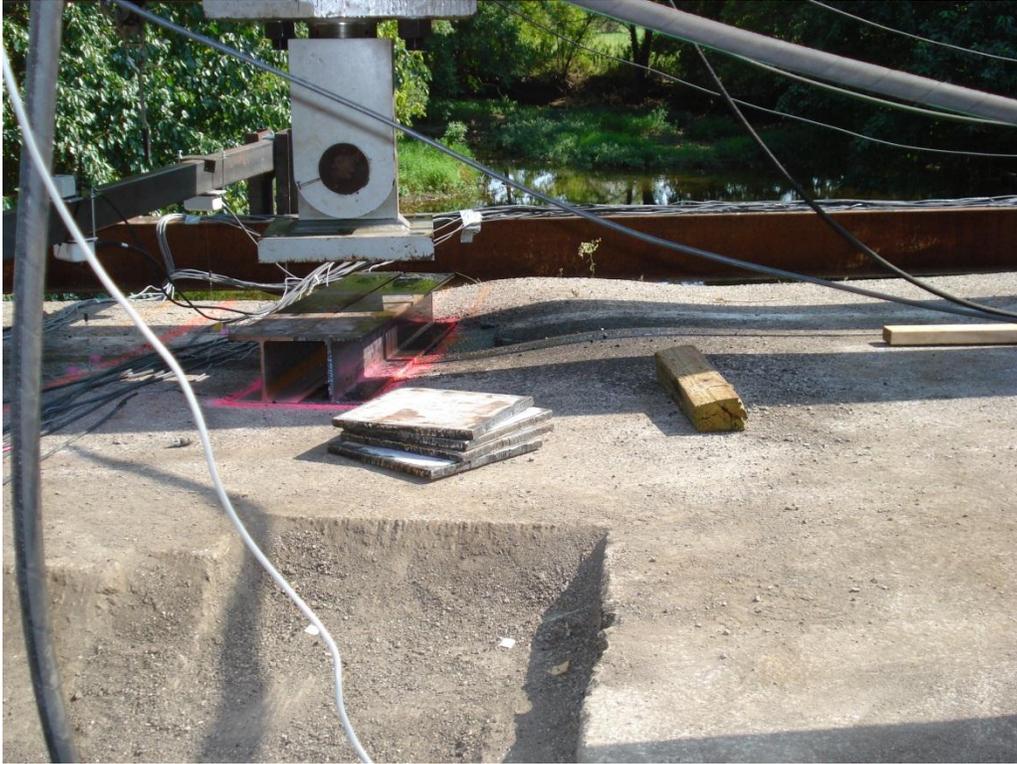
**Figure 88: Buckling of Asphalt Overlay on Beams 1-3**

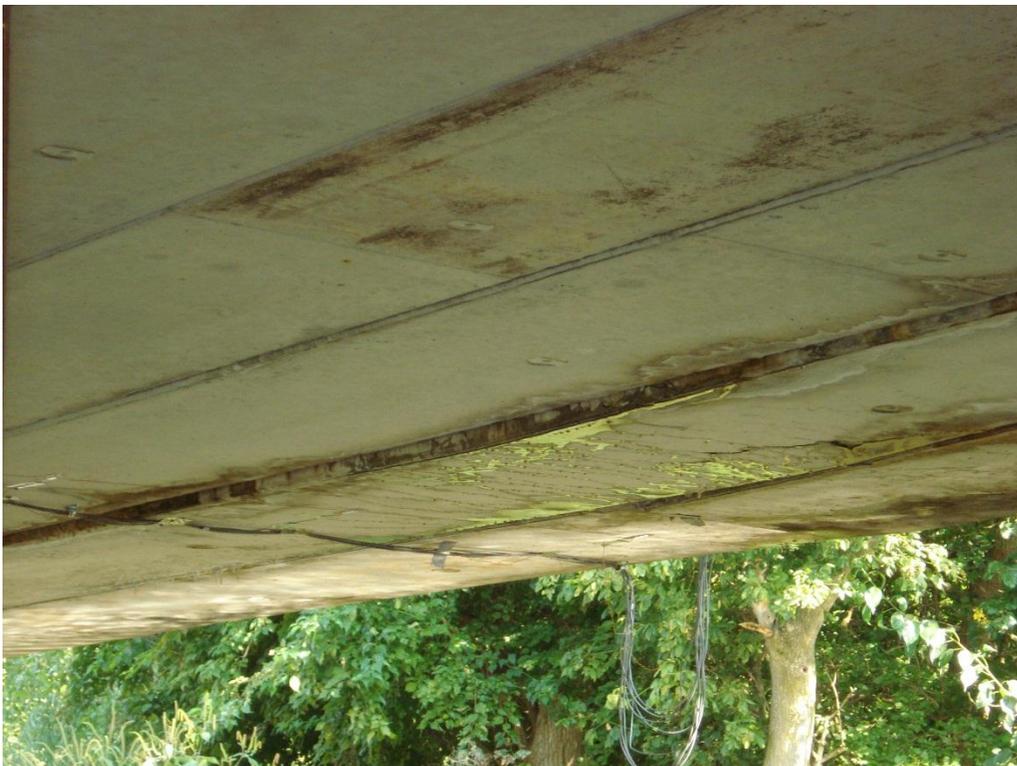
**Figure 89: Failure of Shear Key**

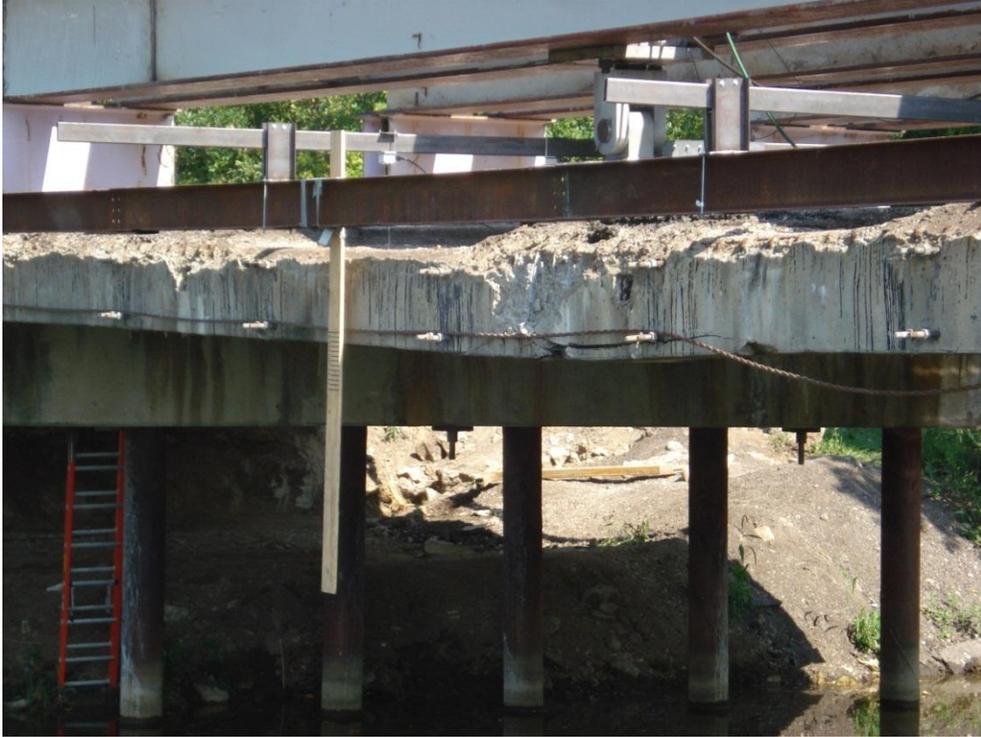
**Figure 90: Spalling and Crushing of Beam 9**

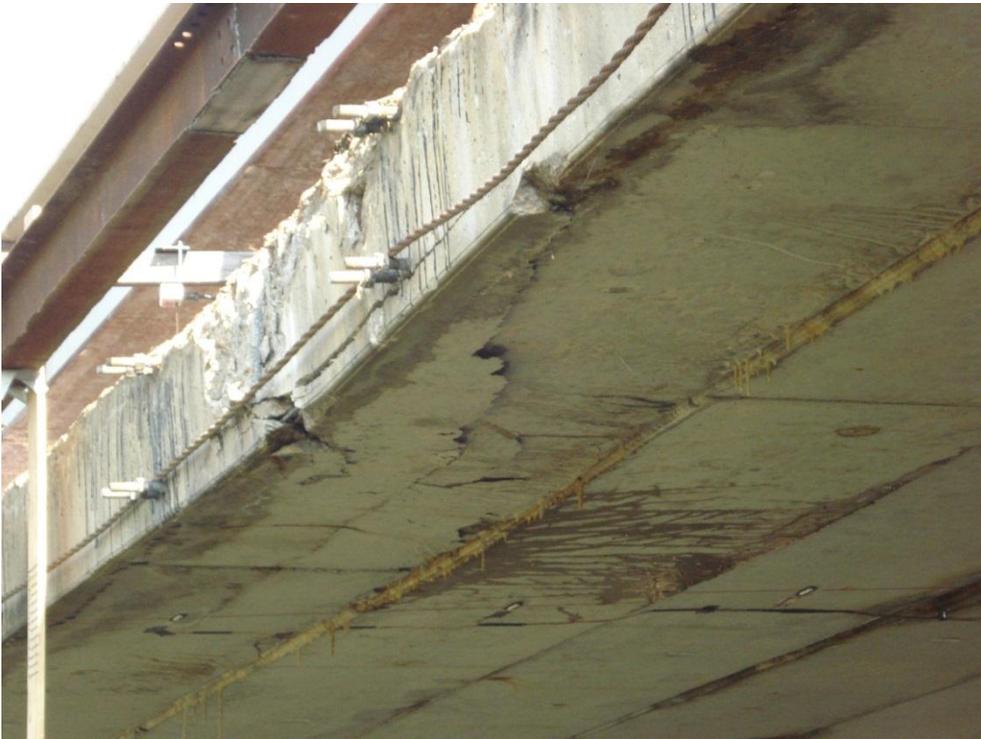
**Figure 91: Spalling and Cracking of Beams 8 and 9**

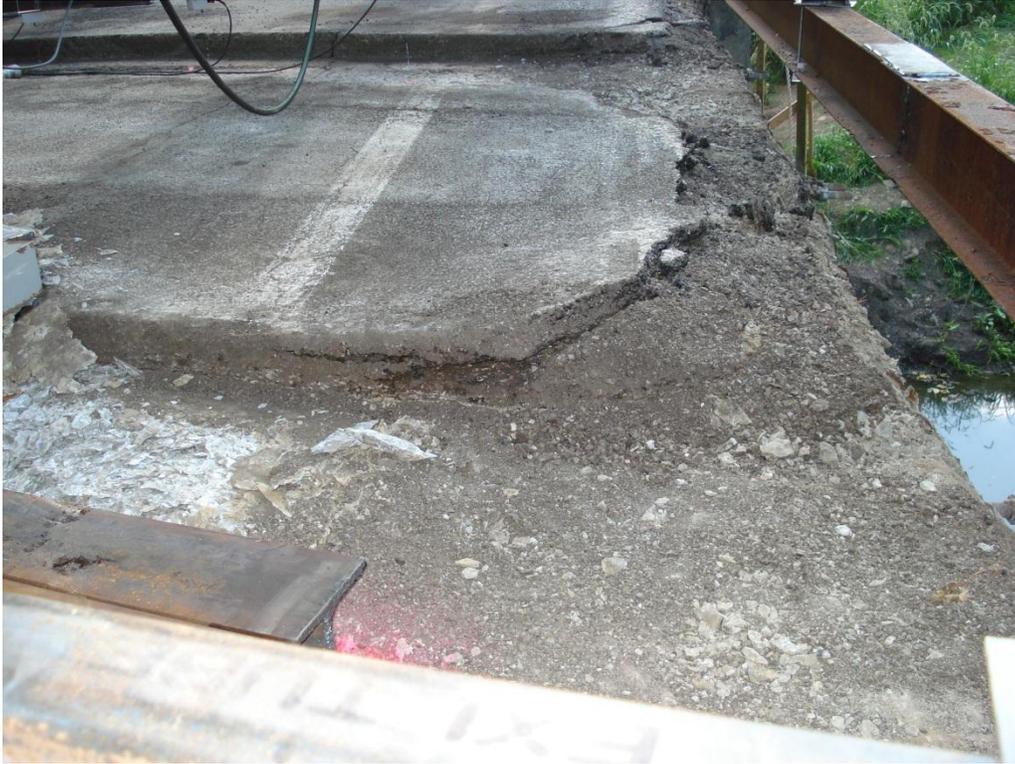
**Figure 92: Crushing of Beam 8 Top Flange**

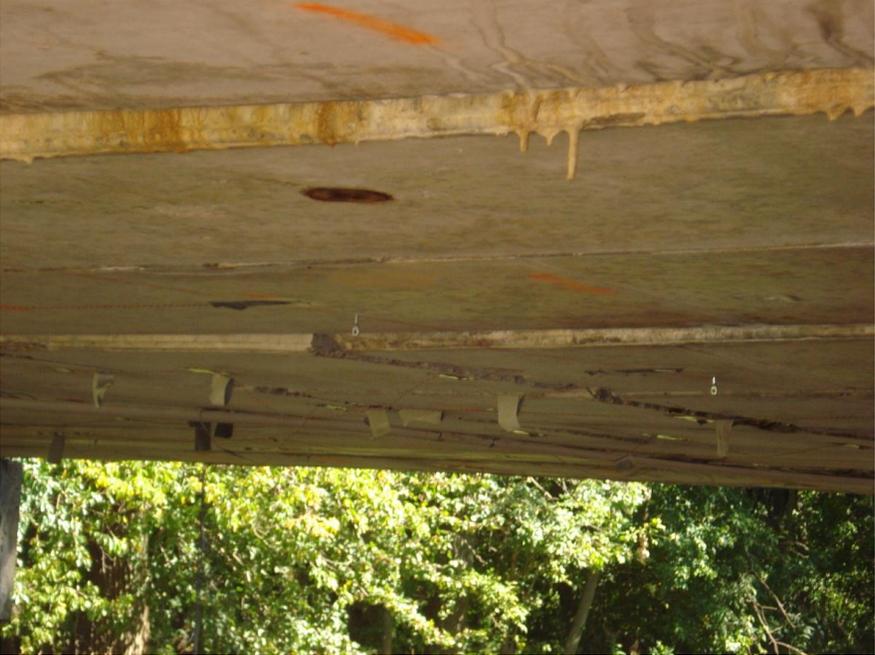
**Figure 111: Shear Key Failures Between Beams 8-9 and 6-7 Prior to Collapse (West Span)**

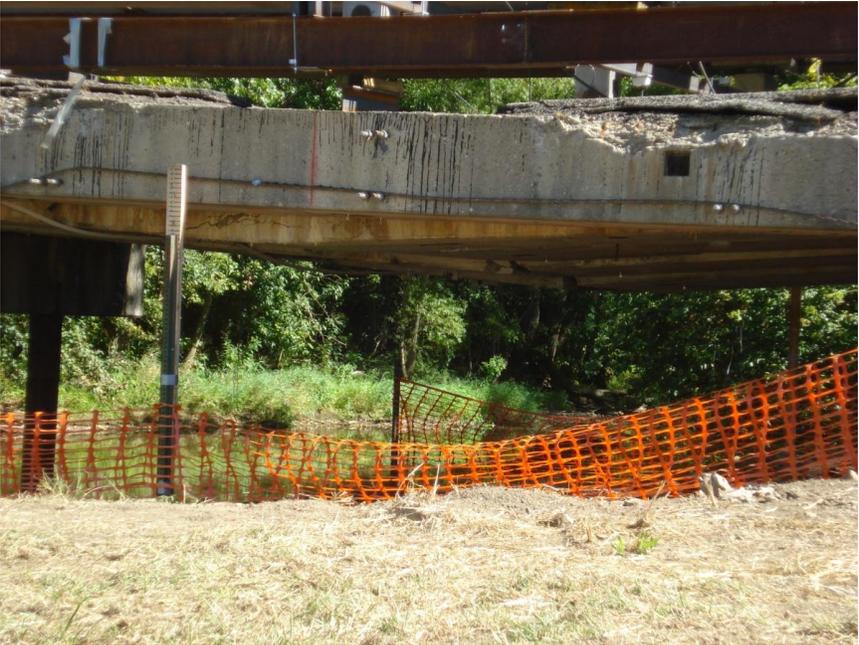
**Figure 112: Shear Key Failures Between Beams 8-9 and 6-7 Prior to Collapse (West Span)**

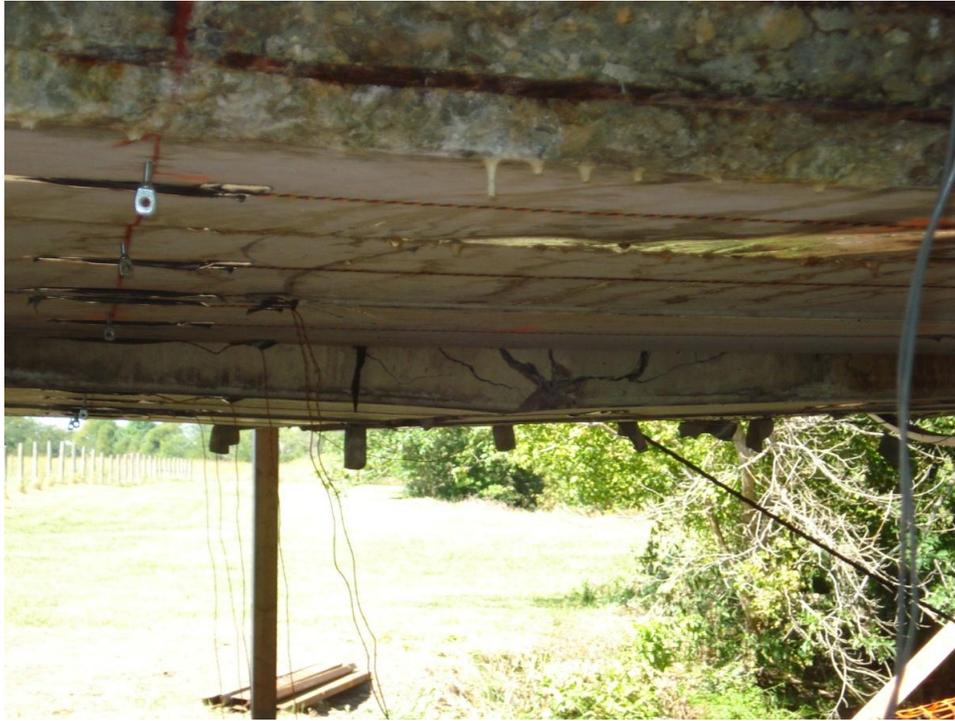
**Figure 113: Shear Key Failure between Beams 3 and 4 Prior to Collapse (West Span)**

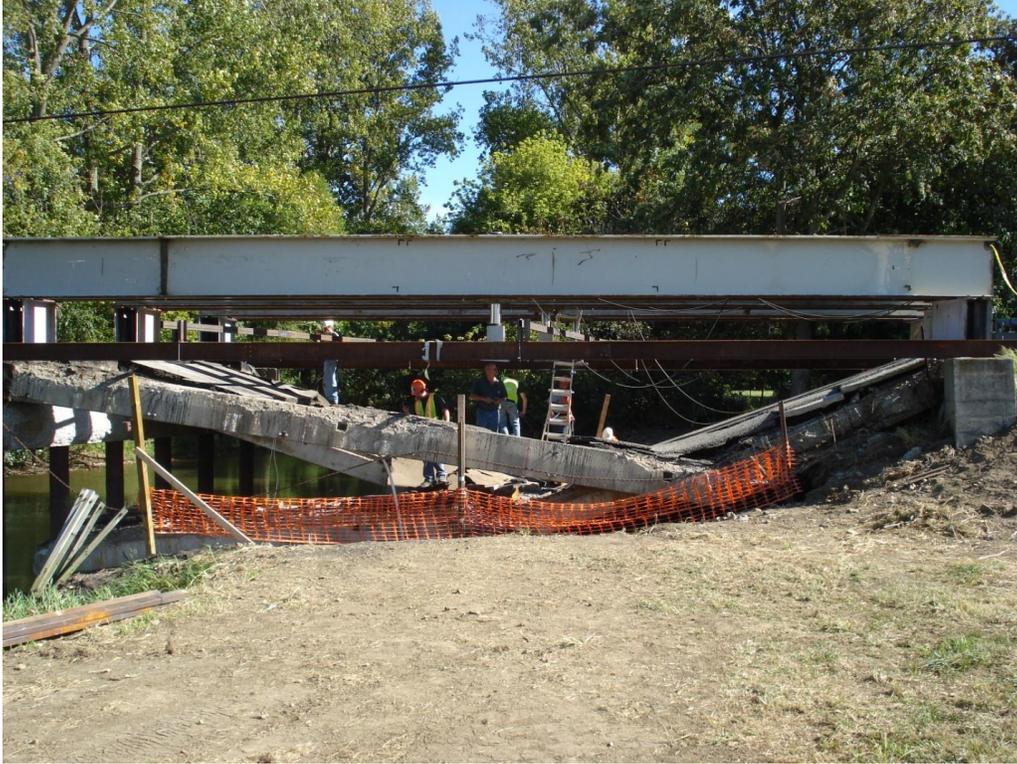
**Figure 114: Collapsed Bridge (West Span w/ Frame)**

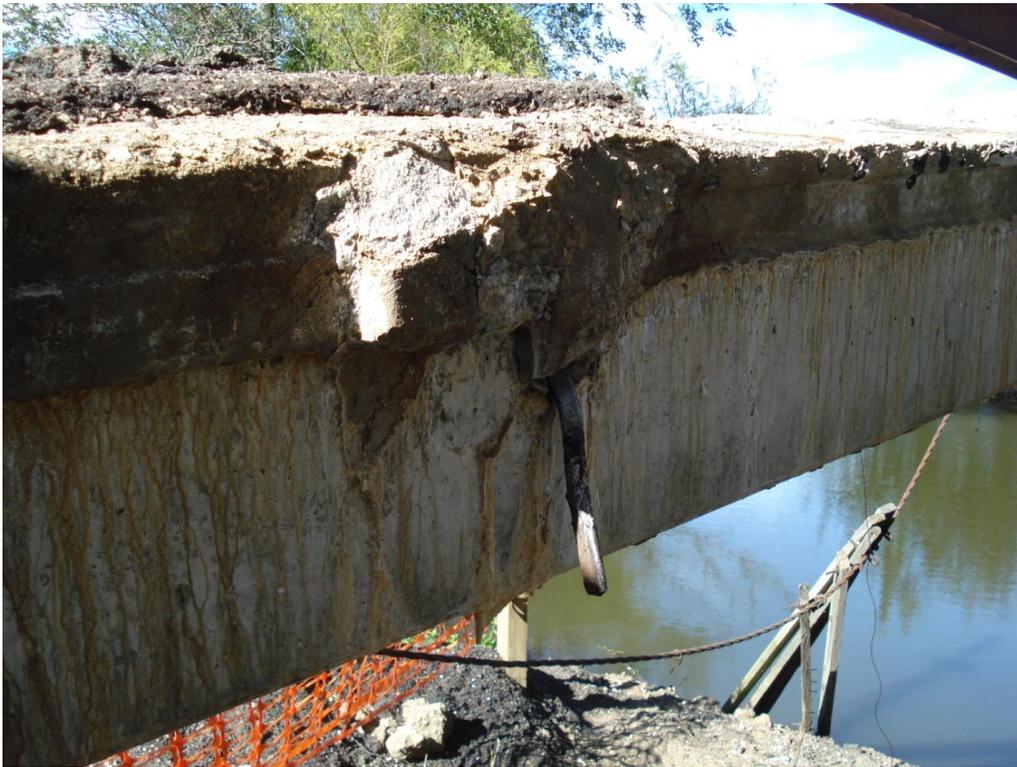
**Figure 117: Fractured Transverse Bar (West Span)**
