U.S. Department
of Transportation

Federal Railroad
Administration

Full-Scale Locomotive Dynamic Crash Testing and Correlations: Locomotive Consist Colliding with Steel Coil Truck at Grade Crossing (Test 3)

9. SPONSORING/MONITORING AGENCY NAME(S) AND ADDRESS(ES) U.S. Department of Transportation Federal Railroad Administration Office of Railroad Policy and Development 1200 New Jersey Avenue, SE Washington, DC 20590		10. SPONSORING/MONITORING AGENCY REPORT NUMBER DOT/FRA/ORD-11/16.I

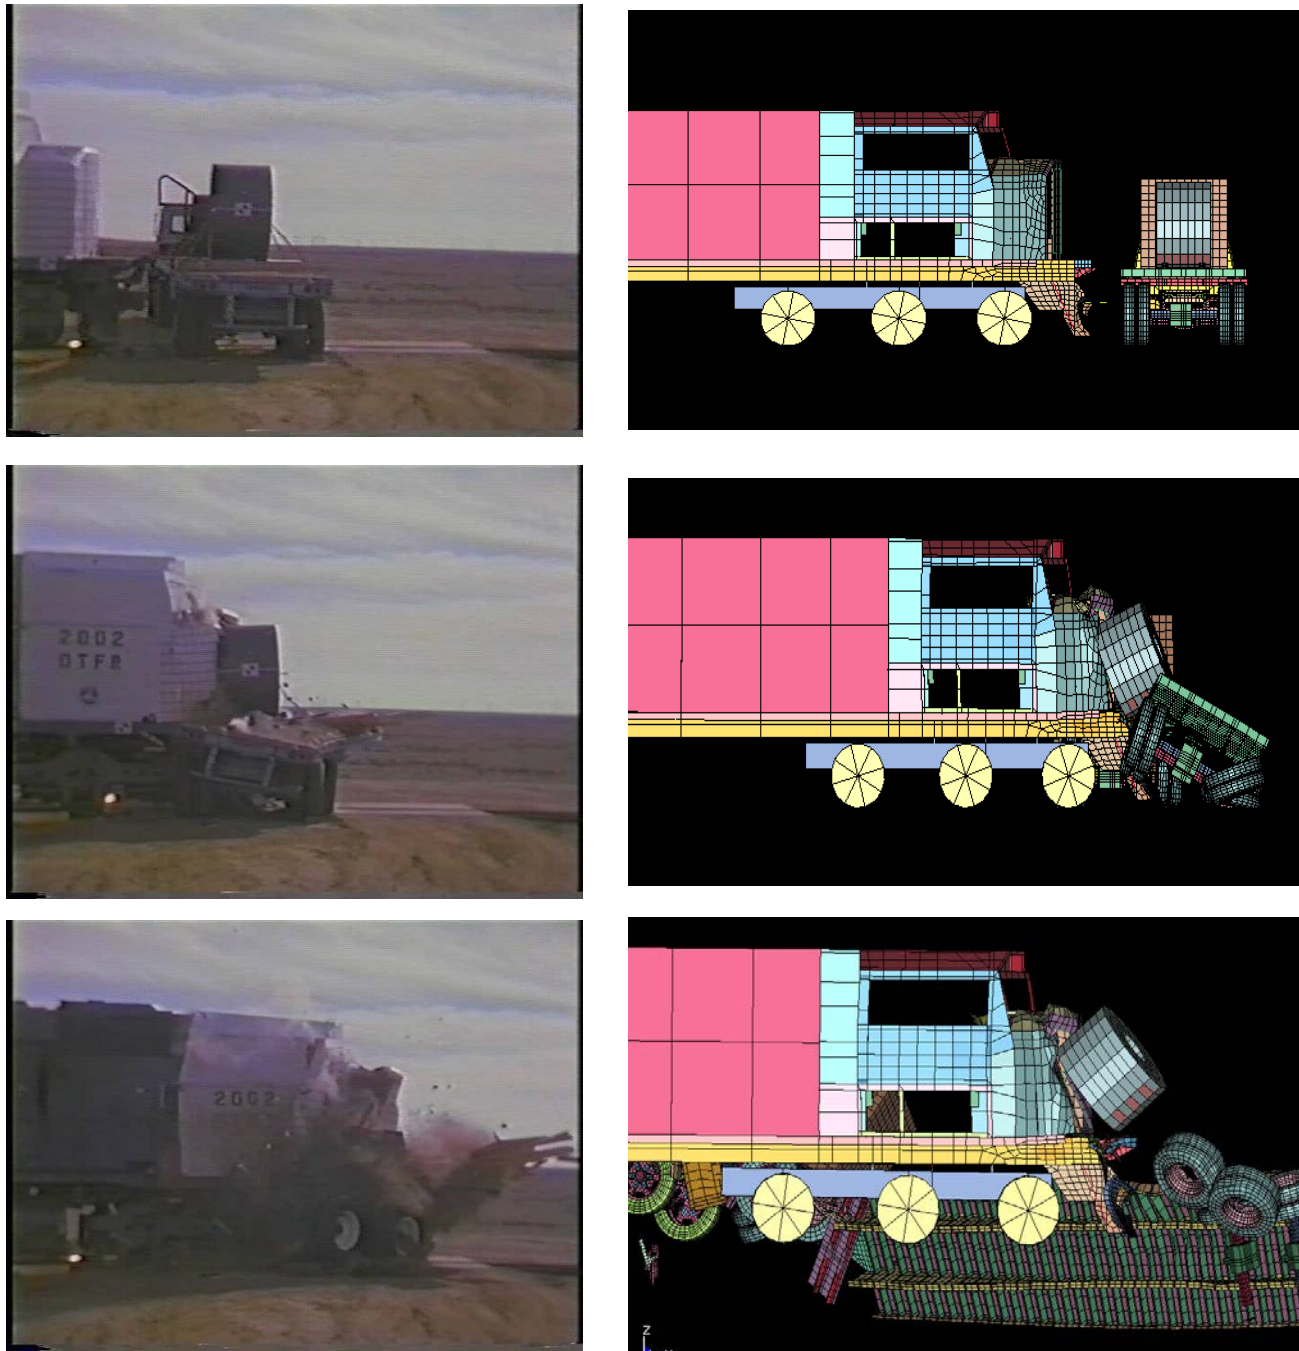
Figure 12. Test 3: Kinematic Comparison between Test and Simulation

the draft gear, coupling system, and plow, were trapped under the trailer. The anticlimber pushed the trailer, causing deformation and damage.

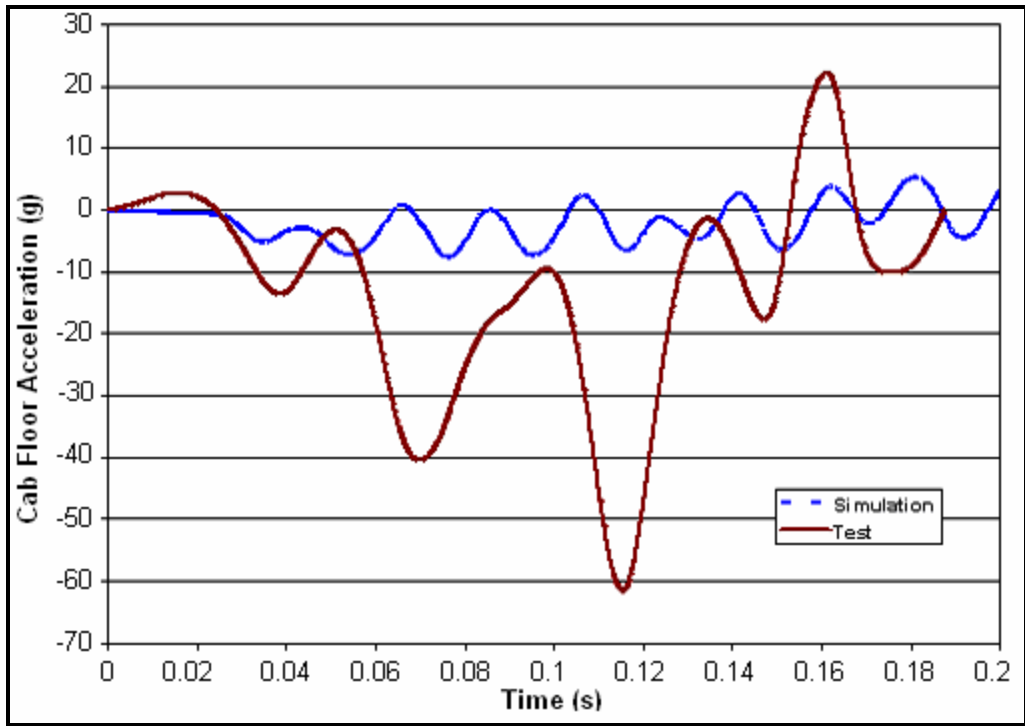
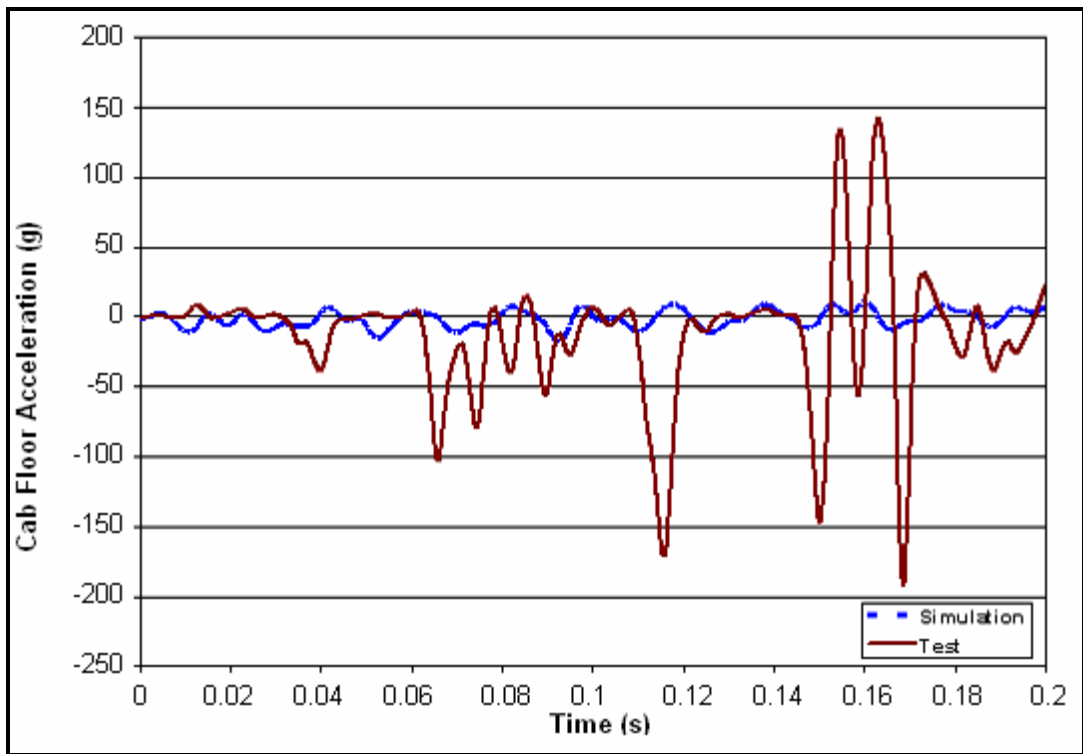
Simulation accelerations in the locomotive longitudinal direction do not correlate well with the test accelerations. Close examination of the high-speed film data revealed that the coil penetrated the cabin and impacted with the accelerometers. Consequently, the test values are not considered reliable.

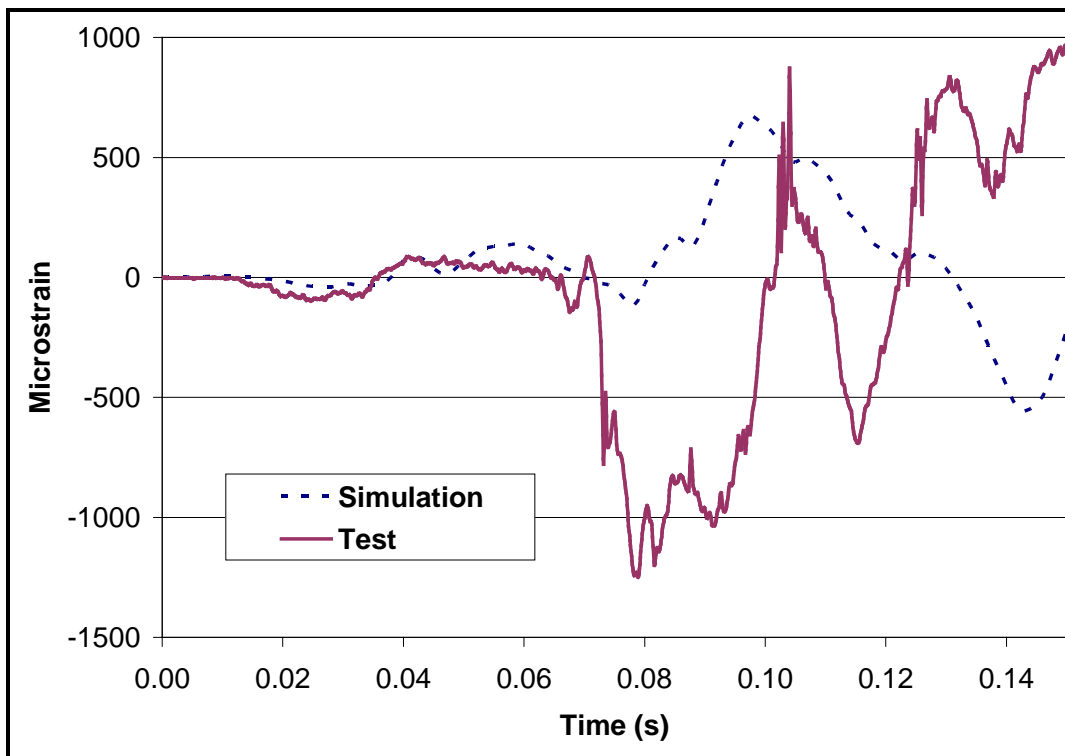
Figure 25. Windshield Postbottom Left Vertical Strain

As shown in Figure 25, simulation results sometimes compare reasonably with test data. A possible reason for disagreement is that the instrumentation was damaged due to the collision. Right collision poststrain correlations at locations 3 (Figure 17) and 10 (Figure 20) confirm the structural failure of the collision post.

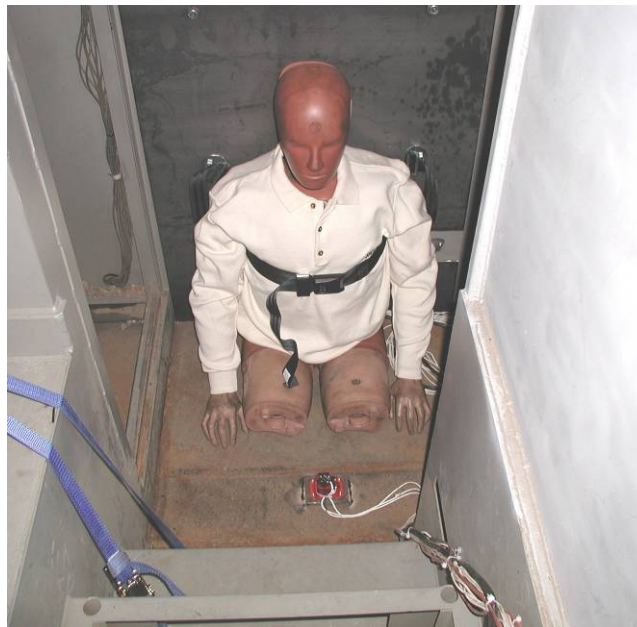
Figure 26. Test 3: ATD Position before Collision

The project team seated the ATD on the stairwell floor of the locomotive, facing rearward with its back against the interior door. Figure 26 shows the ATD before the collision, with the accelerometers positioned to measure acceleration of the head and chest and forces in the neck and femur. The test showed that most parts of the ATD suffered extensive damage.
