# Precast Concrete Elements for Accelerated Bridge Construction

## Volume 2. Laboratory Testing, Field Testing, and Evaluation of a Precast Concrete Bridge: Madison County Bridge

**Final Report**  
**January 2009**

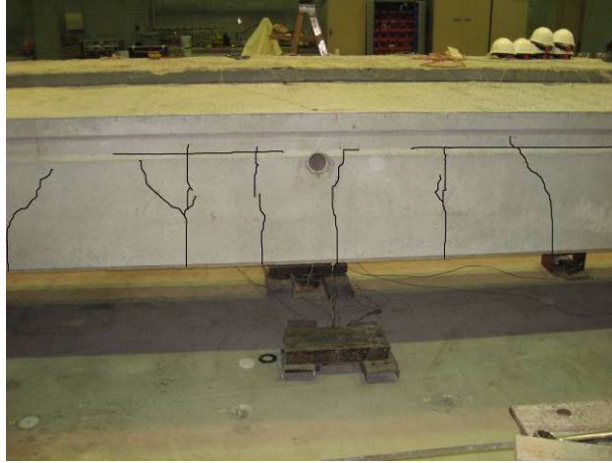
A photograph of the cracked box girder after testing is shown in Figure 4.7. The first cracks were observed at a load of 56.5 kips, which is equivalent to a moment of 781 kip\*ft. Cracks tended to progress horizontally after reaching the shear key. Coincidentally, this is approximately the location where the chamfer began and the thickness of the web increased.

Table 4.4 presents the theoretical and experimental cracking moment values. The Iowa DOT calculated the theoretical cracking moment to be 721 kip\*ft. Two different experimental cracking moments were calculated. One was calculated using the strains measured during loading and Hooke's Law, while the other value was based on the moment due to the measured applied load. Using the measured strain value, cracking occurred at a moment of 856 kip\*ft. Similarly, a cracking moment of 781 kip\*ft was calculated from the applied loads. Both of the experimental values exceed the theoretical crack moment. Note that the theoretical cracking moment was calculated assuming a concrete strength of 5,000 psi.

**Figure 4.7. Photograph of flexural cracking after flexure test**

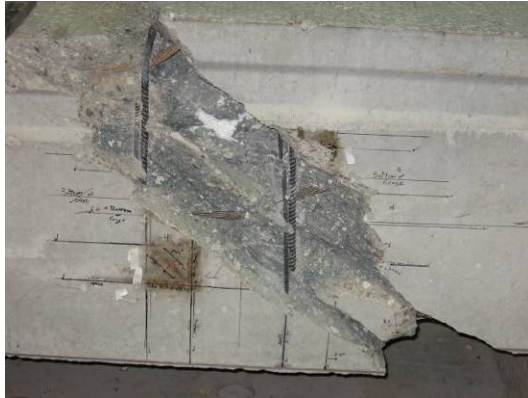
Figure 4.13a shows the shear crack after testing concluded. The angle of the shear crack was measured to be approximately 45 degrees. Inspection of the failure afterwards revealed a #3 stirrup fractured at the time of failure. This can be seen in Figure 4.13b.

**a. shear crack after failure**

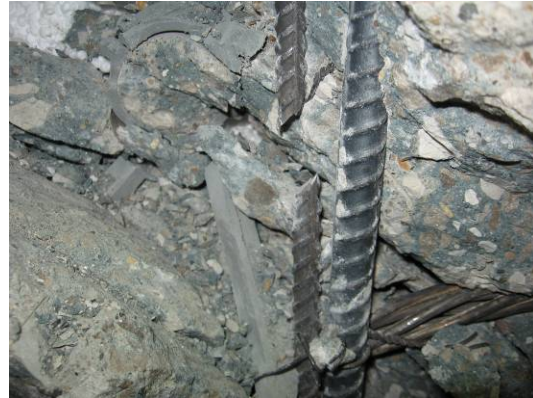
**b. fractured stirrup**

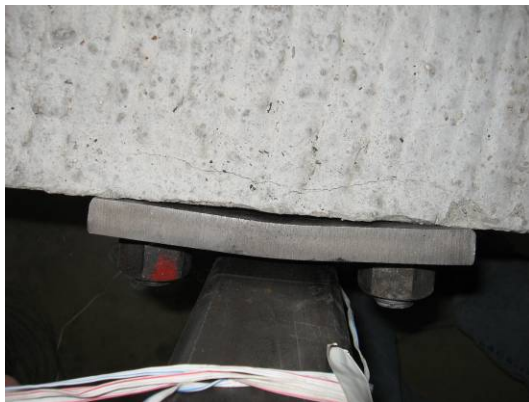
**Figure 4.19** shows the components of the guardrail connection after different post failures. The base plate for each post yielded during testing. **Figure 4.19a** shows the yielded base plate for post 1, along with a longitudinal concrete crack that developed. Post 1 was the only location where longitudinal concrete cracking occurred. During loading, the portion of the post base bearing against the base plate buckled, which is shown in **Figure 4.19b**. The width of the posts was measured to have increased as much as 1/2 in. to 3.5 in. A ruptured 3/4 in. bolt from test 2 is shown in **Figure 4.19c**, and sheared base plate threads can be seen in between the threads of a 3/4 in. bolt in **Figure 4.19d**. A summary of the results for the guardrail connection tests are presented in Table 4.7. Values presented in the table include the magnitude of the maximum applied load, at which post the failure occurred, the force carried by the post, the force applied to the 3/4 in. bolt at failure, the capacity of the connection, and the failure type.

**a. yielded base plate and concrete cracking**

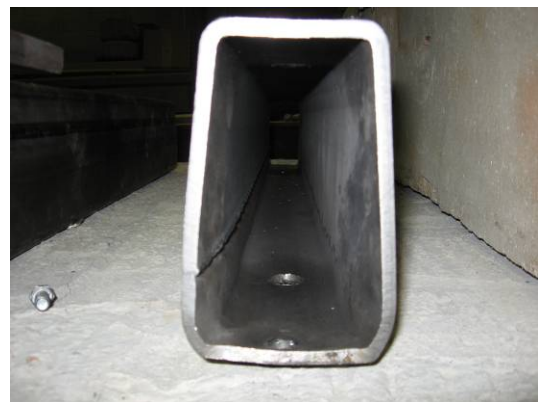
**b. buckled post**

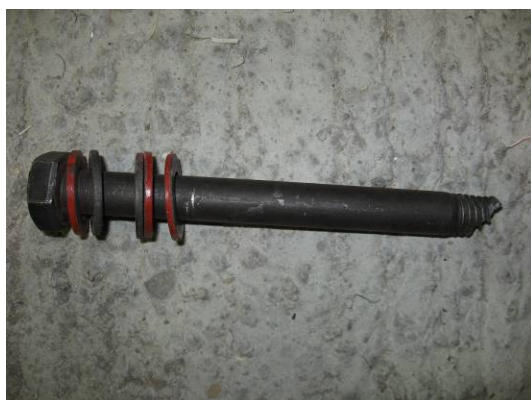
**c. ruptured bolt**

Loading during test 1 reached 15.4 kips. At this load, the 3/4 in. bolt connecting post 1 to the base plate ruptured. Using the strain data collected during testing, a 7.29 kip force was resisted by the post at failure. Using simple statics, this is equivalent to a tensile force of 41.0 kips in the bolt. The published strength of a 3/4 in. bolt is 39.7 kips.

The applied load during test 2 reached 16.9 kips. The 3/4 in. bolt connecting post 4 to the base plate ruptured during the test. The bolt force equaled 41.9 kips.

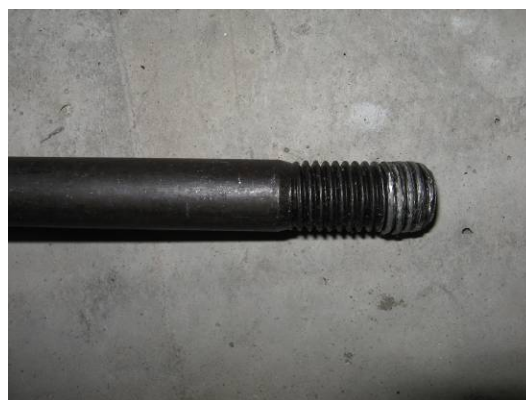
**d. bolt with sheared base plate threads**

Failure during Test 3 occurred when the threads of the post 6 base plate sheared. The theoretical force required to shear the base plate threads was 32.2 kips, and the applied bolt force was calculated to be 36.7 kips. One explanation for this discrepancy would be the shear area of the threads exceeding the area used in the calculations.

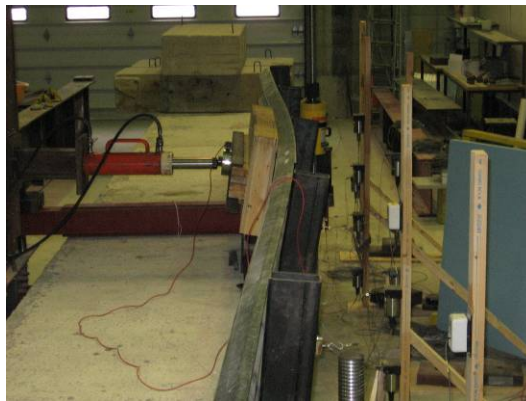
Deflections in the field may actually be greater than those recorded because testing had to be done in two cycles. During the first cycle, once a 15.6 kip load was applied the box girder moved horizontally. Testing was halted when this occurred and the girder was further secured to the ground. When testing resumed, the guardrail was loaded to failure. Yielding of the 3/4 in. bolt was observed following the first test cycle; therefore some of the plastic deformation capacity was used.

**Figure 4.25. Photograph of deflected guardrail during test 4**
