Performance Evaluation of Arizona's LTPP SPS-1 Project: Strategic Study of Flexible Pavement Structural Factors

Final Report 396-1
February 2012

Nichols Consulting Engineers
1885 South Arlington Avenue
Suite 111
Reno, Nevada 89509

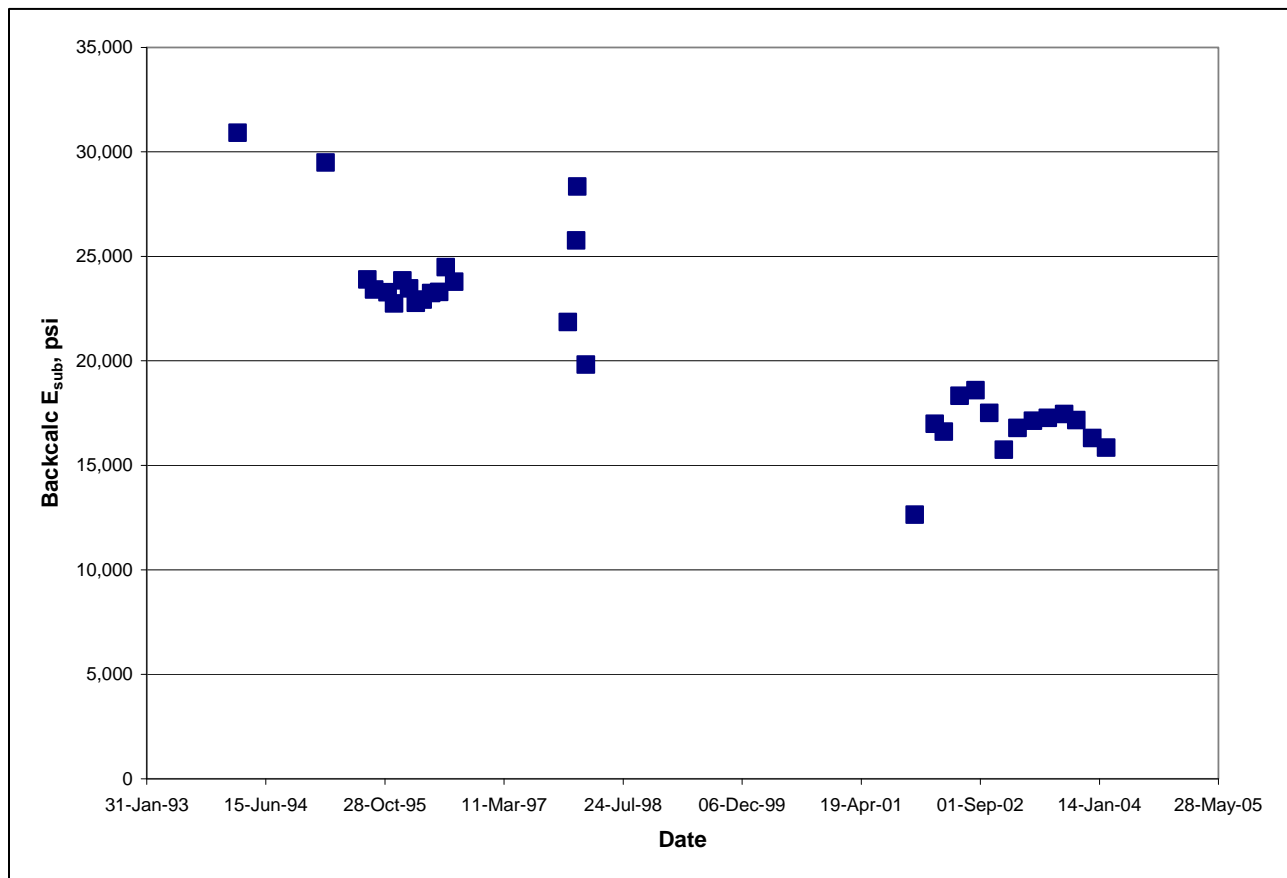
Figure 5. Backcalculated subgrade modulus decrease over time, section 0113.

This decrease in subgrade modulus over time is presumed to be due to a gradual increase and leveling off of the subgrade moisture content after construction. The fairly steady trend in decreasing subgrade moduli over time is illustrated by the values backcalculated for SMP test section 0113, shown in Figure 5 and Table 6.

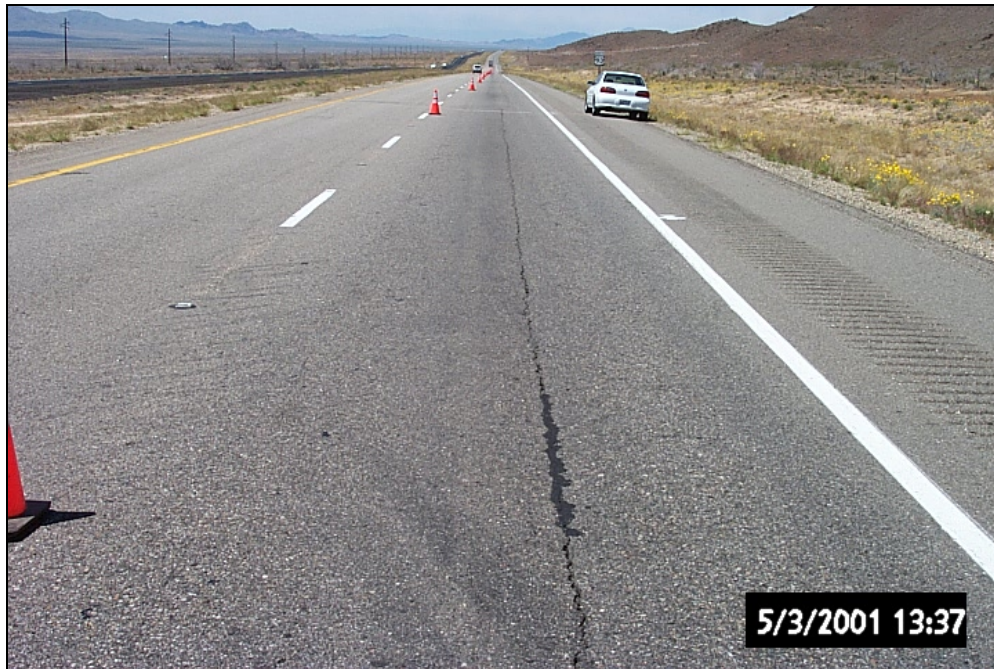
Figure 10. Photograph of paving seam.

Unfortunately, much of the longitudinal and fatigue cracking was a result of surface cracking that seemed to be associated with a construction joint located within the right wheel path on the final paving course. The deflection data indicates that most of the pavement sections remained structurally competent through the life of the study.

contribution of the paving seam and will be described in subsequent sections of this report.

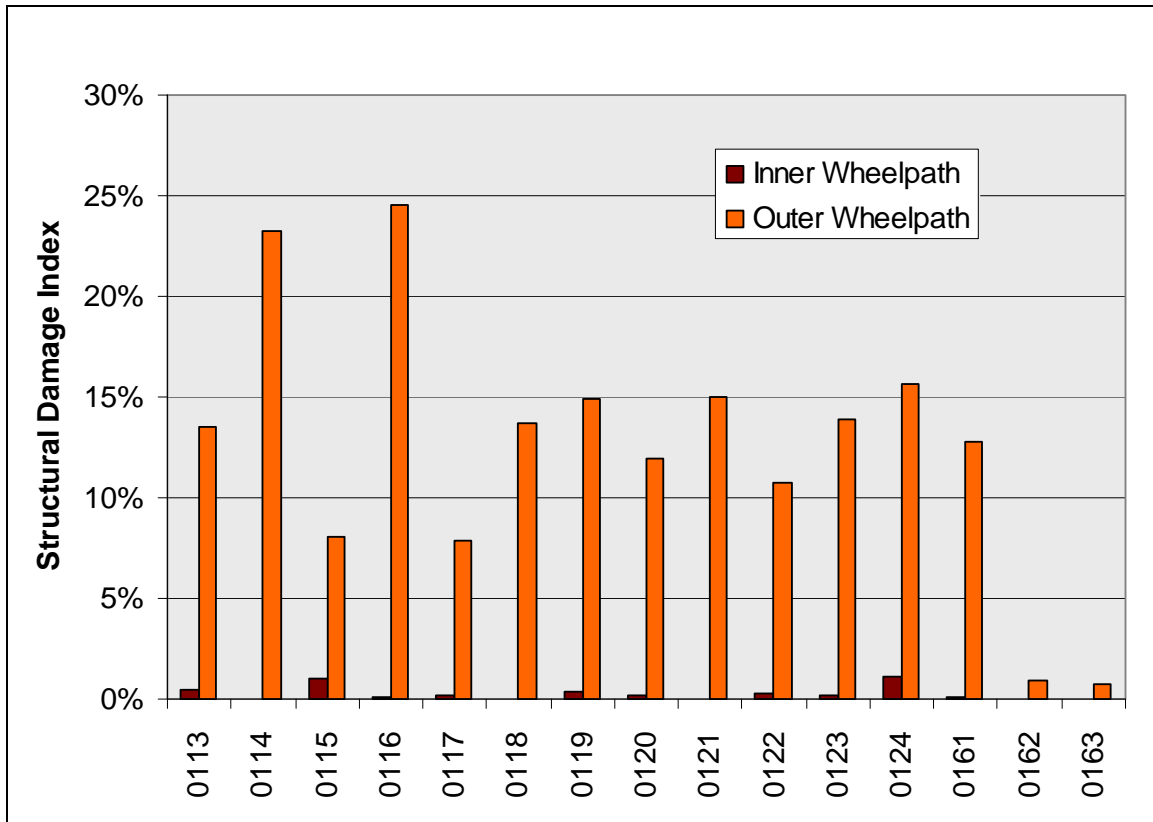
Figure 18. Structural Damage Index separated by wheel path.

As mentioned previously, the paving seam present throughout the SPS-1 project has contributed to the damage accumulated; however, the extent of the seam's influence on performance cannot be completely determined and isolated from deterioration that would have occurred naturally due to environment and traffic. To provide a complete picture of the deterioration, Figure 18 provides structural damage index values for each wheel path. Figure 18 does not isolate construction issues from natural deterioration, but it is expected that the paving seam will have a greater influence on the deterioration of the outer wheel path as compared to the inner wheel path, due to the proximity of the outer wheel path and the paving seam.

From Figure 18, it is apparent that the outer wheel path—largely governed by the paving seam—has driven the overall structural damage. The outer wheel path of every section contains significantly more deterioration as compared to the inner wheel path.

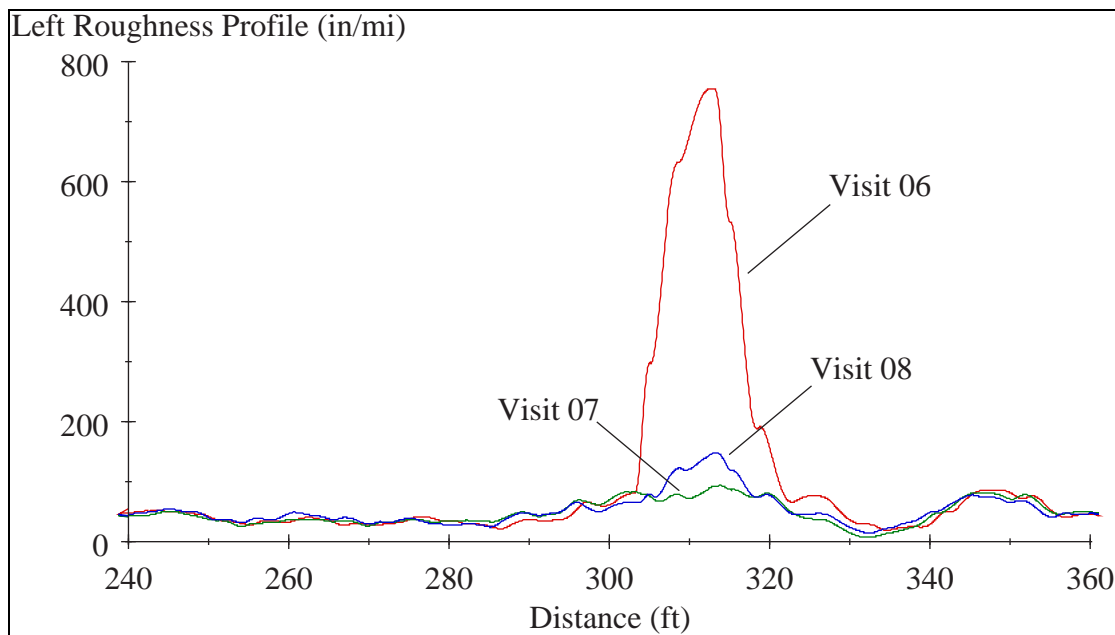
Figure 42. Roughness profile of section 0122, 10-ft base length.

Figure 42 shows how a roughness profile can help find and quantify isolated roughness. The figure shows the roughness profile of section 0122 using a 10 ft base length for visits 06, 07 and 08. With a 10 ft base length, isolated roughness is easy to identify. In visit 06, the peak roughness at the dip is about 755 in/mi. In the same location, the roughness is 88 in/mi. This is a difference of 667 in/mi over 10 ft. Since that value represents the roughness over just one fiftieth of the segment, it suggests that the single dip contributes about 13 in/mi to the overall IRI of the section. This is most of the difference between the IRI in visits 06 and 07.

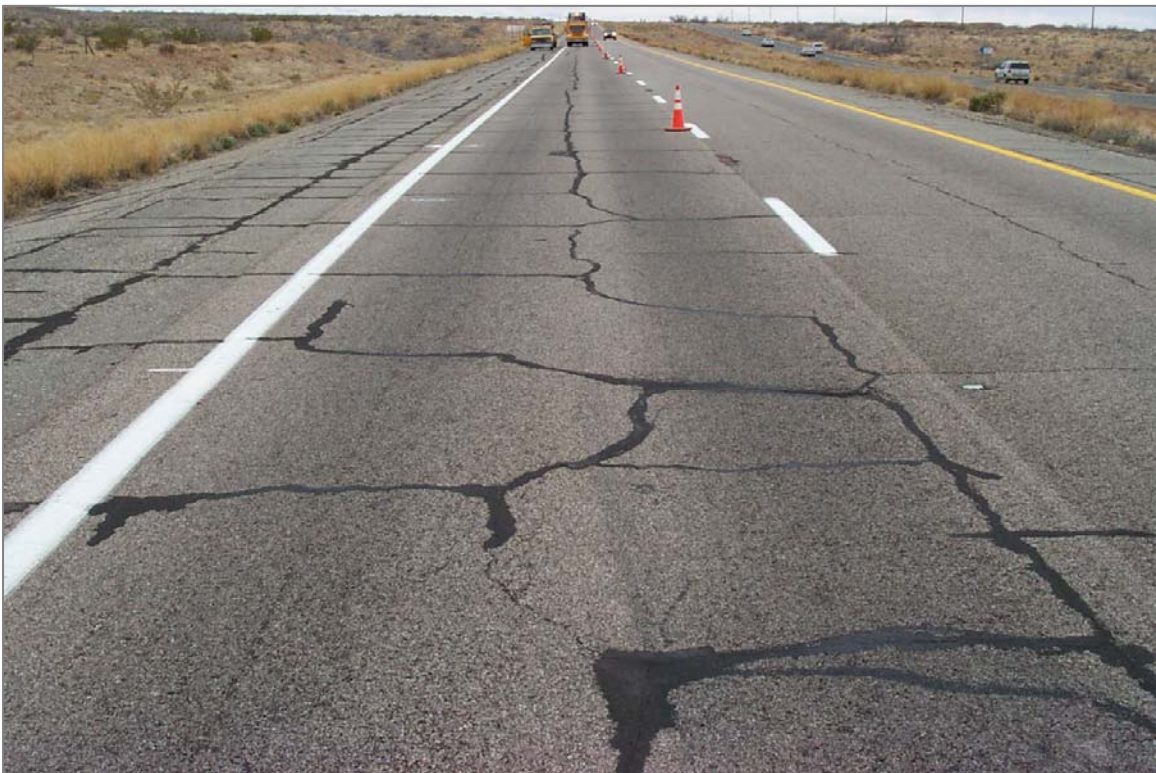
Figure 45. Section 0163 showing long dip in last 100 ft.

The long dip in the last 100 ft of the section appears clearly in Figure 45 below. This is certainly considered a rough feature by passing vehicles.
