Field Testing and Evaluation of a Demonstration Timber Bridge

Final Report
February 2012

IOWA STATE UNIVERSITY
Institute for Transportation

Sponsored by
Iowa Highway Research Board
(IHRB Project TR-604)
Iowa Department of Transportation
(InTrans Project 08-343)

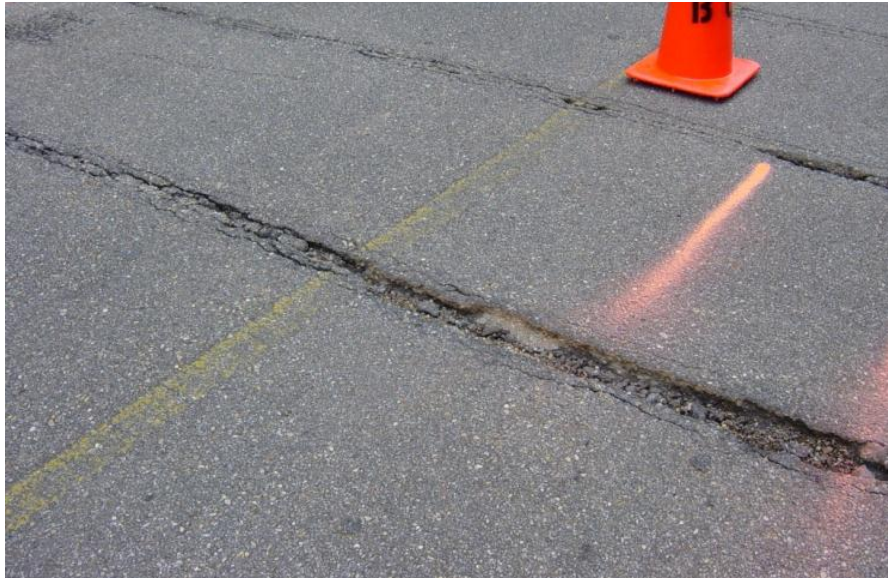
Figure 2.1. Wearing surface deterioration resulting from cupped deck panels

The physical condition of the transverse glued-laminated deck panels were also found to likely impact and even compound the deterioration of the asphalt wearing surface in some cases. In general, the most severe wearing surface deterioration was found on bridges that had cupped deck panels. Figure 2.1 illustrates one case of significant deck panel cupping and the subsequent effect on wearing surface condition (Hosteng et al. 2005).

The cupping of the deck panels is believed to be a result of insufficient panel-to-girder connections combined with significant moisture content gradients between the top and bottom surfaces of the deck panel. Although bridges with flat, uncupped deck panels had wearing surface deterioration that was less severe than those with cupped panels, in most cases, the deterioration was significant nonetheless. Lastly, of the bridges tested, those with the best-performing asphalt wearing surfaces were also found to have lower global midspan girder deflections as shown in Table 2.2.

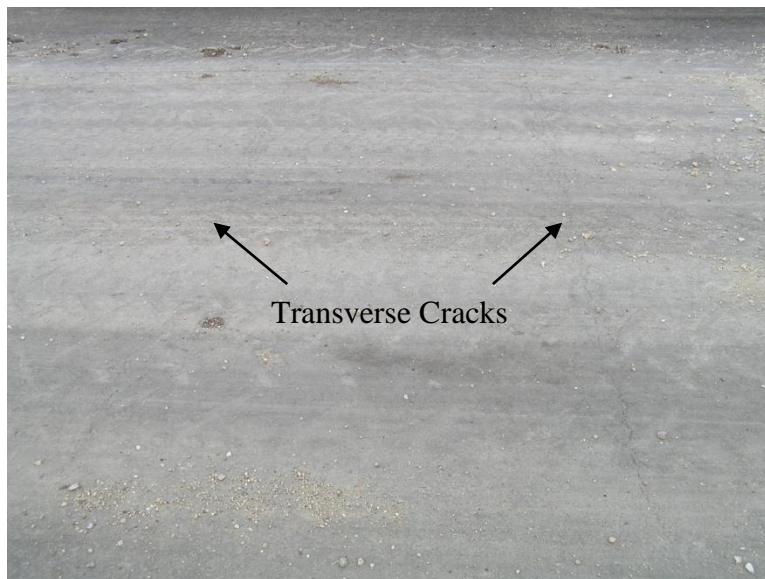
Figure 5.1. Transverse cracking evident one month post construction on Span 2

Inspection of the wearing surface one month following construction of the bridge noted transverse cracking at the deck panel joints on Span 2, as illustrated in Figure 5.1, and less noticeable cracks on Span 1 over the deck panel joints. However, cracking over the plywood joints was also observed in Span 1.

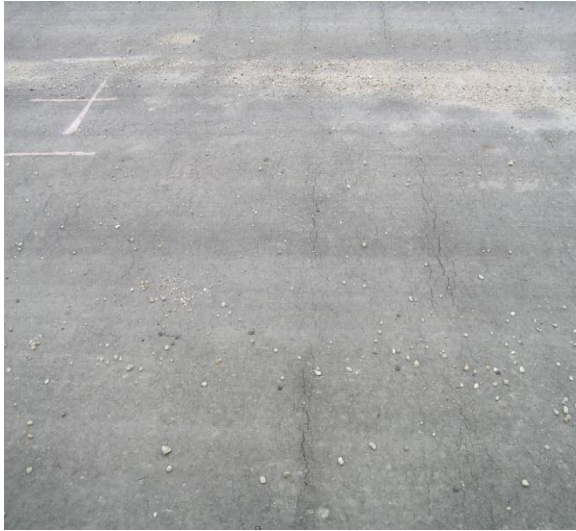
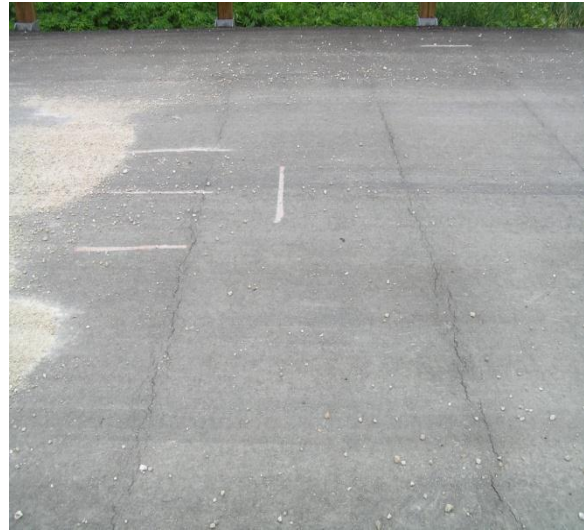
Figure 5.2. Transverse cracking two months post construction

One month after the initial inspection and testing, a follow-up inspection was completed. The substructure and superstructure were, again, in excellent condition and unchanged. The wearing surface condition was unchanged as well, with the exception of one observation. On Span 1, additional minor cracking in the wearing surface was noted at the deck panel joints, in addition to the cracking at the transverse plywood joints noted a month earlier, as shown in Figure 5.2.

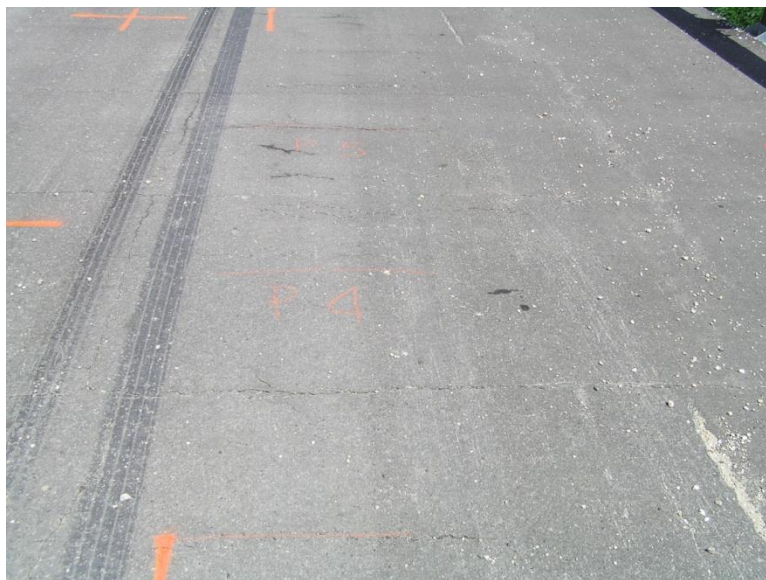
Figure 5.3. Transverse cracking, Span 1, one year post construction

Approximately one year after construction of the demonstration bridge, the research team conducted a second visual inspection and load test on the structure. Visual inspection of the substructure and superstructure components again indicated that these components were in excellent condition. Inspection of the asphalt wearing surface revealed cracking of the wearing surface at the deck panel joints on Span 2 (no plywood); on Span 1 (with plywood), visible cracking was evident at the transverse plywood joints as well as at the panel joints (see Figure 5.3).
