**Research Project # 2005-051**  
**Accelerated Bridge Paint Test Program**  
**July 6, 2011**

**Introduction**

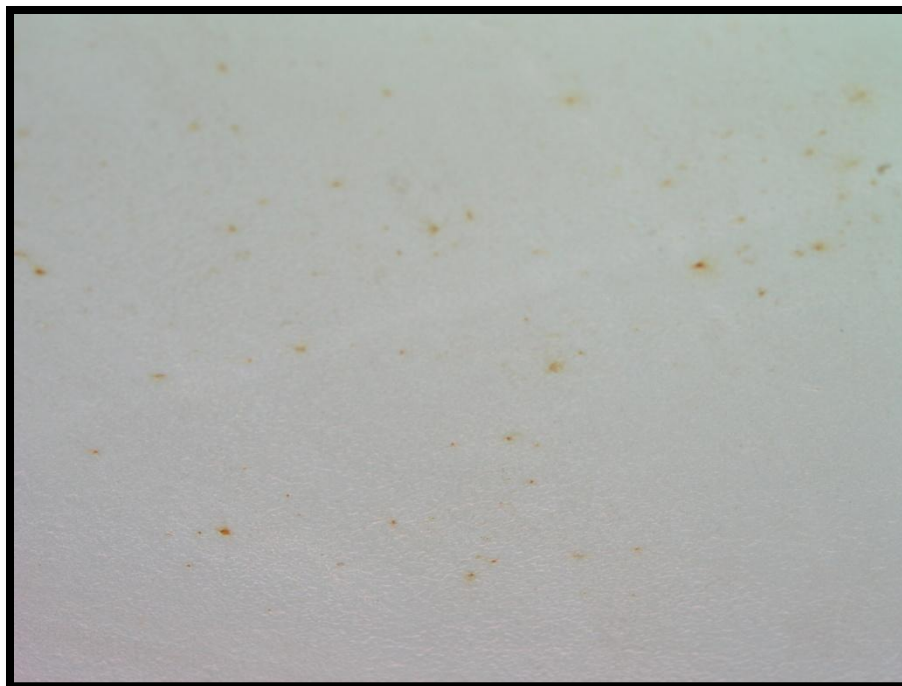
Photo 4, Spot surface rust on experimental area

There was some spot surface rust on the experimental area. Speculation by the KTA-Tator representative was there had been some initial problems during the start-up of the two coat paint system application. Based on these observations the KTA-Tator consultant plans to come back to the bridge to do a more in depth visual inspection and some additional Tooke Gage testing to measure the thickness of each coat. Winson King had taken some spot checking of the coating thickness and found that many rust spots were not meeting the specified thickness of paint. Attached to the end of the report is the dry film thickness readings taken from the experimental and control girder and readings taken from the control panels. It appears from sample testing performed that the three-coat paint system was applied

more consistent and within acceptable coating limits, but the two-coat paint system was applied inconsistently. The construction notes will also, be reviewed to determine if there were application problems that could lead to this early rusting.

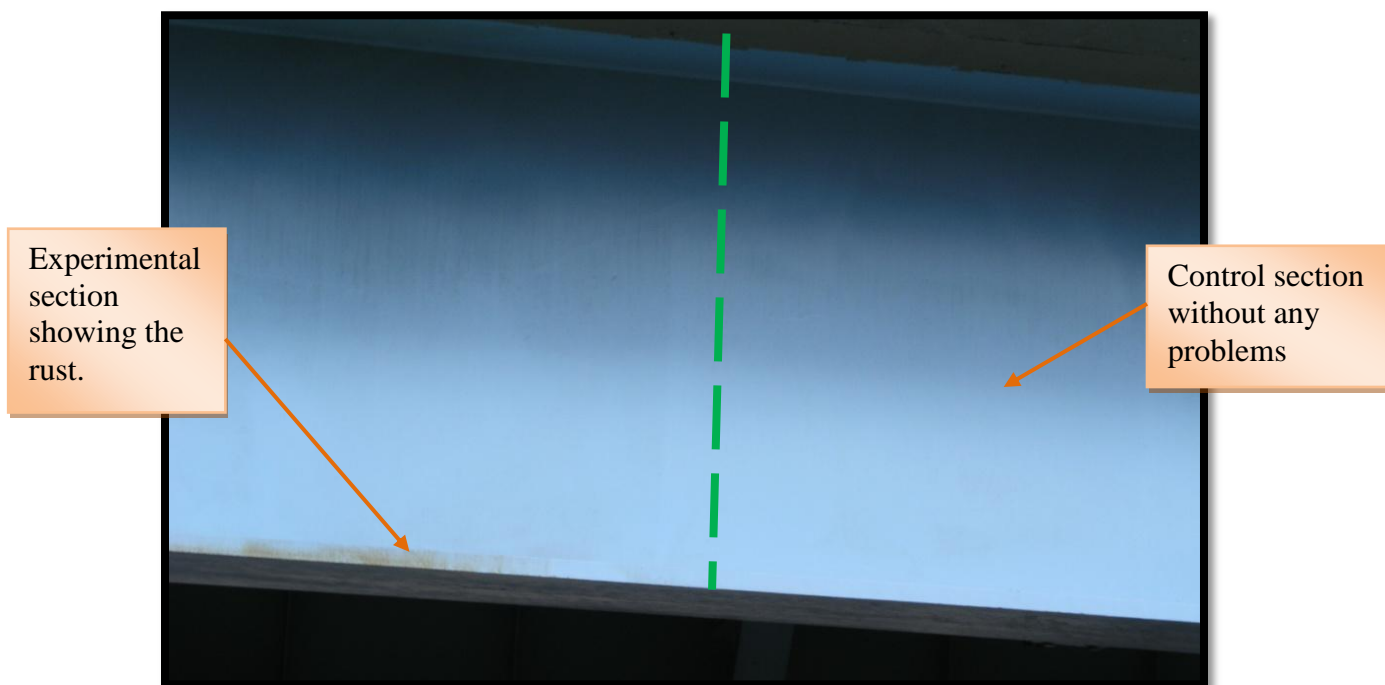
Photo 5, Shows the paint condition of the experiment and the control sections

Physical access limited by length of reach resulting in limited DFT work. Initial inspection DFT records should be reviewed for Bays 1, 2 and 3. Two Coat System is more variable and exhibited more rust on bridge. Took gauge readings should be taken in areas of pinpoint rusting, solvent issues related to initial high viscosity primer may have contributed to greater than expected presence of rust on Two Coat Areas. Three Coat Control System did not exhibit pinpoint rusting on the bridge structure. Performance of the Two Coat System was not equal to the Three Coat Control paint system applied to the structure.

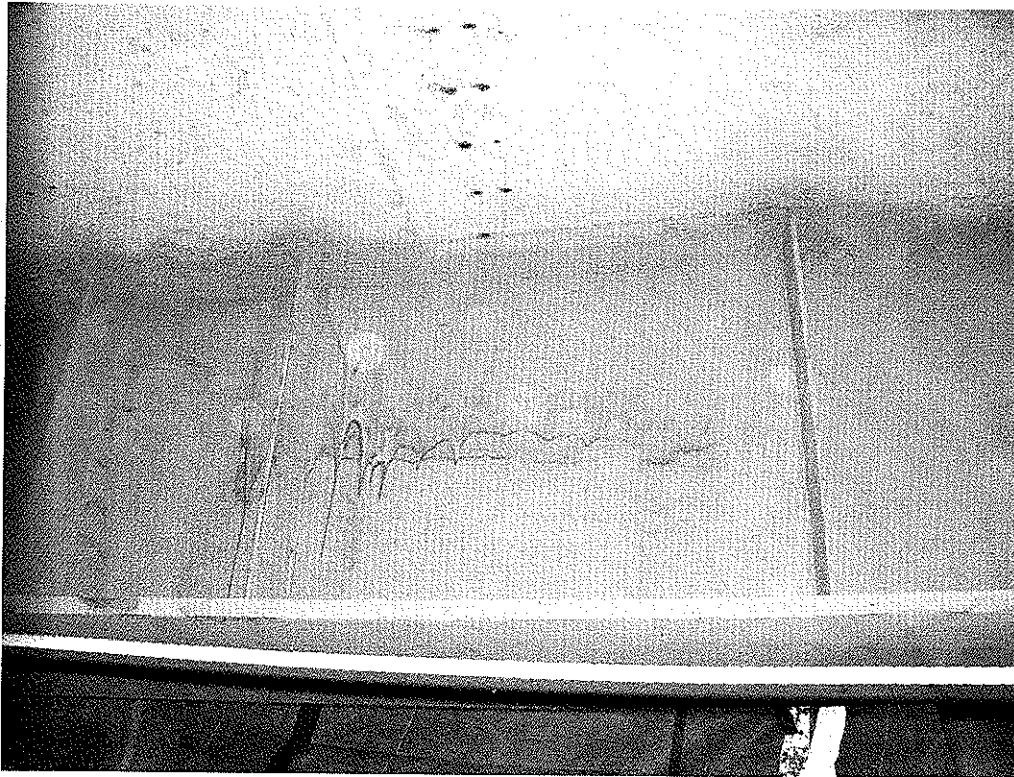
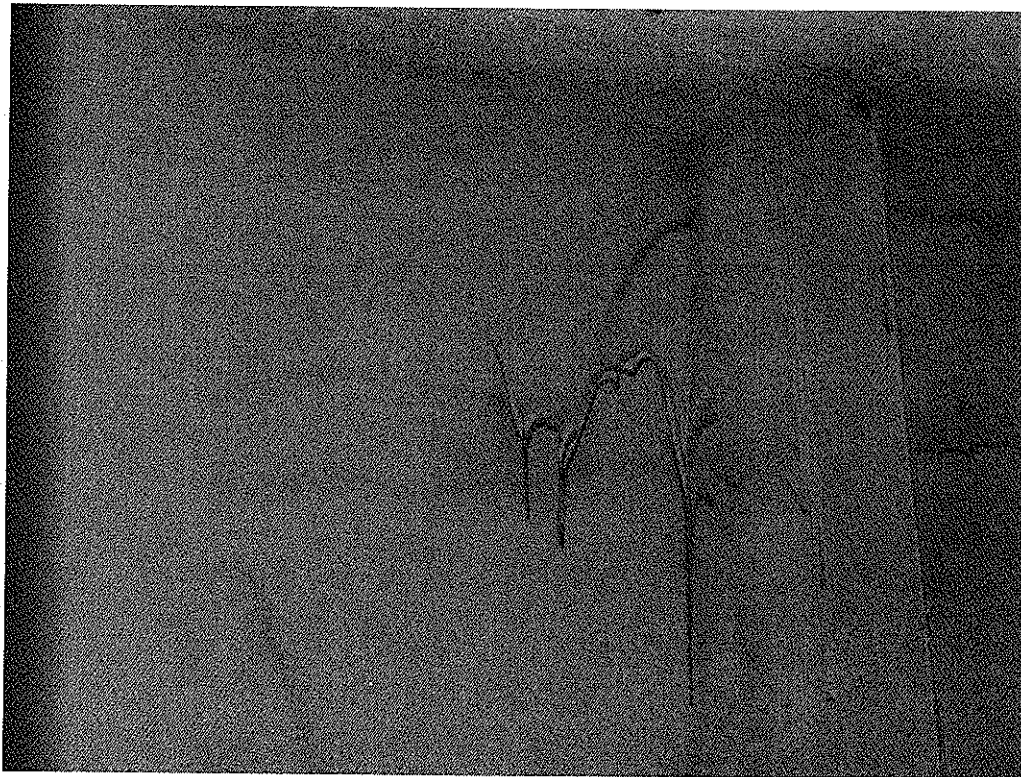
Photographs 20 through 22 show runs and sags during the initial application of Corathane I Galvapac Zinc Rich Primer in Span 3.

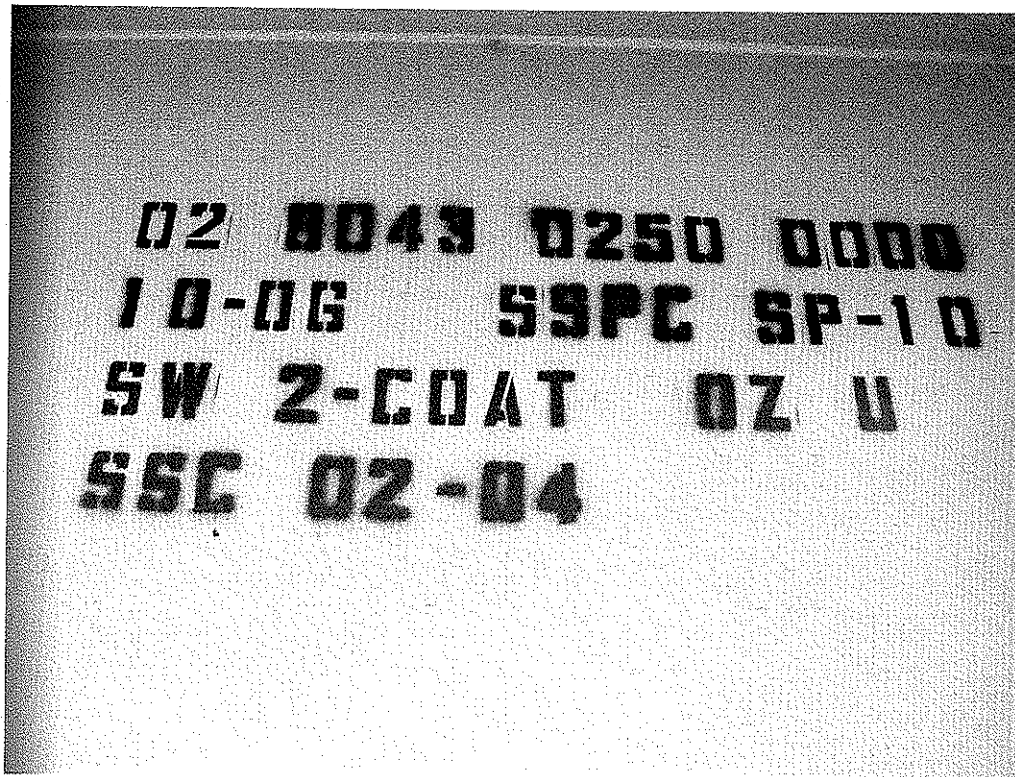
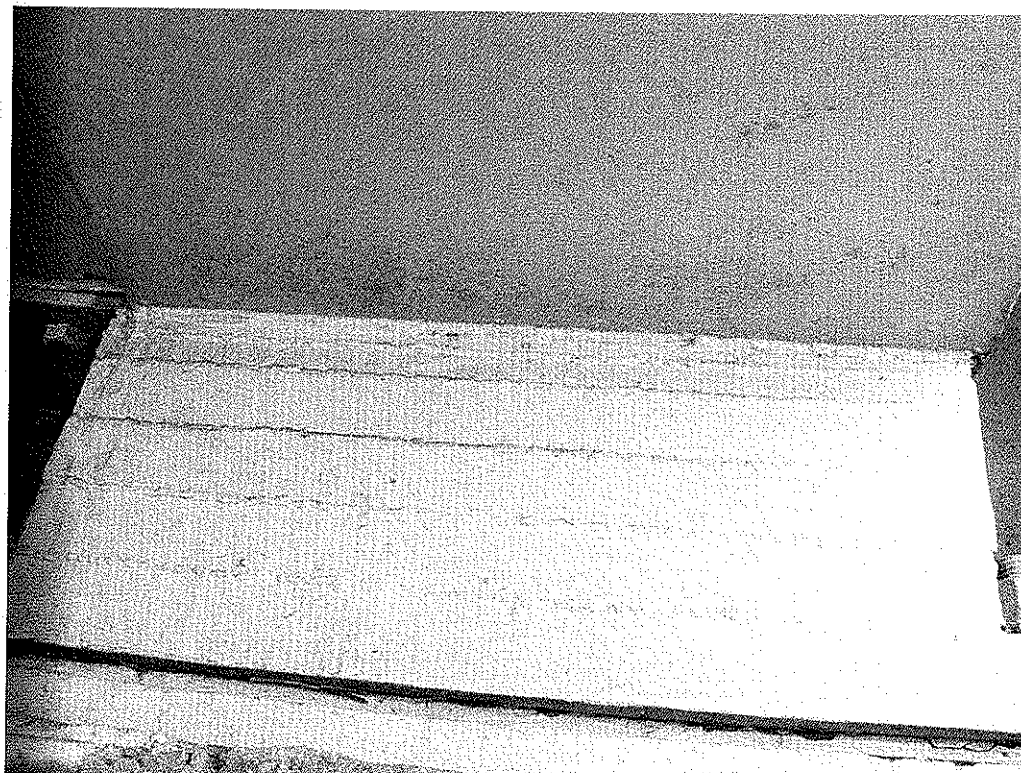
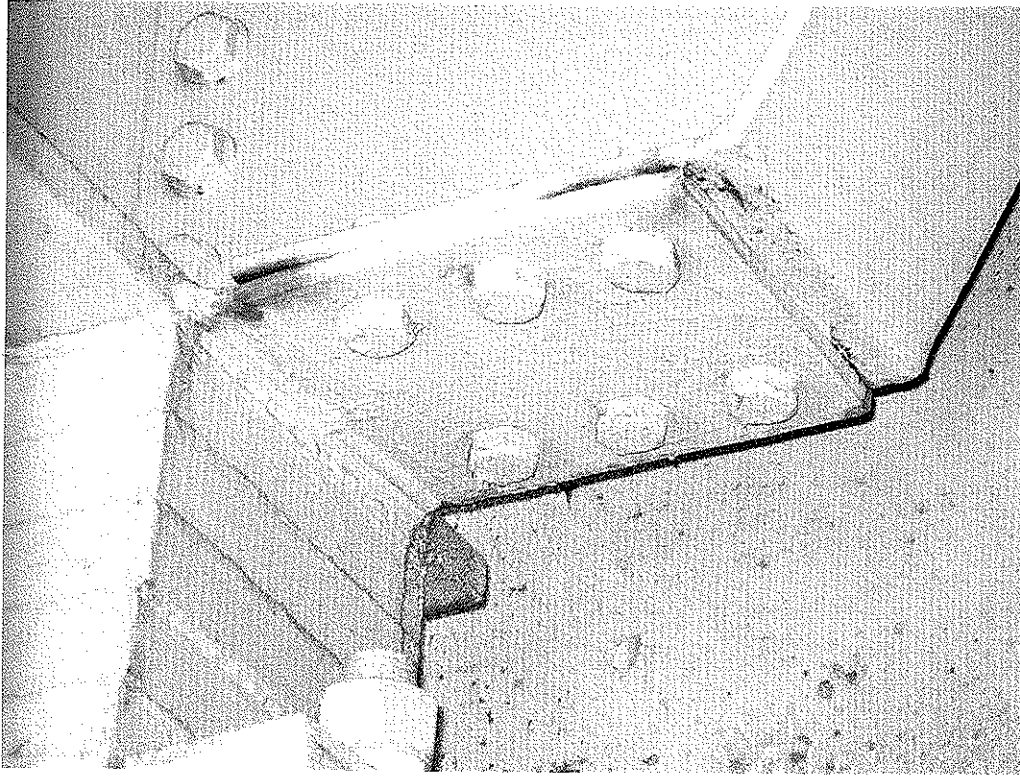
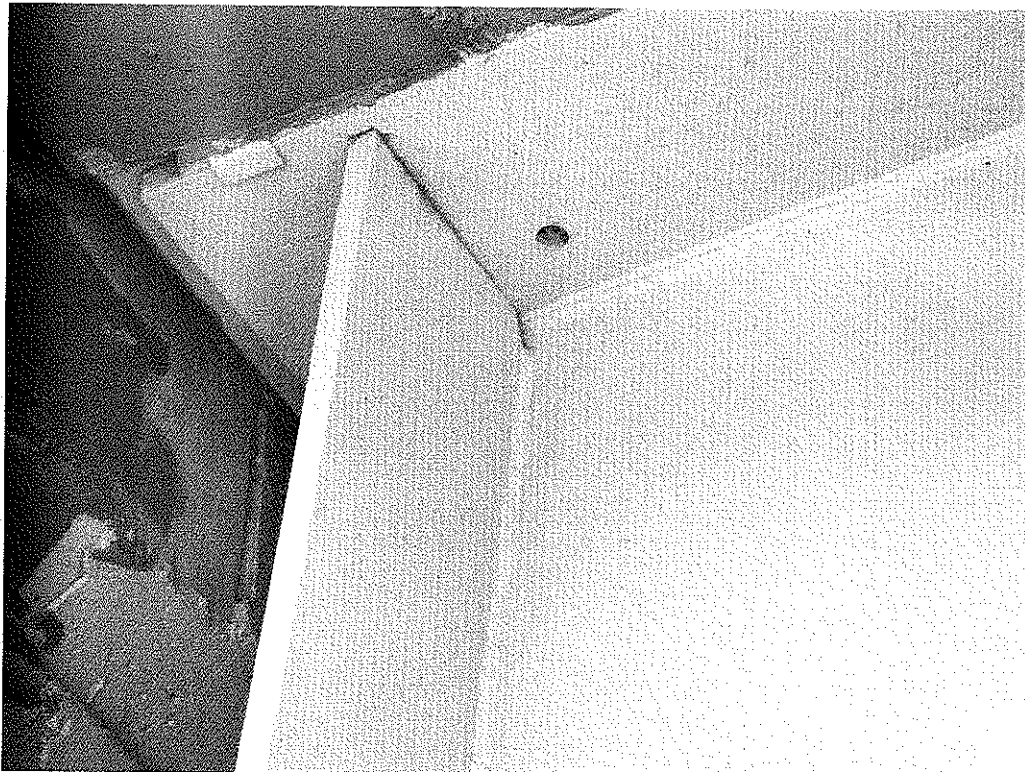
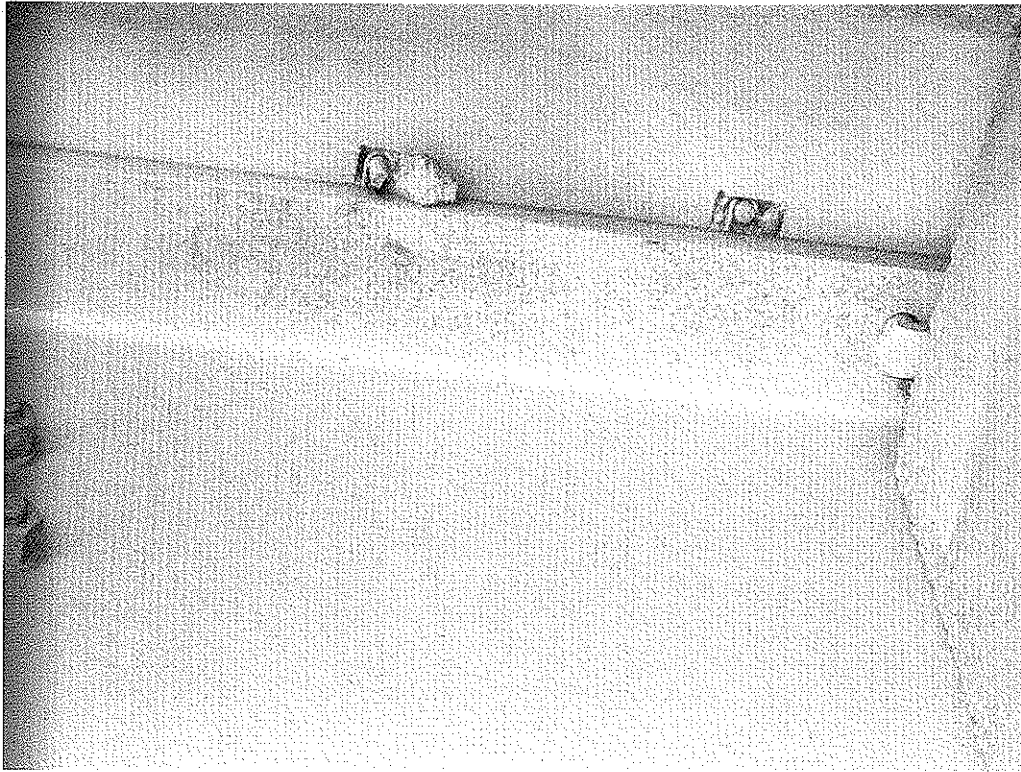
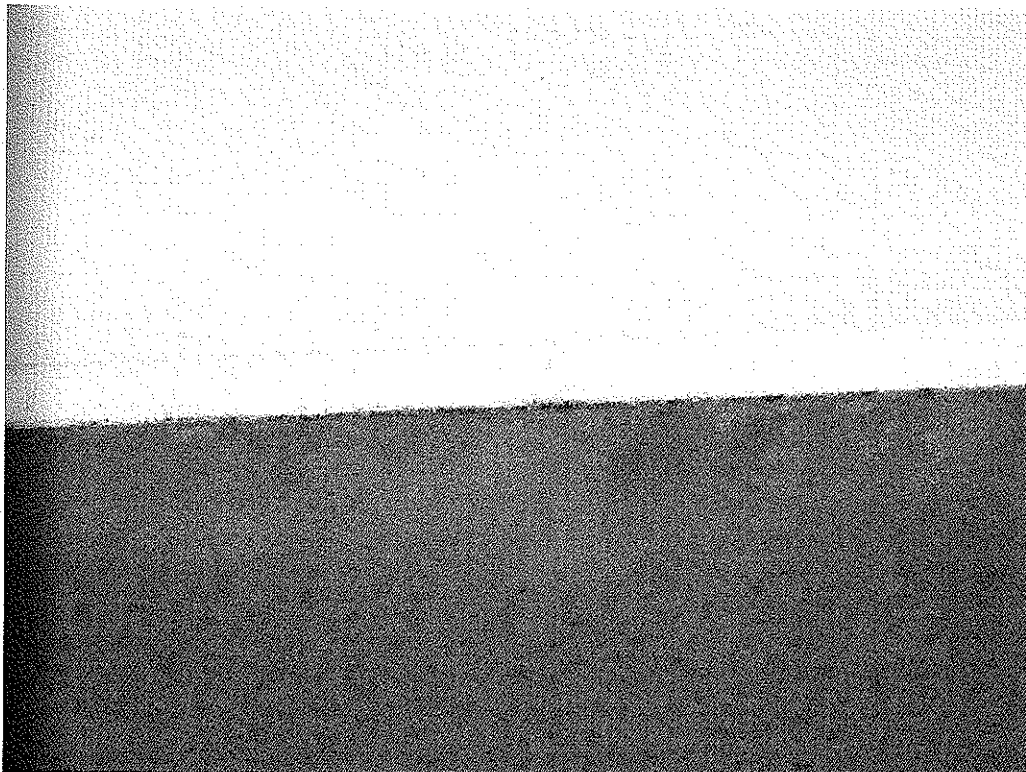
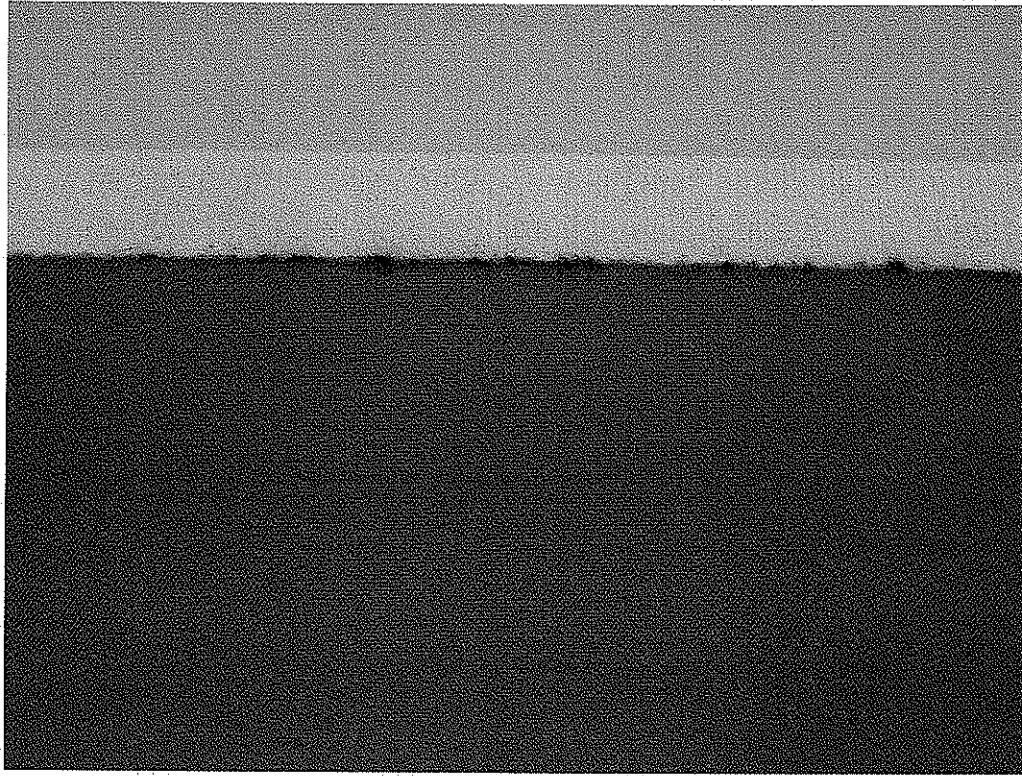
At the baseline inspection conducted in year 0 (2006), both the three-coat (OZ/E/U) system applied in Span 3, Bay 3, and the two-coat (OZ/U) system applied in Span 3, Bays 1 and 2, were in good condition. By the end of Year 1 (2007), the two-coat system in test Bays 1 and 2 displayed minor pinpoint rust along flange edges (i.e., girders, floorbeams) and bolt heads and threads. Minor staining/bleeding was observed in some crevice areas. The pinpoint rust along flange edges most closely approximated SSPC Vis-2 Rust Grade 9-P, 0.03% Rusted.

Photographs 6 through 12 show 2-coat OZ/U Control Span in Year 1, 2007. Note minor pinpoint rust on flanges/edges and minor rust stain bleed from crevice areas.

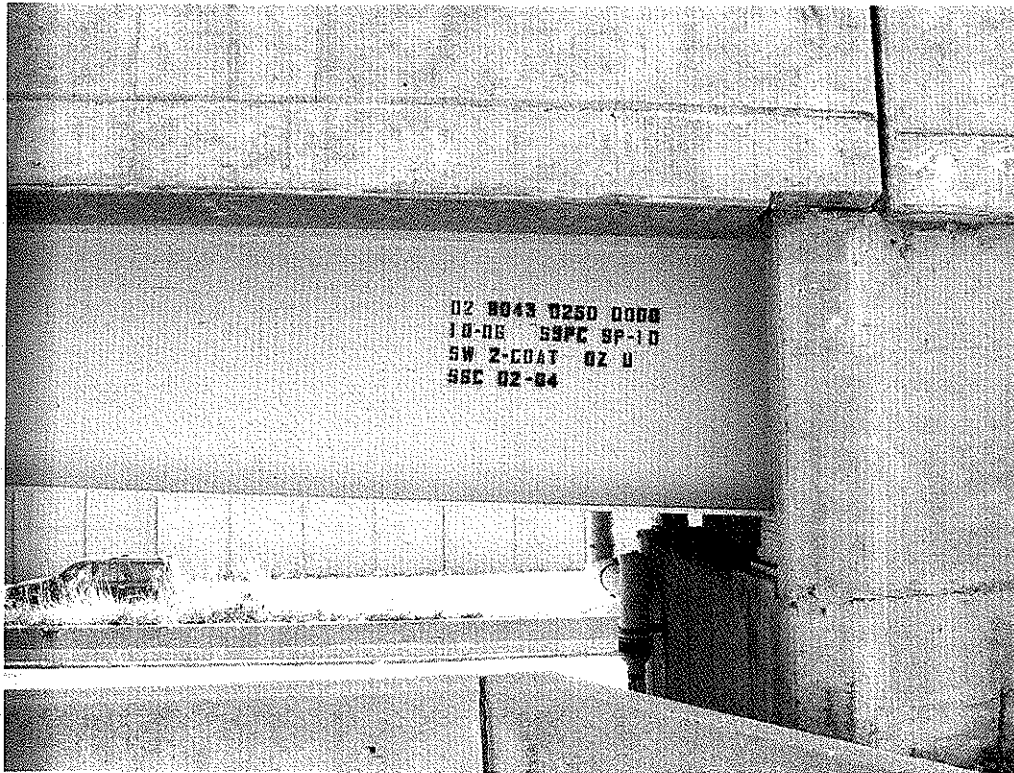
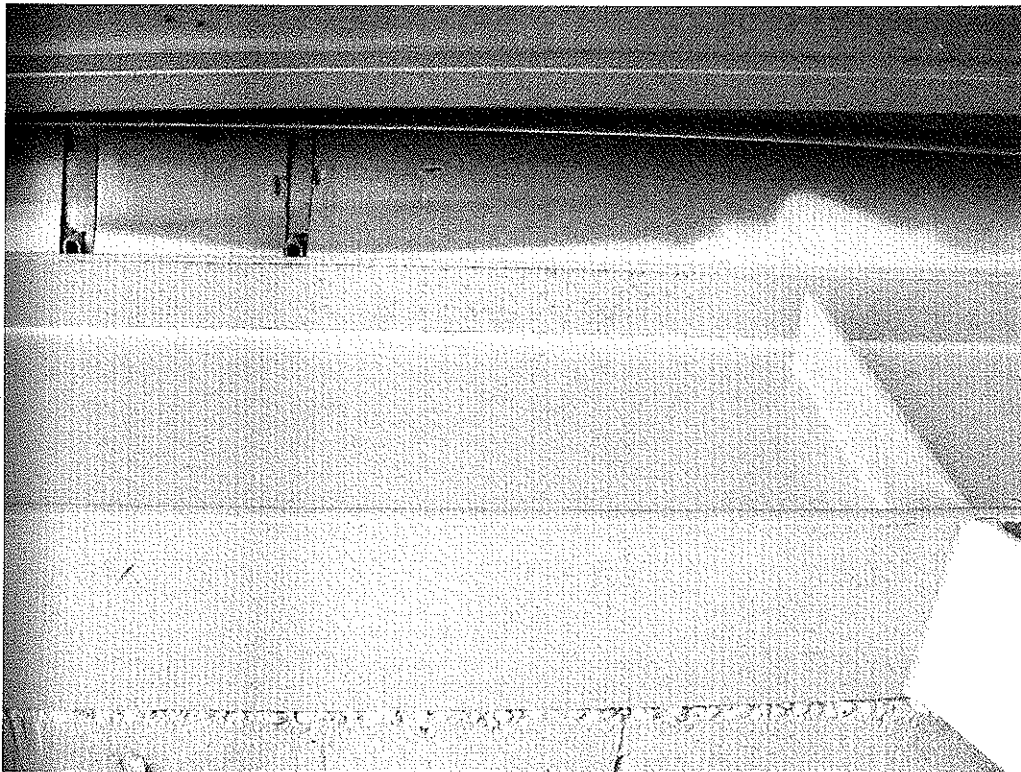
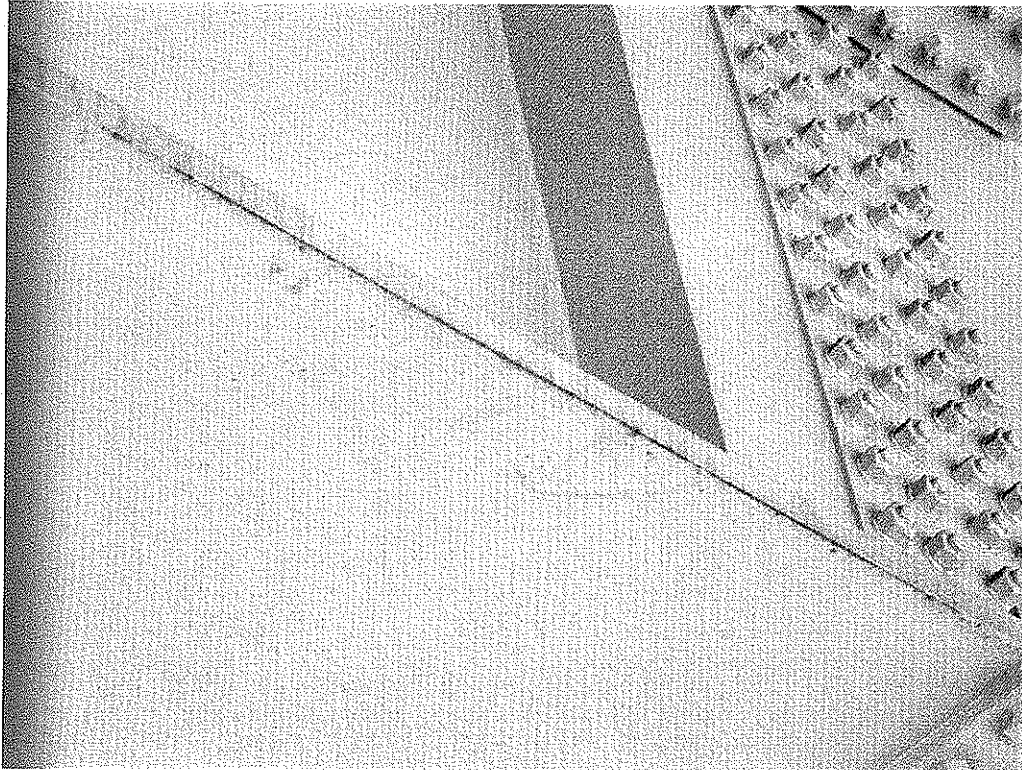
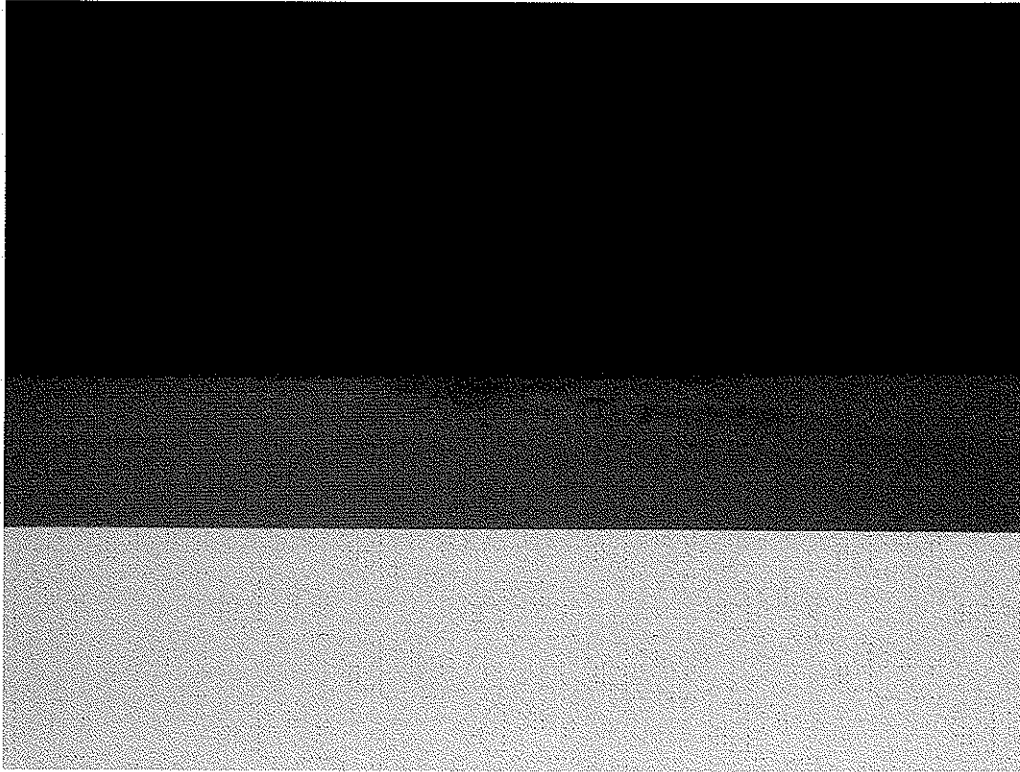
In Year 2, edge rust on flanges noted in Year 1 had increased slightly, and scattered patches of pinpoint rust also became visible on the bottom flanges, webs, and stiffeners of girders and floorbeams. The rate of scattered rusting most closely approximated SSPC Vis-2 Rust Grade 9-P, 0.03% Rusted to 8-P, 0.1% Rusted. Many of these areas had the appearance of application-related “thin spots” in the coating film.

Photographs 3 through 9 show 2-coat OZ/U Control Span 3, Bay 1 and 2, Year 2, 2008.  
Note increase in pinpoint rust on flanges/edges vs. Year 1, 2007.

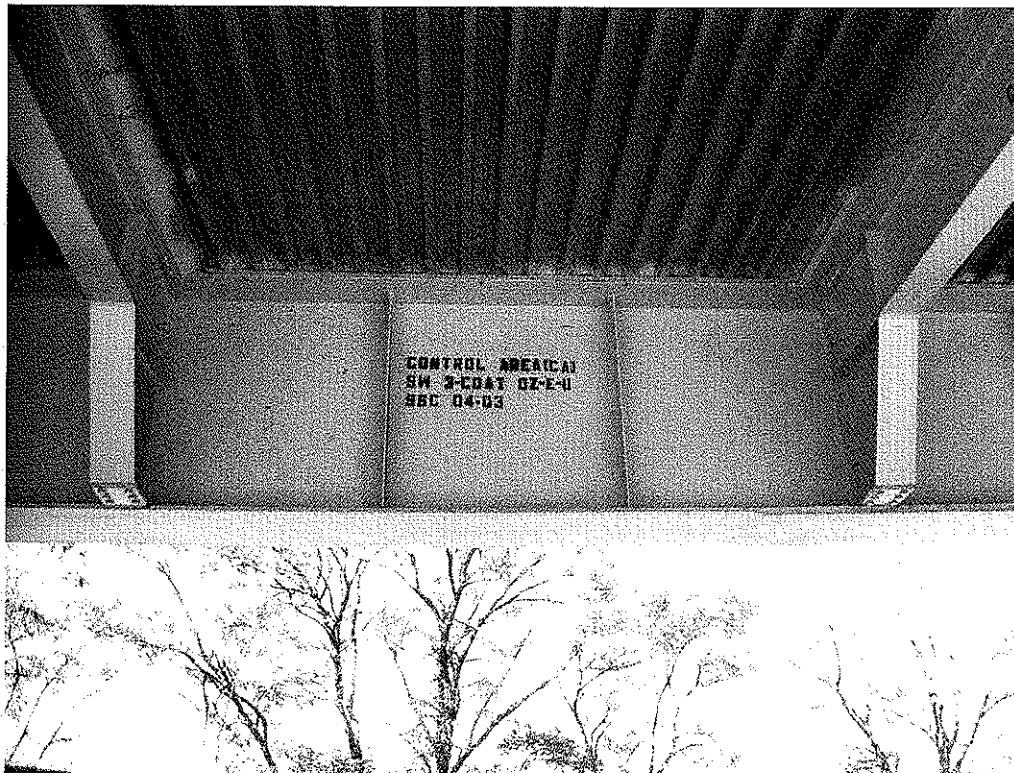
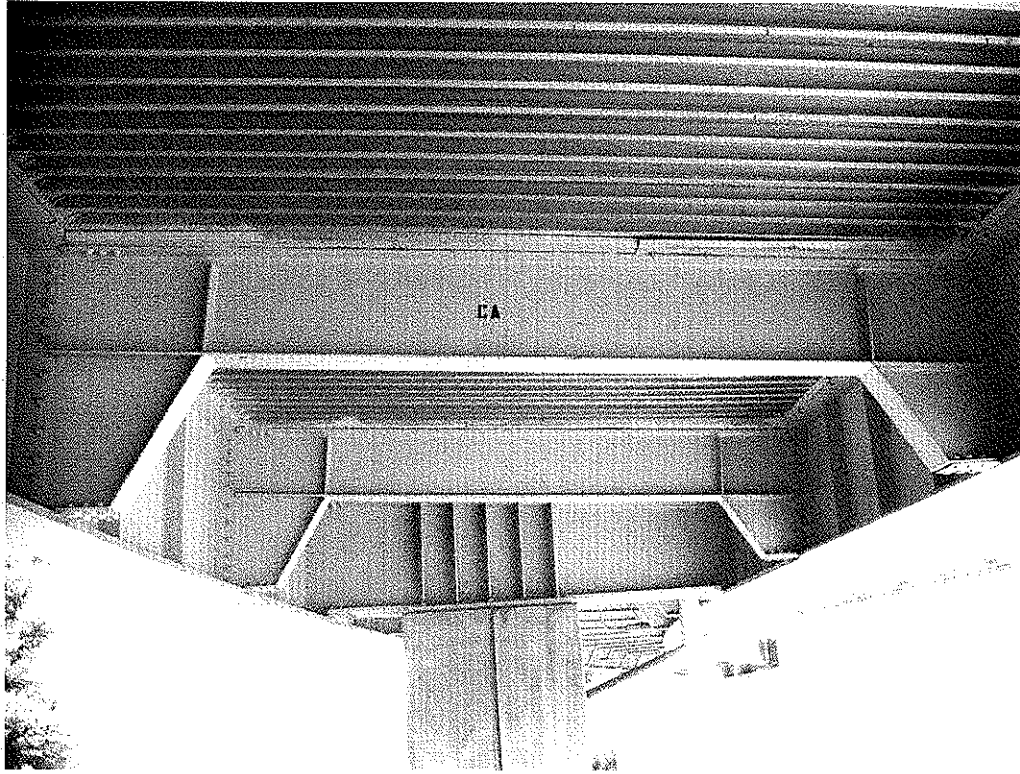
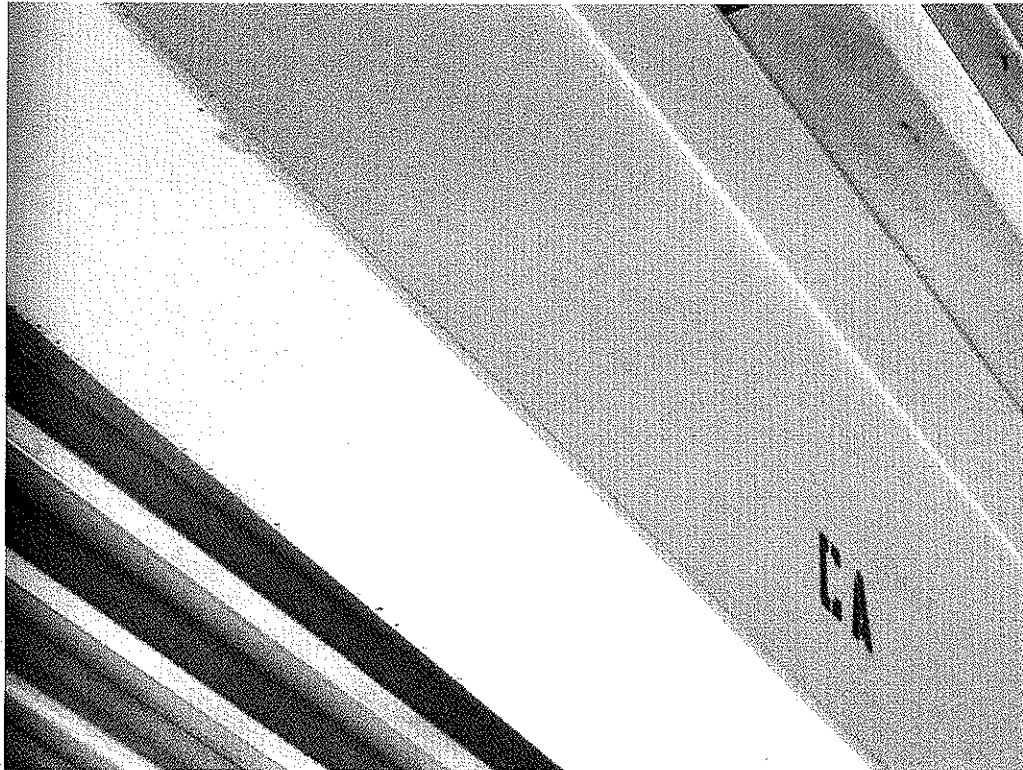
The appearance of the three-coat system in Bay 3 generally remained consistent; however, two or three minor and isolated single pinpoints of rust had formed along the bottom flange edge of a few members.

Photographs 10 through 13 show 3-coat OZ/E/U Control Span 3, Bay 3, Year 1, 2008. Only a few very minor pinpoints of rust were visible.

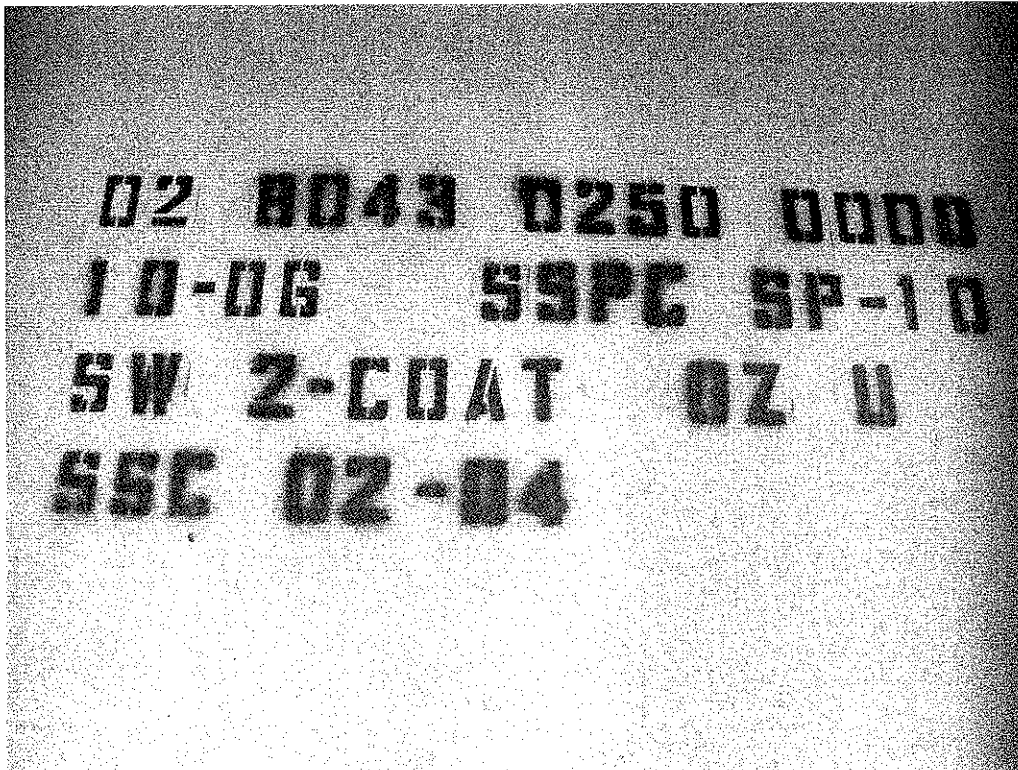
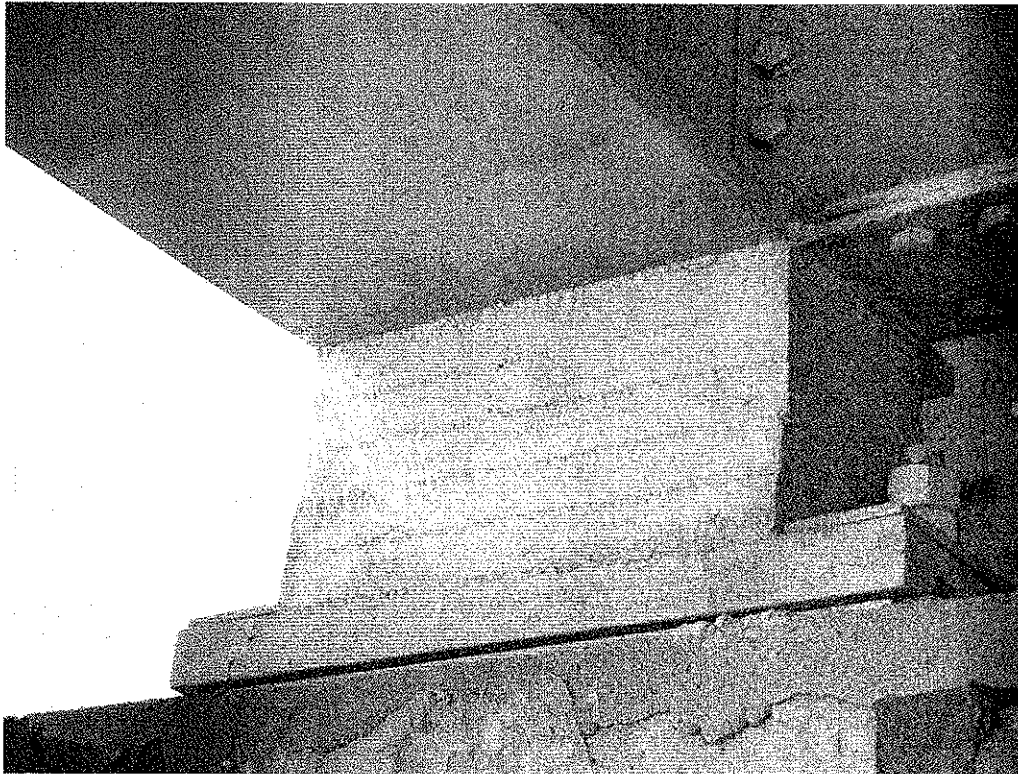
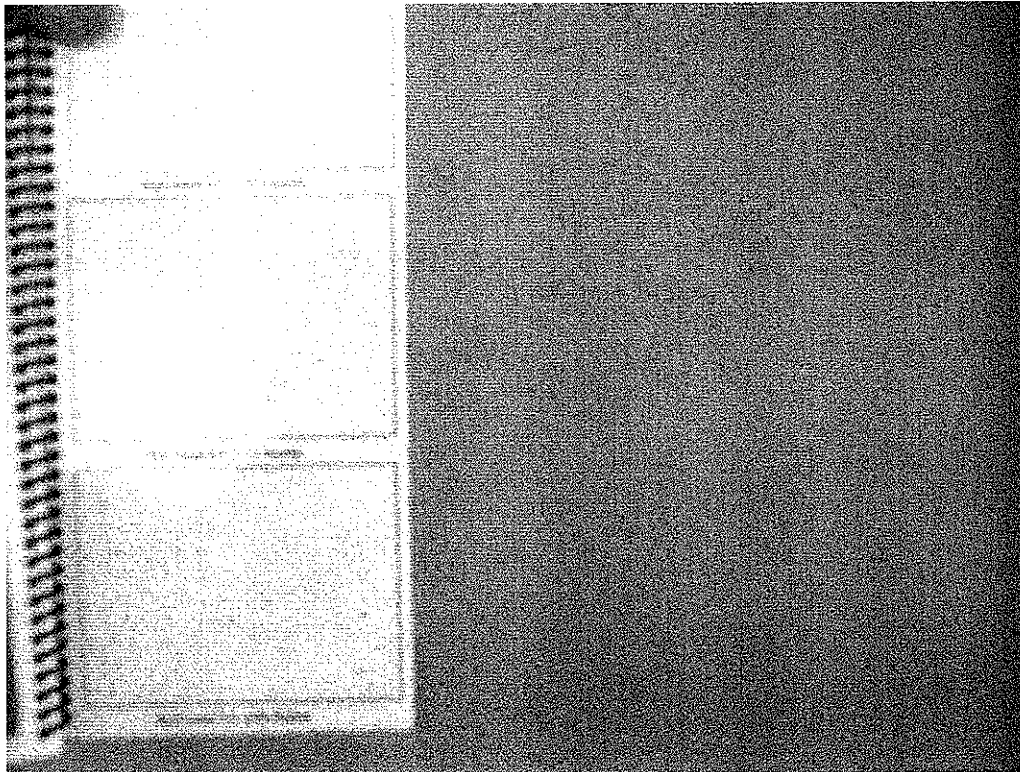
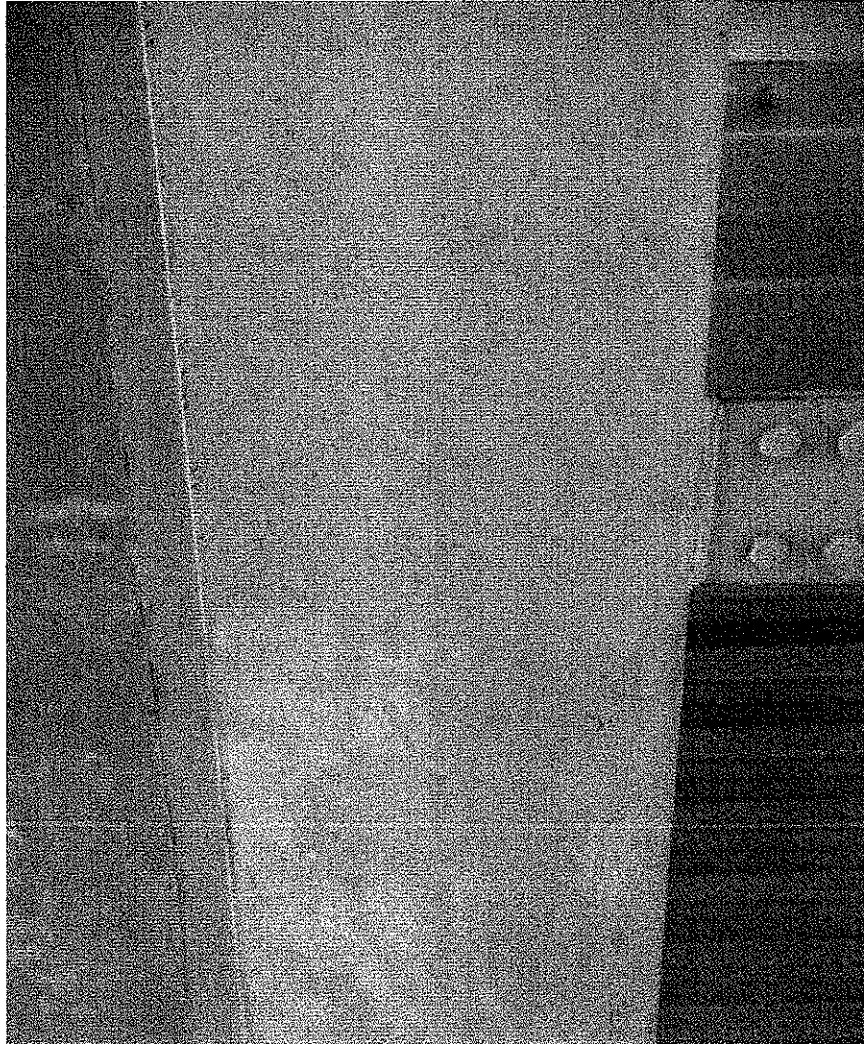
By Year 3, the edge rust on flanges noted in previous inspections had again slightly increased. Most notable was the increase of splotchy, streaky patches of pinpoint rust on the flanges, webs, and stiffeners of the east fascia girder. The rust rating of 9-P noted in 2008 increased in 2009 to a range of 8-P, 0.1% Rusted to 7-P, 0.3% Rusted. The appearance of the

spotchy, patch-like pinpoint rust area had a more pronounced application-related "thin spot" appearance than was apparent in 2008.

Photographs 1 through 7 show two-coat OZ/U Control Span 3, Bays 1 & 2, Year 3, 2009.  
Note continued increase in pinpoint rust on 1-7 flanges/edges from Year 2, 2008.

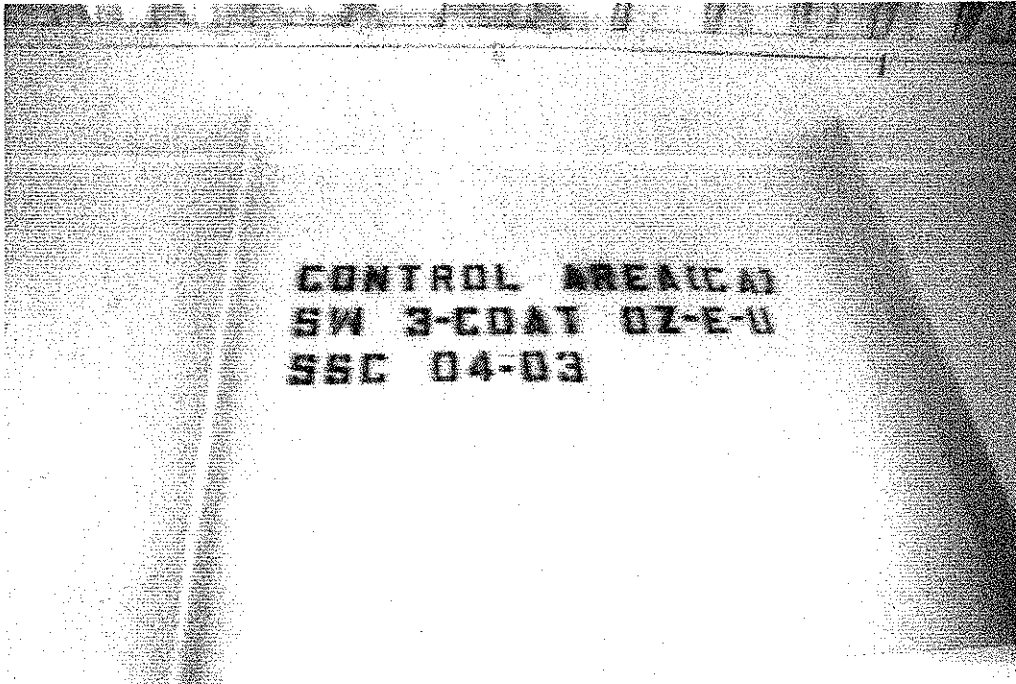
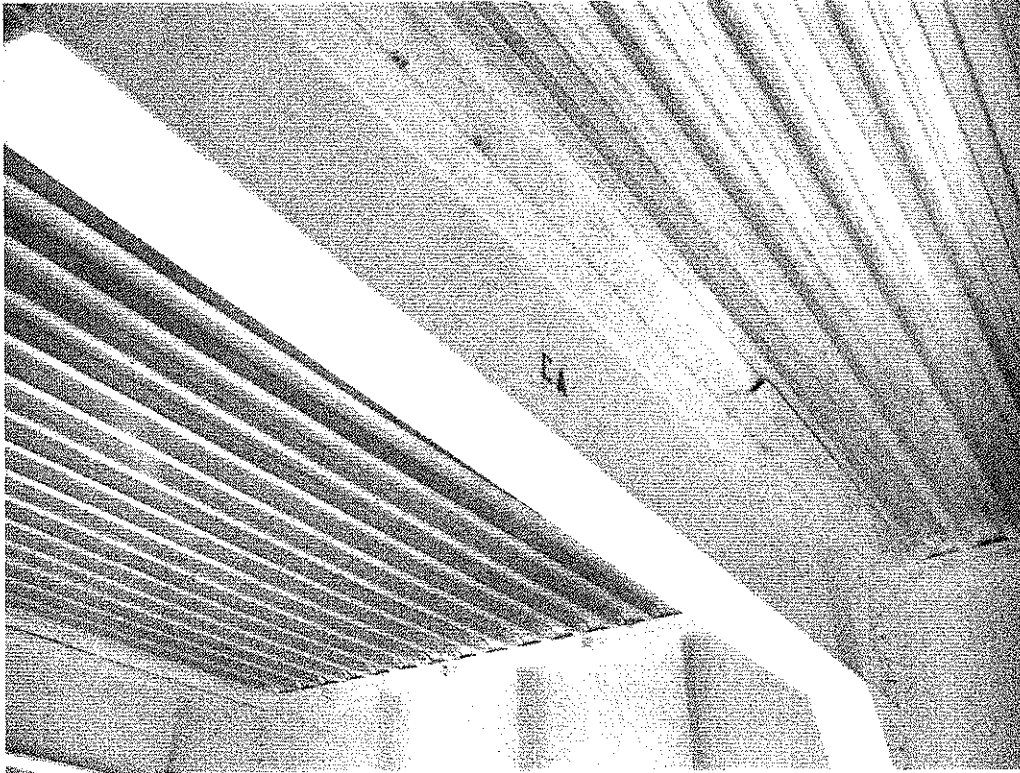
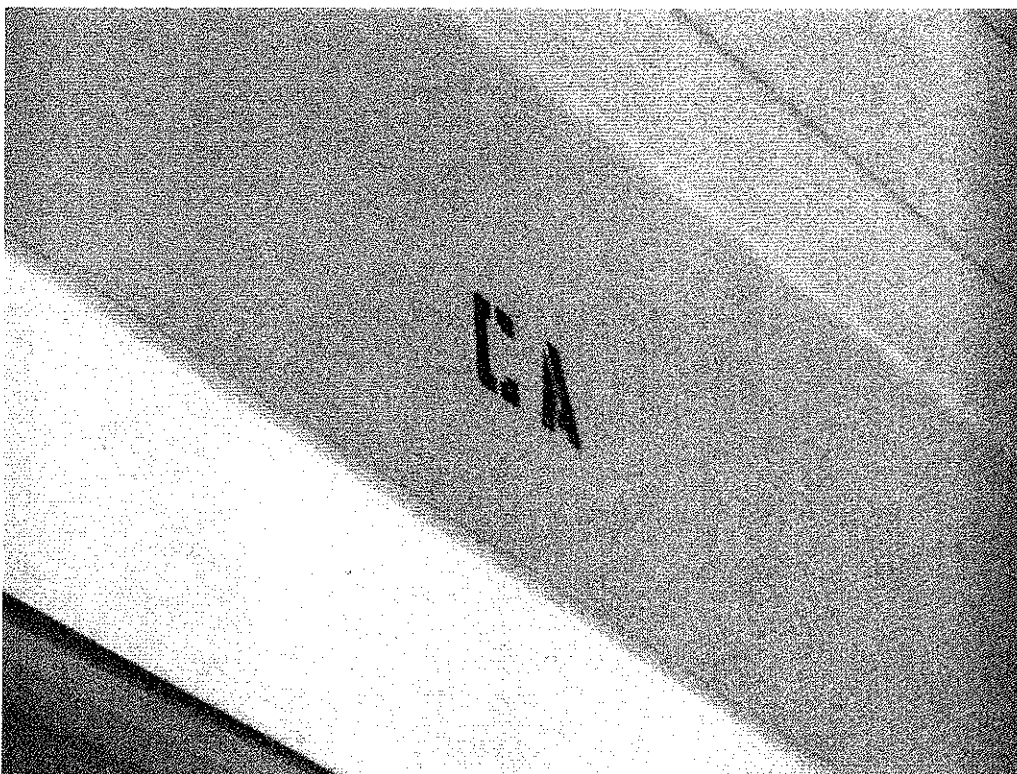
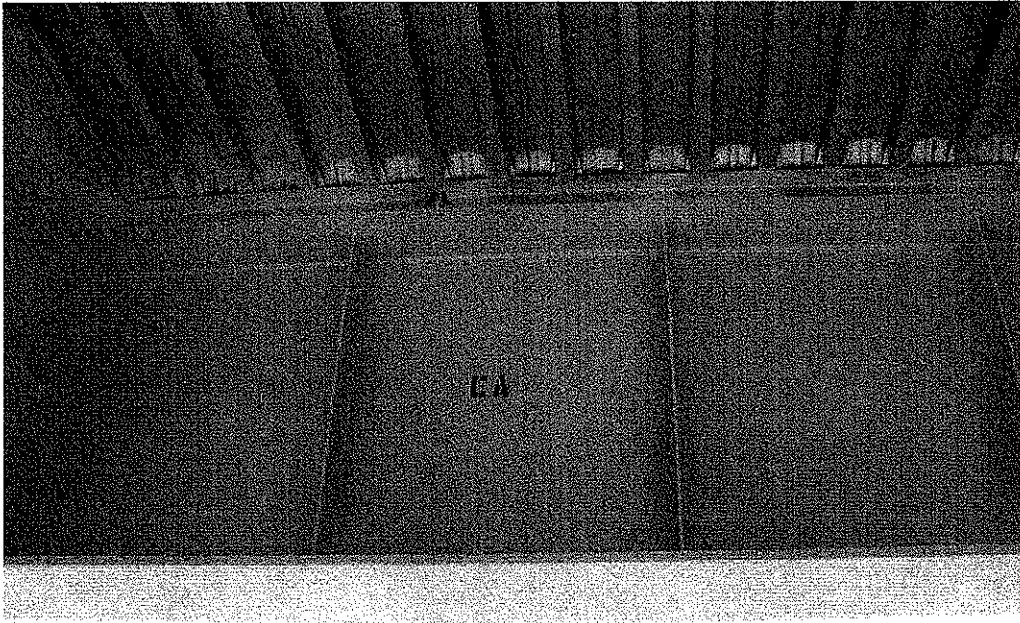
The appearance of the three-coat system in Bay 3 generally remained good. A "halo" of rust stain had formed on the coating film around the periphery of the single, isolated pinpoints of rust noted in Year 2. In addition, a few isolated pinpoints of rust were visible on the top flange of some members.

Photographs 8 through 14 show three-coat OZ/E/U Control Span 3, Bay 3, Year 3, 2009.  
Only very minor pinpoint rust was noted.
