**Research Project # 2005-051**  
**Accelerated Bridge Paint Test Program**  
**July 6, 2011**

**Introduction**

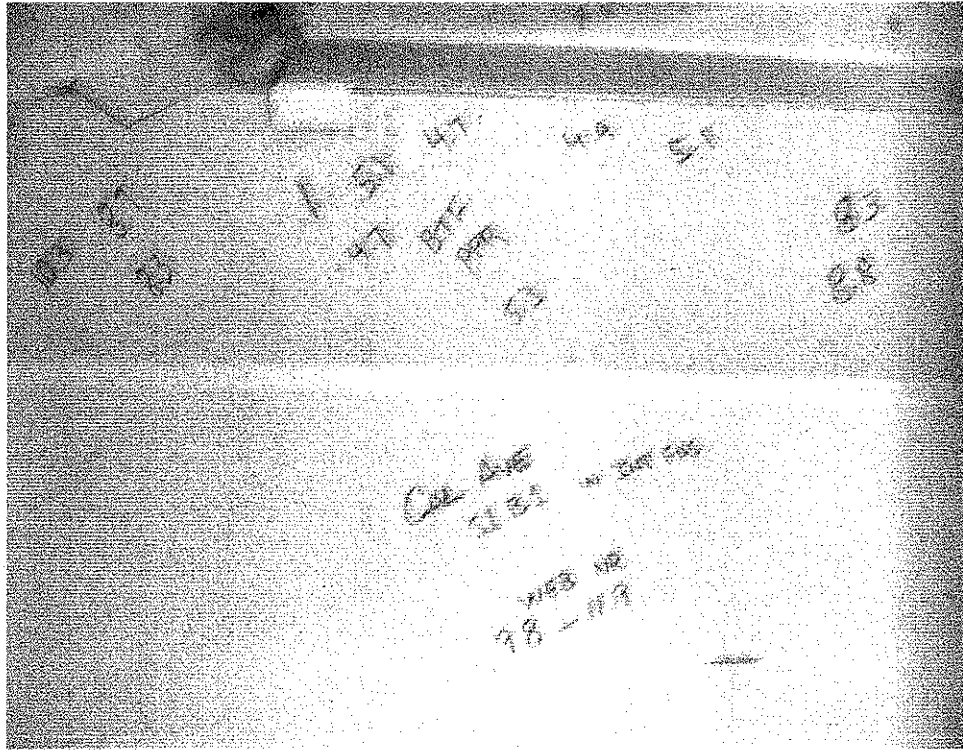
Photograph No. 15

Because the spotchy, streaky patches of pinpoint rust in the two-coat test bays appeared to be thickness related, dry film thickness measurements (both destructive and non-destructive) were performed in and around the pinpoint rust areas. The measurements clearly identified a relationship between dry film thickness and the occurrence of pinpoint rusting. In simple terms, thinner areas exhibited pinpoint rust, and thicker areas did not.

Non-destructive measurements (using a Positector 6000 Magnetic Dry Film Thickness Gage) identified that the total coating system thickness in rusted areas ranged from 4.5 to 5.7 mils. Destructive (Tooke Gage) measurements indicated that the thickness of the Corothane I Galvapac Zinc-Rich Primer ranged from 2.0 to 3.0 mils and the Fast Clad Urethane Finish ranged from 2.5 to 6.0 mils in these areas. The total coating thickness of non-rusted areas surrounding rusted areas was considerably greater, ranging from 8.3 to 13.4 mils.

With regard to the pinpoint rust problem, the pattern of pinpoint rust suggests that a uniform film of coating was not applied in these areas. A review of Daily Inspection Reports confirms that coating material (material appeared thick in the can) and spray application problems with the Corothane I Galvapac Zinc Primer (material not atomizing properly/clogging of spray gun) occurred during early paint operations. The Corothane I Galvapac Zinc Primer is a moisture-cured urethane formulation. Industry experience has shown that moisture-cured urethane formulations are more sensitive to "package stability" than other high-performance coatings such as epoxies, aliphatic urethanes, etc. In fact, special processes are needed during manufacture of moisture-cured urethanes to maintain product integrity. Unfortunately, the contractor's "learning curve" and issues associated with the application of this primer, along with product stability issues with the initial batch of primer, appear to have affected the application characteristics in early phases of the project. As a result, in spots where the two-coat system was applied too thin, pinpoint rust problems developed. In addition, the contractor used a mesh size of Black Beauty abrasive that produced a surface profile that was slightly deeper than specified (specified depth 1.5 to 3.5 mils, actual up to 4.5 mils). While profile depth problems are often encountered on field projects, they are generally overcome by making simple and slight adjustments to increase the total dry film thickness. Increasing the thickness allows for sufficient coverage on the highest peaks of the increased surface profile depth. However, in instances where material and spray application problems resulted in a non-uniform coating film being applied, the highest peaks of the surface profile may not have been sufficiently covered. These problems likely contributed to and explain why the non-uniform, thin coating film applied to spans early in the project formed scattered streaks and patches of pinpoint rust.

Photographs 15 through 18 shows dry film thickness measurement taken at pinpoint rust locations in two-coat OZ/U Control Span 3, Bays 1 & 2. Note that there was a definite correlation between the occurrence of pinpoint rust and the coating system dry film thickness. These issues are discussed in the "Discussion" section of this report.
